**Archaeological Watching Brief Report  
St Mary's Church, Church Hill  
Ringmer  
East Sussex, BN8 5JX**

**NGR: 544584 112516  
(TQ 4584 12516)**

**Faculty Consent: 2020 – 05423  
ASE Project No: 210055  
Site Code: SMR 22  
ASE Report No: 2022118  
OASIS ID: archaeol6-506802**

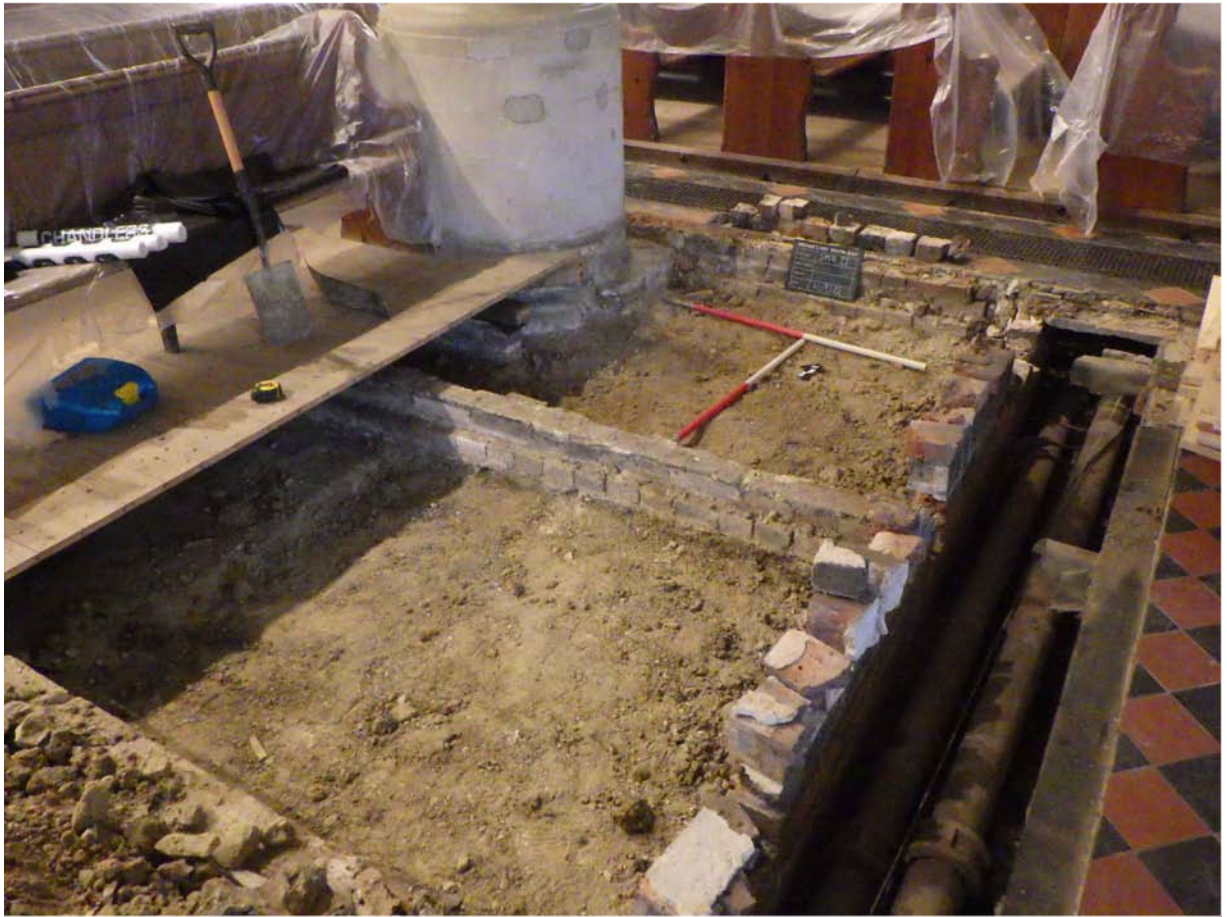
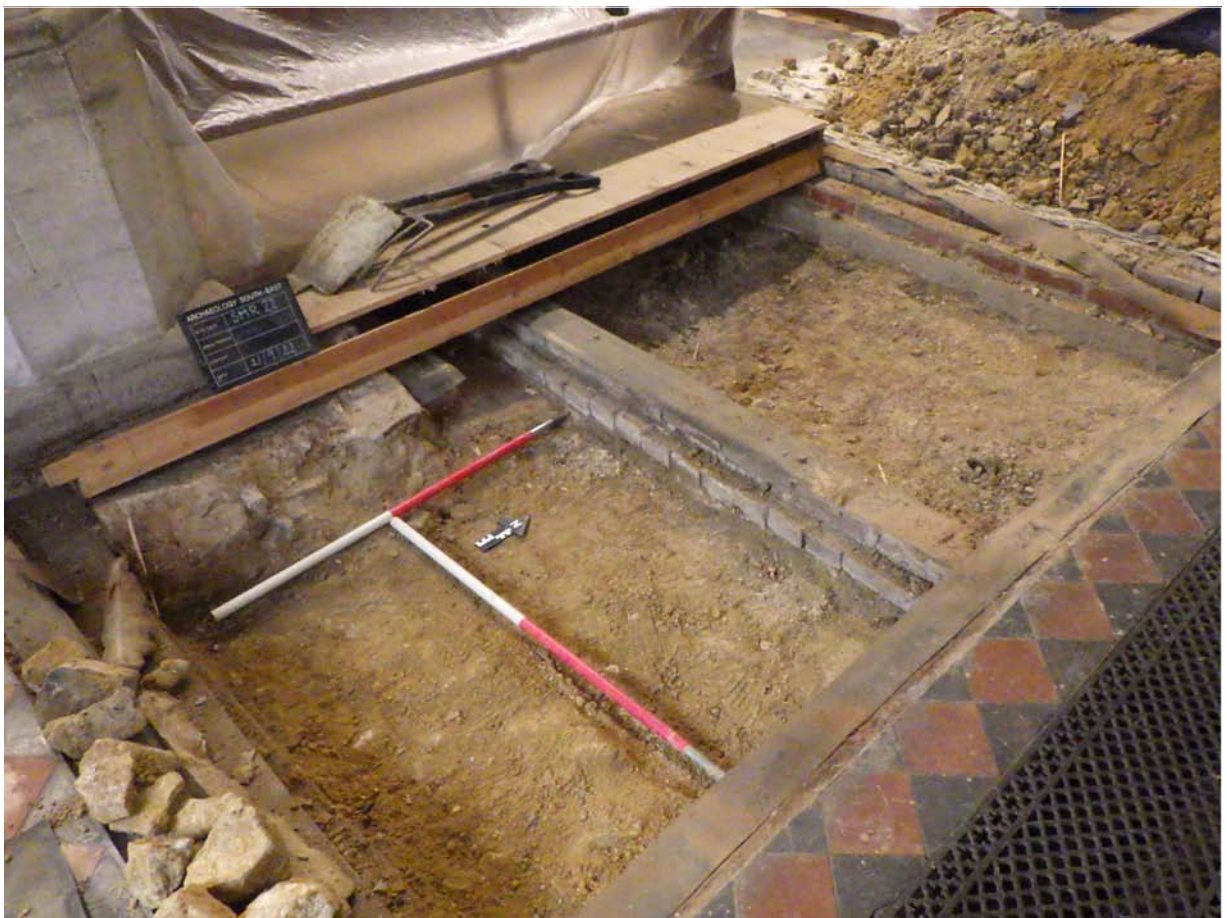
© Archaeology South-East		St Mary's Church, Ringmer	Fig.3
Project Ref: 210055	May 2022	Photographs of Monitored Areas	
Report Ref: 2022118	Drawn by: LG

4.2.3 In the north side, a light greyish white silty sand [01], with less than 0.01m was immediately above a dark greenish brown clay [02], excavated to a maximum of 0.10m in thickness. This clayey deposit contained frequent charcoal and clay flecks, but no finds were encountered.

4.2.4 In the south side, the excavation revealed a loose, mid-yellow-brown sand [03], with frequent, medium sized blocks of unworked sandstone. [03] was excavated up to 0.10m in thickness. Immediately below was [04], a chalky sandy silt deposit, which was not excavated.

4.2.5 The bases of the adjacent nave supporting pillars were partially exposed. The north pillar revealed an angular, hexagonal shaped base below the cylindrical column presently visible above ground, while the south pillar revealed an unworked, irregular stone foundation.
