The Parish Church of St Andrew, Loxton, North Somerset

Archaeological Watching Brief

Watching Brief Report

Ref: LSA 21

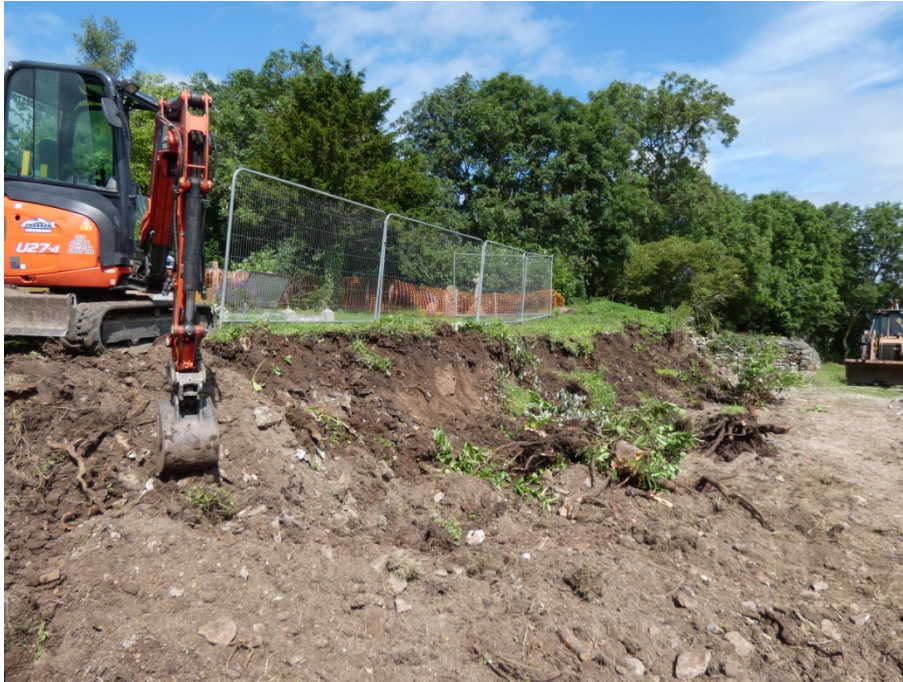
Pl. 1: View of site from S during removal of former boundary wall

2.2.1 Initially the remains of the boundary wall were removed by machine and the site prepared for the erection of the new structure under intermittent archaeological supervision. The exposed section was then cleaned manually as necessary and recorded, both photographically and through the drawing of the full 22.50m length of the exposed section at a scale of 1:50.

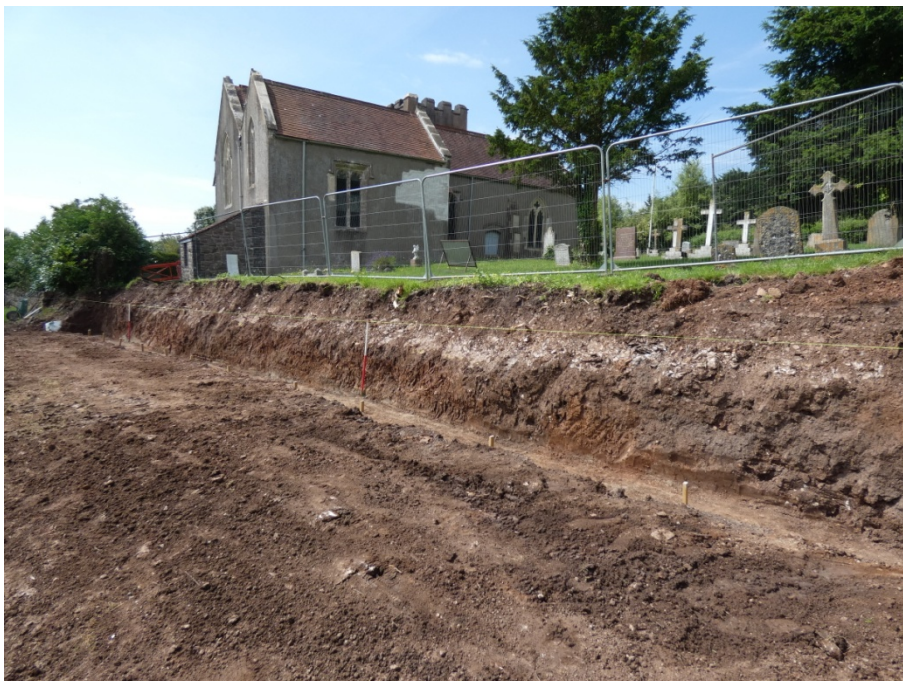
Pl. 2: General view of exposed section from NE (scales=1m)

2.3.1 A length of the former retaining wall measuring 22.75m was removed allowing access to and examination of a section through deposits to the west up to 1.75m in height. Depths of deposits provided below are given relative to the level of the surface of the ground within the churchyard rather than to that of the field to the east.

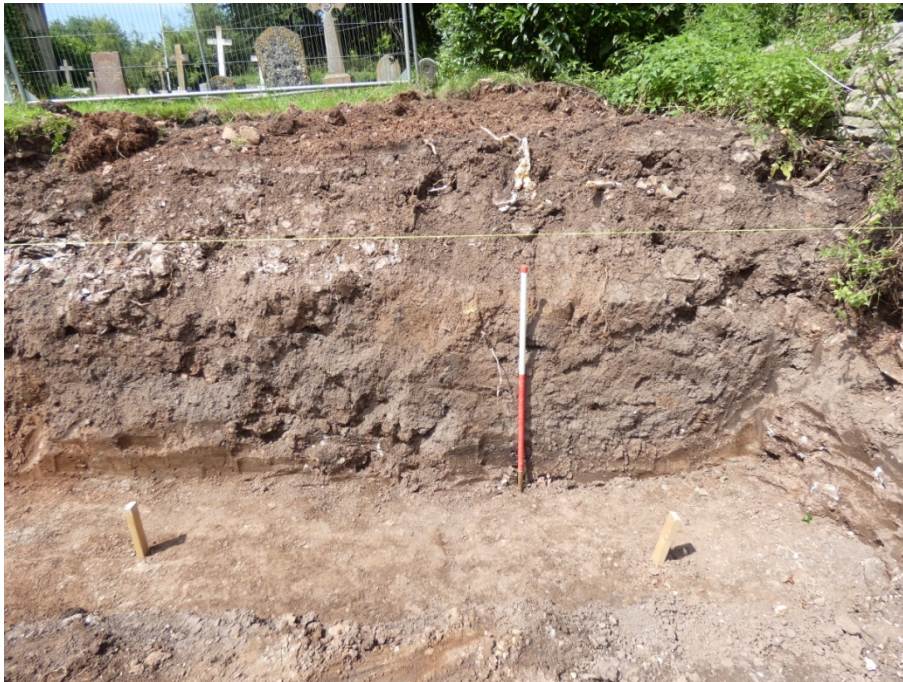
Pl. 3: E facing section through ditch [123] to N of site (view from E; scale=1m)

2.3.3 The largest of these was [123] at the northern extent of the area which was over 2m in width and aligned approximately east-west with a northern edge almost coincident with the existing north boundary wall of the churchyard (113). Feature [123] contained four fills, the lowest of which, [122], was most likely the result of prolonged weathering and silting during the period of use of the ditch and contained a high proportion of charcoal but very few other coarse components (pl. 3). This was overlain within the feature by a sequence of three possibly increasingly deliberate backfill deposits of which (121) contained a high density of limestone rubble, concentrated along the southern side some of which showing sides of having been burnt. Immediately south of [123] substrate (124) was cut by probable east-west aligned linear [118] containing a single fill of silty-clay (117) yielding abraded limestone and charcoal flecks (pl. 4). Feature [116] lay towards the south of the area and represented a large probable steep-sided linear on an approximate east-west orientation. This contained a lower fill of compact silty-clay (115) with inclusions of charcoal and small abraded limestone sealed by silty-loam (114) which contained similar, if more frequent, inclusions. Unfortunately none of the features in this group contained readily datable material.

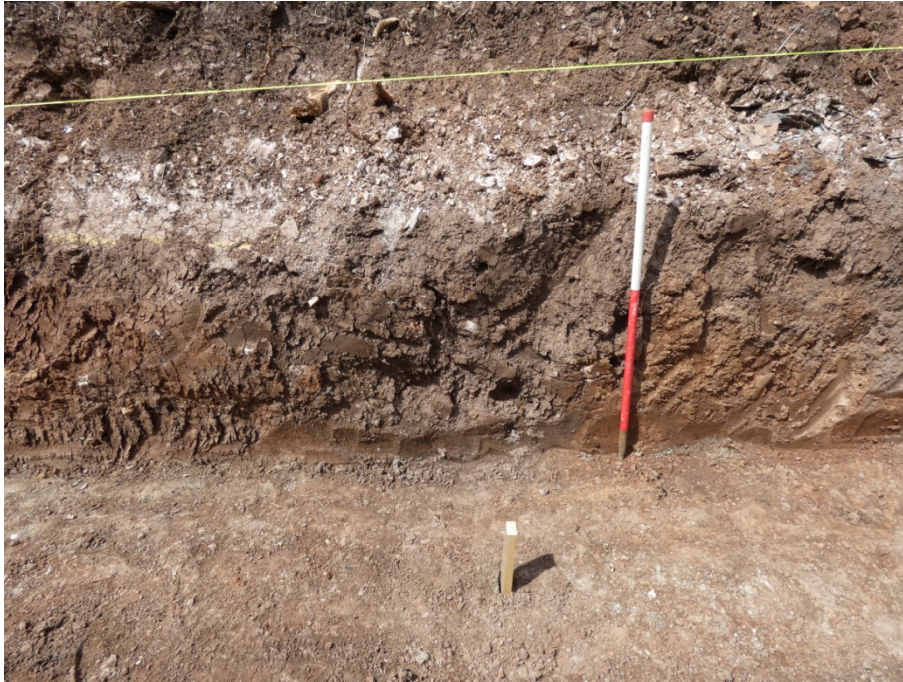
Pl. 4: E facing section through probable ditch [118]; picture also shows adjacent horizons including demolition deposit (103), above (view from E; scale=1m)

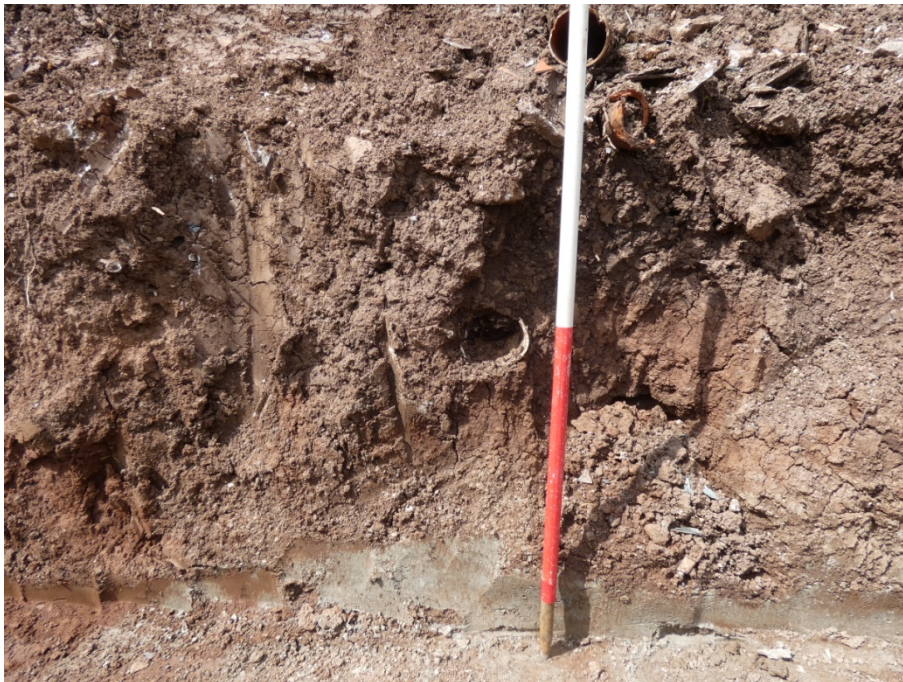
Pl. 5: Part of southern area of investigation showing ?in situ skull in [133] (centre) & truncated leg bones of inhumation in [131] (left) (view from E; scale=1m)

2.3.4 The upper fills of these three, potentially early features were sealed by an extensive build-up of dark grey-brown clay-loam (112) most probably representing an accumulation of top soil over a prolonged period at the level of a former ground surface. Present within this material and contained grave cuts penetrating through to lower horizons, were four articulated inhumations, or parts thereof all concentrated to the south of the area, immediately to the east of the church itself. These were all supine and extended and orientated east-west with lower limbs laid to the east. Each had been truncated at different points by the later terrace formed during the construction of the boundary wall and, in the case of burial (133) only the skull remained undisturbed (pl. 5). The grave cuts did not appear to be discreet and formed two intercutting pairs. A fifth burial was noted to the south of the area of investigation where foot and lower leg bones were found to have weathered out from behind the surviving length of wall here.

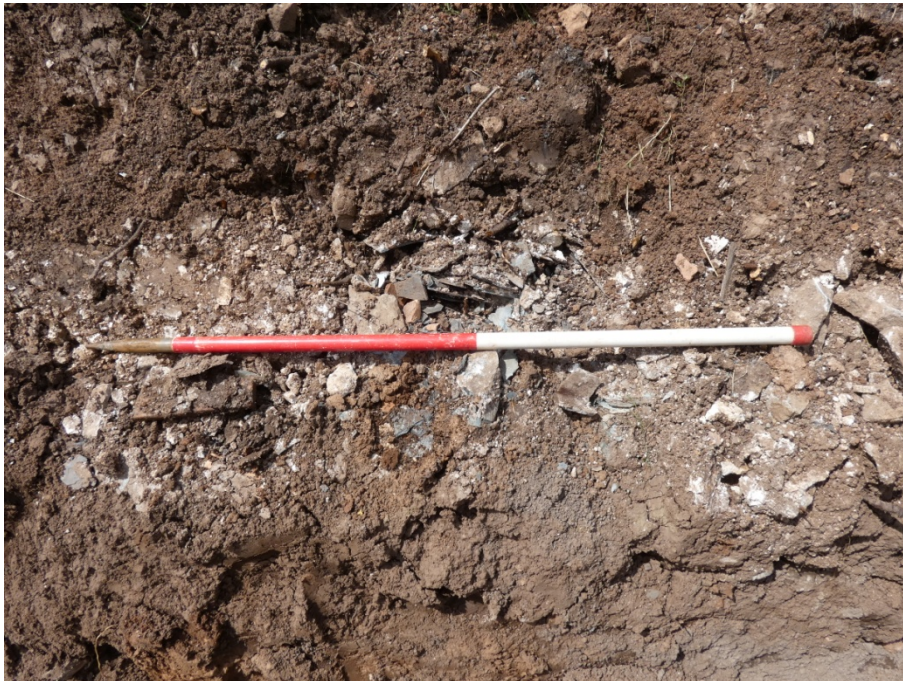
Pl. 6: Detail of demolition deposit (103) (view from E; scale=1m)

2.3.5 Probable former ground surface (112) and the associated grave fills were subsequently overlain by an extensive deposit of mixed soil and building waste (103), consisting predominantly of lenses of lime wall plaster, Mortar Slate roof tile fragments and limestone rubble (pl. 4 & 6). Also within this material were fragments of glazed medieval ridge tile. Deposit (103) was cut in the centre of the area by a small waste pit [105] containing 19th century material and finally overlain by a build-up of modern topsoil and turf (102) to the level of the modern ground surface within the churchyard. Following the development of (102) a depression seems to have remained in the area adjacent to the northern boundary wall which was later in-filled by the deposition of limestone rubble and soil (100).
