ST. MARY'S CHURCH,
WYCLIFFE, COUNTY DURHAM.

REPORT ON AN ARCHAEOLOGICAL INVESTIGATION

OSA REPORT NO: OSA22WB03

May 2022

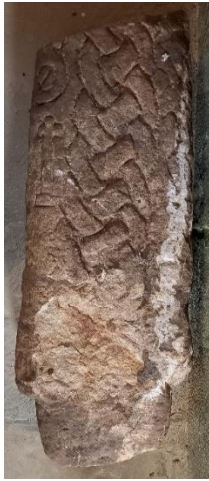
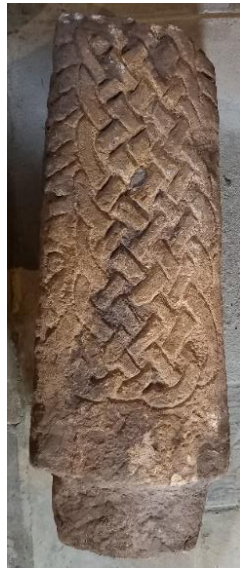
A (*broad*). Above the damage to the lower portion of the shaft, this face is filled with a clear and well-formed wide-band regular four-strand interlace pattern of Type Ai (Cramp, 1984: xlv). Approximately two-thirds of the way up the length of the shaft on the left-hand side the outline of a small free-armed cross set in a squared base has been incised beside the interlace; above it is a circular motif filled a small circle divided diagonally down the centre to create to half-spheres. Above this motif a plain wide band extends up into the break at the top of the stone (see detail)

B (*narrow*). This face of the shaft is filled with a coherently laid-out pattern of Borrestyle ring-chain, a motif characterised by a central run of truncated triangles flanked by side loops (Kershaw, 2010: 2); here, this is bounded horizontally approximately one-third up from the base of the shaft.

C (*wide*). This face is filled by a wide band regular six-strand interlace pattern of Type Ai (Cramp, 1984: xlv). Towards the top of the shaft, on either side, are a series of curved sloping incisions that appear to create the impression of cable edge-moulding, but they do not run the

D (narrow). Like B, this face of the shaft is filled with a regular run of Borrestyle ring-chain.

The tapering form of this fragment, along with the tenon leave little doubt that it once formed the lower portion of a cross-shaft, while the presence the Borre style ring-chain on the two narrow faces means that it can be fairly securely dated to between the mid-9th and 10th centuries (Kershaw, 2010, 2-3). This was an early Scandinavian motif used to decorate a wide range of media and takes its name from its appearance on a number of objects recovered from a ship-burial at Borre in Norway (Wilson, 1976: 502). It is found on a large number of artefacts recovered from across Britain, and on Anglo-Scandinavian sculpture is featured most famously on the 10th century cross at Gosforth, Cumbria (Gosforth 1, Bailey and Cramp, 1988: 100-104). It is not, however, found elsewhere in this area of Co. Durham and what was North Yorkshire (Cramp, 1984; Lang, 2001). This has interesting implications for the distribution of this distinctive feature in the Anglo-Scandinavian sculpture of the Danelaw that warrants further research. The wide band interlace pattern on both the wide faces of the shaft (A and C) also helps date the monument to this period of sculptural activity and, unlike the distribution of the Borre style ring-chain, is found elsewhere in this area (Lang, 2001: 28). Furthermore, the distinctive manner in which the patterns have been arranged across the shaft, without being set within defined panels or contained by edge-mouldings, is a feature of a shaft from Chester-le-Street, Co. Durham, that has been dated to the late 9th century (Chester-le-Street 1, Cramp, 1984: 53-54) and Haxby in North Yorkshire, dated generally to the 10th century, where the wide band interlace pattern, Type Ai, also features on one of the broad faces, A (Haxby 1, Lang, 2001: 124).

While these patterns help to date and situate the shaft within the wider regional context of sculptural decoration, the motif of the outline cross in a base on A is without precedence in the corpus of extant Anglo-Saxon sculpture, of Anglian or Viking-age date, and is of considerable symbolic significance. Although not stepped, the base is large and recalls those that survive across the island of Ireland, and which can be found, less commonly, in Britain: at Lindisfarne on Holy Island (founded by the Columban mission from Iona), for example, or at Whitby, in North Yorkshire (founded from Lindisfarne), which have been dated to the eighth through 9th centuries (Lindisfarne 19, Cramp, 1984: 201; Whitby 55 and 56, Lang, 2001: 265-266). In most cases, the cross bases extant across the region were probably intended to be buried allowing the cross to appear as if planted in the ground (see Hawkes,

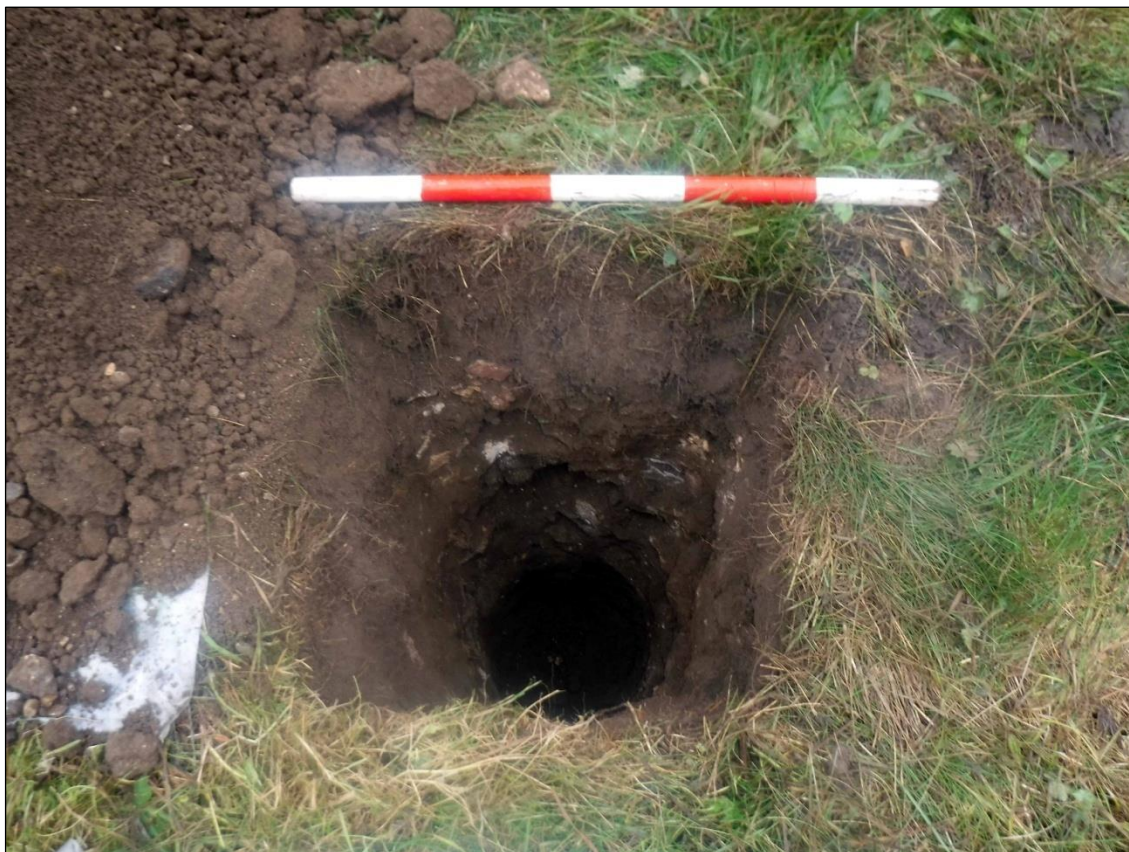
Plate 1. Trench 11 sample section, rubble layer below topsoil looking south.

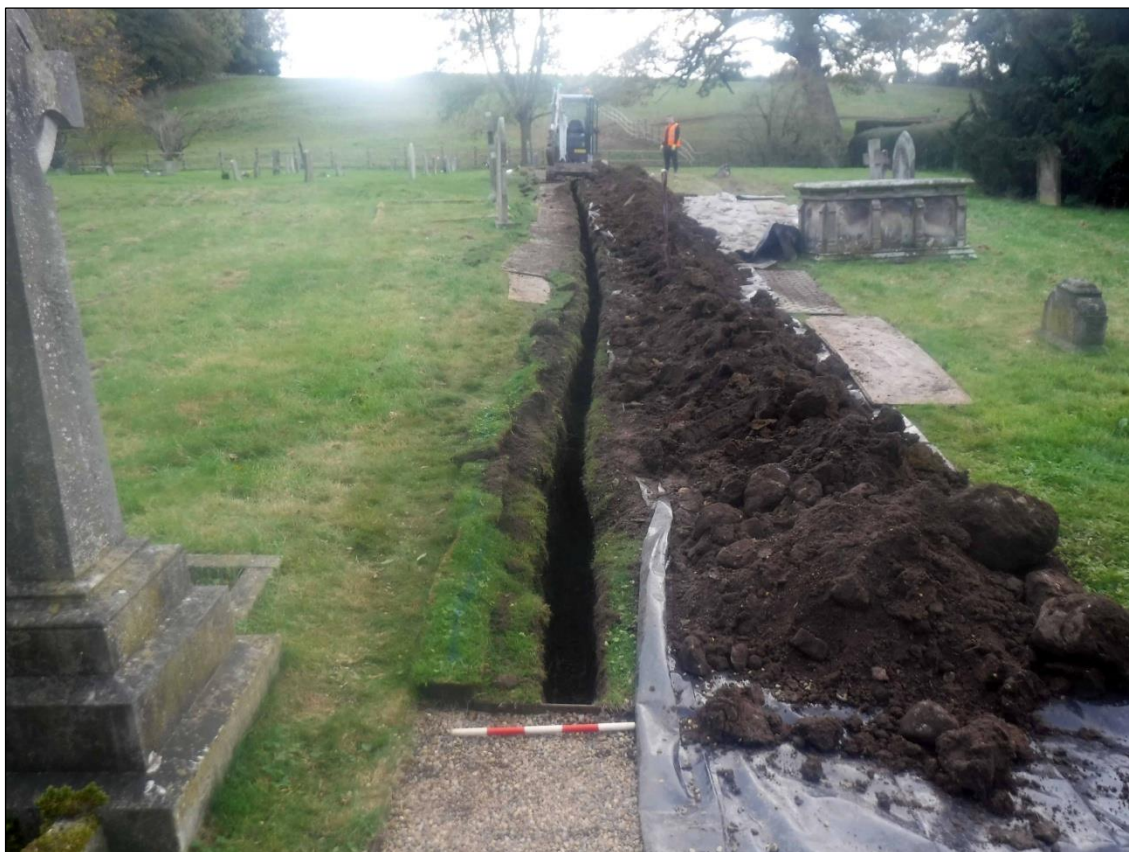
Plate 2. Trench 15 south side of church looking south.

Trench 15 was c.88m long and ran from the southern church boundary to the north side of the church (Plate 2). The trench was c.0.25m wide and machine excavated to a maximum depth of 0.75m. This trench revealed a graveyard soil (1502) throughout, a minimum depth of 0.4m and a maximum depth of 0.75m, from which occasional fragments of disarticulated human bone were encountered. Pockets of natural deposits (1503) comprised of a yellowish brown clay were occasionally observed closer to the southern side of the church porch area where five potential east to west aligned grave cuts were encountered at c.75m deep (Plate 3).

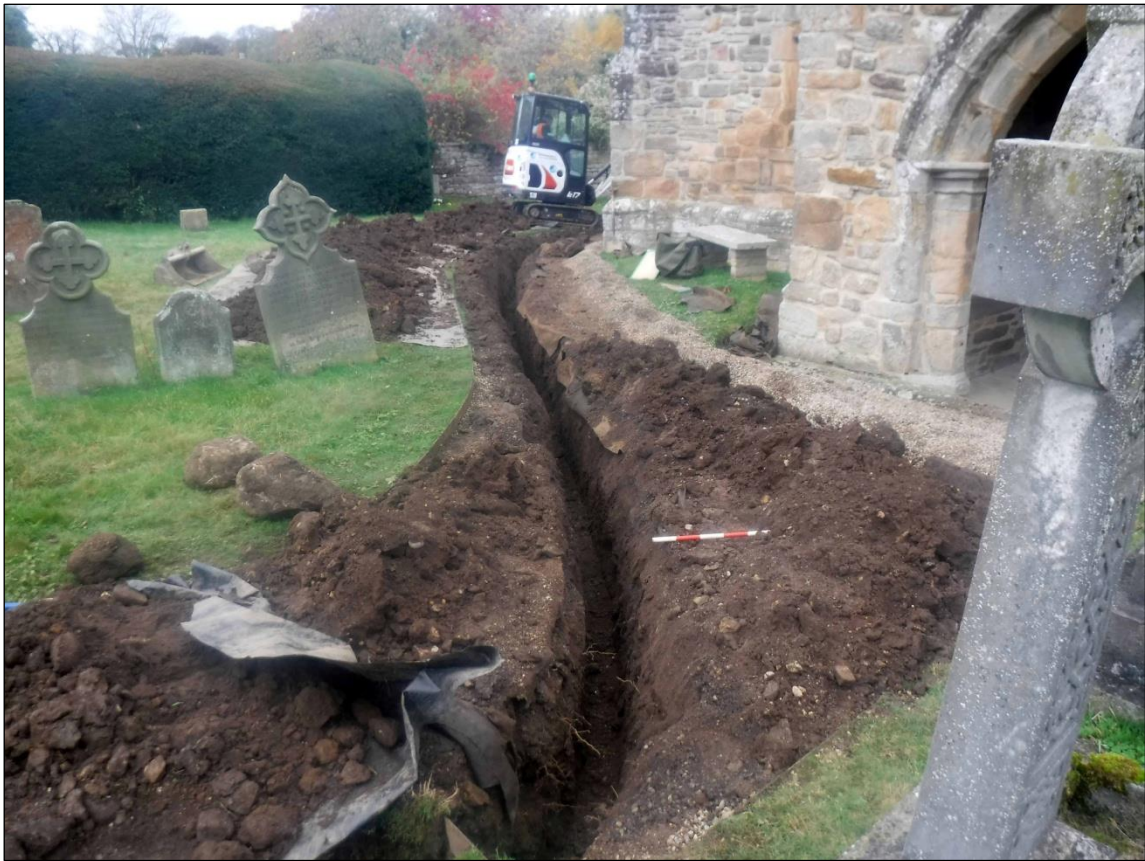
Plate 3. Trench 15 south side of church location of probable inhumations looking northwest.

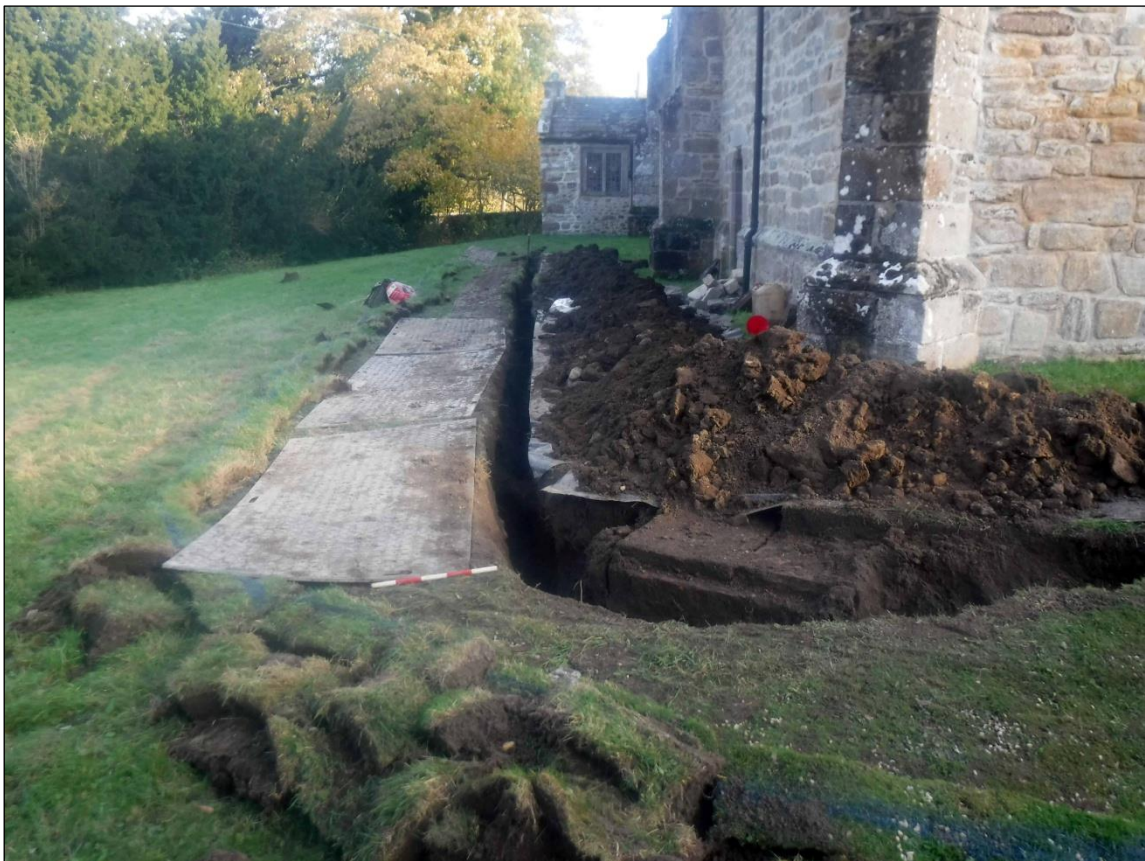
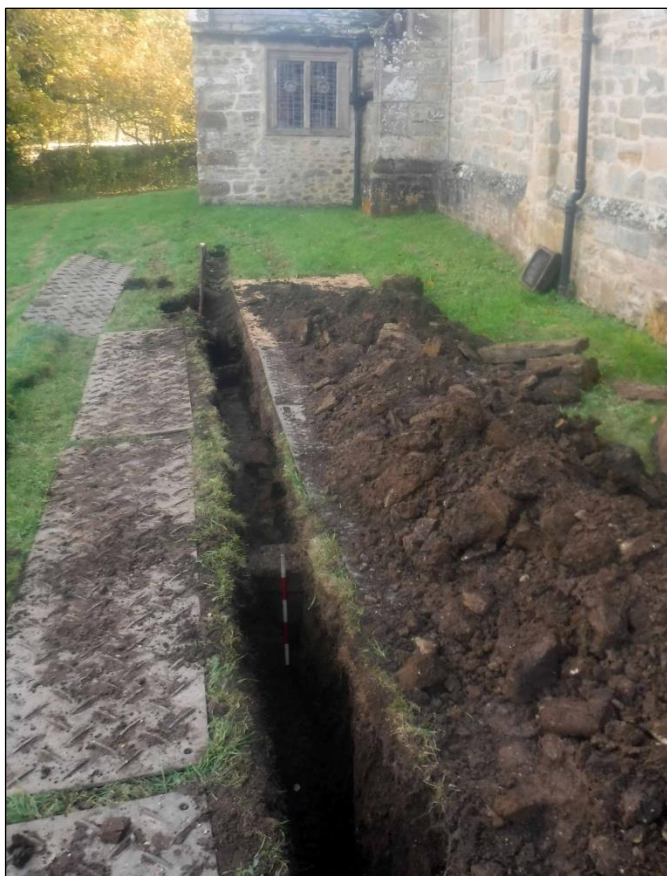
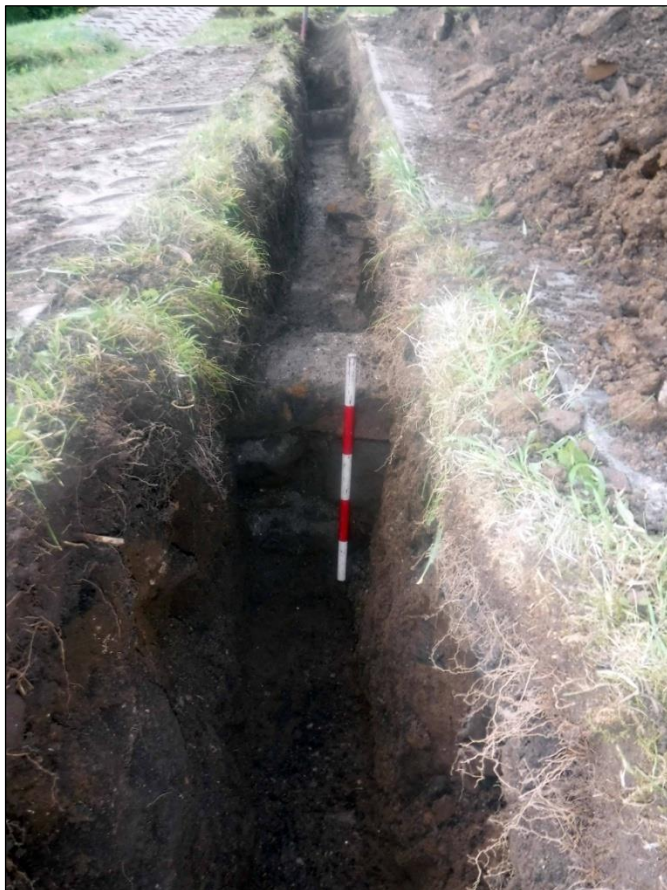
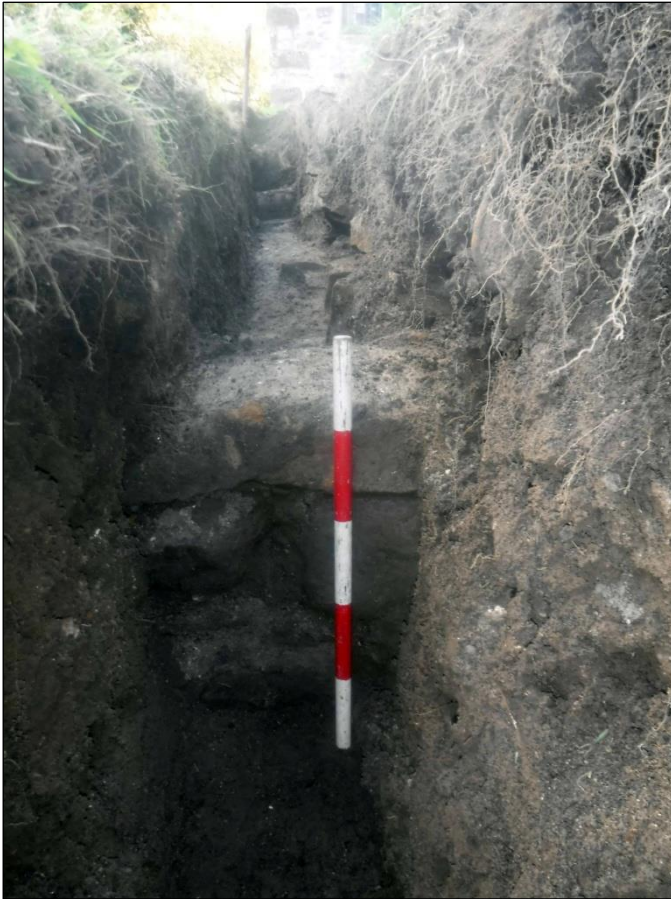
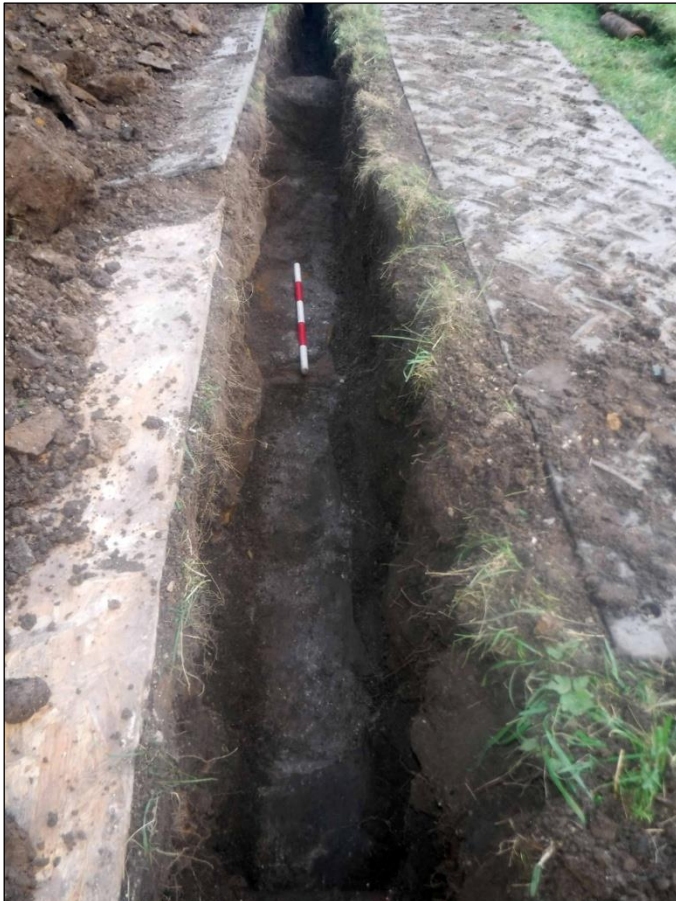
Plate 4. Trench 15 north side of church looking east.

Plate 5. Trench 15 foundation (1509) looking east.

Plate 6. Trench 15 foundation (1509) looking east.

Plate 7. Trench 15 foundation (1509) detail looking east.

Plate 8. Trench 15 foundation (1509) looking west.

Partly revealed within an unintentional overshoot of Trench 15 on the northern side of the church was an east to west aligned wall foundation (1509) that ran parallel with the northern side of the church (Plates 4 - 8). The foundation was exposed for a length of c.4m and depth of 0.4m with outer facing elevations to the west and north. Foundation (1509) was constructed from random coursed roughly hewn sandstone blocks and platy sandstone bonded with grey mortar that consisted of lime and charcoal fleck inclusions. Above (1509), exposed within the north facing section, was a robbing / demolition deposit (1508), comprising disturbed foundation blocks, a total of 0.26m thick. Above (1509) within the south facing section was a probable disturbed graveyard soil (1506) that was 0.37m thick. Deposit (1506) was cut into by a 19th - 20th century surface water drain (1504). A similar probable graveyard soil (1507) was butted up the west elevation of the foundation that was 0.4m thick. Sealing (1508) the upper disturbed foundation was (1505) that was a layer of probable demolition/construction debris 0.2m thick. Fragments of window glass were recovered from (1505) of a probable post-medieval or early modern date. Overlying (1505) was the topsoil (1500) that was 0.2m thick.

Foundation (1509) may represent an earlier church configuration possibly pre-dating the mid-13th to mid-14th century build and remodelling of the church. The investigation has highlighted the presence of a distinct layer of rubble identified in a number of trench interventions on the north and west sides of foundation (1509) and incidentally the same rubble layer was identified within the earlier 2019 evaluation within Trench 2 (OSA, 2019). It could be suggested that the rubble layer represents a mix of demolition debris of the earlier church structure and construction debris from the mid-13th century church build or the 14th century remodelling. A pottery sherd dated to the 11th - 13th century was recovered from the rubble layer within Trench 17 and this would possibly support this suggestion. The 2019 evaluation Trench 1 revealed an inhumation that pre-dated the north wall of the extant church which suggests the presence of an earlier church that was smaller than the extant church of which foundation (1509) may represent the northwestern extent of the earlier build. Potential medieval inhumations revealed on the south side of the church, close to the porch (Trench 15) presumably represents an earlier graveyard configuration either of a mid-13th to mid-14th century or earlier date. Foundation (1509) would appear to have been further disturbed by the 19th century church restoration with the installation of drainage.

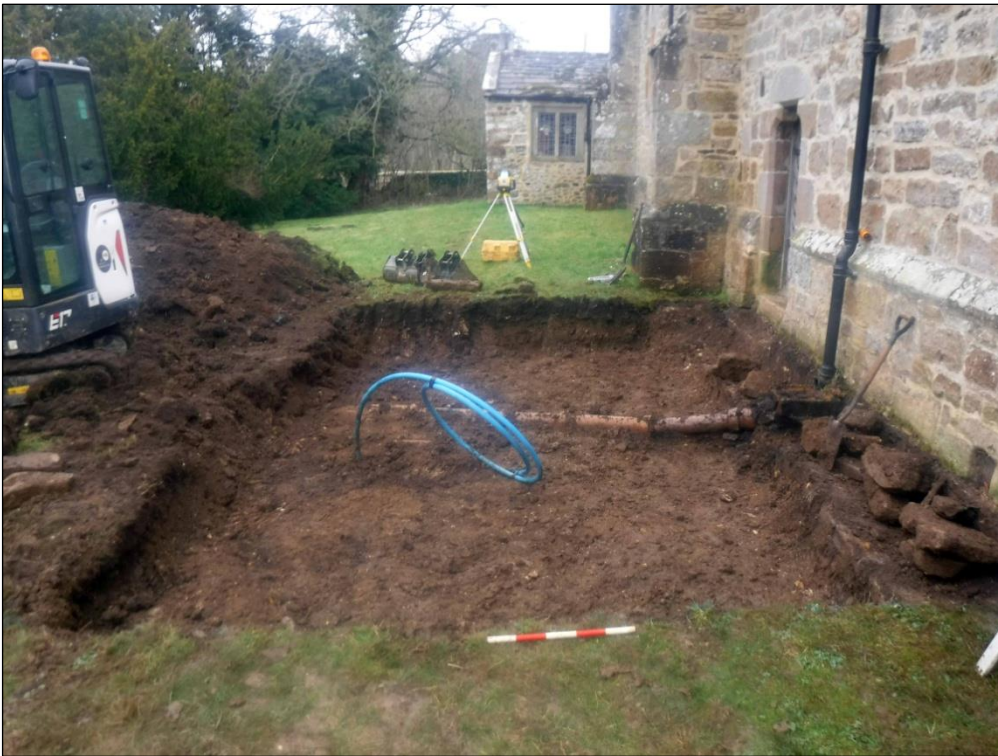
Plate 9. Trench 16 looking east.

The raft foundation measured c.6m by c.4m and was machine excavated to maximum and minimum depths of 0.5m BGL (below ground level) and 0.3m BGL, respectively (Plate 9). Exposed along the southern limit of the trench was the extant church foundation (1603). Foundation (1603) was butted up to by deposit (1602) a probable graveyard soil exposed for a depth of c.1m and from which occasional disarticulated human bone were recovered. Partially embedded into (1602) was a large fragment of a stone cross shaft (1604) (see details below). Sealing (1602) was (1601) a layer of demolition/construction debris that was 0.28m thick.

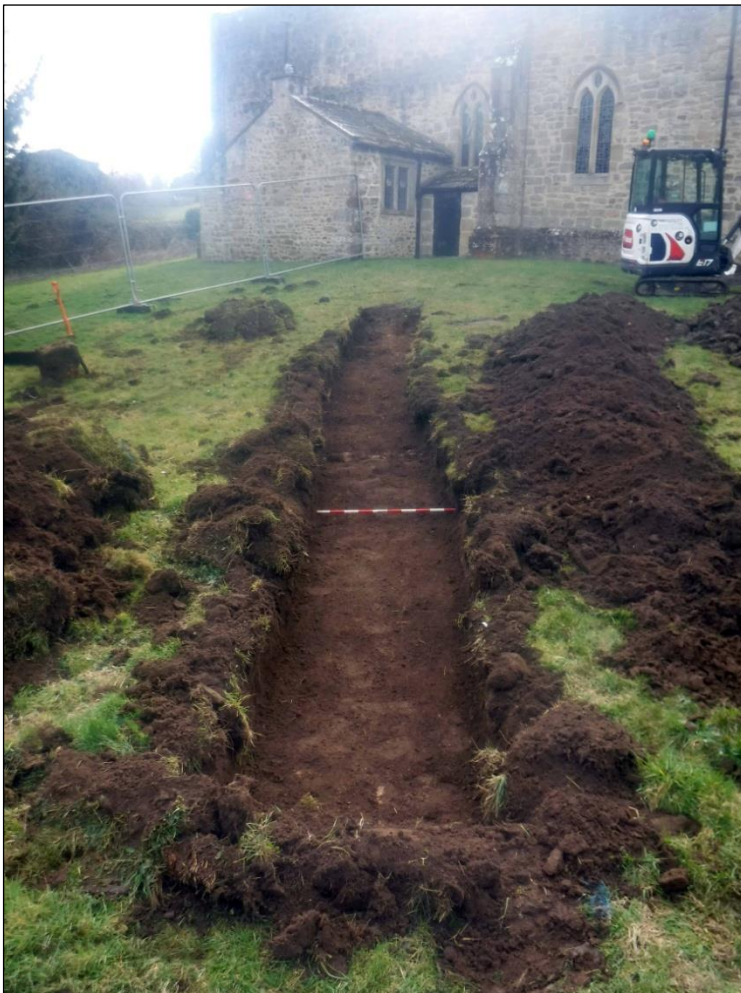
Plate 10. Trench 17 looking southeast.

Trench 17 was orientated north to south and was 12.5m long and 1m wide and machine excavated to depth of 0.5m (Plate 10). Situated within the northern half of the trench was a probable graveyard soil (1704) with an excavated depth of 0.1m. Small fragments of disarticulated human bone were recovered from (1704). Within the southern half of the trench was demolition/construction debris (1703) that was exposed for a depth of c.0.12m. Recovered from (1703) was a large stone block with a socket hole (see details below). A pottery sherd dated to the 11th - 13th centuries was also recovered from (1703). Demarking

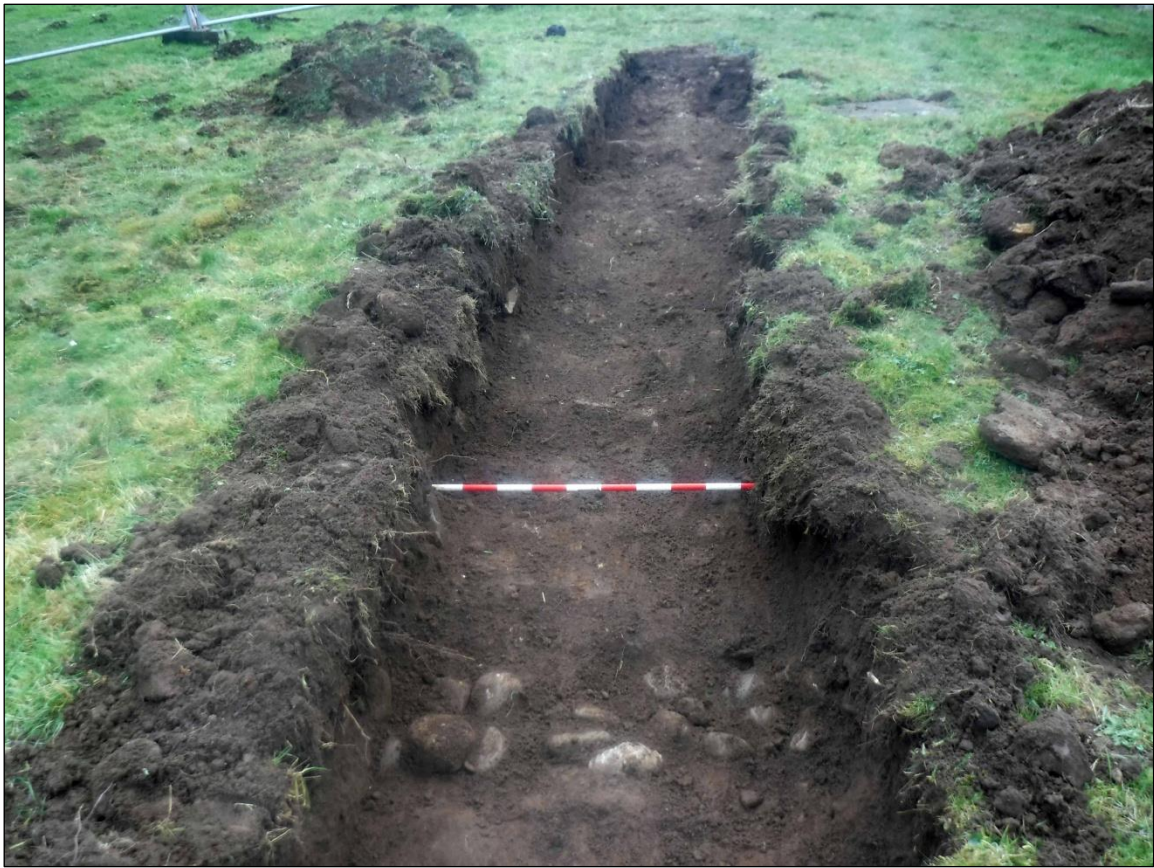
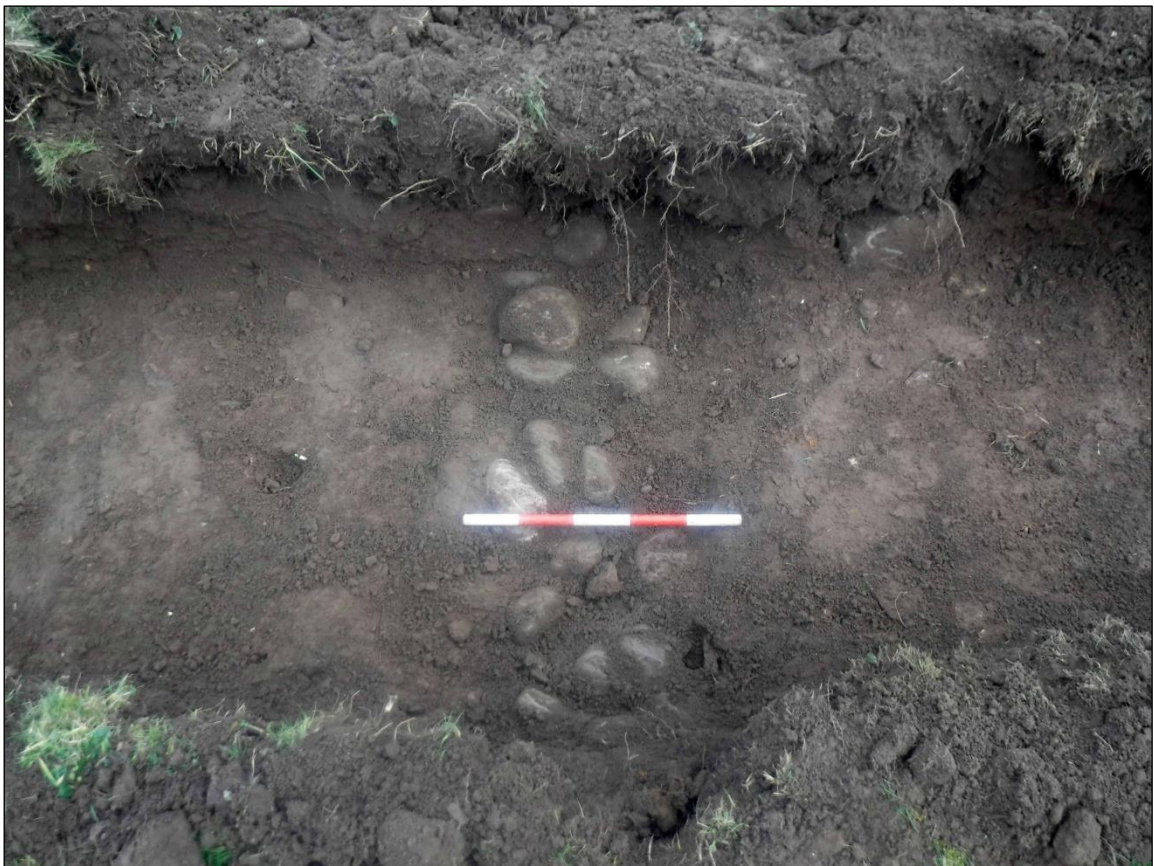
Plate 11. Trench 17 linear [1702] and rubble layer (1703) looking southeast.

Plate 12. Trench 17 linear [1702] looking southwest.

the interface between (1704) and (1703) was a cobblestone filled linear [1702] that was orientated roughly northeast to southwest (Plates 11 and 12). The relationship between [1702] and deposits (1704) and (1703) on either side is uncertain as the base of the cobble feature was not reached within the maximum depth of the trench. The possibilities are that [1702] either cuts or was butted up to by (1704) and (1703). The function of this linear is uncertain. It may represent a relatively recent soak away or be an earlier trench constructed foundation for a wall.

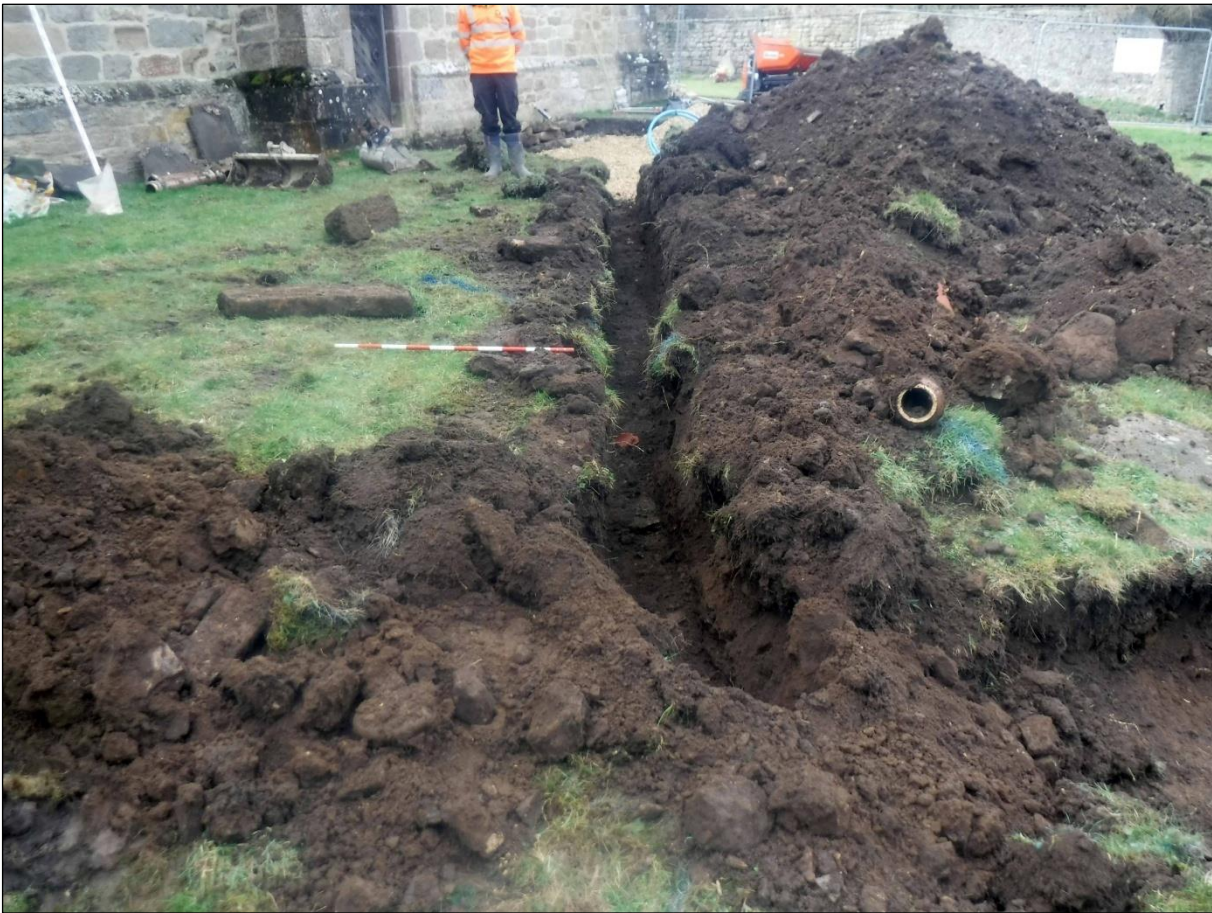
Plate 13. Trench 18 looking southwest.

Trench 18 was a linking pipe trench between Trench 16 and 17 and was 0.3m wide and machine excavated to c.0.6m deep (Plate 13). A similar sequence of deposits was recorded as was seen in Trench 16, that included a graveyard soil (1102) exposed for a depth of c.0.1m that was sealed by a demolition/construction debris layer (1101), 0.3m thick which was overlaid by a topsoil (1100) that was 0.25m thick.

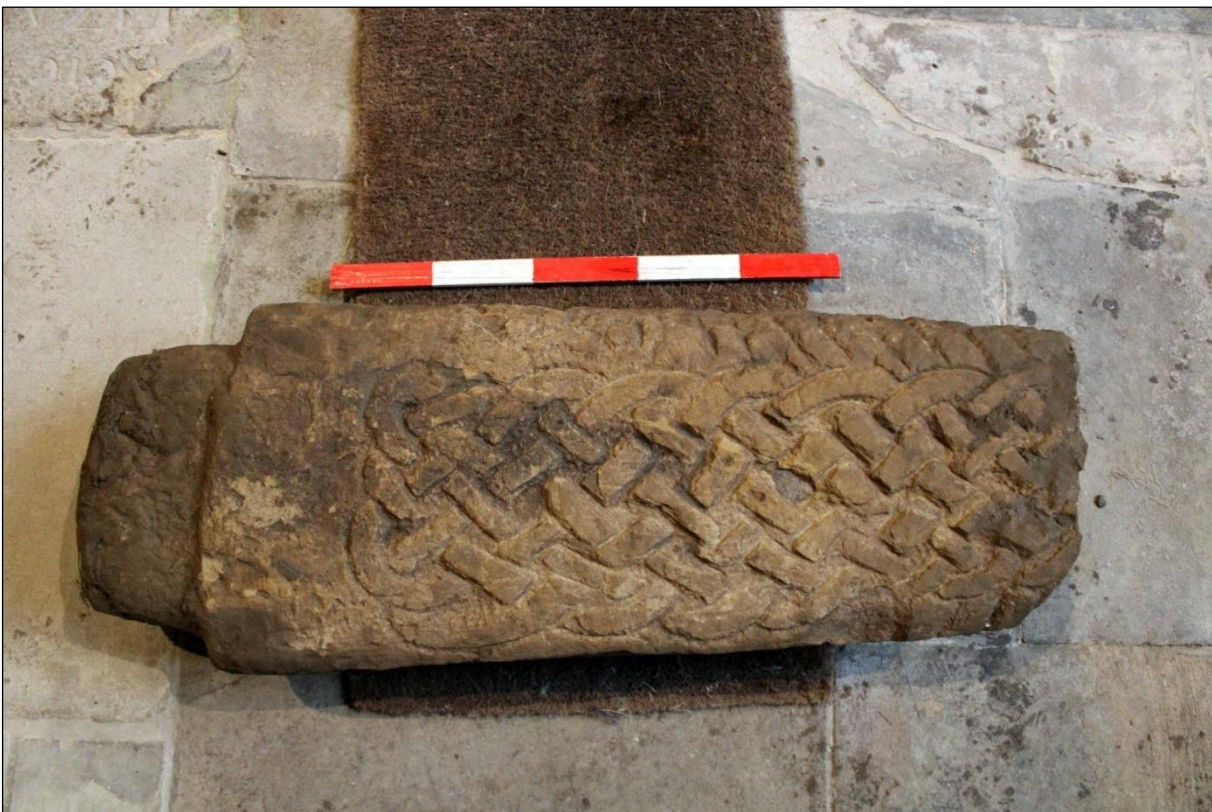
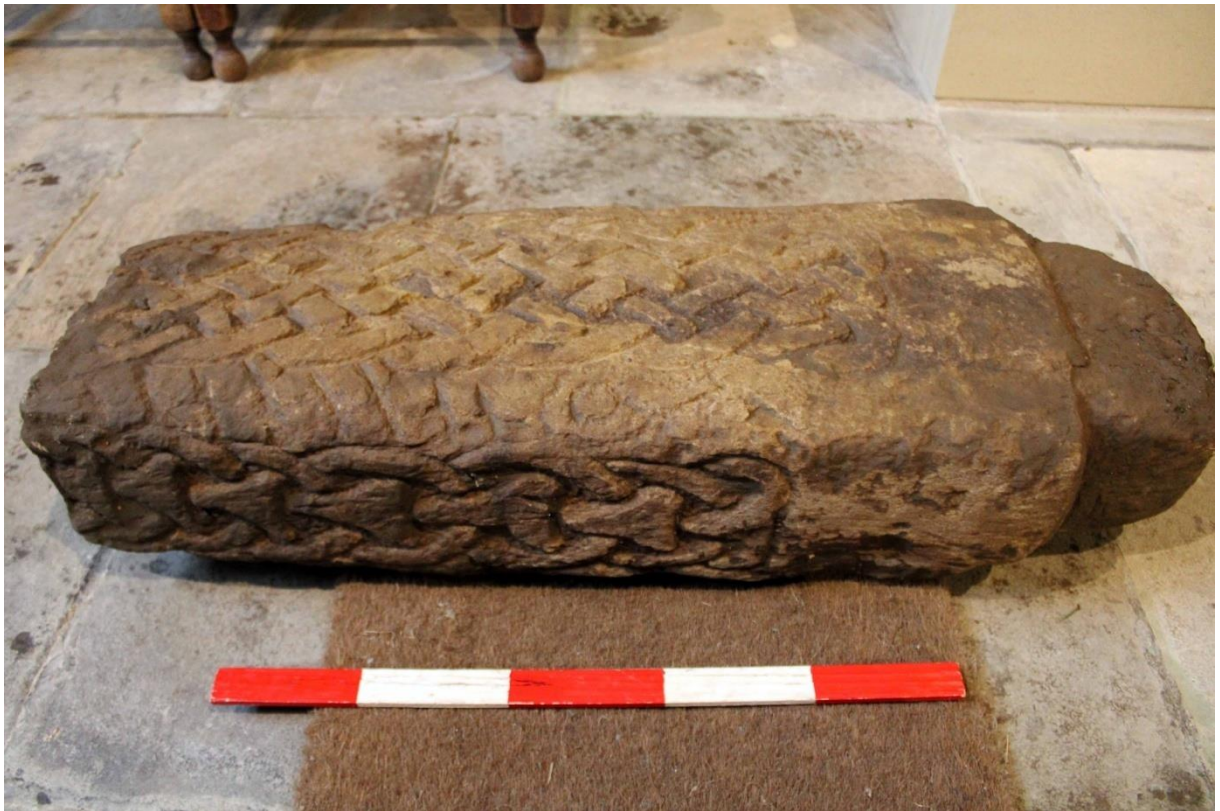
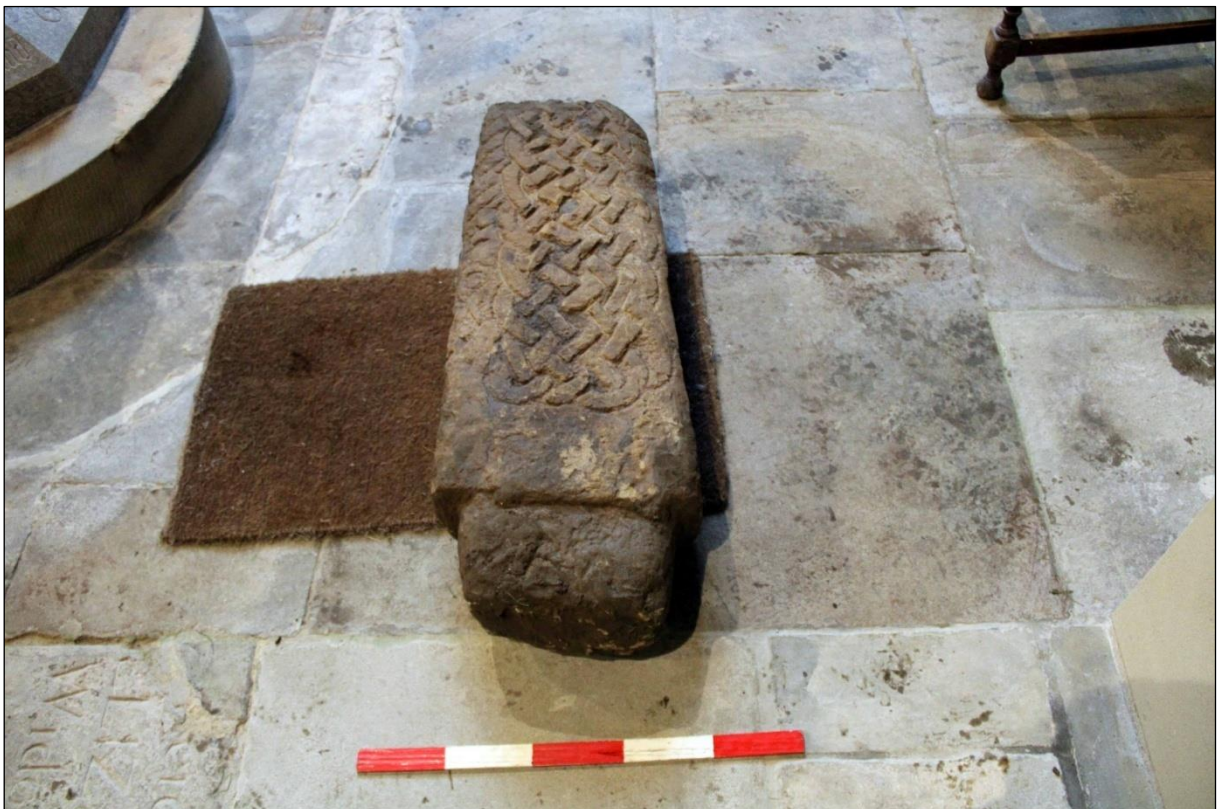
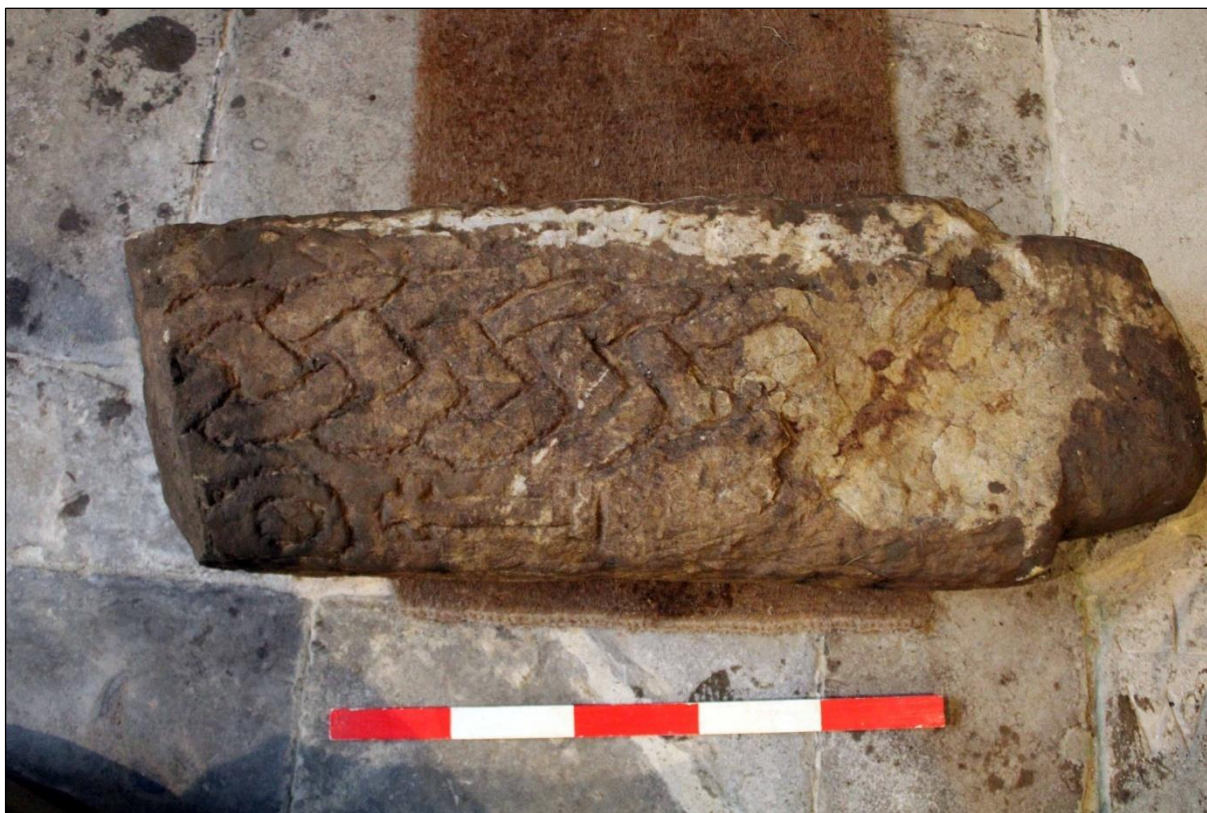
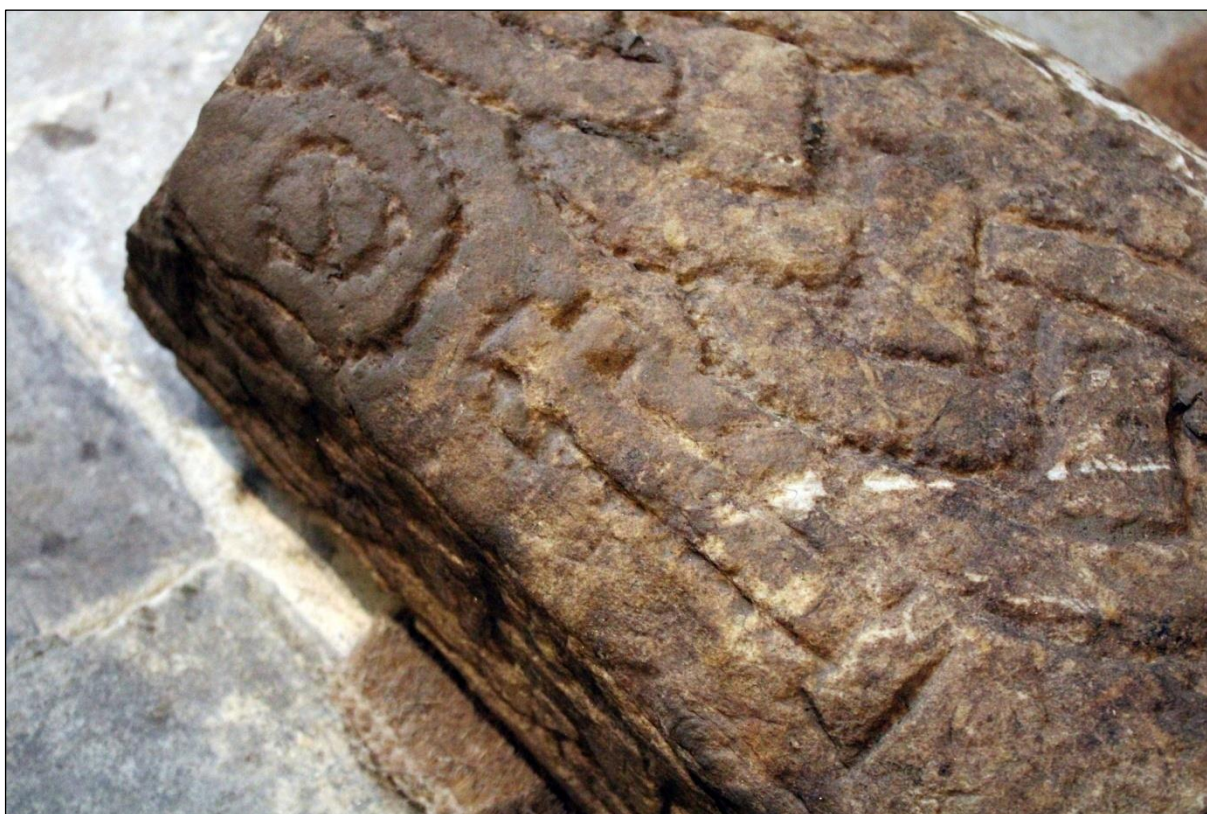
Plate 14. Stone cross shaft (1604).

Plate 15. Stone cross shaft (1604).

Plate 16. Stone cross shaft (1604).

Plate 17. Stone cross shaft (1604).

Worked stone (1604) represented the lower portion of a stone cross-shaft with a rectangular section profile (Plates 13 - 18). The shaft was recovered from context (1602) a probable graveyard soil within Trench 16. An interim report on the cross-shaft was produced by Prof. Jane Hawkes and is presented in Appendix 5.

It measured c.0.87m long, 0.37m wide towards the base and tapered up 0.25m where it was broken, and was 0.15m thick. At the base was a tenon that was 0.16m long, 0.28m wide and 0.12m thick. Displayed on each side of the shaft were engraved interlacing motifs. The stone cross shaft is provisionally dated to the later Anglo-Saxon period and early indications suggest it is a potentially a unique piece of stonework of regional interest.

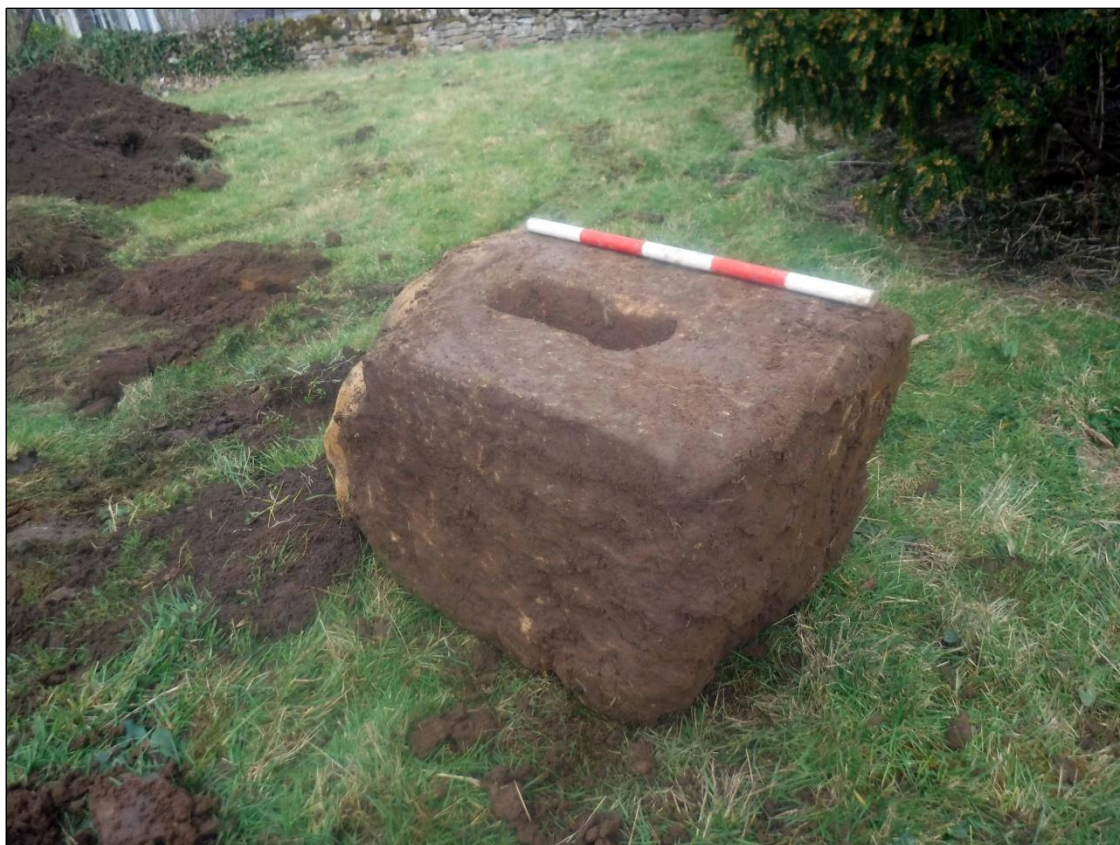
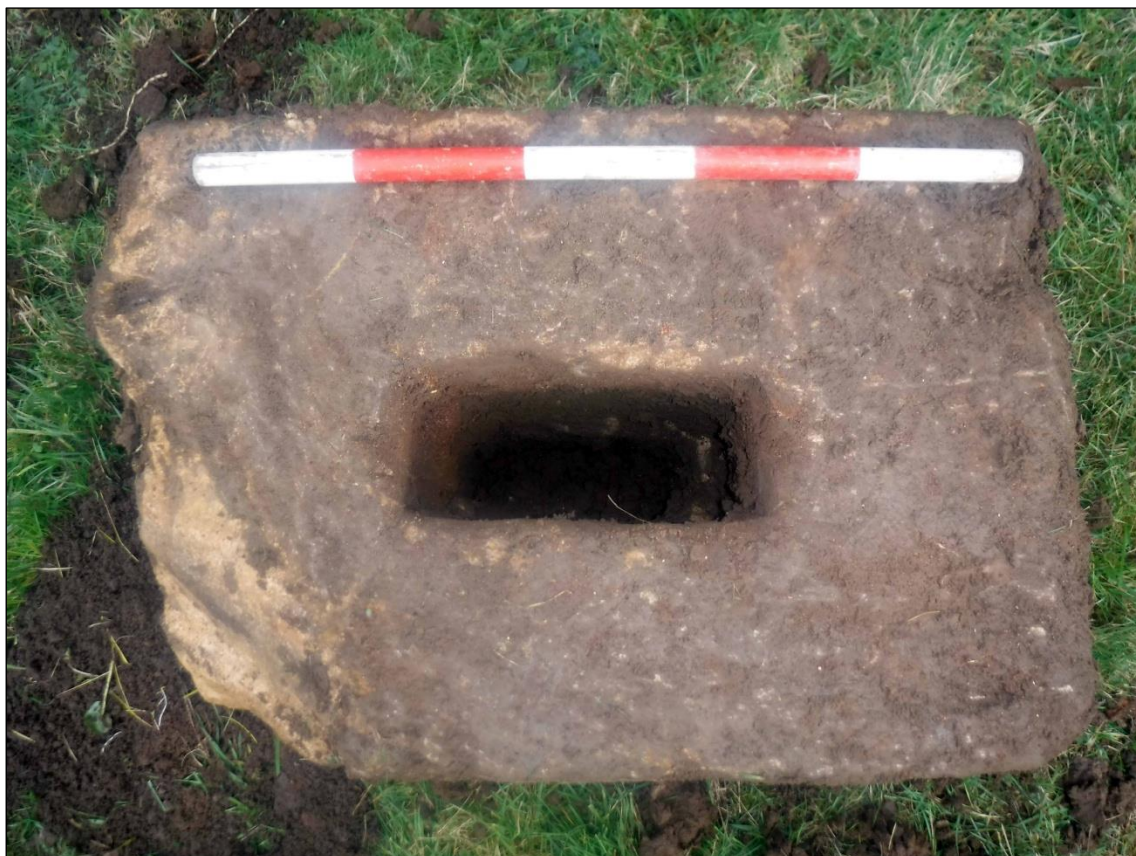
Plate 18. Socketed stone foundation block (1705).

Plate 19. Socketed stone foundation block (1705).

A large, worked sandstone block (1705) was recovered from (1703) a demolition/construction debris layer within Trench 17 (Plates 19 and 20). The block measured 0.6m wide, 0.4m wide and 0.4m deep at the surface and tapered in slightly at the base. Located within the centre of the upper surface was a rectangular socket hole 0.22m long and 0.09m wide that was worked all the way through the block with a slight stepping in towards the base. This block may represent the base for a cross or headstone and its date is unknown.
