ST. MARY'S CHURCH,
WYCLIFFE, COUNTY DURHAM.

REPORT ON AN ARCHAEOLOGICAL INVESTIGATION

OSA REPORT NO: OSA22WB03

May 2022

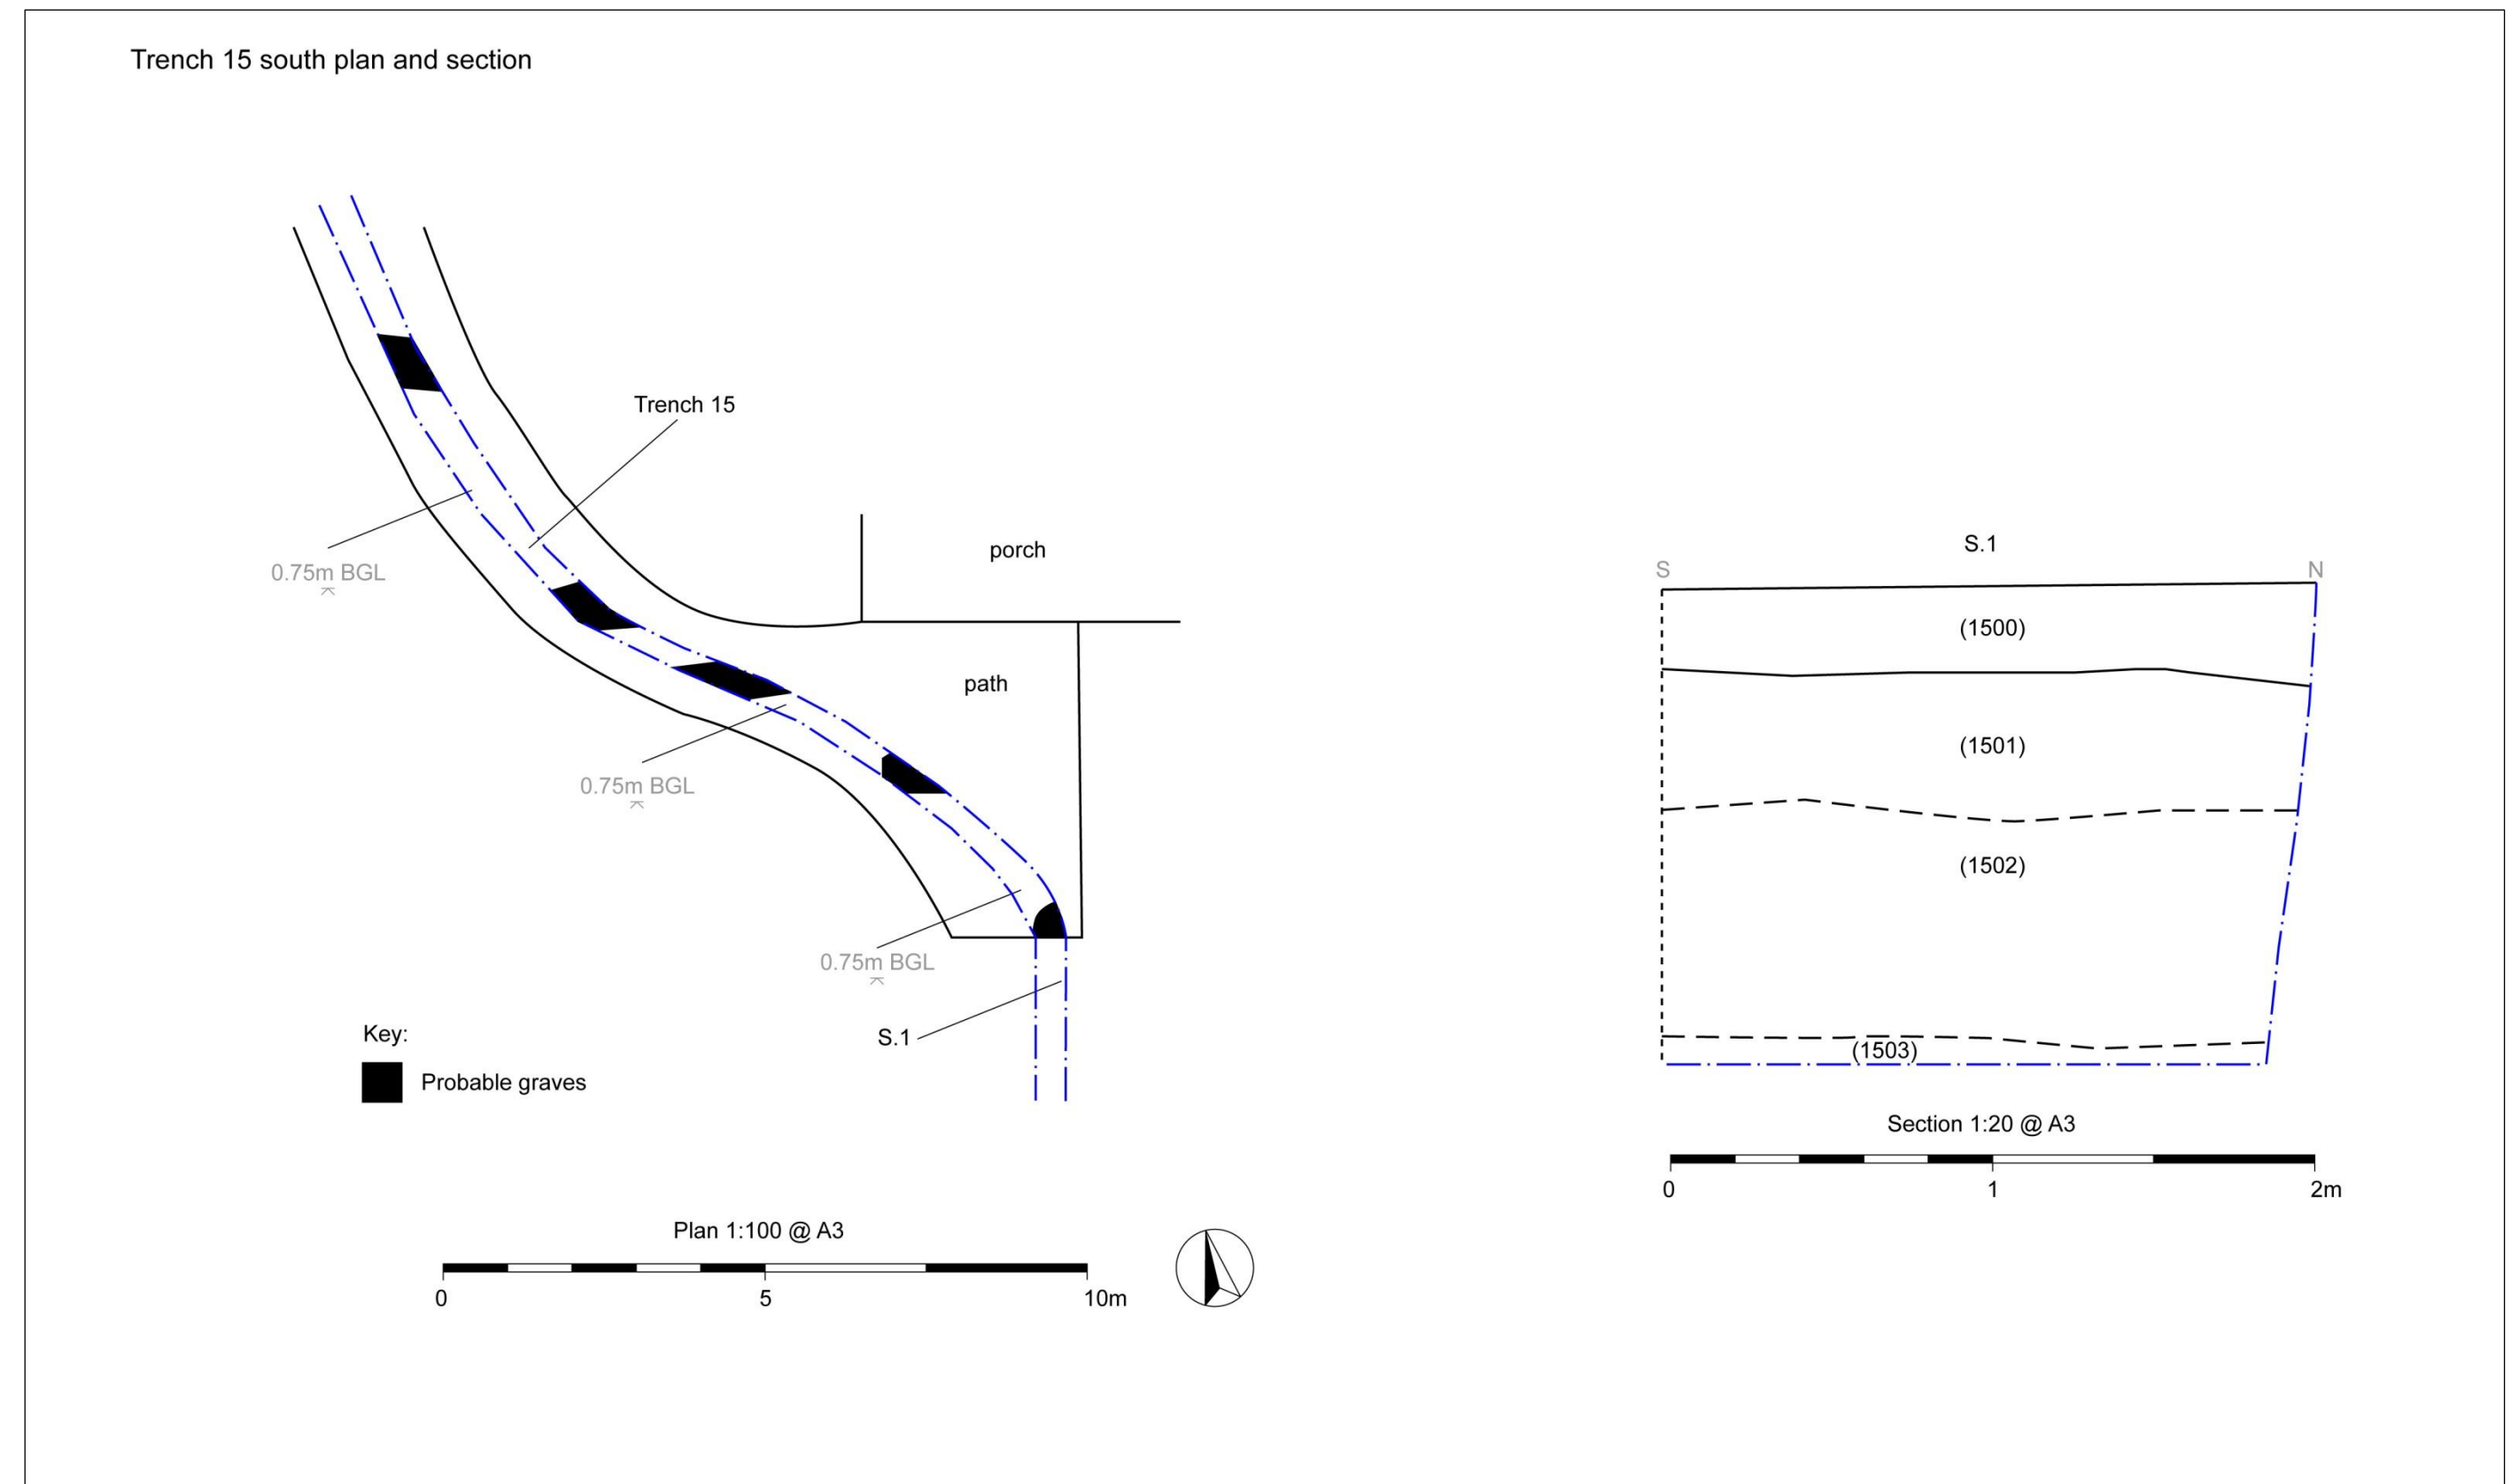
Figure 4. Trench 15 south side of church, plan possible burials and sample section.

Trench 15 was c.88m long and ran from the southern church boundary to the north side of the church (Plate 2). The trench was c.0.25m wide and machine excavated to a maximum depth of 0.75m. This trench revealed a graveyard soil (1502) throughout, a minimum depth of 0.4m and a maximum depth of 0.75m, from which occasional fragments of disarticulated human bone were encountered. Pockets of natural deposits (1503) comprised of a yellowish brown clay were occasionally observed closer to the southern side of the church porch area where five potential east to west aligned grave cuts were encountered at c.75m deep (Plate 3).
