**Energy Audit Report for
Dorking St Martin Church**

May 2019

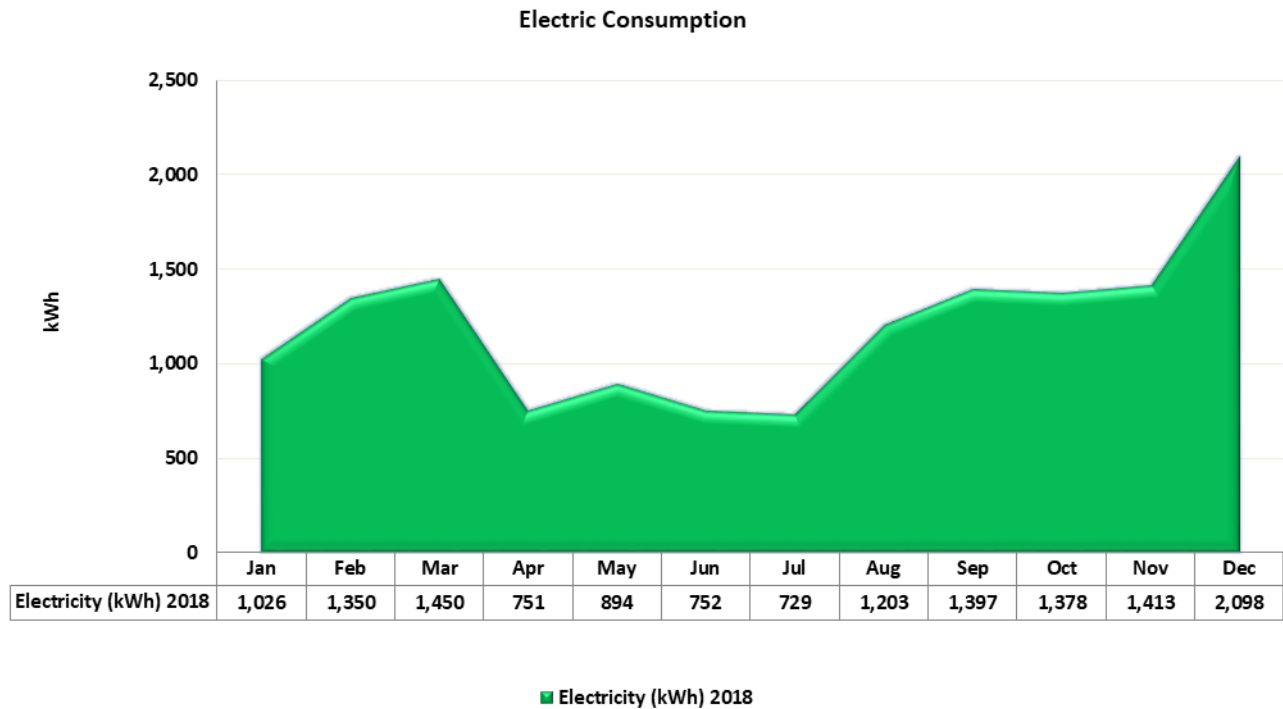
4.2 MONTHLY DEMAND PROFILE - ELECTRICITY

The electric consumption profile below shows the annual trend for the period of January 2018 to December 2018. The annual profiles show reasonable consistency throughout the year in-line with typical building usage. Noticeable increase in consumption during the Christmas and Easter period. Electric consumptions is largely from lighting and small power.

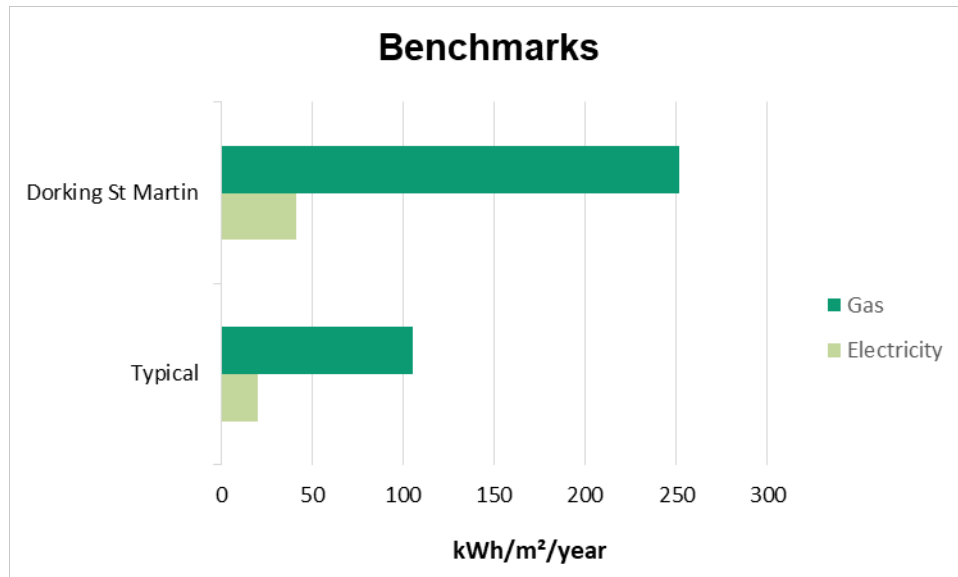
4.4 BENCHMARK PERFORMANCE

The use of benchmarks is designed to show how a building is performing in relation to similar buildings with comparable operation. The benchmarking information is broken down on a meter square basis which can be applied to any building size. The graph below depicts building energy consumption per square meter compared against CIBSE TM46 Guide 2008 Energy Benchmark guide lines.

The electric consumption is performing worse than the typical benchmark by approximately 106% higher and the gas consumption is performing worse than the typical benchmark by approximately 140% higher.

It should however be noted these are standard industry benchmarks that only provide an objective point of reference. Benchmarks can be higher due to higher building use, age and typical heating systems from the typical building stock.

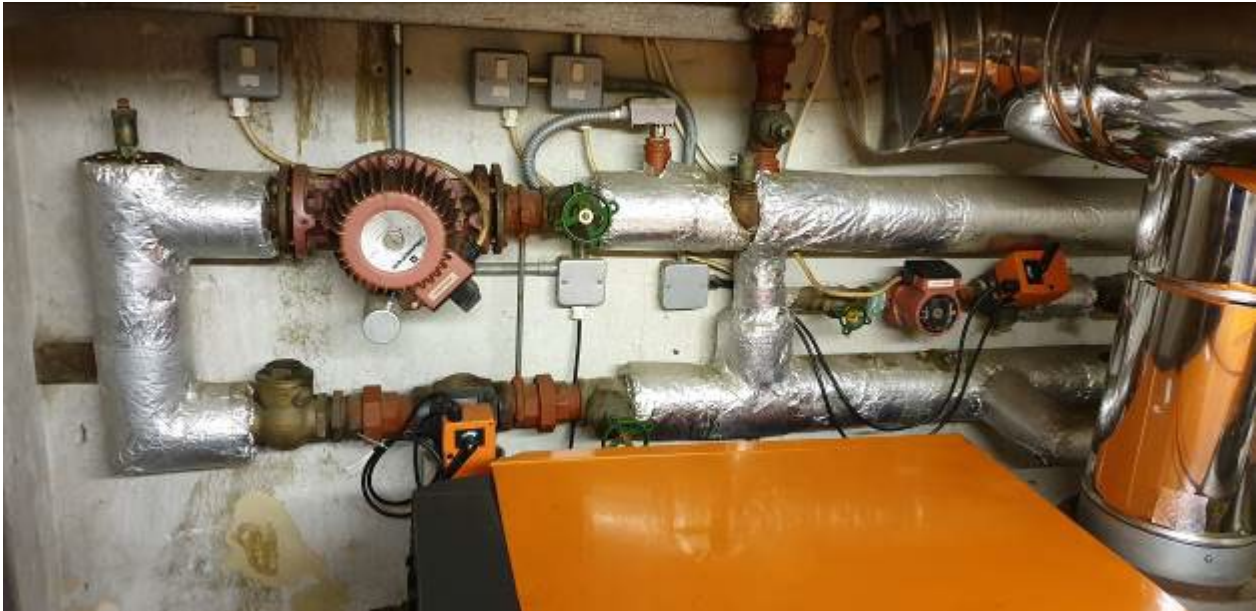
5.3 HEATING SYSTEM – PIPEWORK & DISTRIBUTION

The pipework is generally well lagged in the plant room however some fittings and valves are exposed. It is recommended to install additional lagging to exposed pipe and install valve jackets to reduced heat loss into plant room.

Heating	10	Install additional lagging to exposed heating pipes and valve jackets	3,085	£74	0.6	£100	1.4
Heating	11	Install Thermal Insulation Foil under heating pipework in trenches	8,815	£210	1.6	£760	3.6
TOTAL ELECTRICITY SAVINGS			8,238	£882	4	£2,404	2.7
TOTAL GAS SAVINGS			11,901	£284	2.2	£860	3.0
GRAND TOTAL			20,139	£1,166	7	£3,264	2.8

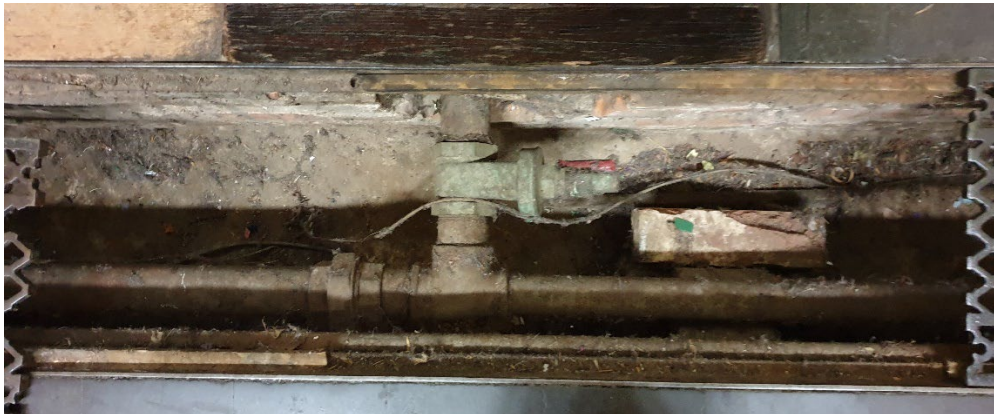
5.4 HEATING SYSTEM – HEAT EMITTERS

Heating to the church area is via cast iron radiators of varying sizes across the church floor which are supplied from heating pipes running in floor trenches covered with grilles. It is recommended to install thermal insulation foil below the pipework to reduced heat loss into exposed concrete floor, which can be reflected upwards into the church area.

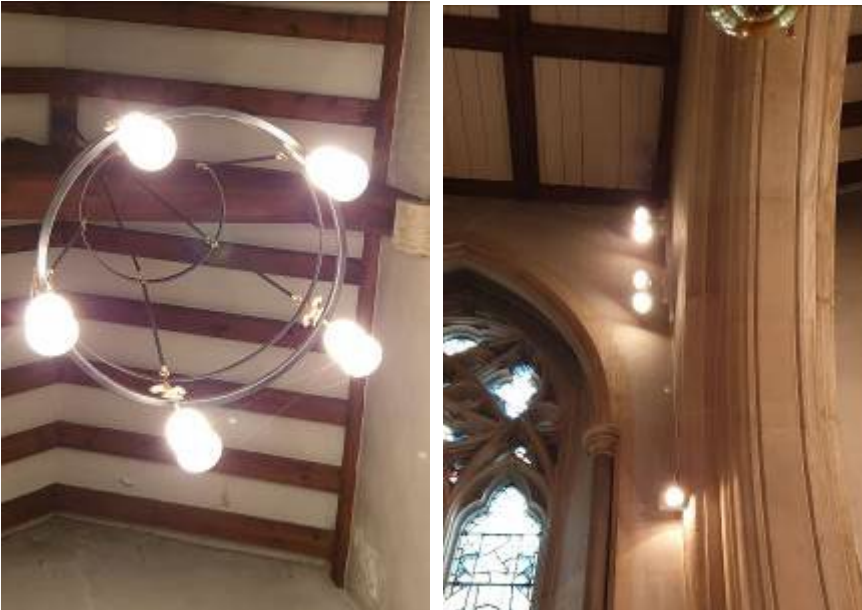
■ Lady Chapel:

- Currently hanging chandelier with 25W fluorescent lamps - recommend to replace with 3.5W LED replacements
- Spotlights with 50W halogen lamps – recommend to replace with 7.5W LED replacements

Category	#	Actions	Potential savings			Investment (£)	Simple payback (yrs.)
			Elec/Gas KWh/yr.	Cost £/yr.	tCO2/yr.		
Lighting	1	Lady Chapel - replace 25W candle lamps with 3.5W LED replacements	128	£14	0.1	£18	1.3
Lighting	2	Lady Chapel - replace 50W halogen lamps with 7.5W LED replacements	239	£26	0.1	£126	4.9
Lighting	3	Chancel - replace 120W PAR 38 spotlights with 12.5W LED replacements	1,207	£129	0.7	£223	1.7
Lighting	4	Chancel - replace 50W halogen lamps with 7.5W LED replacements	318	£34	0.2	£168	4.9
Lighting	5	Chancel - replace 300W floodlights with 60W LED replacements	1,198	£128	0.6	£302	2.4
Lighting	6	Nave - replace 25W candle lamps with 3.5W LED replacements	102	£11	0.1	£14	1.3
Lighting	7	Nave - replace 120W PAR 38 spotlights with 12.5W LED replacements	2,415	£259	1.3	£445	1.7
Lighting	8	Nave - replace 300W floodlights with 60W LED replacements	2,396	£257	1.3	£960	3.7
Lighting	9	Vestry - replace all 58W T8 fluorescent lighting to 22W LED replacement unit	235	£25	0.1	£148	5.9

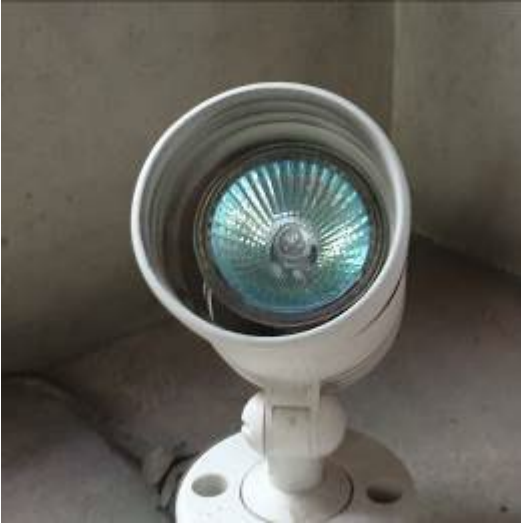
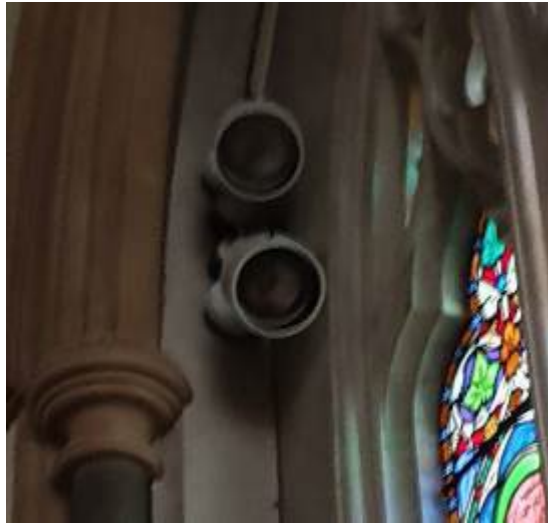
■ Chancel:

- Spotlights with PAR 38 120W fluorescent lamps – recommend to replace with 12.5W LED replacements
- Spotlights with 50W halogen lamps – recommend to replace with 7.5W LED replacements
- 300W floodlights - recommend to replace with 60W LED replacements

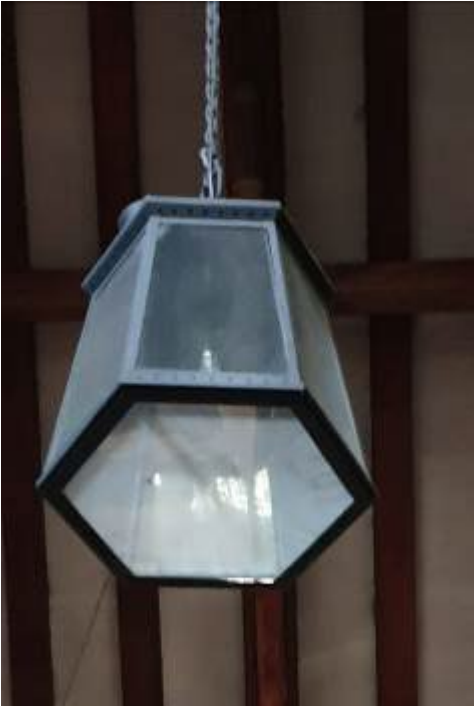
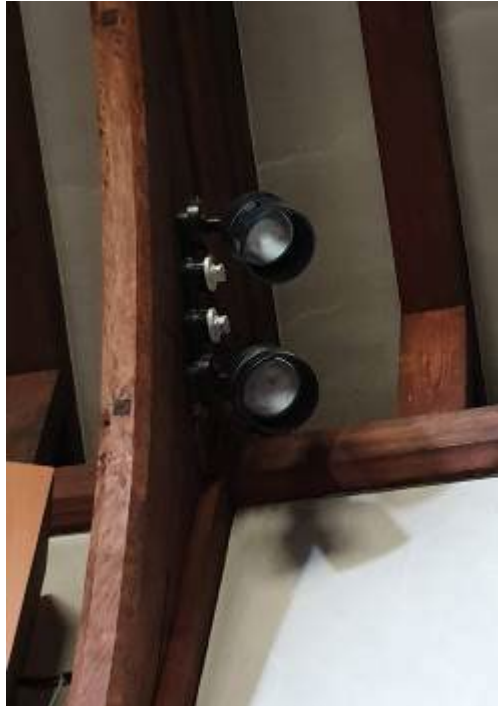
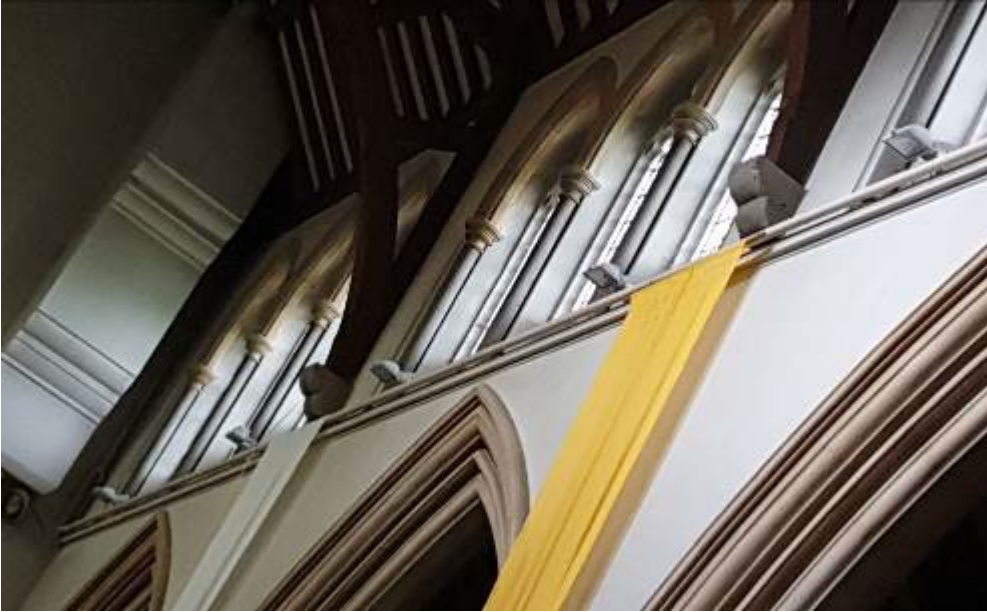
■ **Nave:**

- Currently hanging chandelier with 25W fluorescent lamps - recommend to replace with 3.5W LED replacements
- Spotlights with PAR 38 120W fluorescent lamps – recommend to replace with 12.5W LED replacements
- 300W floodlights - recommend to replace with 60W LED replacements

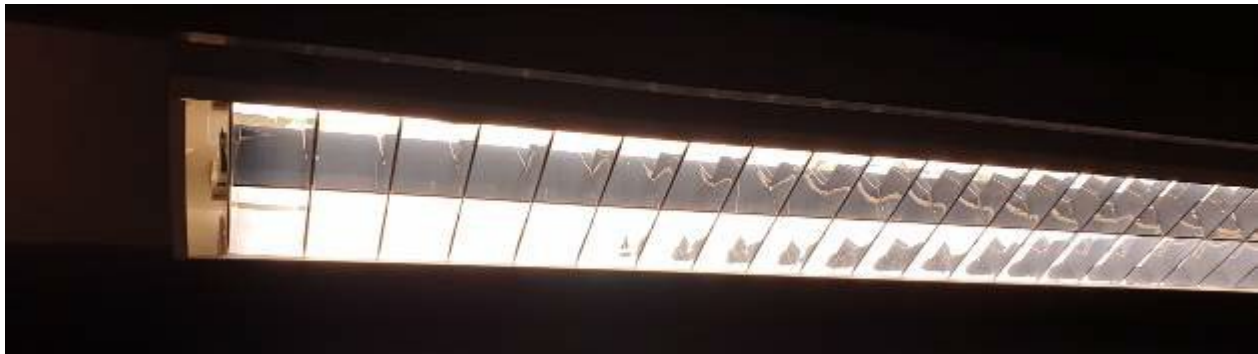
■ **Vestry:**

- Currently twin fluorescent lamps (T8 58W each) recommend to replace with 22W LED complete unit replacement.
