Energy Audit Report for St Andrew's Church

June 2019

ESOS Energy conducted an Energy Audit at St Andrew's Church in Cobham on 5<sup>th</sup> May 2019. The audit consisted of a site visit and data analysis during which all church areas were investigated.

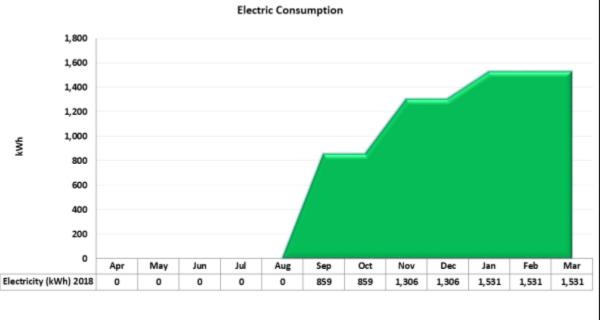
Electricity (kWh) 2018

The electric consumption profile below shows the annual trend for the period of September 2018 to early April 2019. Consumption data is missing for other months so unable to accurately comment on annual trend.

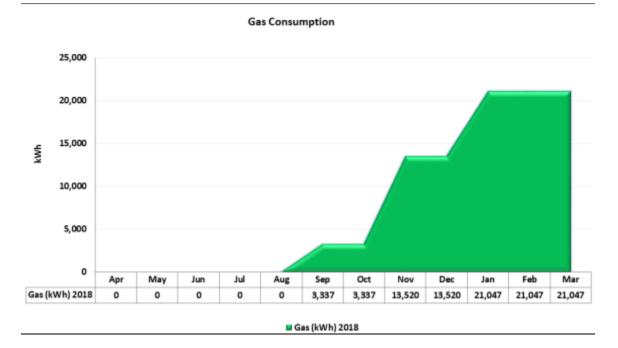
The gas consumption profile below shows the annual trend for the period of September 2018 to early April 2019. Consumption data is missing for other months so unable to accurately comment on annual trend.
