**Christ Church
Woodhouse
Huddersfield
West Yorkshire**

Archaeological Watching Brief

Report No. Y243/16

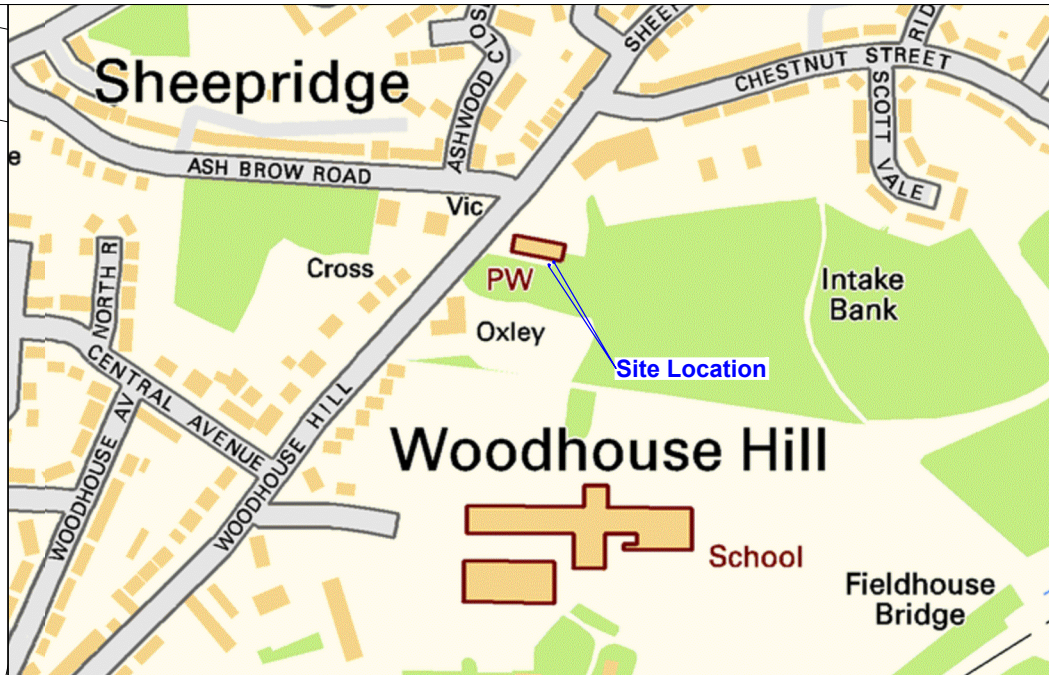
Title:
Site location and plan

A culvert (004-007) was identified abutting the perimeter of the foundations for the organ chamber (Figs 1-3). It measured 0.6m in width, a maximum of 0.32m in depth and was cut into the redeposited clay backfill (008). At the time of investigation the culvert was out of use, being filled with a humic, dark black clay silt with leaf litter (004). Its walls (006) were formed of machine made, unfrogged, unstamped, red, 9 inch standard stretcher bricks, some of which were cropped to fill gaps. The culvert was capped with large Yorkstone flags (005) of variable dimensions. It is likely the culvert was contemporary with the organ chamber.

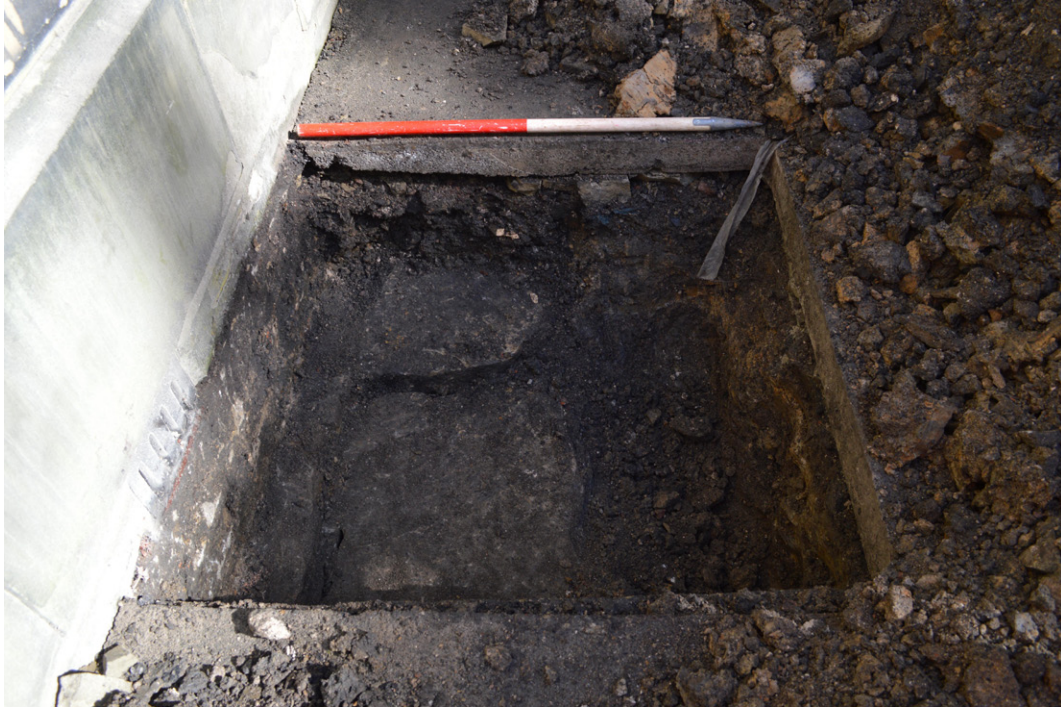
Fig. 2 - Culvert capping stones in Test Pit 1

005	007	Around organ chamber	0.6	0.1	Culvert capping stones	York stone flags overlying brick supports, either side lengthways, to cap culvert. Abutts the foundation stones to the Organ Chamber, 009. Underlies (003).
006	007	Around organ chamber	0.13	0.2-0.32	Culvert walls	Two rows of standard 9" red brick, set 0.24m apart forming the sides of the culvert. Built directly onto the impermeable clay 008. Arranged in stretcher on bed formation. Underlies capping stone 005, whilst deposit 004 abutts its interior elevation. Some bricks have been halved. Bricks were machine made, unfroged and unstamped.
007		Around organ chamber	0.6	0.42	Cut	Linear cut for culvert, with vertical sides and flat base, cut in to 008 with very clear horizon. Contains within it 004, 005 and 006.
008		Across site	>1	>0.6	Deposit	Very firm, light-mid yellow grey clay with sandstone fragments included. Presumed to be redeposited clay associated with the construction/post-construction works for the organ chamber. Abutts foundation stones 009, of the organ chamber, underlies 003 with very clear horizon
