**WATCHING BRIEF ON THE REMOVAL OF STONE FLAGS FROM
TOWER AND NAVE FLOORS AT ST JOHN'S CHURCH, KINGSCOTE**

October 2022

WEST TOWER AND NAVE WEST FLOOR : PROPOSED DETAILS
ST JOHN'S CHURCH, KINGSCOTE, GLOUCESTER DIOCESE

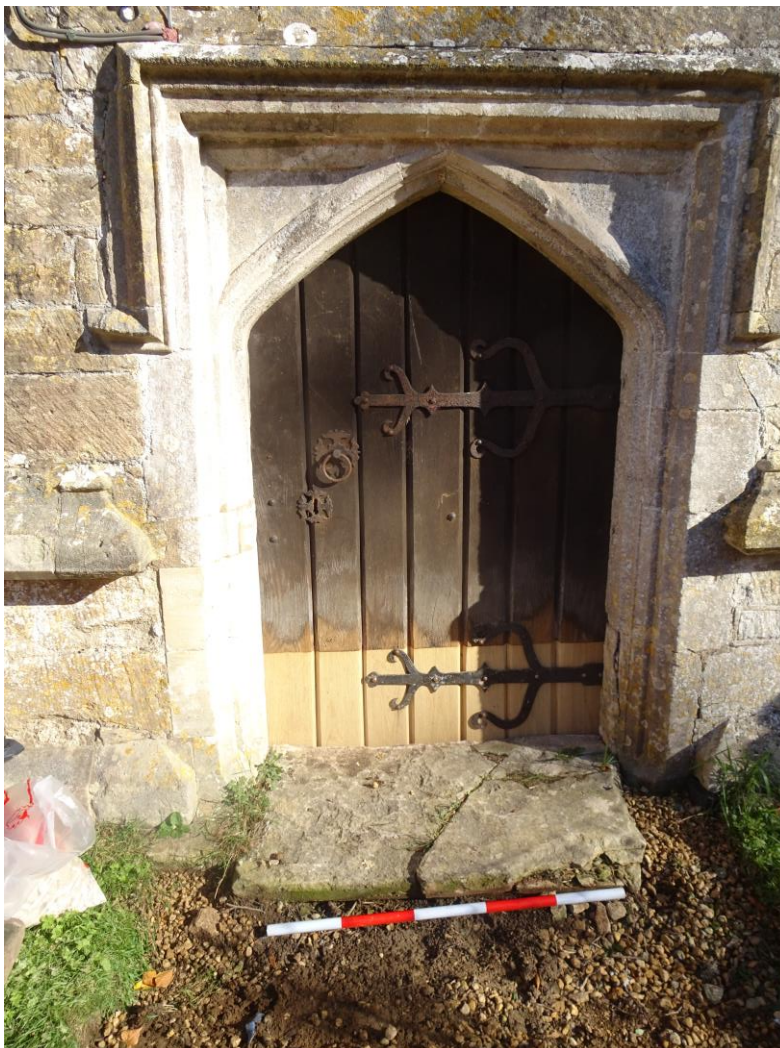
A large limestone block occupies the threshold immediately west of the west door of the tower (**Plates 2 & 3**). The stone measures c. 1.2 x 0.85m and is split into two pieces. The eastern end of the stone has been cut to run flush with the door jamb and is over a course of red brick, probably installed during or after the 1851 restoration (**Plate 3**). The stone originates locally and is made from an oolitic limestone. Beneath the stone is a single course of brickwork, which itself sits on a screed deposit. No significant archaeological deposits, features, structures or artifacts were recorded.

Plate 2. The threshold of the west door leading into the tower

The limestone threshold stone lying immediately west of the west door of the tower did not reveal any archaeological deposits, features, structures, or artefacts (**Plates 2 and 3**).

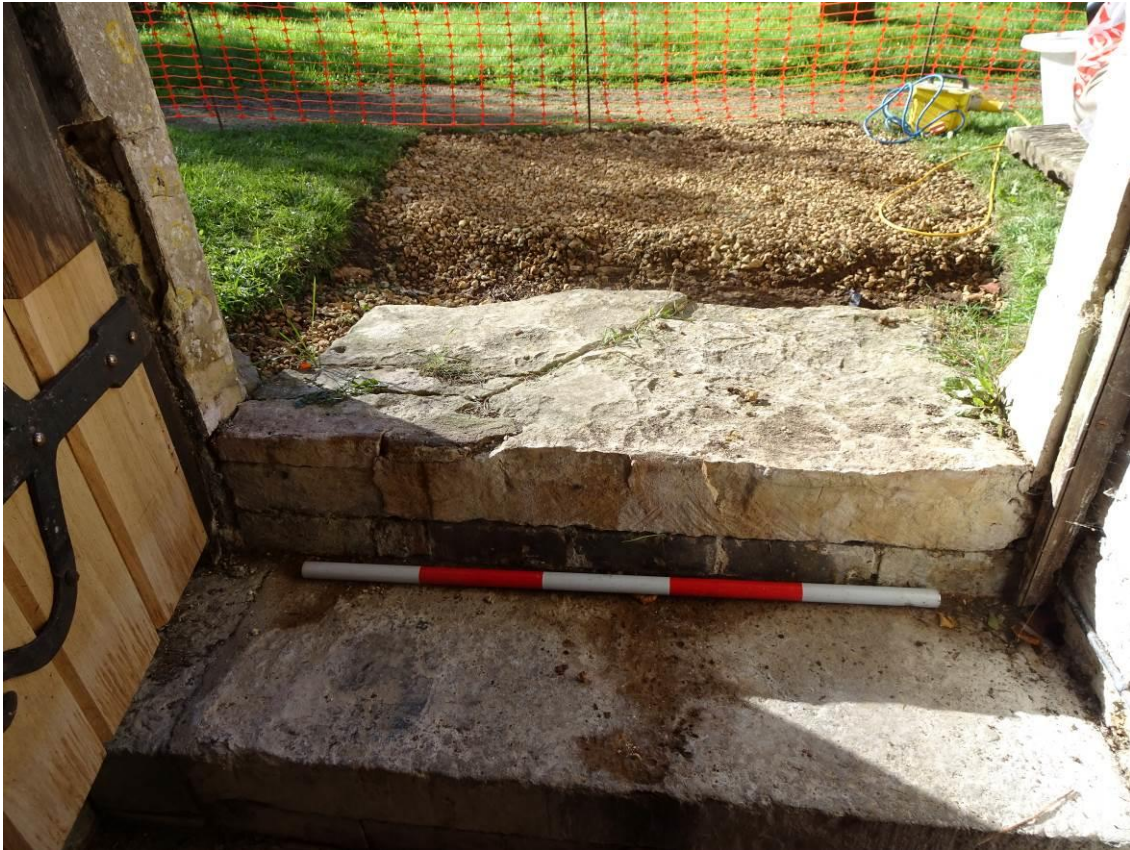
Plate 3. The threshold stone, looking westwards into the churchyard

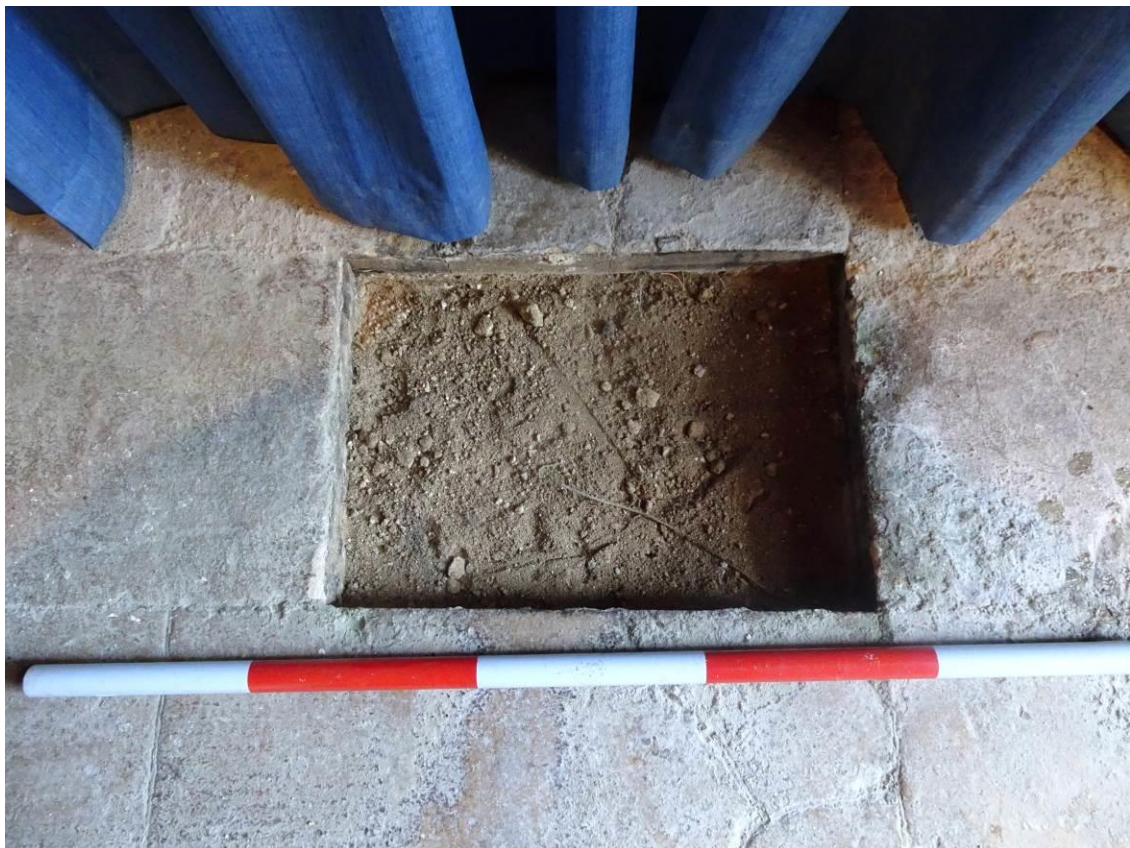
Within the tower floor, just one flagstone was removed (**Plates 4 & 5**) Trench 1. The flagstone measured 0.47 x 0.38m and was excavated to a depth of c. 0.10m below the existing floor level. Exposed beneath the flagstone was a loosely compacted dry sandy substrate which extended to the base of the trench, c. 0.10 m below the existing floor level. No significant archaeological deposits, features, structures or artifacts were recorded.

Plate 4. Trench 1. Exposed subbase material within the tower floor, following removal of flagstone

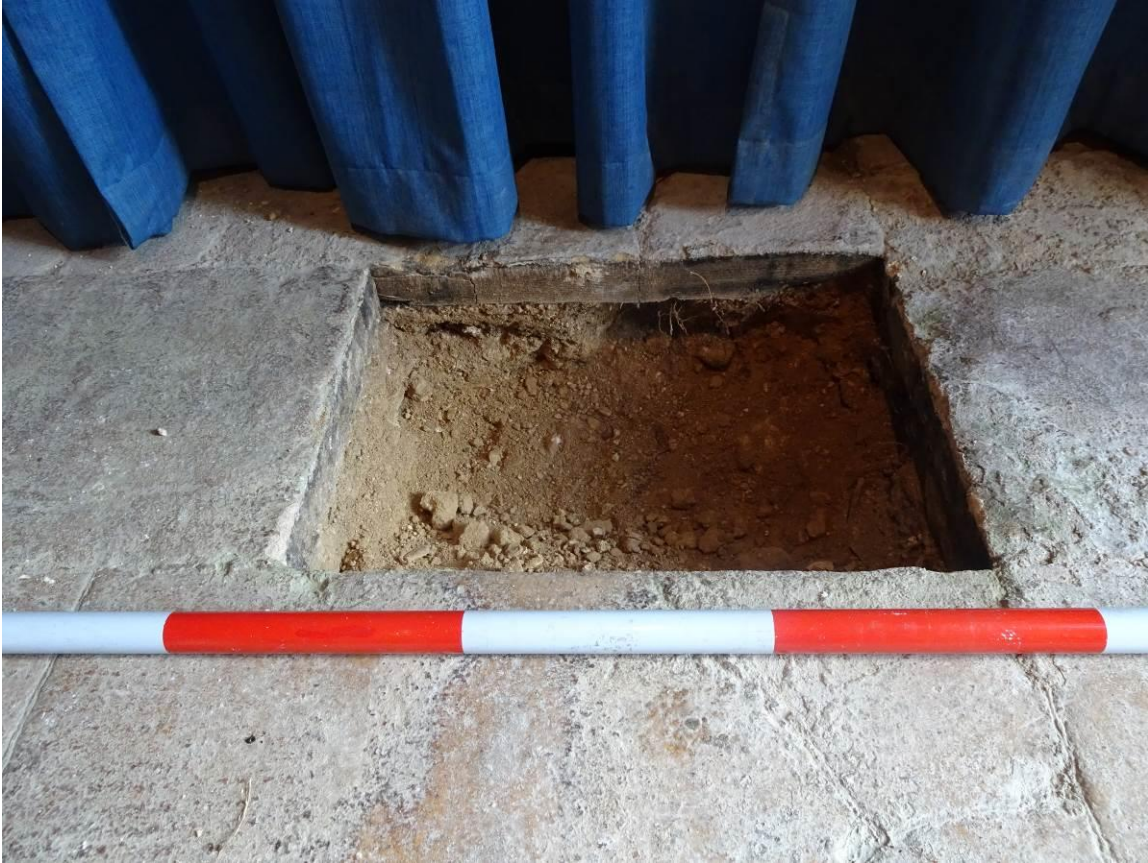
Plate 5. Trench 1. Excavated subbase material within tower floor to desired depth, looking north

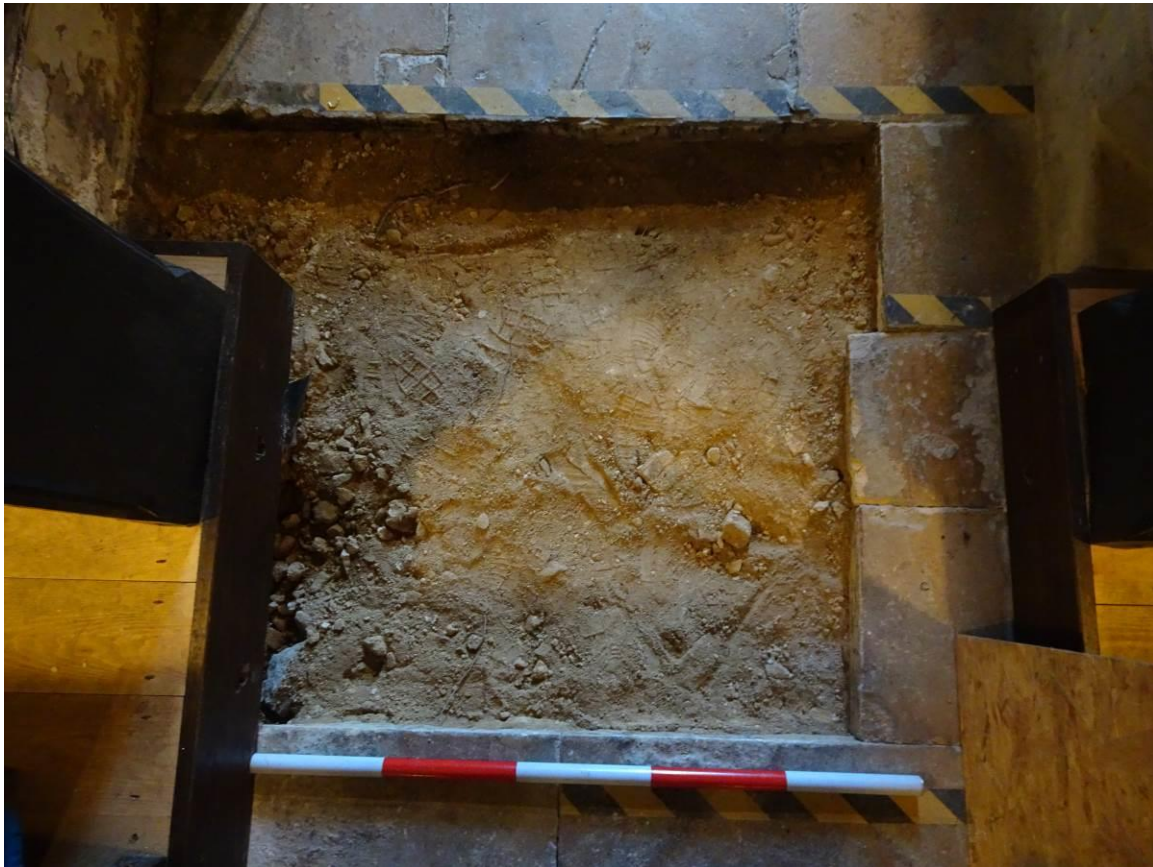
Within the nave floor and extending to where the nave and tower floors converge, six flagstones was removed (**Plates 6 & 7**) Trench 2. The trench area measured 1.05 x 1.08 m and was excavated to a depth of c. 0.10m below the existing floor level. A section of the trench on its southern flank extended underneath a floor that supports the pews. Exposed beneath the flagstone floor was a loosely compacted dry sandy substrate which extended to the base of the trench, c. 0.10 m below the existing floor level. No significant archaeological deposits, features, structures or artifacts were recorded.

Plate 6. Trench 2 (western Nave) Exposed subbase material within the Nave floor

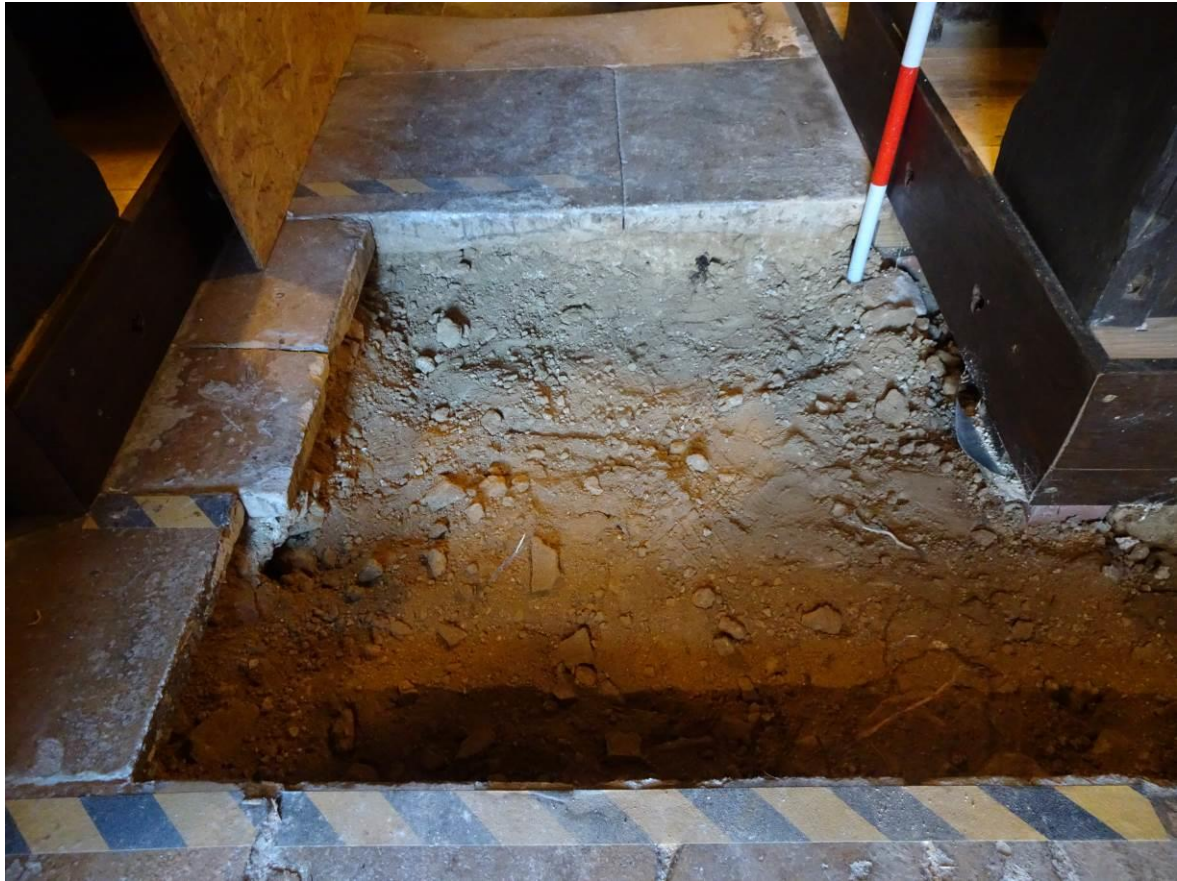
Plate 7. Trench 2. (Western Nave area) Excavated subbase to the desired depth, looking east

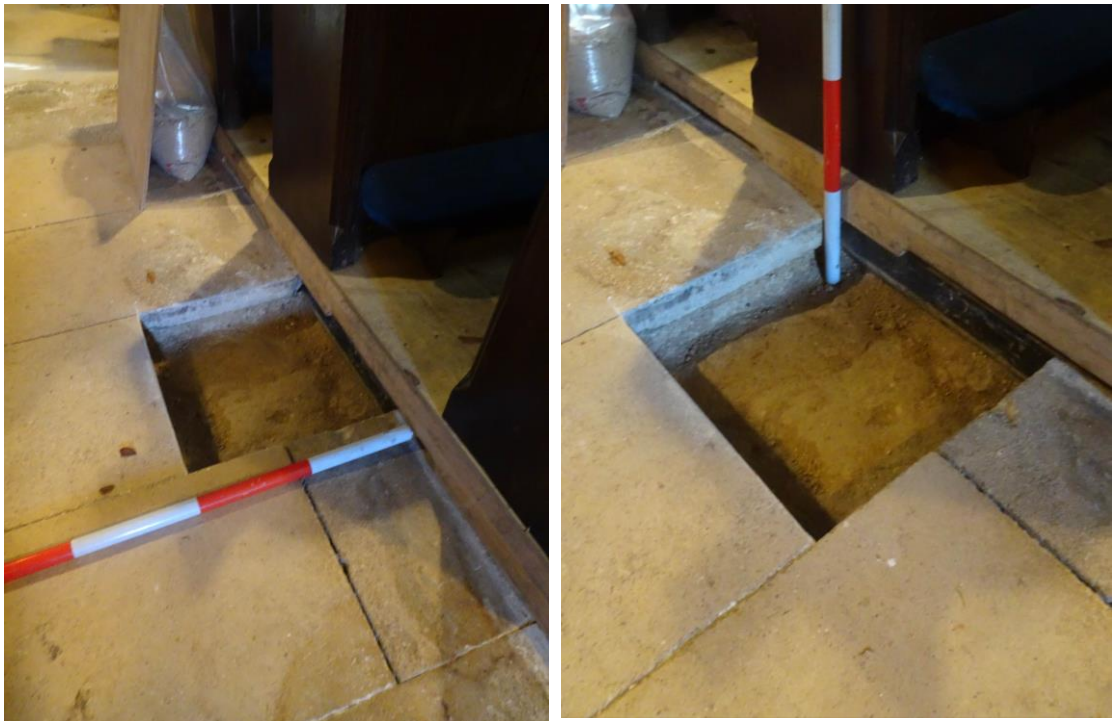
To the east of Trench 2, along the aisle was a small trench that measured 0.50 x 0.45m (**Plates 8 & 9**) – Trench 3. A section of this trench extended underneath the pews on its southern flank. Exposed beneath the flagstone was a loosely compacted dry sandy substrate which extended to the base of the trench, c. 0.10 m below the existing floor level. No significant archaeological deposits, features, structures or artifacts were recorded.

Plate 8. Trench 3 (central Nave). Small trench revealing the subbase material
Plate 9. Trench 3 (central Nave). Excavated subbase material to the desired depth
