Holy Trinity Church

Rothwell

Archaeological Monitoring and Investigation

Report no. 3961

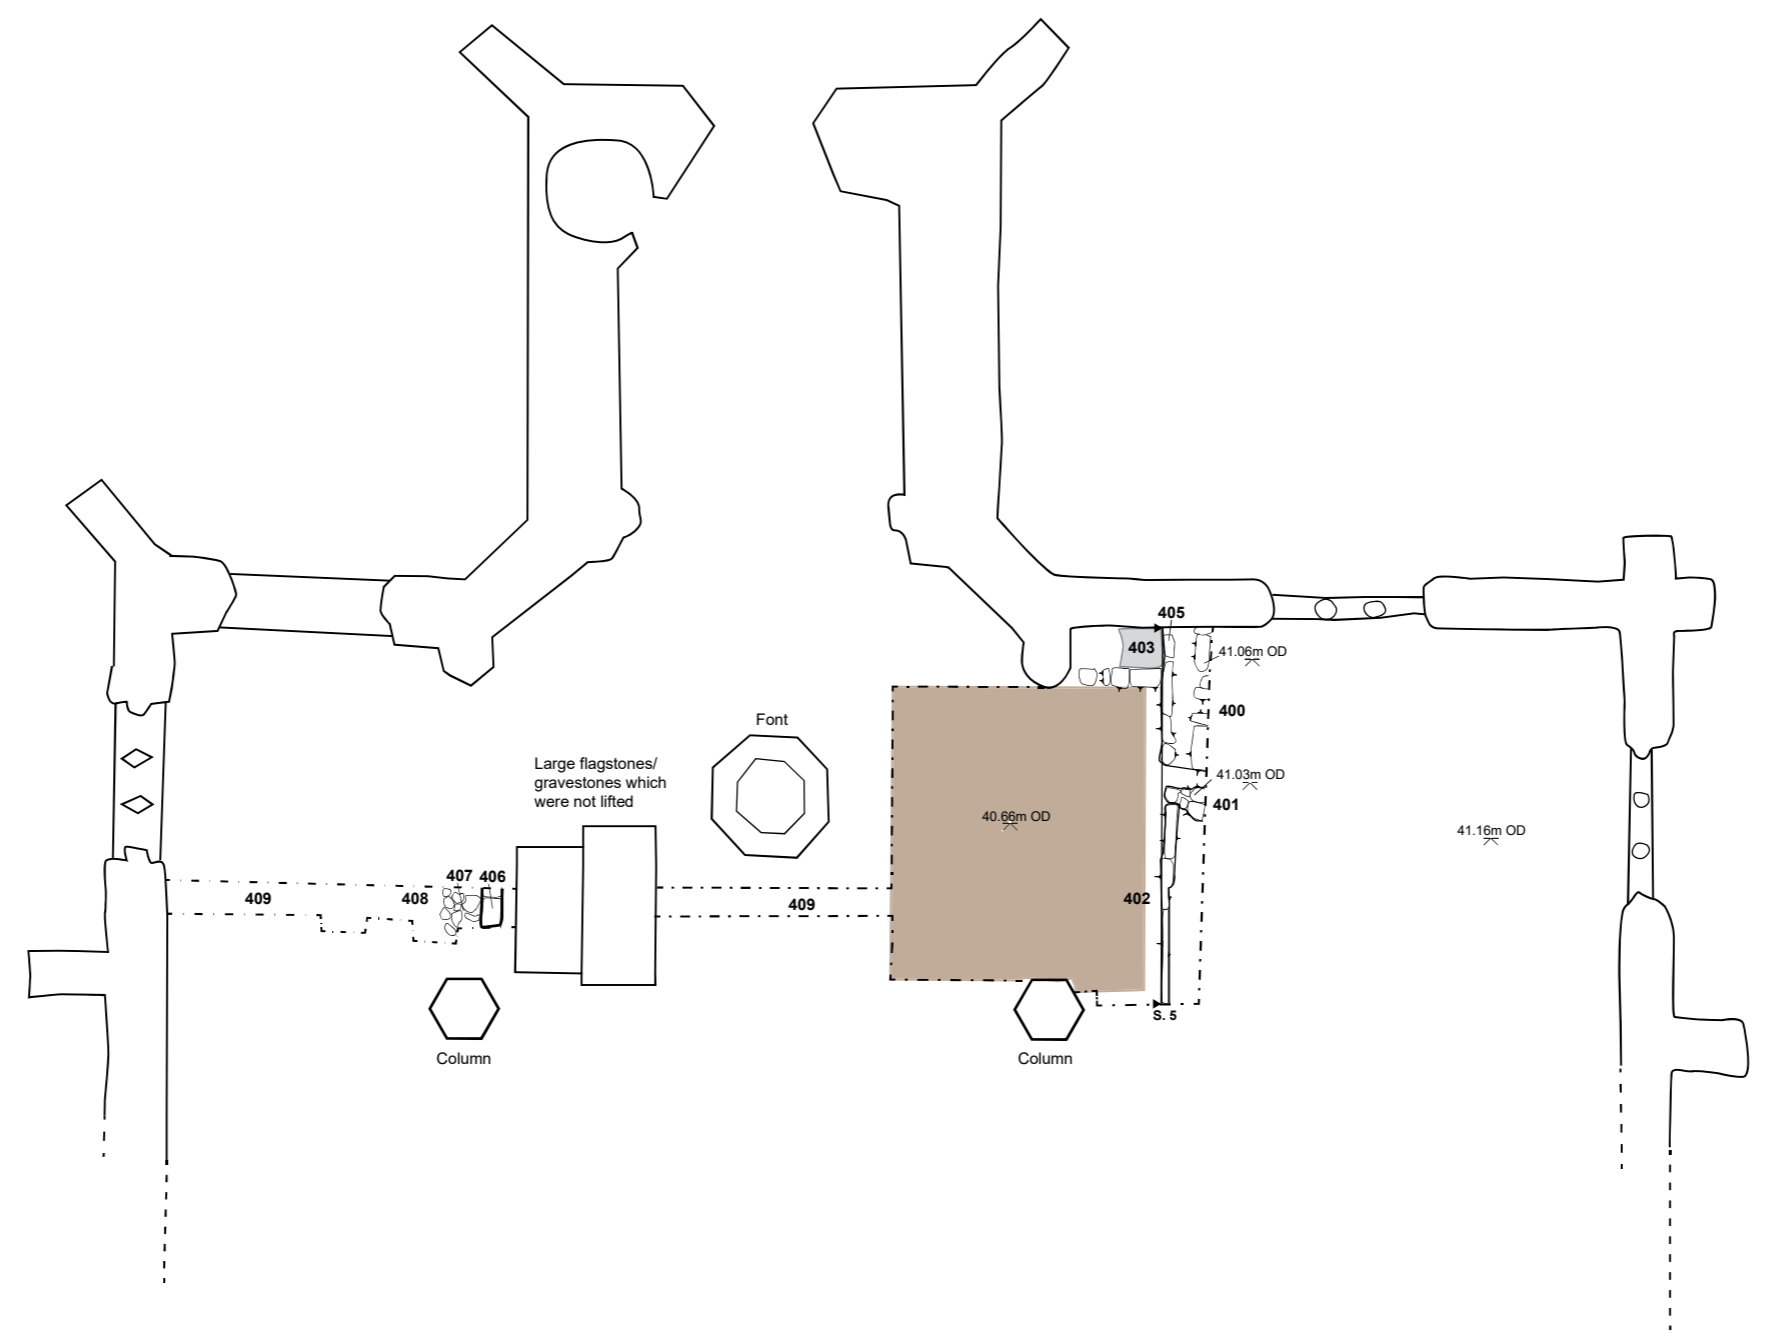
Project No. XH72 *Project Code: HTR22*
Fig. 3
Plan of western end of church showing internal works

The indoor works revealed walls/structures below the flagstones and within service Trench 4 which was approximately L shaped, and was initially aligned east to west before being extended north to south (Fig. 3)

Wall/structures 400, 401, 402 and 405 are located at the western end of the north aisle, below a flagstone surface/wooden floor (410/411) (Figs 3 and 4).

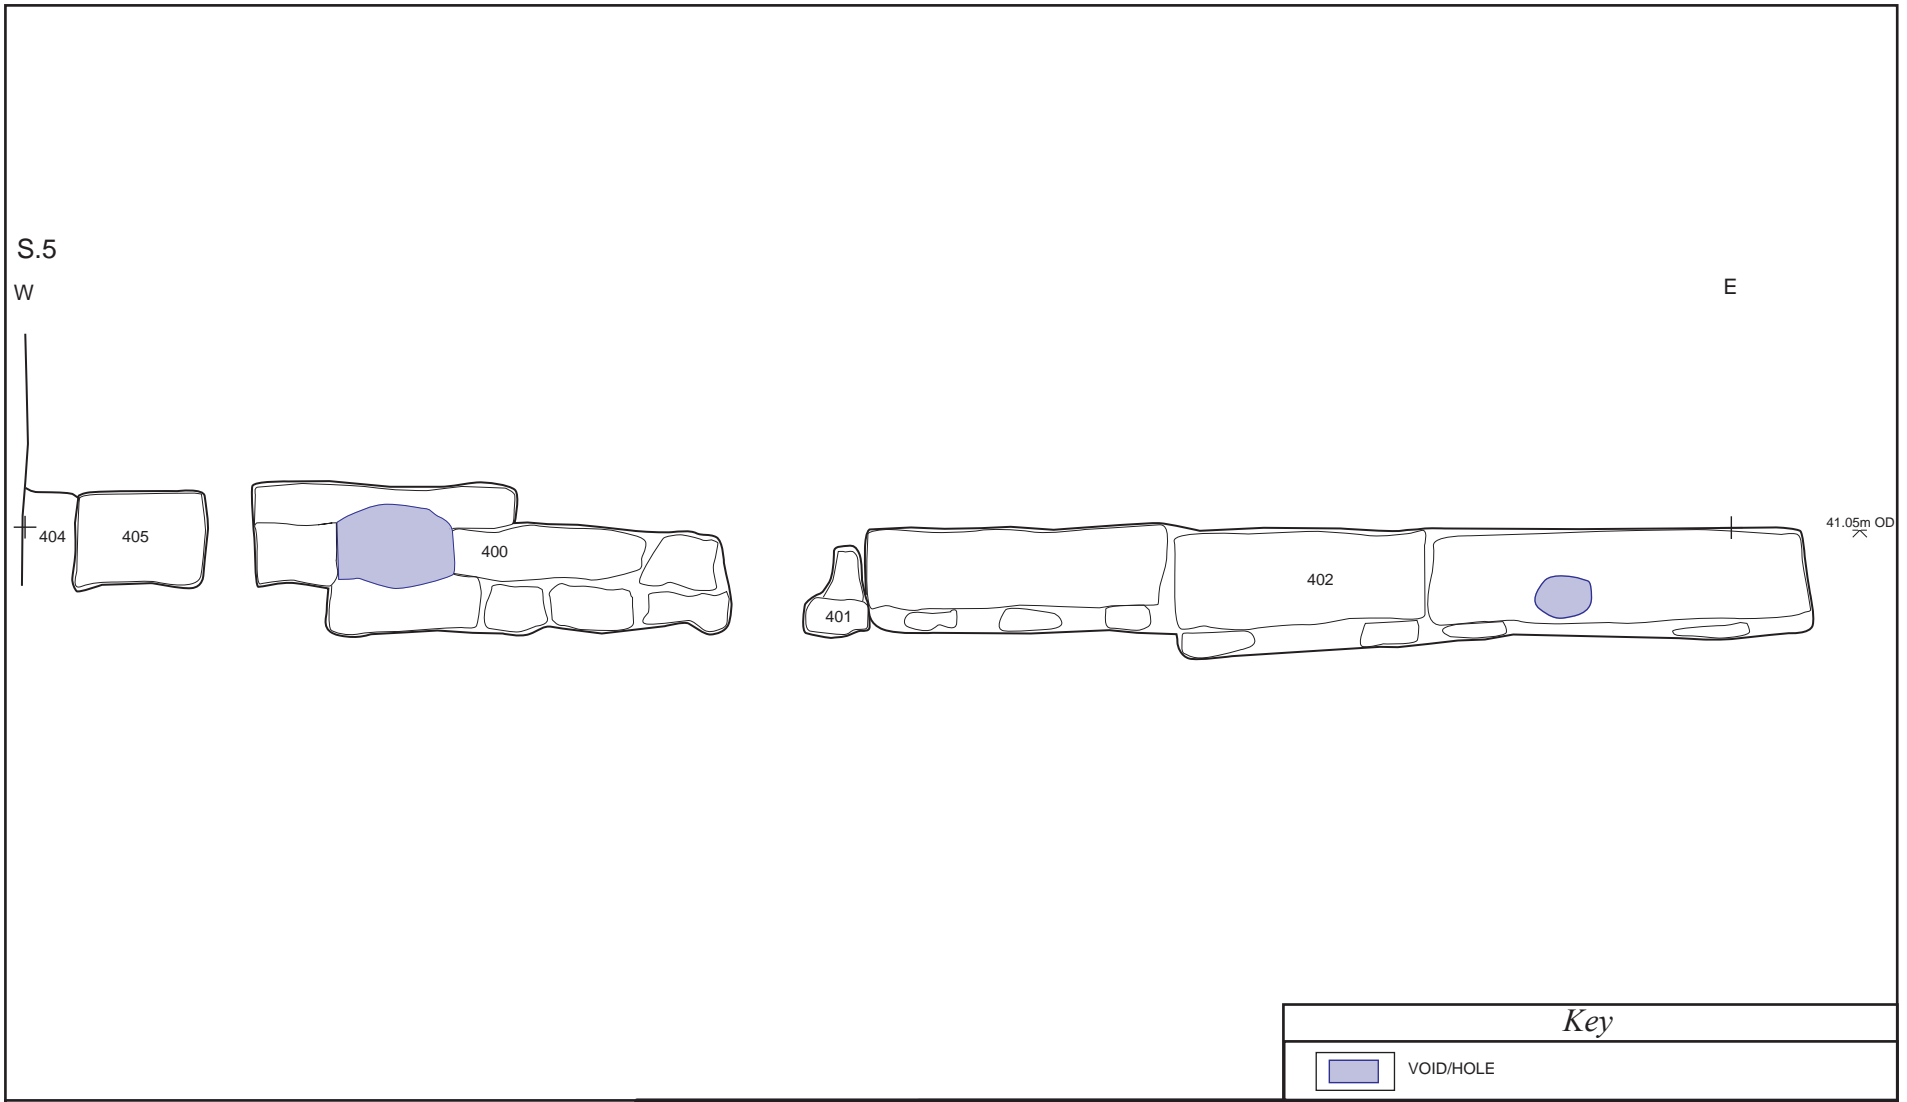
Fig. 4

South elevation of walls

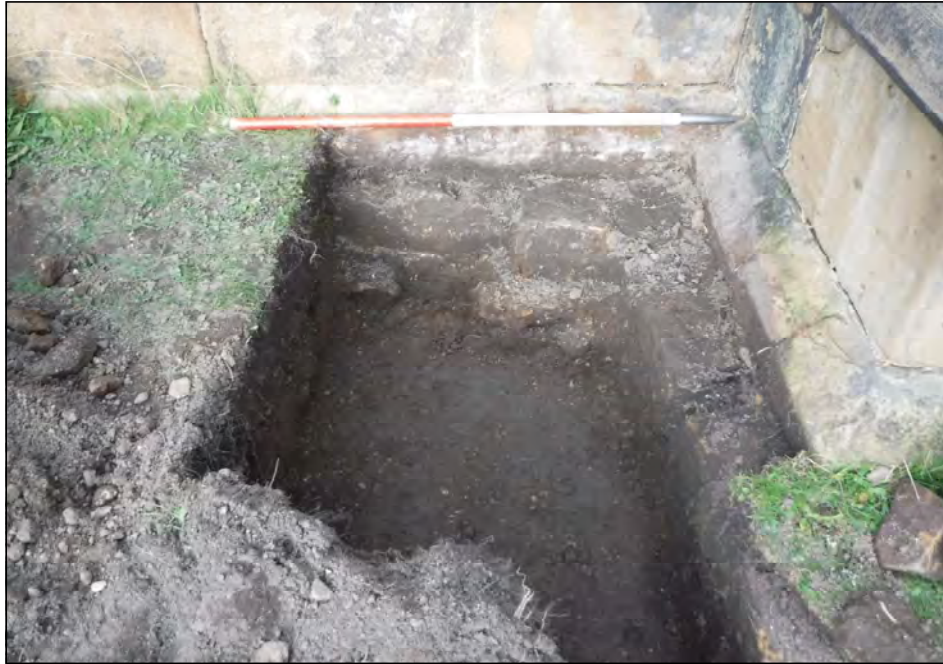
The stratigraphy of the outdoor trenches consisted of a turfed dark brown-grey, fine sandy silt topsoil (100, 200 and 300) above a light yellow-brown coarse clay-sand/broken sandstone subsoil (101, 201 and 301). The shallow nature of the trenches meant that the natural geology was not seen (Plates 1- 4).

Plate 1. Trench 1 up to the south wall of the church, looking north

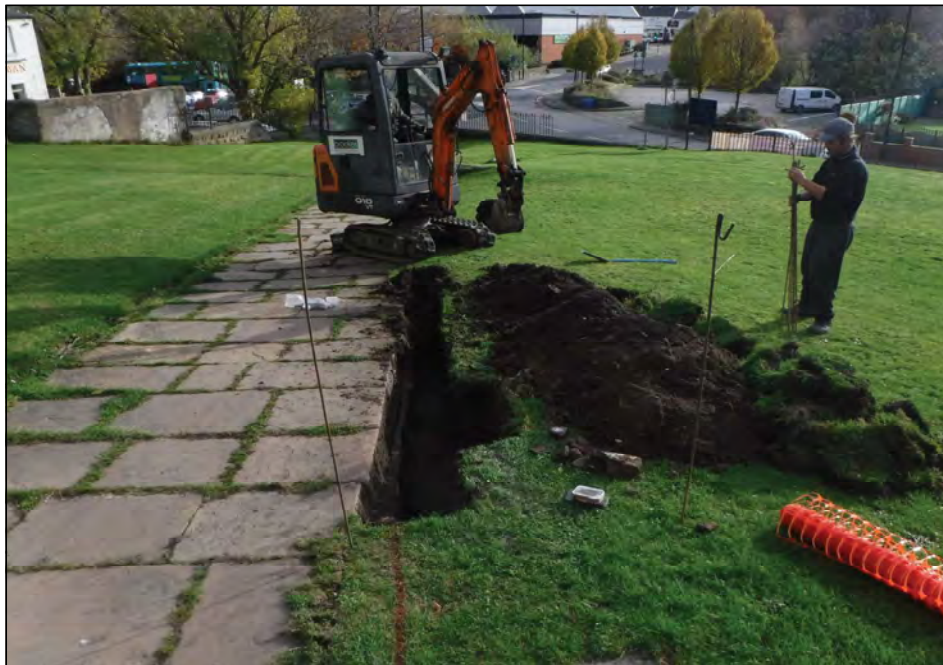
Plate 2. Trench 2 being excavated, looking southeast

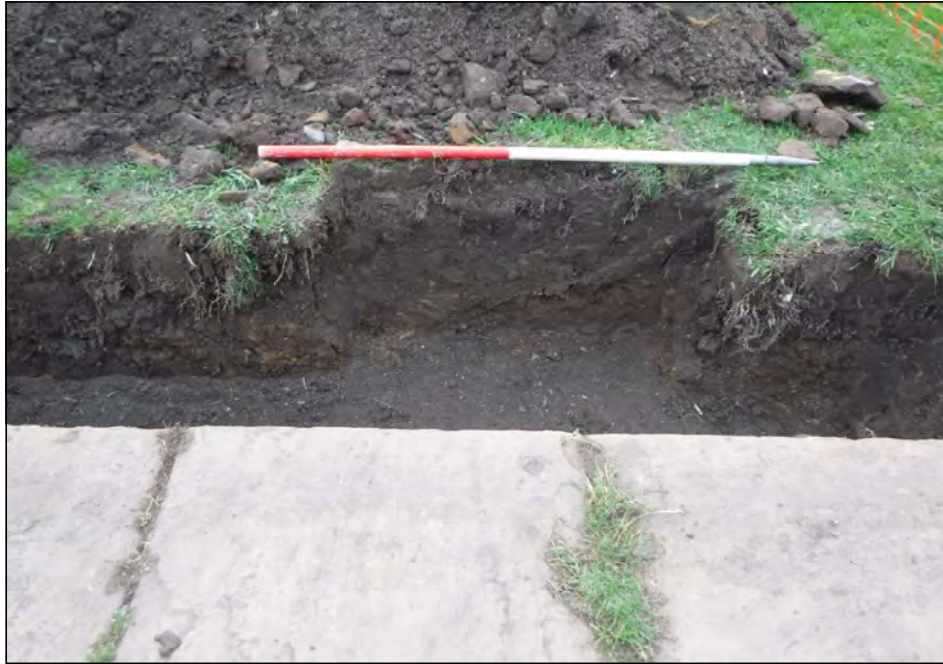
Plate 3. Northeast facing section of Trench 2, looking southwest

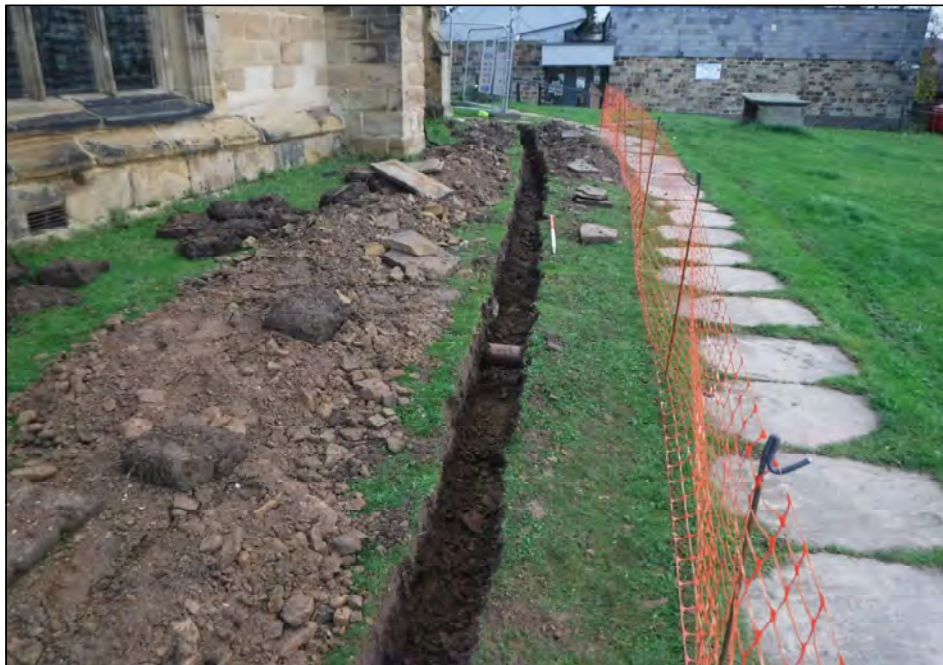
Plate 4. Trench 3 with modern drainage pipe in the base, looking northeast

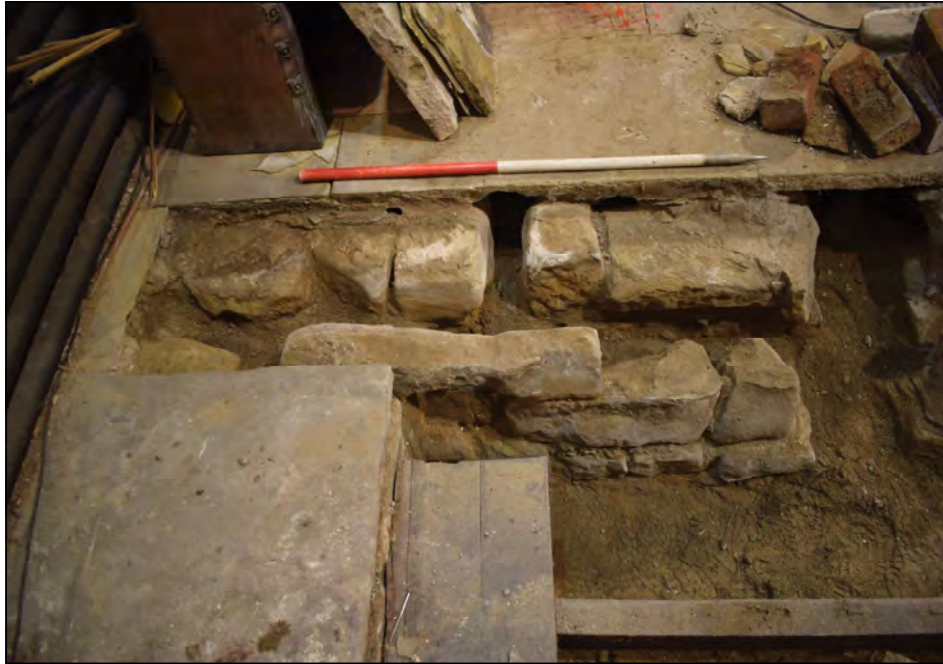
Wall 400 was in an approximate T shape. Its longest length was 2.10m with a maximum width of 0.50m and height of 0.40m. It consisted of some weathered sandstone blocks on a rubble deposit (403). The blocks were bonded with lime mortar. Two small holes had been created within the wall possibly for drainage (Plate 5).

Plate 5. Wall 400 with wooden floor removed, looking north

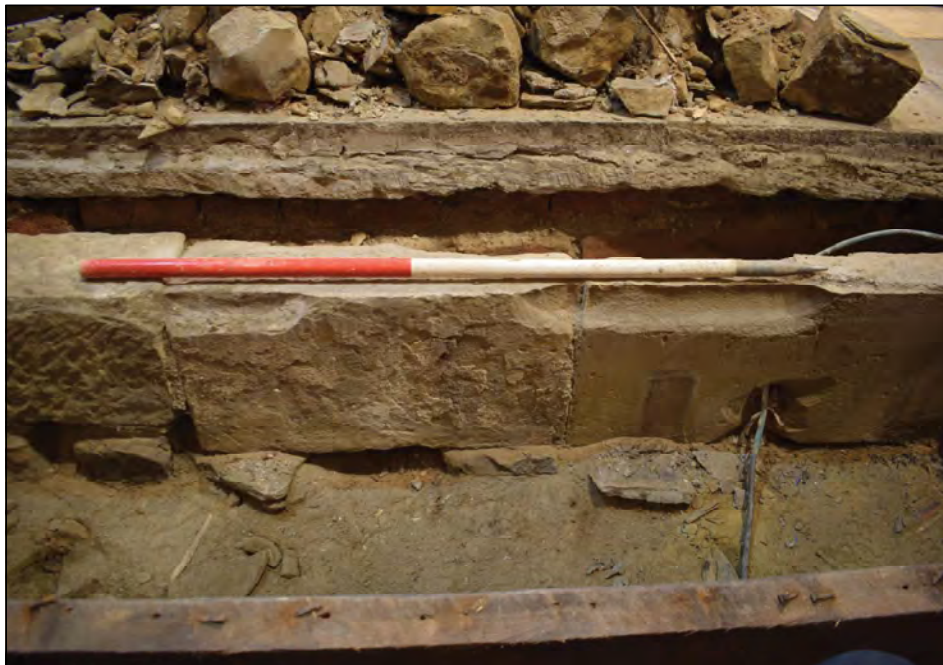
Abutting wall 401 to the east was wall 402. Wall 402 consisted of three dressed sandstone blocks which were below the flagstone floor/wooden floor (410/411). The sandstone blocks sat on top of small pieces of stone to level them up. One of the stone blocks had a hole in it, through which earlier electrical wiring had been inserted. The wall was aligned east to west and measured 2.50m long, 0.20m wide and 0.28m high (Plate 6).

Plate 6. Wall 402, looking north

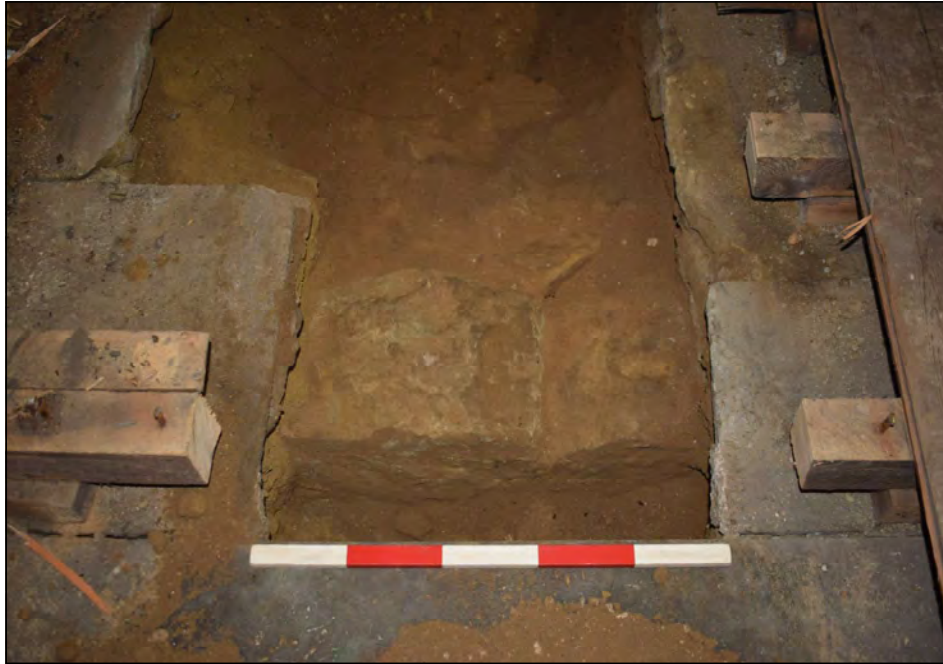
Wall 406 was located at the southern side of the nave (between the nave and the south aisle). This wall was aligned east to west between two of the church's octagonal pillars/columns and was visible for 0.30m in length (Plate 7). The wall measured 0.20m wide and was 0.23m high. The wall consisted of weathered sandstone blocks of various sizes, bonded with lime mortar. This wall was bedded onto deposit (409). To the south of 406 were two different rubble deposits (407 and 408). Deposit 407 was mid-grey-yellow sandy/rubble deposit. This was possible associated with wall 406. Deposit 408 was a light yellow-grey, loose sandy deposit with inclusions of mortar and angular sandstone pieces. This was possibly related to the 19th-century remodelling of the south aisle.

Plate 7. Wall 406 and deposit 407 beneath floor surface 410, looking south

Wall 406 although not very wide, possibly relates to the removal of the southern wall when the south aisle was added or when this side of the church was remodelled in the 19th century.

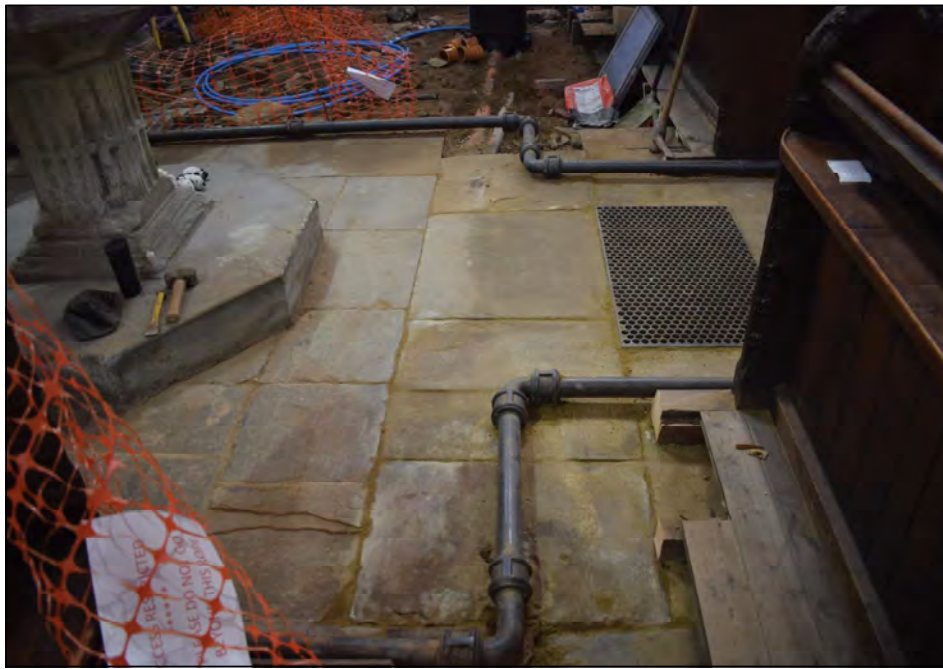
All along the length of Trench 4 and below the flagstone floor (410) was deposit 409. This deposit was a light yellow-grey silty sand with frequent lime mortar inclusions. The deposit also contained occasional fragments of disarticulated human bone. All the bone that was removed, although disarticulated, was replaced as close as possible to where it had been excavated. The original flagstones were replaced once the works had been completed (Plate 8).

Plate 8. Flagstones replaced over Trench 4, looking north
