AN ARCHAEOLOGICAL WATCHING BRIEF AT
THE CHURCH OF ST. MICHAEL, GREAT COATES ROAD,
GRIMSBY, NORTH EAST LINCOLNSHIRE.

National Grid Reference: TA 2413 0902
NELMS Site Code: GRIMS: 2023.001
Faculty Reference: 2022/070476

PREPARED FOR MR. DAVID TAPPIN OF THE PAROCHIAL CHURCH COUNCIL

June 2023

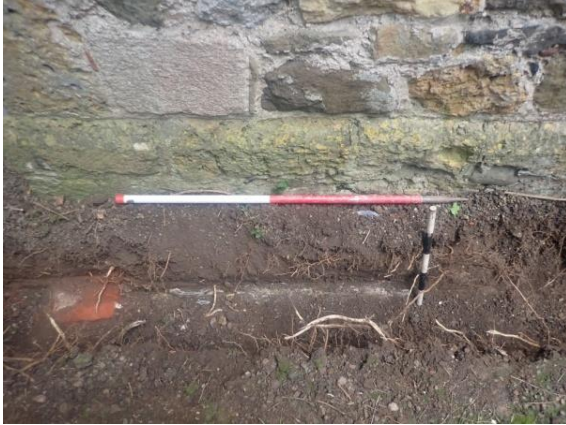
Plate 11: Representative Section 1, from the east

- 001** Undated made ground horizon. Soft and friable, mid orange brown silty clay with small chalk and mortar fragments and flecking 2% and frequent small-medium, chalk, limestone and ironstone fragments. Above **(002)**. Recorded within **Representative Section 1**. Depth - 0.16m.

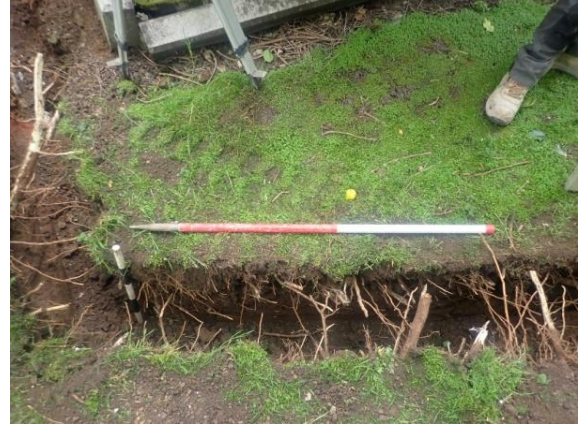
- 7.3 The mechanical excavation of the new service trench, thence extended to the south-east; the extent of which is also shown on **Figure 3**. This further and final section of new service trenching was excavated to the same width of 0.30m and to depths of between 0.40m-0.60m below ground levels [**Plates 12-13 and 15-31**]. These further excavations went through a relatively shallow topsoil horizon (**003**) and into the underlying graveyard soil (**002**), which extended to the base of these excavations. The site deposit sequence here was recorded within **Representative Sections 2-5 [Plates 14 and 32-34]**.

Plate 14: Representative Section 2, from the south-west

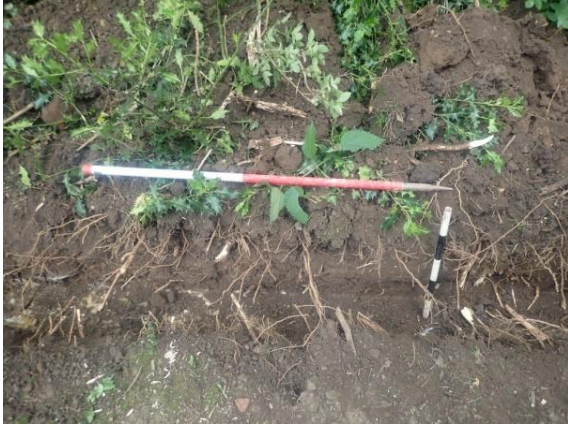
Plate 32: Representative Section 3, from the north-east

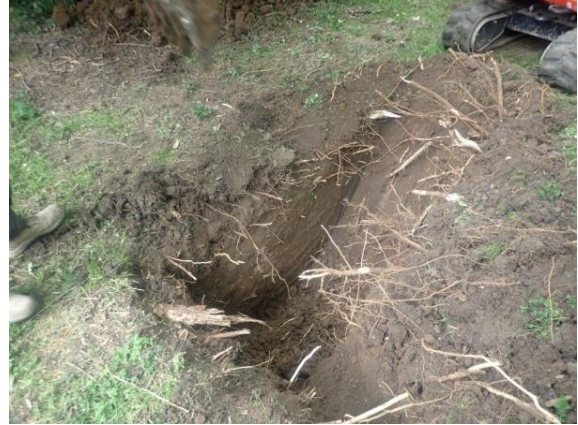
Plate 35: Excavation of the soakaway, from the north

- 7.4 This was then followed by the monitored mechanical excavation of the new soakaway that was located at the south-eastern end of the service trenching. This final mechanical excavation extended to a length of 3.50m, to a width of 1.80m and to a depth of 1.30m below ground levels. This excavation went through the shallow topsoil horizon (**003**), the graveyard soil horizon (**002**) and into an underlying natural horizon of boulder clays (**004**), which was recorded at the base of these excavations [**Plates 35-39 and 41-43**]. The site deposit sequence within this final excavation was recorded within **Representative Section 6 [Plate 40]**.

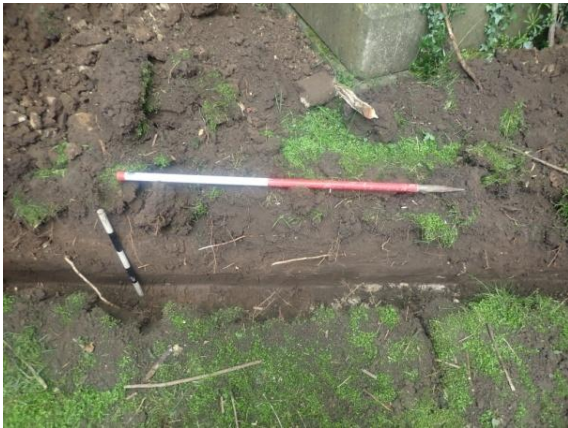
Plate 33: Representative Section 4, from the north-east

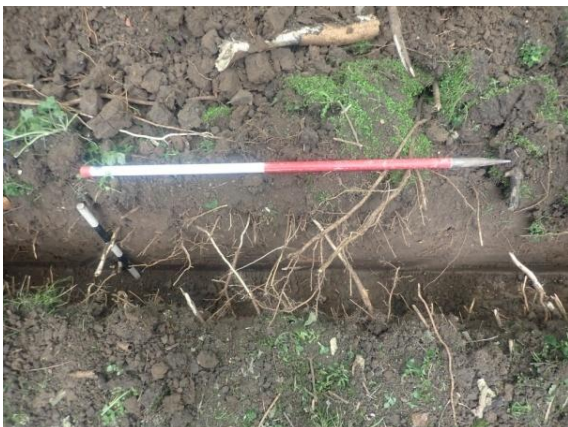
Plate 34: Representative Section 5, from the north-east

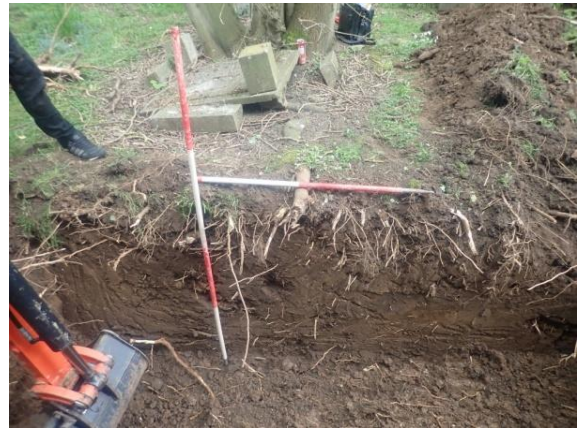
Plate 40: Representative Section 6, from the east

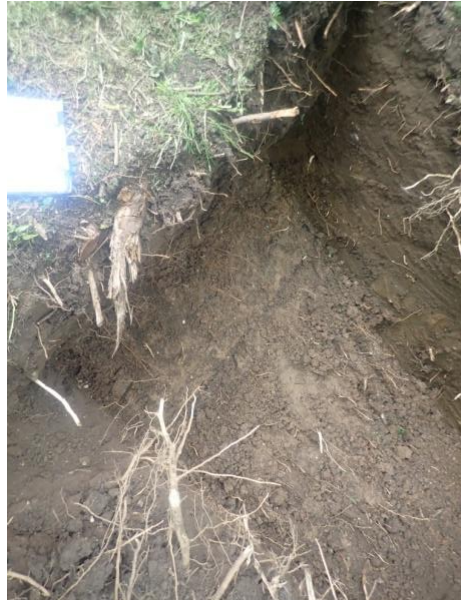
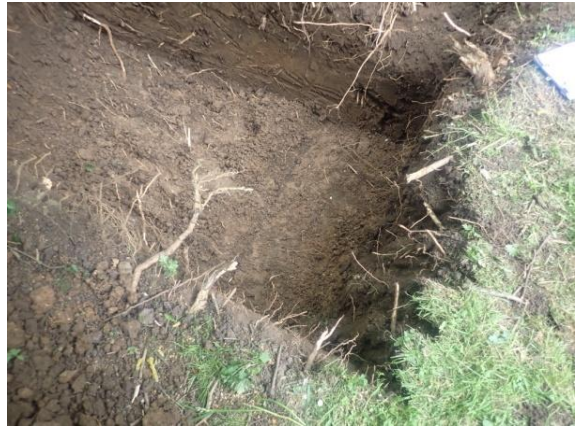
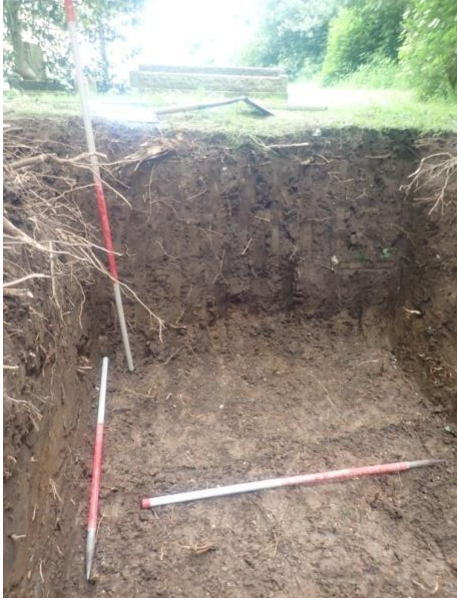
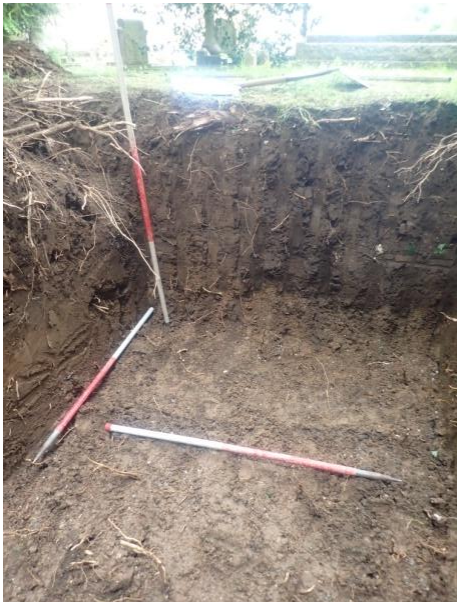
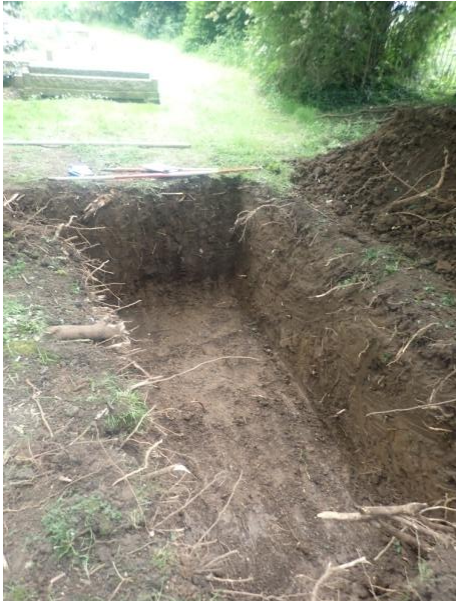
- 7.5 At the northern end of and at the base of the soakaway excavation, the remains of an undated *in situ* inhumation burial [**005**] with fill (**006**) were identified. The site of this burial was defined at depth by the rotted remains of an *in situ* wooden coffin, the eastern end and the southern side of which had been preserved within this excavation [**Plates 44-47 and 51**]. The area of this burial was recorded within **Sections 7-9 [Plates 48-50]**. An iron coffin nail and two wooden fragments of the former coffin lid were observed within the grave fill (**005**), which were left where they were seen. There were no other surface finds.

Plate 44: View of the *in situ* wooden coffin, from the south-west

Plate 45: View of the *in situ* wooden coffin, from the north-east

Plate 46: View of the *in situ* wooden coffin, from the south

Plate 47: View of the *in situ* wooden coffin, from the south

Plate 51: View of the *in situ* wooden coffin, from the south

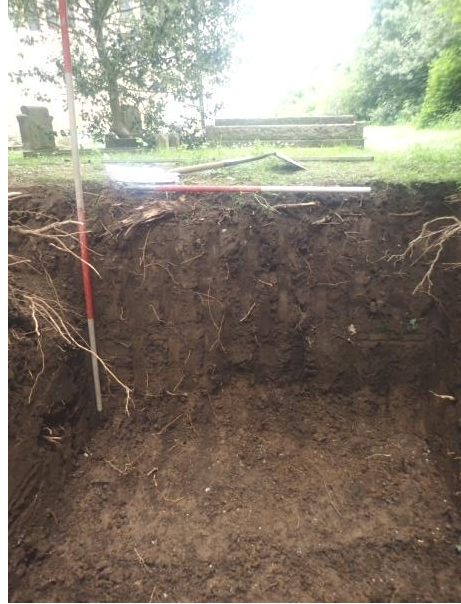
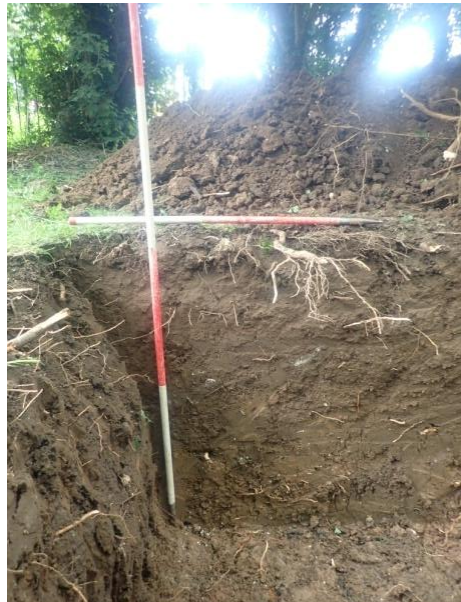
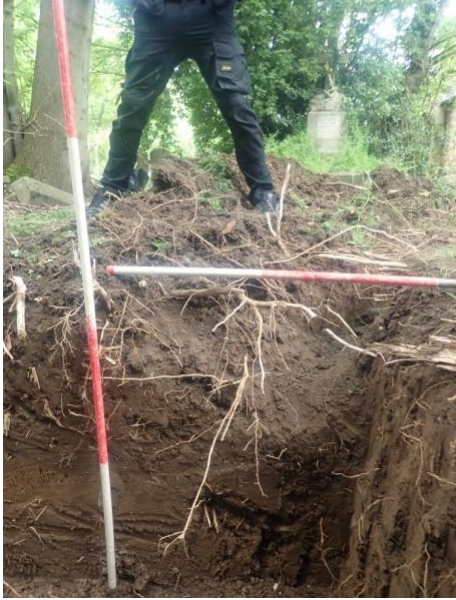
Plate 48: Section 7 of the grave cut [005] with fill (006), from the south

Plate 49: Section 8 of the grave cut [005] with fill (006), from the west

Plate 50: Section 9 of the grave cut [005] with fill (006), from the east

- 005** *In situ* and undated inhumation burial recorded at depth, at the base of and at the northern end of the soakaway excavation. Cut **(004)**. Recorded within **Sections 7-9** and extent featured on **Figure 3**.

- 006** Grave fill of the undated inhumation burial. Soft, light orange brown silty clay with small fragments of chalk and flecking 1%. Below **(002)**. Recorded within **Sections 7-9**. Depth - >0.86m.
