Archaeological attendance during groundworks at St John the Baptist Church, Whitwick, Leicestershire SK 43441 16236

For: Whitwick PCC

ULAS Report Number 2016-168 ©2016

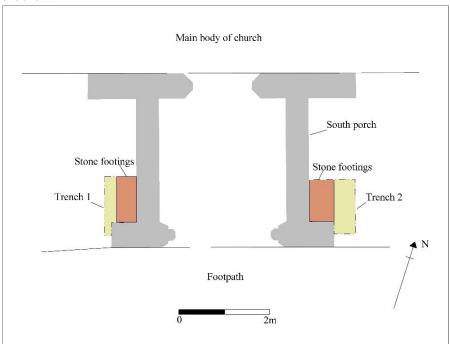
Figure 4: Plan of south porch walls with positions of exploratory trenches

Groundworks commenced on 6th October 2016, with the excavation of two trenches (one on each side of the south porch) to allow a structural engineer access to the footings beneath the porch walls. Archaeological attendance was a condition specified by the Diocesan Advisory Committee and an archaeologist from University of Leicester Archaeological Services oversaw the groundworks. The two trenches are separately discussed below.

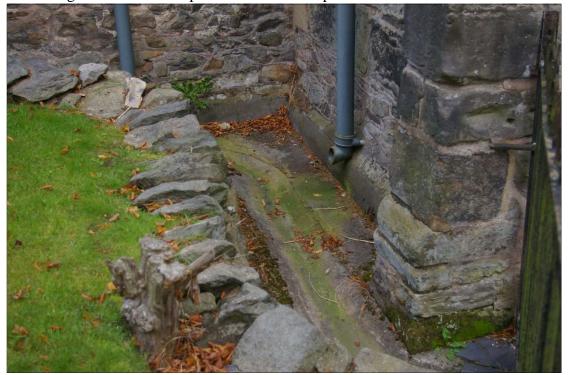
Figure 5: West wall of porch prior to excavation

Trench 1 was hand excavated on the outside of the western porch wall. The trench measured 1.30m x 0.70m and was excavated to a depth of 0.70m. A concrete drain was removed using a Stihl saw and breaker followed by manual digging. The depth was sufficient to allow the structural engineer to examine the footings of the porch wall. The removed spoil, a very dark grey-brown silty sand, was checked for archaeological finds but this proved negative. The trench walls were clear of any archaeological features or deposits other than the porch wall.

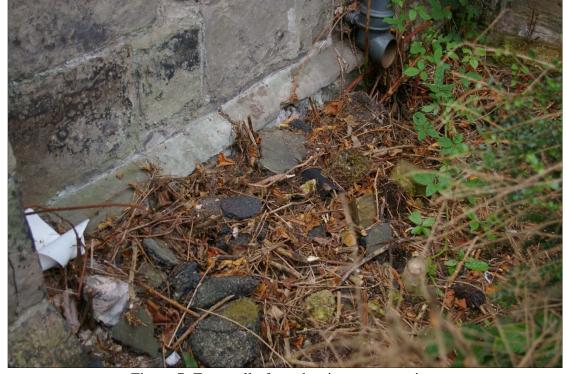
Figure 7: East wall of porch prior to excavation

Trench 2 was hand excavated on the outside of the eastern porch wall. The trench measured 1.20m x 1.0m and was excavated to a depth of 0.50m. The depth was sufficient to allow the structural engineer to examine the footings of the porch wall. The removed spoil, a dark grey brown silty sand, was checked for archaeological finds but this proved negative. The trench walls were clear of any archaeological features or deposits other than the porch wall.
