ST HELEN'S CHURCH, HEMSWORTH
WEST YORKSHIRE
ARCHAEOLOGICAL WATCHING BRIEF

JB Archaeology Ltd

St Helen's PCC

May 2023

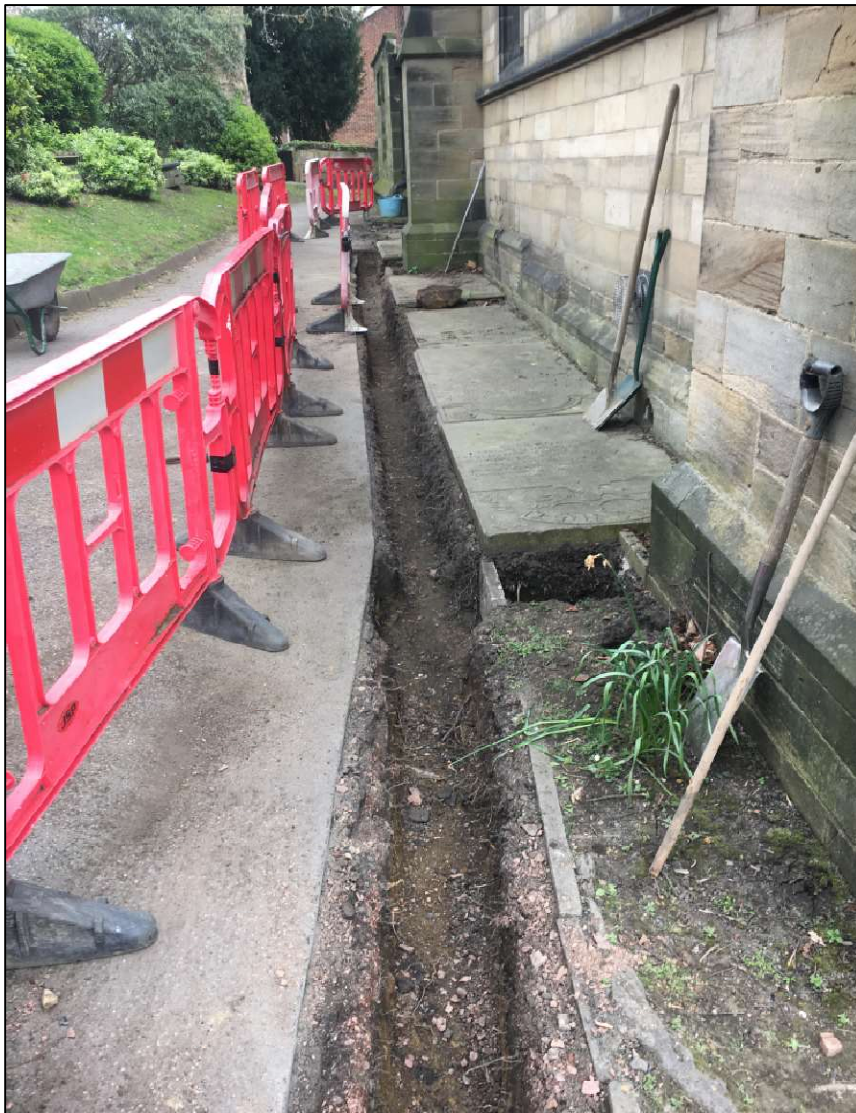
Plate 1. Drain run to north of church, looking east

4.1 Ground works consisted of the hand excavation by the contractors of the new drainage trench under direct and continuous archaeological supervision (Figure 2, Plate 1). The pipe trench was excavated to a depth of c.0.3-0.40m with an average width of 0.50m.

5.1 As would be expected from a church of this age the works encountered a modest amount of disarticulated human bone along the length of the excavations (Plates 1&2). In addition to the disarticulated remains, and slightly surprisingly due to the shallow nature of the works, a skull from what appeared to be an intact burial was encountered at the western end of the church (Plate 2).

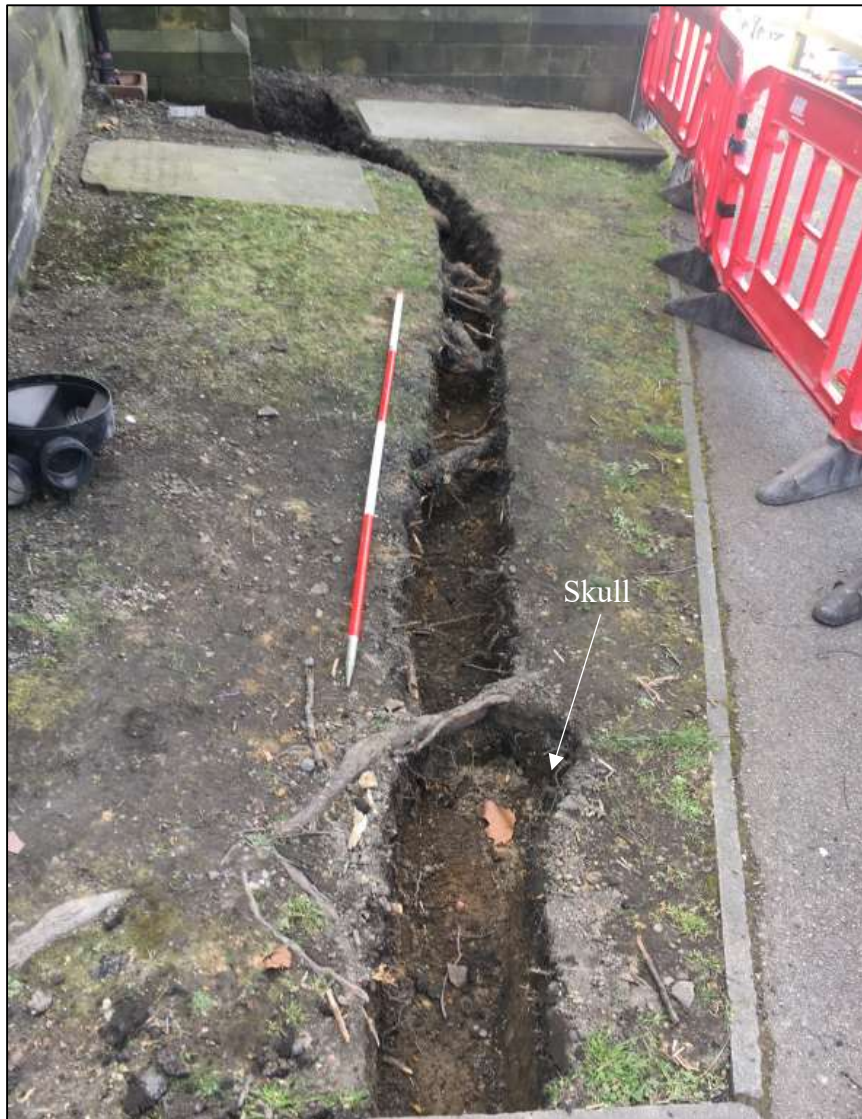
Plate 2. Western section of drainage run, looking south, scale 2m

5.2 The burial was very shallow (c.0.3m deep) and was unusual in that it appeared to be orientated with the head to the east with the remainder of the skeleton

located in the unexcavated baulk as the articulated vertebra could be seen to be running to the west. The skull was briefly recovered to prevent damage during the pipelaying and was reburied in its original position, along with the disarticulated human bone, once the new drain had been laid.

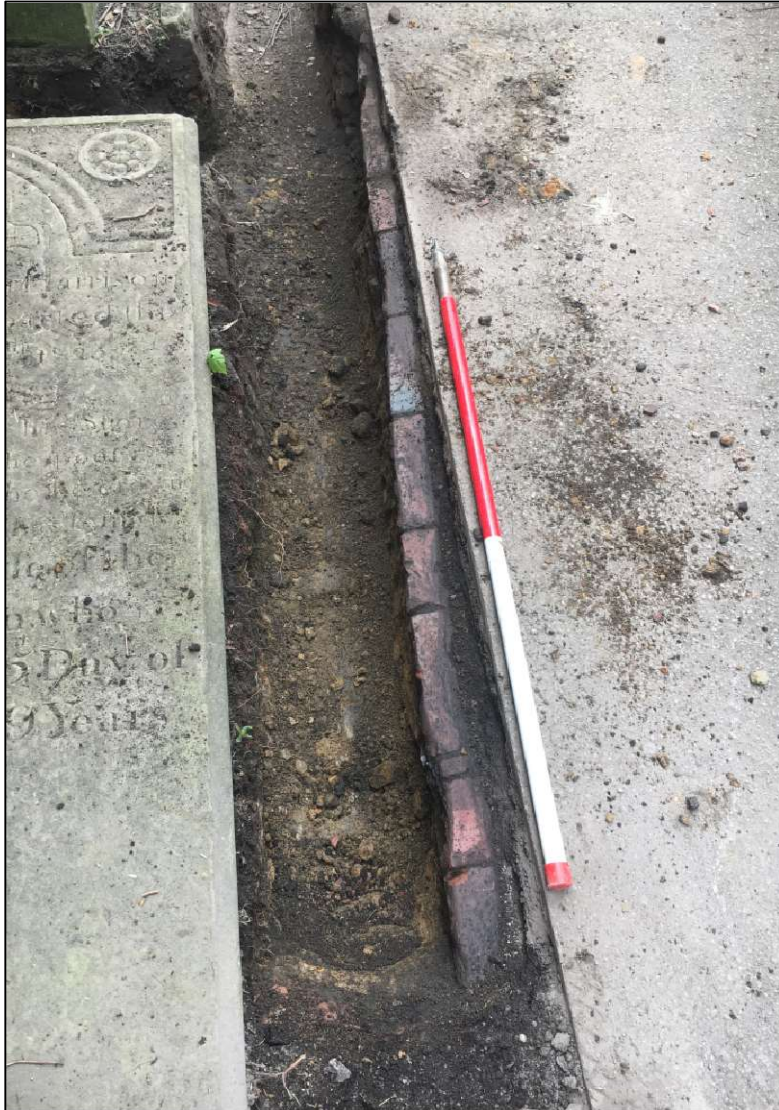
- 5.3 In addition to the human bone a short section of edge laid bricks were exposed in a parallel line to the north wall of the church, this appear to be the remains of the earlier edging to a path (Plate 3). Further evidence for earlier paths was seen on the north-western corner of the drainage trench where a small area of compacted ash was observed (Plate 4).

Plate 3. On edge bricks, looking west, scale 1m

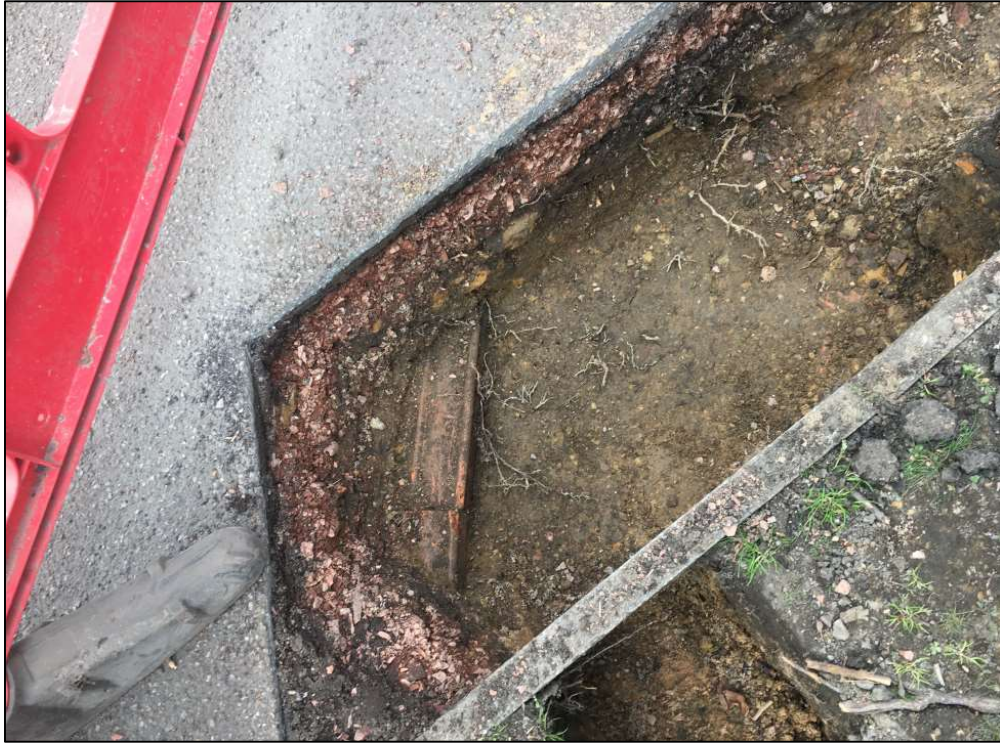
Plate 4. Area of compacted ash, probably former path
