ST GILES CHURCH, CROPWELL BISHOP, NOTTINGHAMSHIRE

Archive Report for:
Archaeological Monitoring

Project Code: SGC16

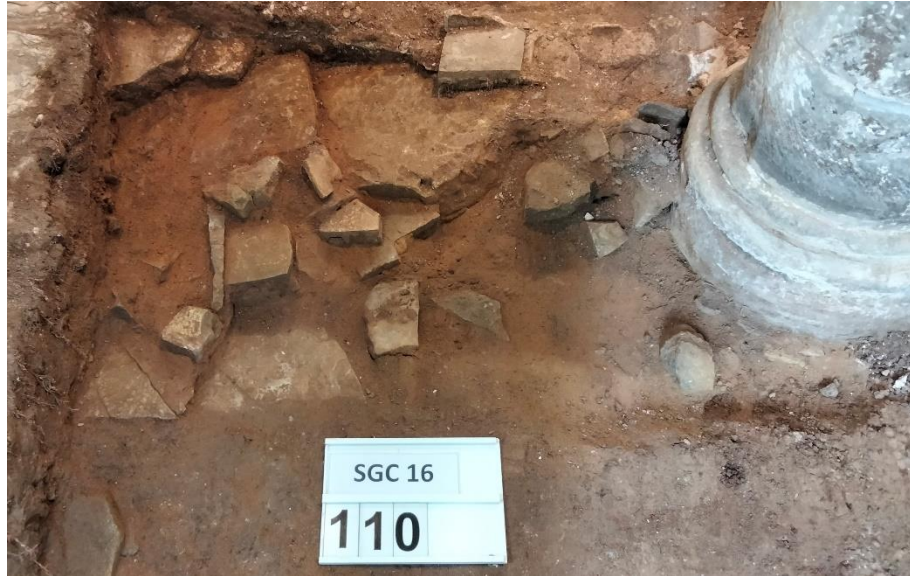
Deposit *117=121* also truncated by a rectangular cut **112**, for a foundation raft structure, *110=109*. This feature was rectangular in plan and was located immediately to the west of the westernmost column of the southern arcade separating the southern side of the nave from the southern aisle (Figure 3). Foundation raft *110=109* was formed of roughly dressed stone blocks measuring a maximum of 0.67m by 0.42m by 0.09m, set in a limestone mortar matrix. It was aligned east to west and measured 1.45m x 0.90m.

Plate 1. Foundation 110=109, facing north

Structure *110=109* abutted the existing column as described and therefore must be circa early 13th century or later in date. However, there was no evidence surviving on the column or the arch it supported to suggest that *110=109* had ever extended above the floor level of the church. It is therefore most likely that the structure represents a foundation raft for the church floor. Given the construction and materials of the raft (similar to font foundation *118* see below), the structure is likely to be of medieval date, although re-used for later floor surfaces.

Two further stone-built structures (**110=109** and **114**) were also recorded. These butted the standing columns of the southern and northern arcades respectively, and so post-date the mid-13th century construction of the arcades. Given their construction similarities with font raft **118**, it is likely that these structures represent floor foundations which were constructed in the 14th century.

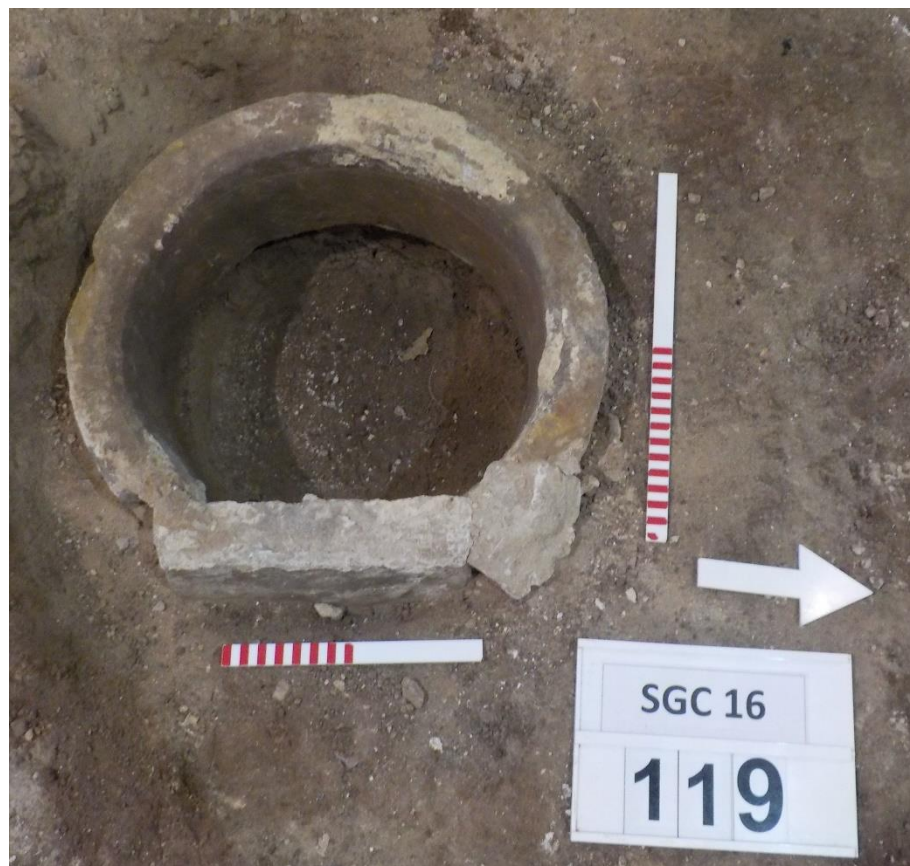
The earliest feature encountered was a 0.50m diameter sub-circular cut, **124**, which was located directly under the position of the font. Cut **124** truncated deposit *117=121* and had a vertical-sided, concave-based profile. It contained a carved c-shaped stone measuring 0.50m in diameter, *119*. The upper surface of the stone appeared to be chamfered and the stone itself was circa 0.08m thick. It appeared to have been re-used, as the open side of the stone had been deliberately closed by the addition of a second, rectangular stone, *126*. This measured 0.35m by 0.20m by 0.09m in size and had been affixed to stone *119* with blobs of limestone mortar.

Plate 2. Font soakaway structure 119 and 126 (foreground) , facing west

Together features 124, 119 and 126 formed a soakaway for baptismal water draining from the font.

Several features of archaeological interest were encountered during the archaeological monitoring. The first of these was the foundation raft for the existing font (**118**), together with the font soakaway drain (**124, 119, 126**) that was situated immediately below the foundation. Leaving aside the possibilities that these structures were built for an earlier font, or that the present font has been moved from its original location at some point, then they clearly date at the latest to the installation of the present font in the 14th century.

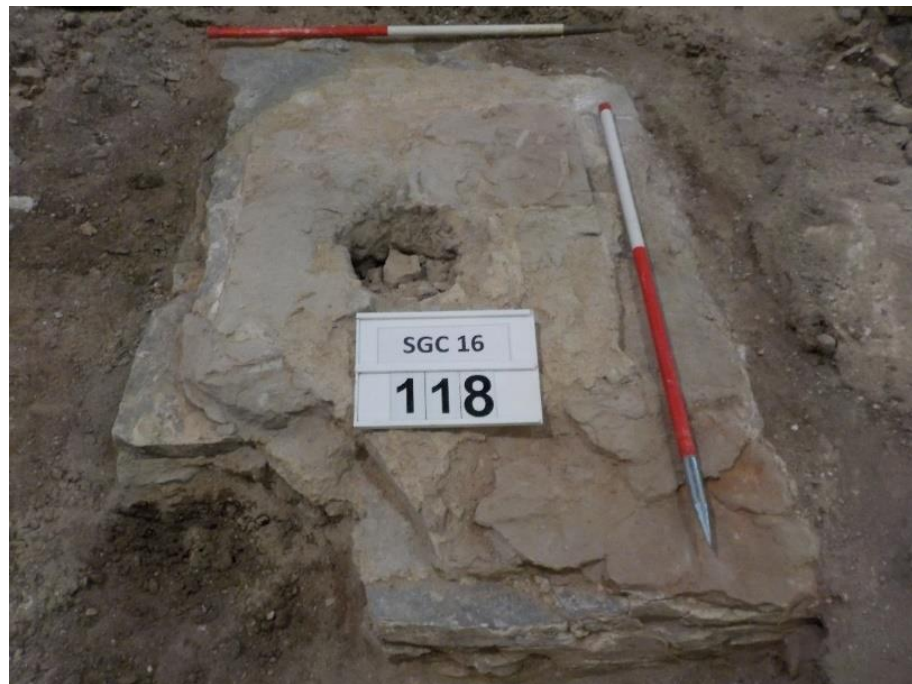
Features **124**, **119** and **126** were surmounted by a large rectangular structure, **118**. This measured 1.70m by 1.30m by 0.36m and consisted of two to three courses of mixed stone, flint and tile, bonded with a cream limestone mortar. The feature incorporated a 0.20m diameter void or pipe leading to the underlying soakaway formed by **124**, **119** and **126**.

Plate 3. Font foundation raft 118, facing west

There is no evidence that the font had ever been moved from its location prior to the commencement of the current works. Since the font is known to be of 14th century date, it follows that the underlying foundation raft and soakaway must date from that period at the latest.

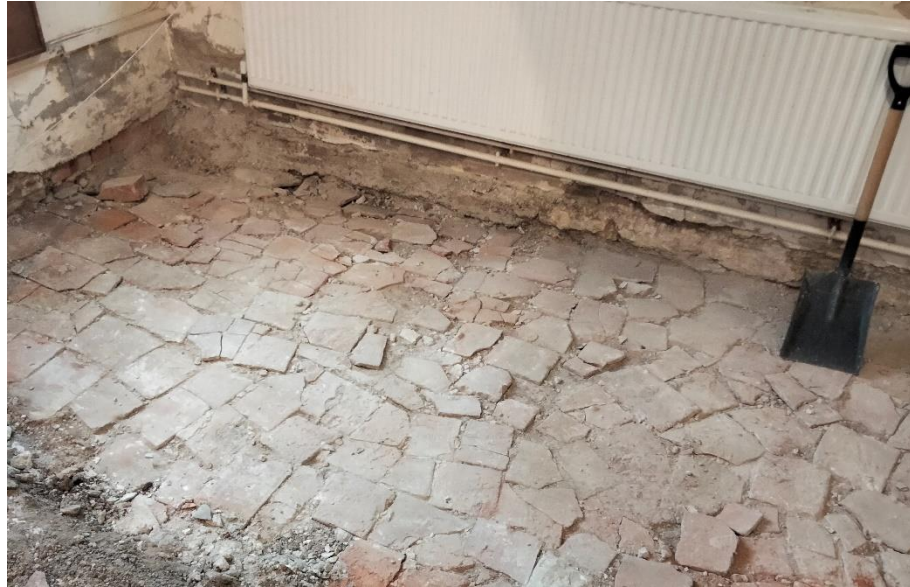
All the features described above were sealed by a sequence of made ground deposits. These included silty sand layer, **111**, a similar overlying layer, **113=102**, a layer incorporating quantities of dumped roof tiles, **106**, and layers of sand containing rubble and limestone fragments **101=121** none of the layers were particularly noteworthy and all represented post-medieval and later levelling and bedding layers for the various church floors.

Plate 4. Layer 106, facing north-west

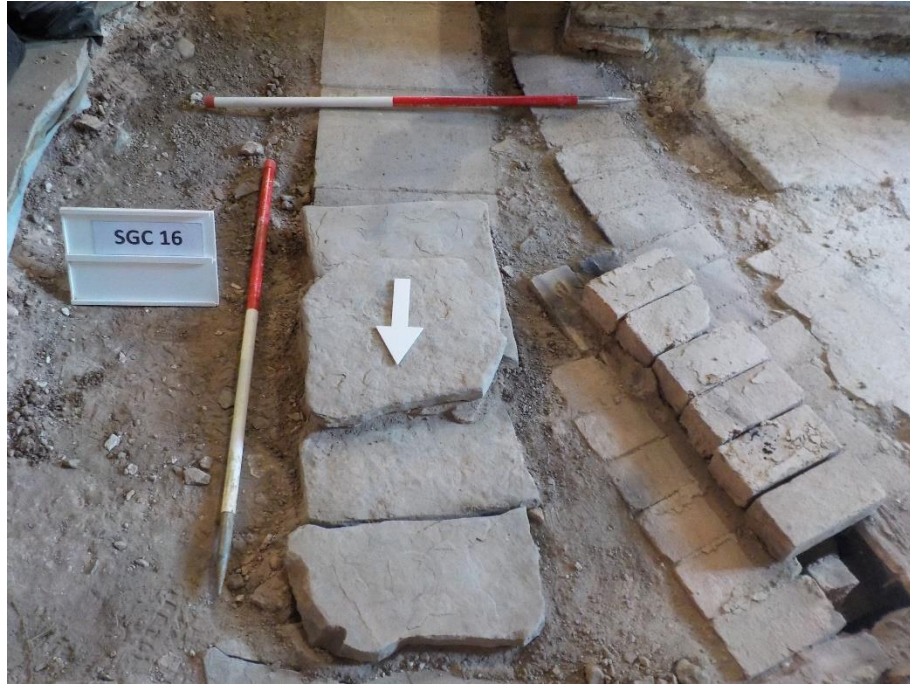
The latest layer in the sequence, a 0.14m deep deposit of silty sand, *103*, was cut by a brick-built flue, *122*, several sections of which were identified. Flue *122* ran from the northern wall of the church (where the exterior boiler house is situated) in a southerly undulating direction for a distance of circa 5m. A second 3m long section of the same flue was identified close to the southern wall of the church.

Flue *122* appeared to be of 19th century date and had been superseded by a second feature; a large brick-lined trench, *125*, containing in-situ iron heating pipes. This feature represents the previously operational heating system which is being replaced by the current development. It ran across the church in a north-south direction. Whereas the southern end of this feature was capped by Victorian iron gratings (which formed part of the existing floor surface prior to the commencement of works) the northern end was capped by re-used Yorkstone flags, *123*.

Plate 5. Flues 123 (left) and 122 (right) facing south

A final feature of interest was the brick-built heating flue **122**. This feature pre-dated the more elaborate Victorian heating system (**125, 123**) and presumably dates to the addition of the boiler house to the northern side of the church.

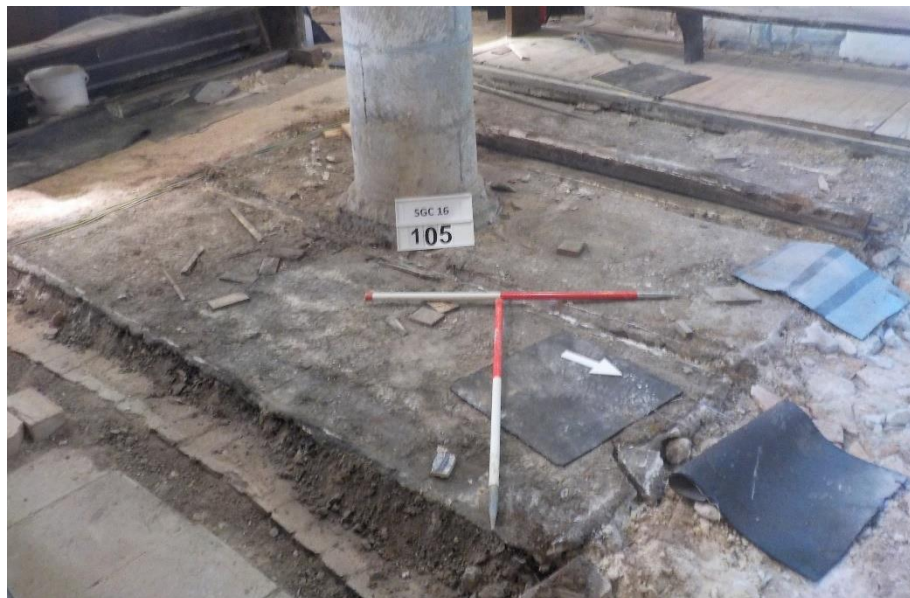
Finally, deposit 103 also formed the bedding layer for two 0.05m thick compact limestone mortar layers, 105 and 104. Both layers measured 4.60m by 2.80m and represented the foundations for the timber platform flooring in the northern and southern sides of the nave respectively.

Plate 6. Floor foundation 105, facing north-west

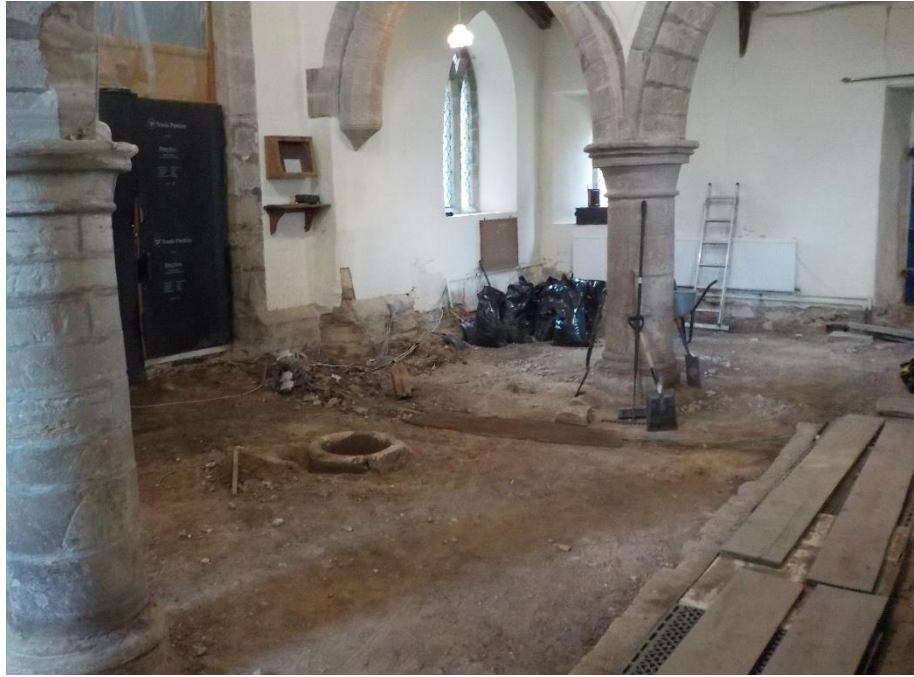
Plate 7. General view of area at formation level of excavation, facing north-west
