St Andrew's Church

Chesterton, Cambridge

Archaeological Watching Brief Report

November 2023

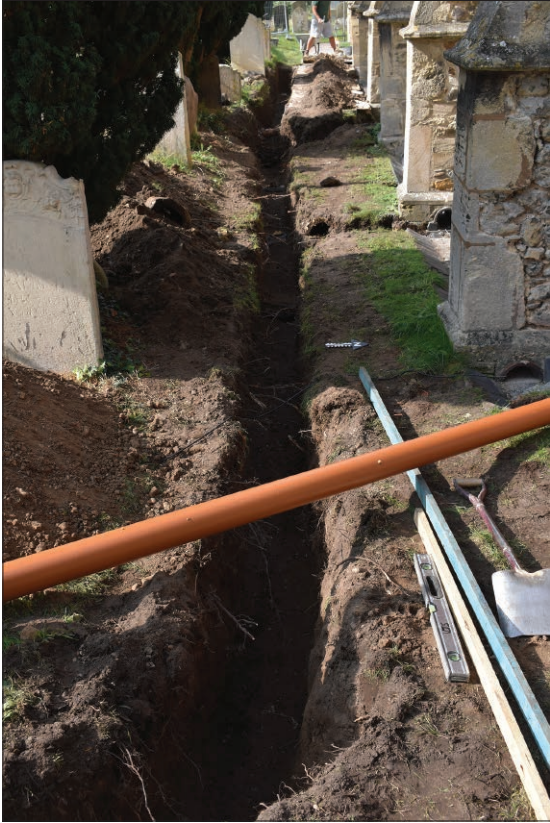
Plate 1: Drain trench through disturbed ground (18), looking west

- 3.4.1 A west-south-west to east-north-east trench for a new drainage pipe was excavated parallel to the outside wall of the south aisle of the church (18.2m long, 0.35-0.4m wide and generally 0.8m deep; Plate 1). Three connecting channels were also dug from this trench to join the new pipe to existing downpipes on the church wall. These channels were generally aligned north-east to south-west and were 2m-2.2m long. At its eastern end, this trench extended south-east for approximately 2.7m into a new soakaway (see below).

- 3.4.3 This drain truncated the deposit below the turf, which consisted of an artefact-rich light brown sandy silt (18). This deposit extended below the depth required for the new pipe trench and had already been identified as disturbed ground by the client. The reasons for this disturbance may include the construction of the south aisle extension in the 14th century, construction of the post-medieval drain, construction of the tarmac footpath, and/or centuries of grave cutting.

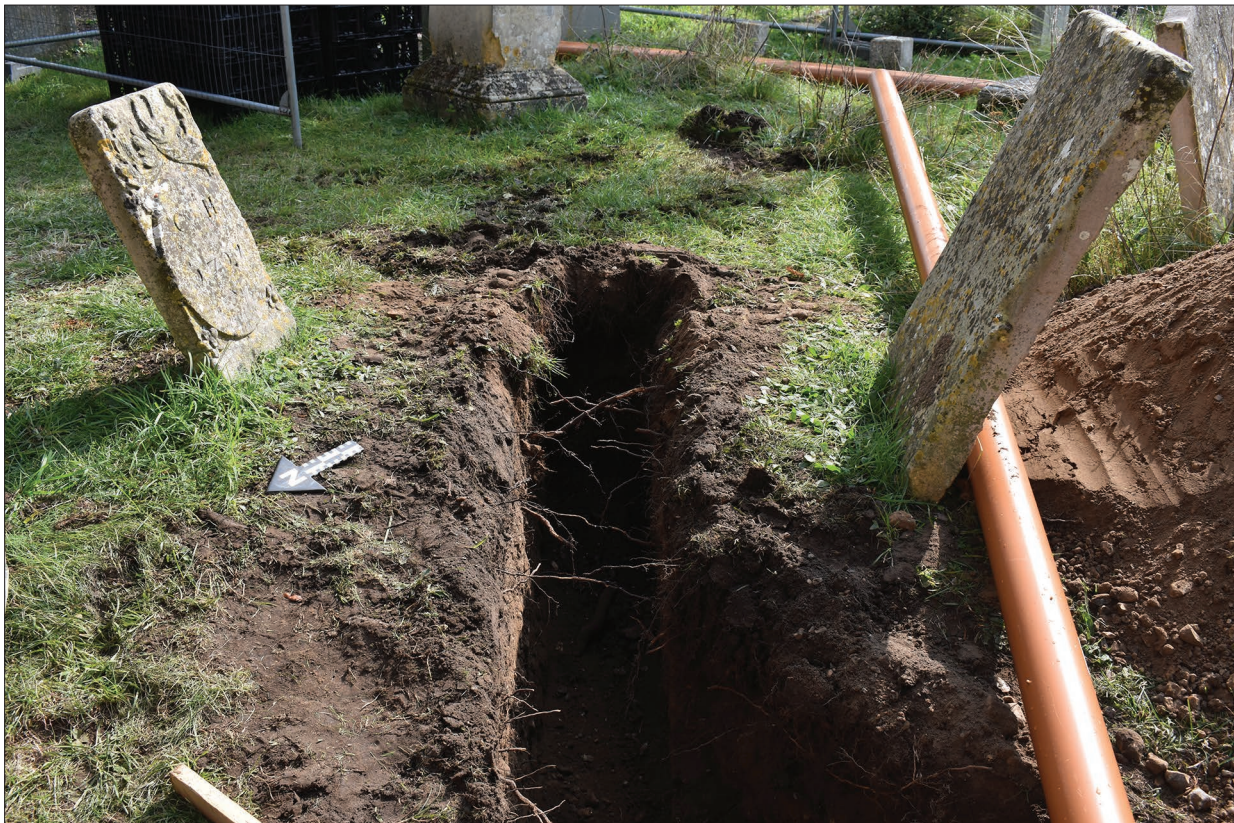
Plate 2: Drain trench through disturbed ground between two possibly relocated gravestones, looking south-east

- 3.4.5 At its eastern end the pipe trench was diverted to the south-east for approximately 2.7m to the new soakaway location. The stretch of the trench passed between two gravestones, but no cuts relating to these graves were encountered in the trench. These two stones were off-set from the otherwise uniform arrangements of gravestones in the churchyard, probably indicating that they had been relocated at some point (Plate 2).

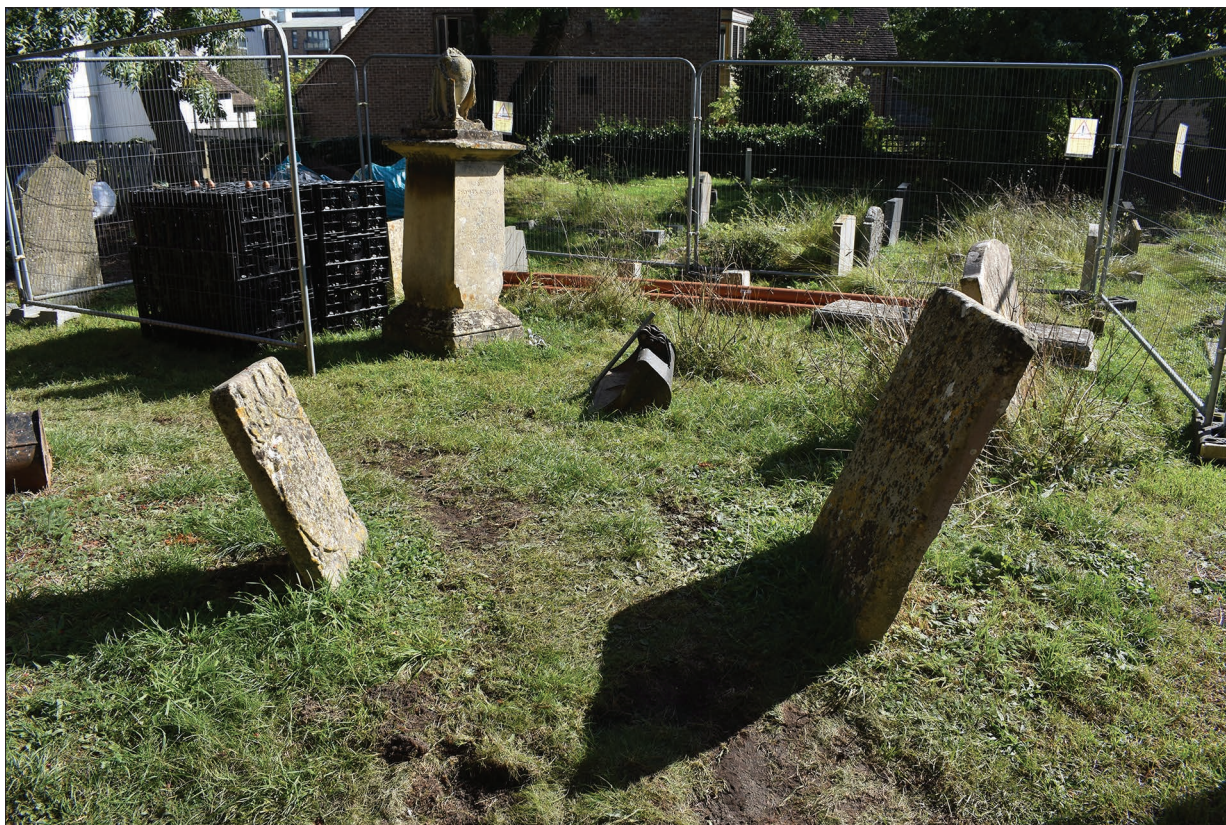
Plate 3: Soakaway location prior to excavation, looking south-east

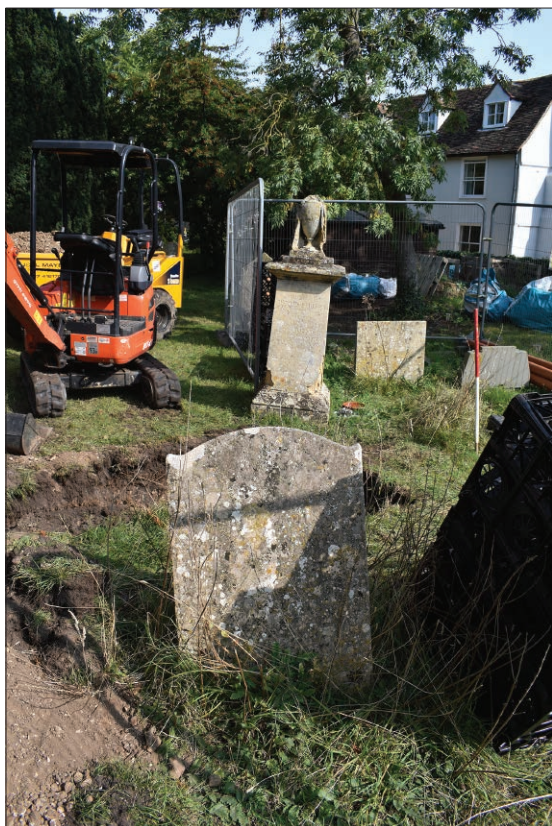
Plate 4: Gravestone associated with grave 1 (foreground) and monument associated with grave 2 (background), looking south-east

- 3.5.1 The soakaway consisted of a cutting measuring 1.6m x 1.6m across and 1.6m deep which was machine excavated approximately 2.7m to the south-east of the eastern end of the pipe trench. Upon removal of the turf the cuts of two graves relating to nearby gravestones were visible in the underlying deposit (Graves 1 and 2, Plates 4 and 5). Grave 1 measured 0.66m wide in the section and the associated burial was not been reached at the bottom of the soakaway. Grave 2 measured 1.06m wide in the section and the associated burial was also not reached. Both of these graves were aligned west-south-west to east-north-east and numerous disarticulated HSR were recovered from their backfills (8 and 9 respectively).

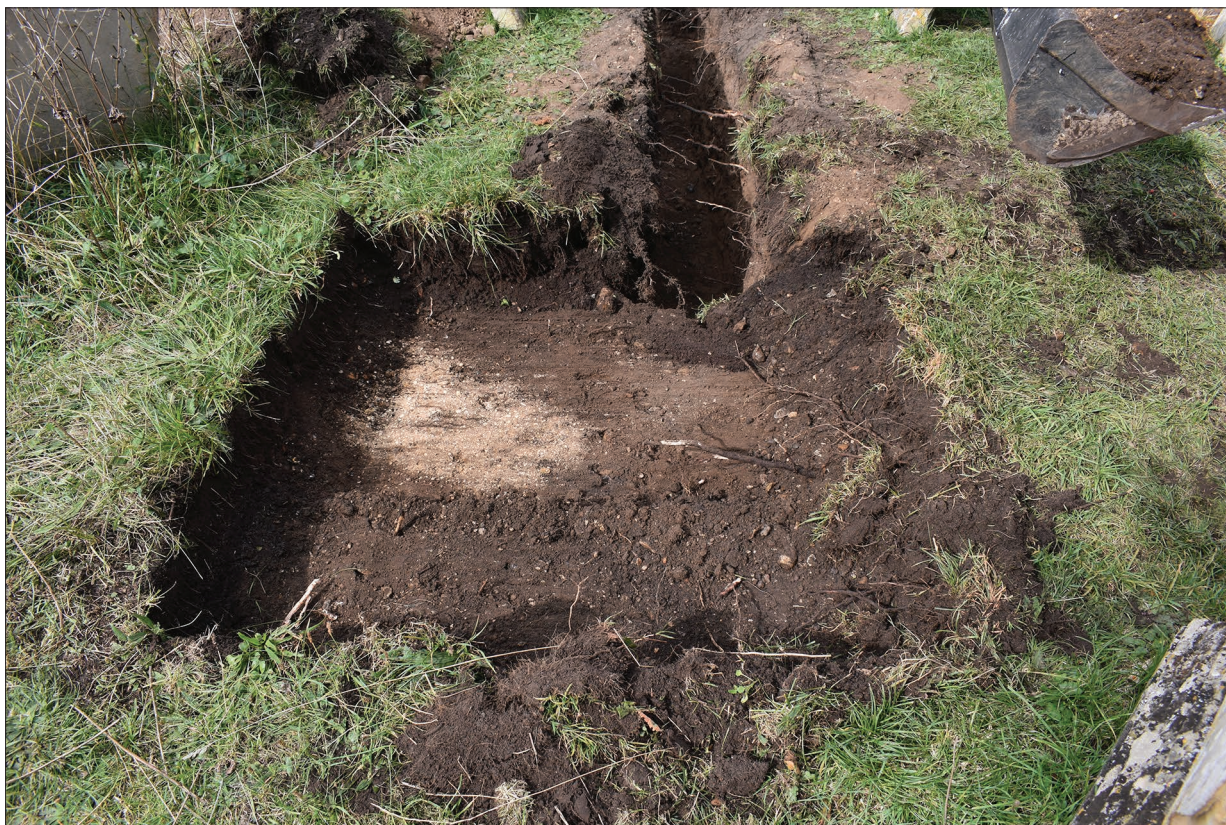
Plate 5: Initial turf removal from the soakaway showing cut of grave 1, looking north-west

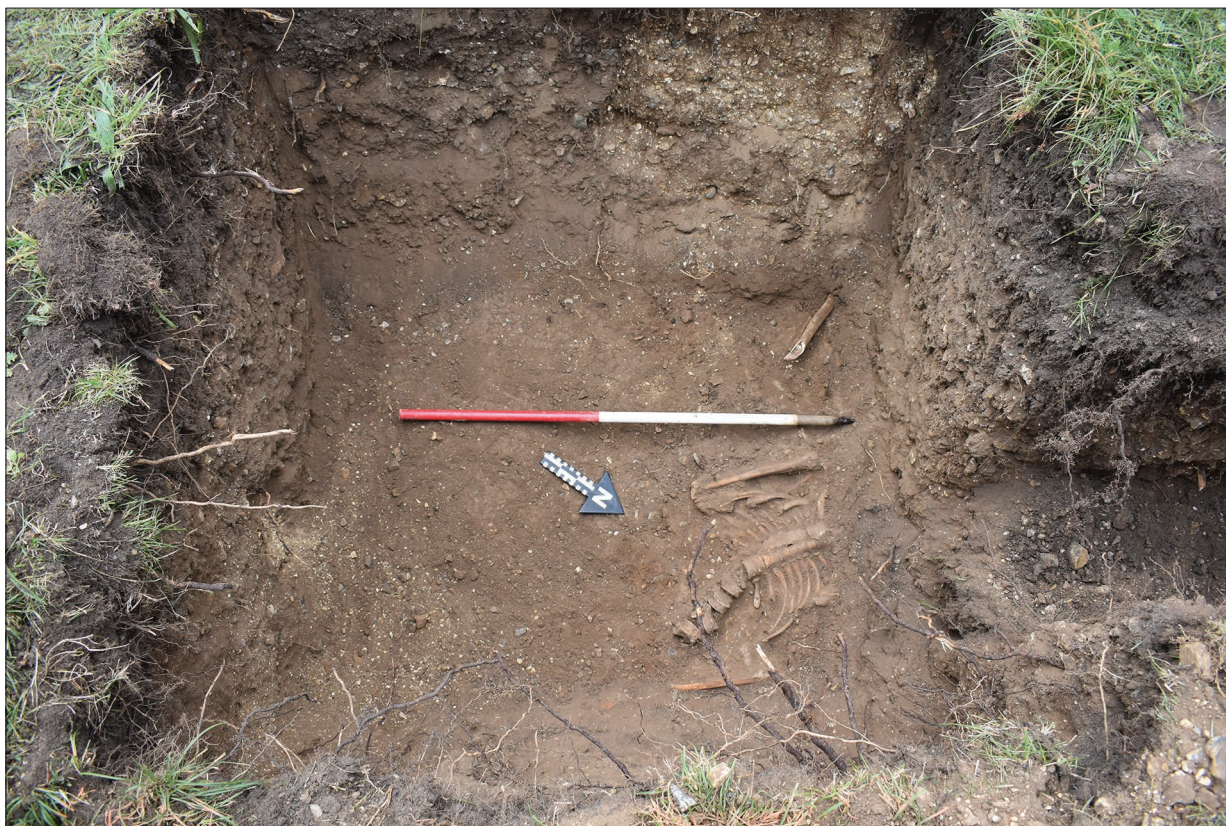
Plate 6: The soakaway at 1m depth, showing Skeleton 4 and fragments of Skeleton 12

- 3.5.3 At a depth of 1.4m the partial remains of an articulated skeleton were encountered (SK 4). Extending from the north-western side of the soakaway and aligned east to west, this comprised the ribs and almost complete set of vertebrae, along with the clavicle, scapula, humerus, radius and ulna on the right side, and the ulna and radius of the left. The rest of the skeleton was not revealed within the soakaway (Fig 3, Plan 1, Plate 6). On-site osteological analysis indicated that these were the remains of an adult male (App. C.1). No cut for Grave 3 was visible either in the section or temporary base of the soakaway, and all that can be said at this level is that it must have been at least 0.5m wide.

- 3.5.4 Close to the western corner of the soakaway an articulated radius and ulna (SK 12) were revealed at the same depth of Grave 3 (Fig 3, Plan 1, Plate 6). Again, no cut was visible for the grave associated with these remains (Grave 11), so only approximations of its dimensions have been recorded.

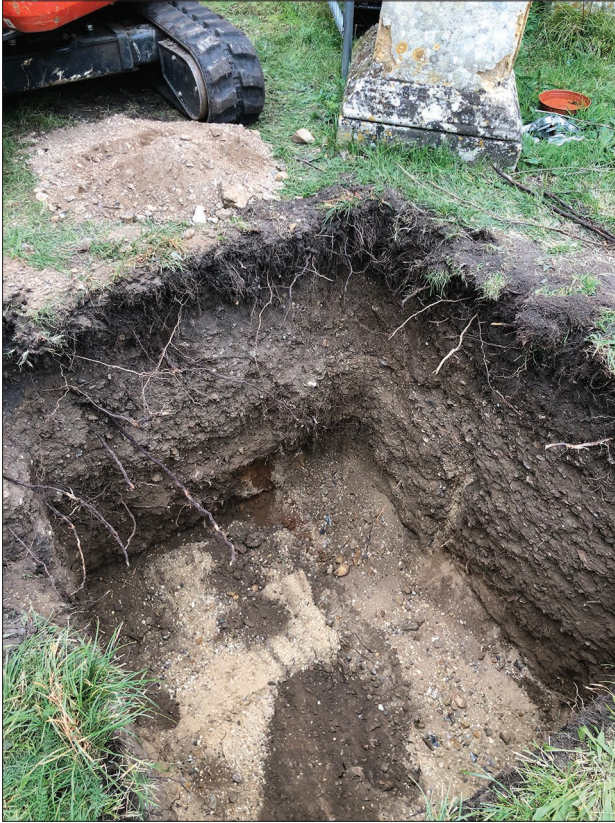
Plate 7: The soakaway at its final depth of 1.6m, showing cut of grave 1 (foreground) and grave 2 (background), looking south-east

- 3.5.6 Upon the removal of SKs 4 and 12, the machine excavation continued to a final depth of 1.6m. This involved the continued excavation of the fills of Graves 1 and 2 (fills 8 and 9) and earlier deposit 14. At a depth of 1.5m the natural geology of sand and gravel was reached, within which were visible the cuts of Graves 1 and 2, and traces of the remaining backfill of Grave 3 (7). All sections of the soakaway were recorded (Section 1; Fig. 3).

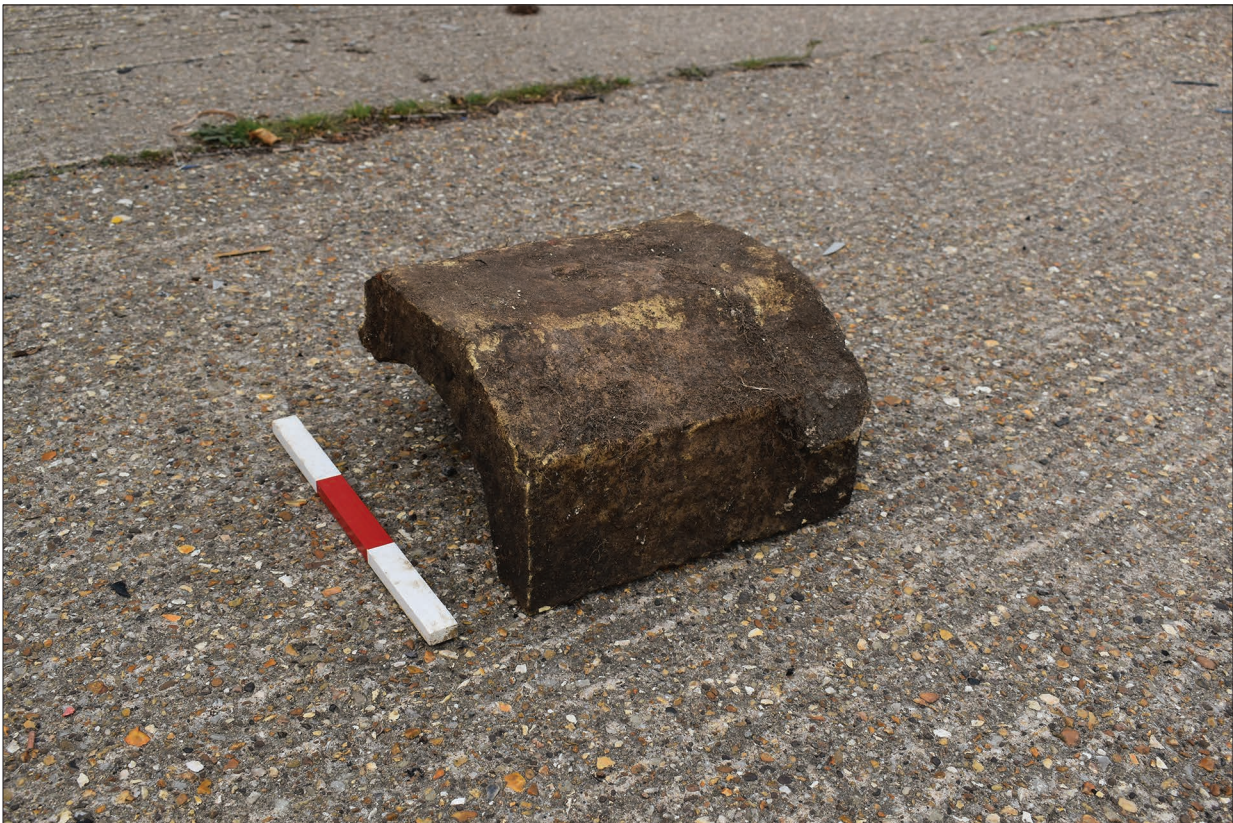
Plate 8: Section of ceramic drain brick

- 3.4.2 The turf along the pipe trench (19) measured 0.2m thick and a tarmac footpath was set into it parallel with the church, extending from the entrance in the south-west corner to approximately halfway along the church. Immediately underneath the turf, approximately 0.8m from the outside wall of the south aisle, a line of yellow ceramic drain bricks was encountered. This line was seen in all three of the connecting channels and was probably the remains of an earlier, defunct, post-medieval drain (Appendix B.3).

- B.3.1 A single example of a near-complete drain brick was assessed from site record photographs and measurements taken on site. The drain brick had a fairly large, squared form (H175mm x L290mm x W315mm). Externally, the outer arrises were chamfered giving it a segmented form. Internally, it had a single large U-shaped channel running its length. It was likely made via extrusion. It was probably a locally produced city drain and may be of a kind quite common in Cambridge. Its yellow gault fabric is typical of later post-medieval ceramic building material in Cambridgeshire. Ceramic field drains have an uncertain start date, but they were relatively common by c. 1800. This form is considered one of the earliest (cf. Scottish Brick History/Museum of English Rural Life: <https://www.scottishbrickhistory.co.uk/evolution-of-the-land-drainage-tile/>). They were either used singly, as a channel, or in pairs to create a closed 'pipe'.

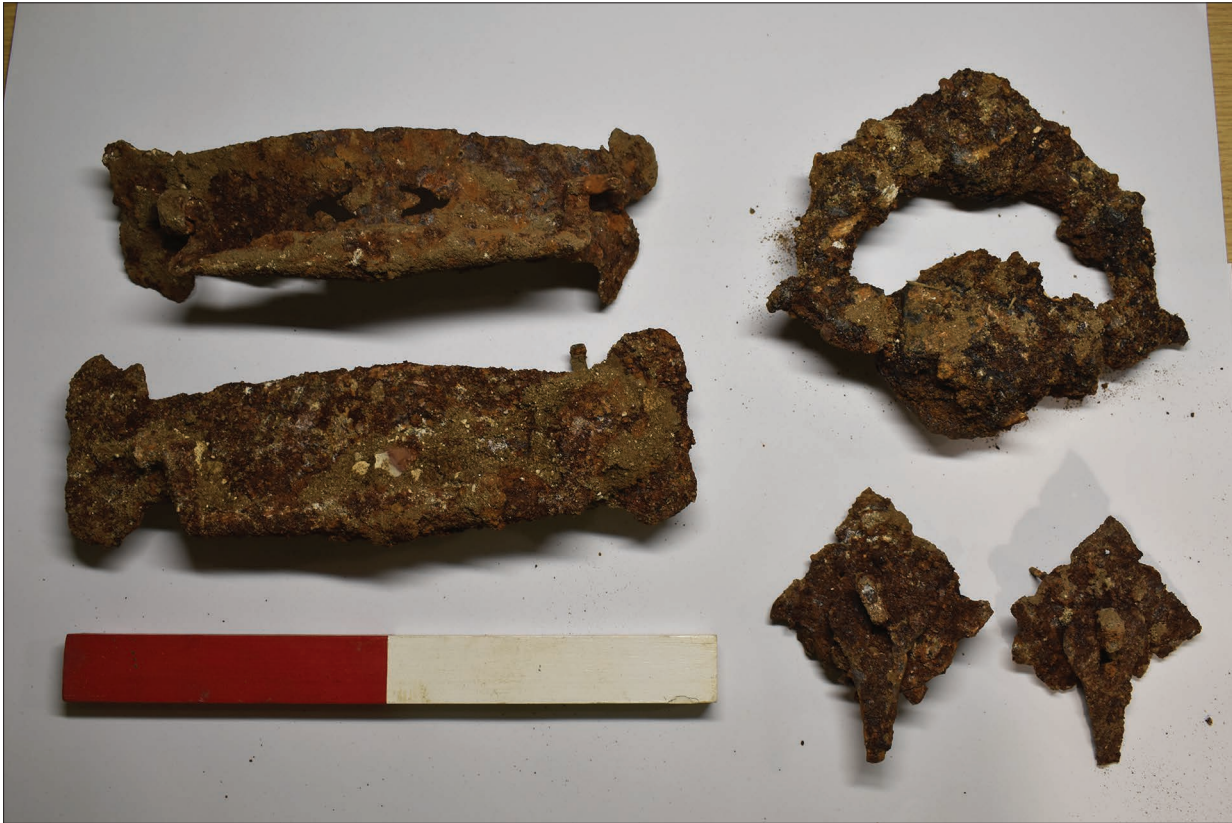
Plate 9: Selection of coffin fittings retrieved from disturbed ground (18)

- B.1.1 A small assemblage of coffin or casket furniture was recorded on site during the monitoring work at St Andrew's Church. The pieces consist of two rectangular handle plates, two diamond shaped handle lugs and a subcircular handle with central lug (Plate 9).
- B.1.2 These fittings are heavily corroded and incomplete. They are likely to have come from more than one decomposed casket. Stylistically the fittings are typical of those used in the late 18th century and throughout most of the 19th century.
