# Church of St Mary the Blessed Virgin, Swainswick

## Archaeological Recording of Reordering Works-Phase 1

Prepared February 2021 for

The PCC of St Mary the Blessed Virgin

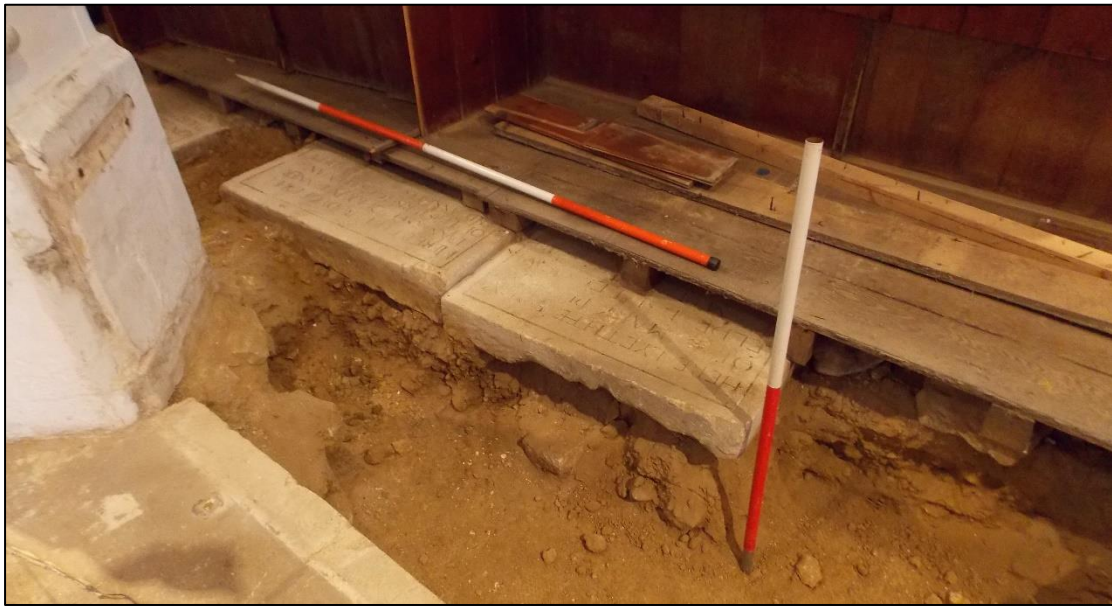
**Figure 2.** Exposed Ledger Stones, central area: facing NE, 1m & 2m scales

Removal of the two rows of pews had exposed the western ends of three substantial stones with a smaller one at the west end of the most northerly one. Two of the stones were located side by side in roughly the centre of the exposed area and the other two formed the north side of the area (Figs 2 & 3). The exposed ends of the stones were seen to protrude between 270mm and 370mm west and could be seen continuing under the existing raised pew platforms.

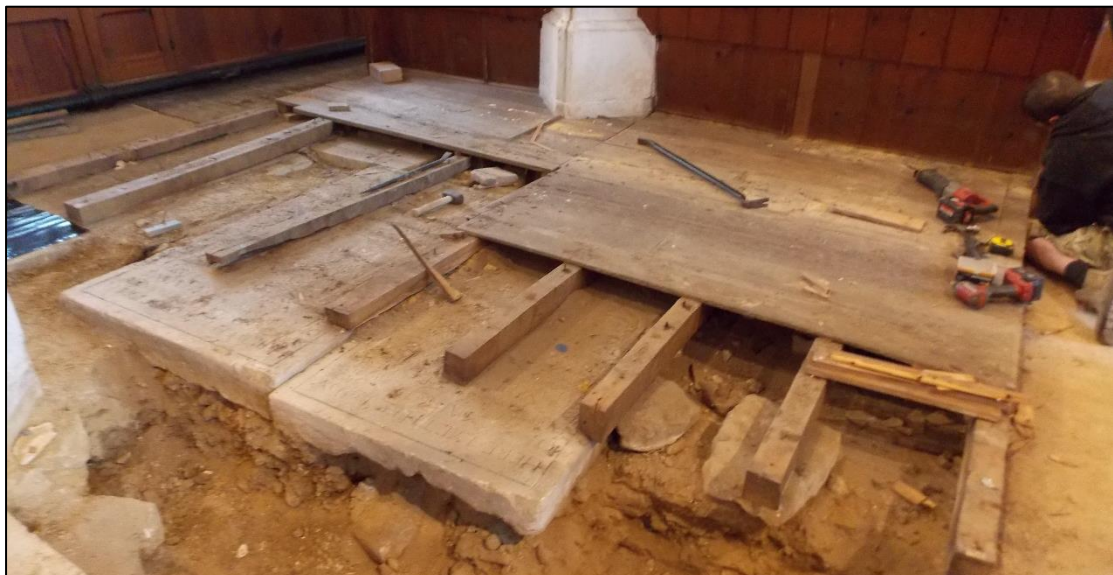
The removal of the remaining pews and raised platform over an area 4.8m long E-W and 3.7m wide N-S revealed that the supporting timber joists had been laid directly on top of the ledger stones and rough blocks of Bath Stone and rubble (Fig. 4).

**Figure 4.** Timber joists resting on Ledger Stones: facing NE

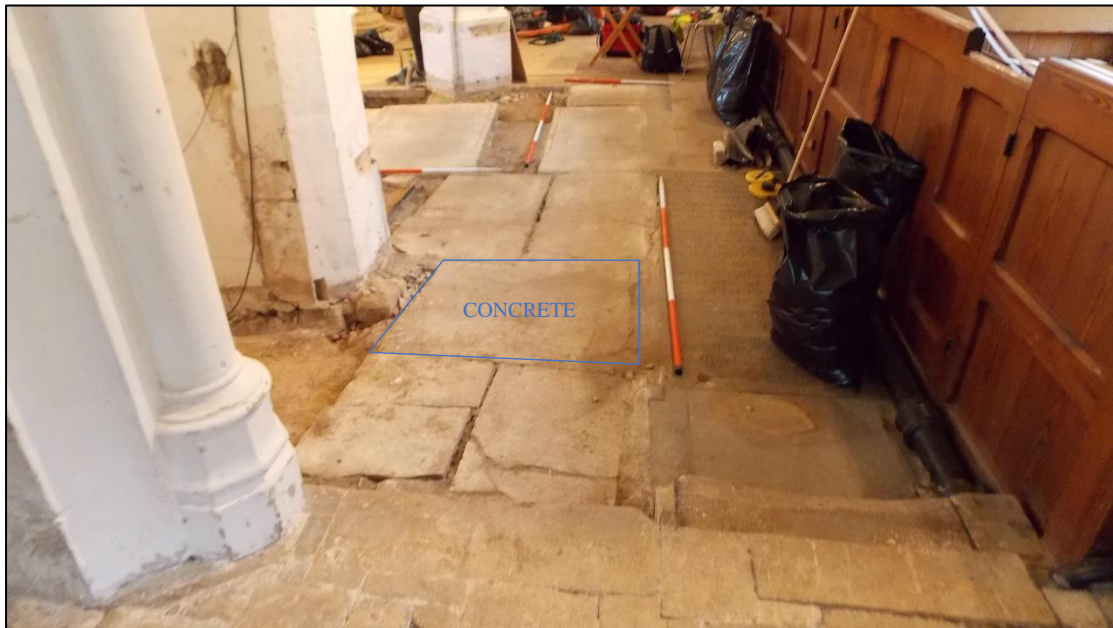
The southern half of the area was up to 120mm below the existing floor level and comprised of light brown sandy soil with frequent lumps of lime, small angular rubble,

and occasional human bone and the northern section contained the remains of Bath Stone flooring and a section of concrete (Fig. 5).

**Figure 5.** Remains of Bath Stone flooring & Concrete: facing W, 2m scale

The surviving Bath Stone flooring uncovered in the northern section during the removal of the pews was in a poor state of repair and was very worn and broken in sections and there was no surviving flooring in the southern half of the exposed area. Sections of broken flooring and ledger stones may possibly have been removed during the fitting of the pews. The poor state of the flooring may have been one of the reasons why new pews and platforms were required.

An area of concrete 1.1m long N-S, 900mm wide E-W was exposed on the north side of the east column in the North Aisle (Fig. 5). This deposit was partially uncovered by the contractors to try and ascertain its depth as the top section needed be removed to allow for the new flooring. It was seen to be at least 450mm in depth, but its function was unclear, it appeared to be butting against the column foundations and a ledger stone to the north (Fig. 21). This deposit may possibly be functioning as a support for an unstable vault below the ledger stone.

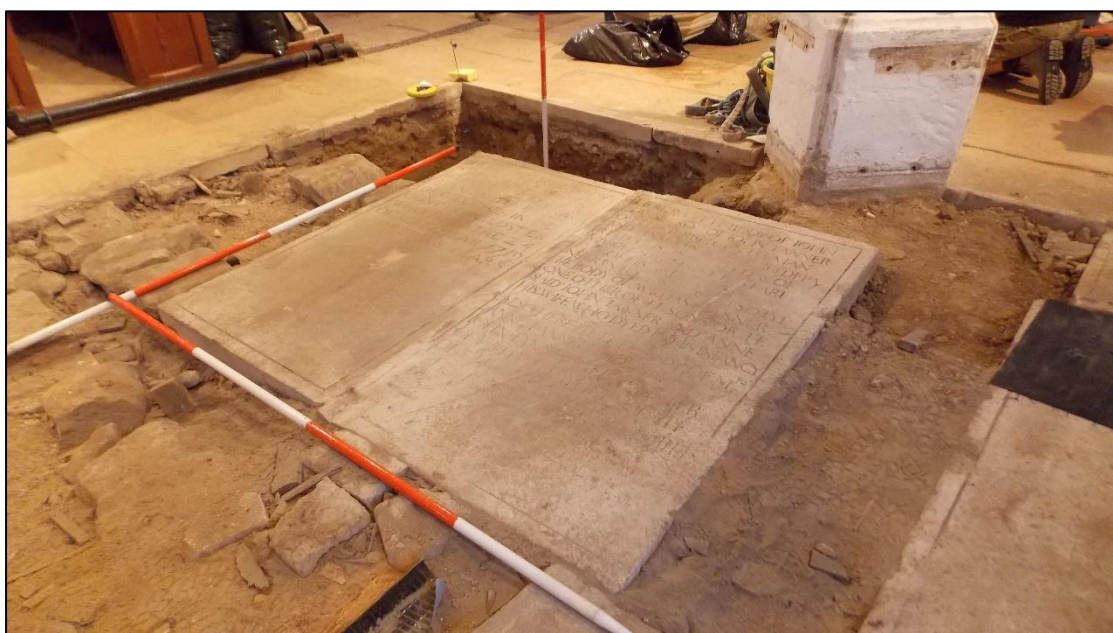
The ledger stones located side by side were of similar dimensions, both measuring 1.53m long x 150mm in thickness, with the most southerly being 840mm wide and the other being 915mm in width (Figs. 6 & 7).

**Figure 6.** Ledger Stones located side by side: facing SW, 1m & 2m scales

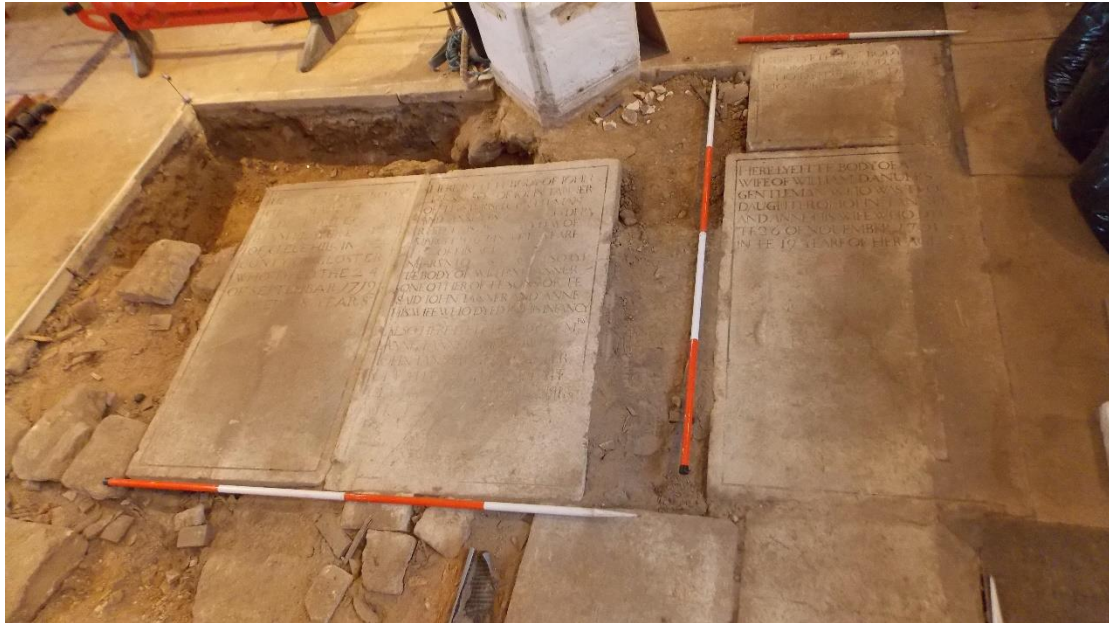
**Figure 7.** Ledger Stones located side by side: facing W, 1m & 2m scales

The memorials dedicated to Thomas Atwood and Anne Danuers were very worn along their north sides where they had not been protected by the pew platform as can be clearly seen in figures, 7, 11 & 12. The PCC have been informed of the fragility of the incised lettering and decoration around the ledger stones and have been advised to use some form of protection if temporary seating is to be placed on them.

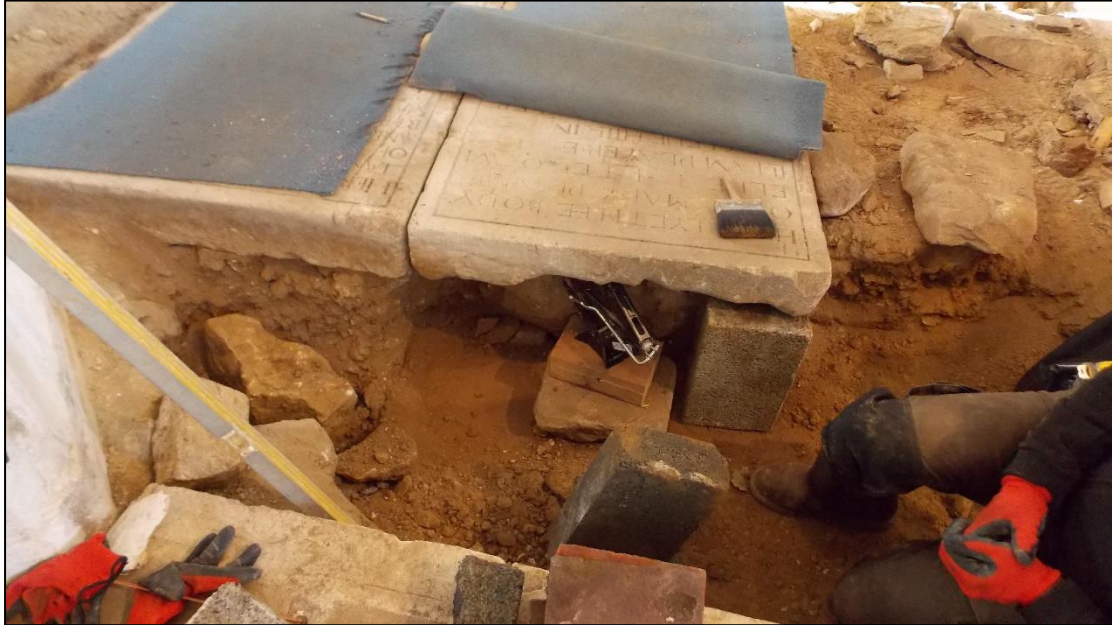
**Figure 14.** Raising Ledger Stone to required height: facing E

The ledger stones were not disturbed further apart from the west end of the one dedicated to Mary Player which had its height adjusted by approximately 50mm to bring it up level with the adjoining stone. This adjustment was achieved by removing some of the loose soil around the exposed end and gently raising it to the required height (Fig. 14) and then constructing a supporting wall underneath (Fig. 15).

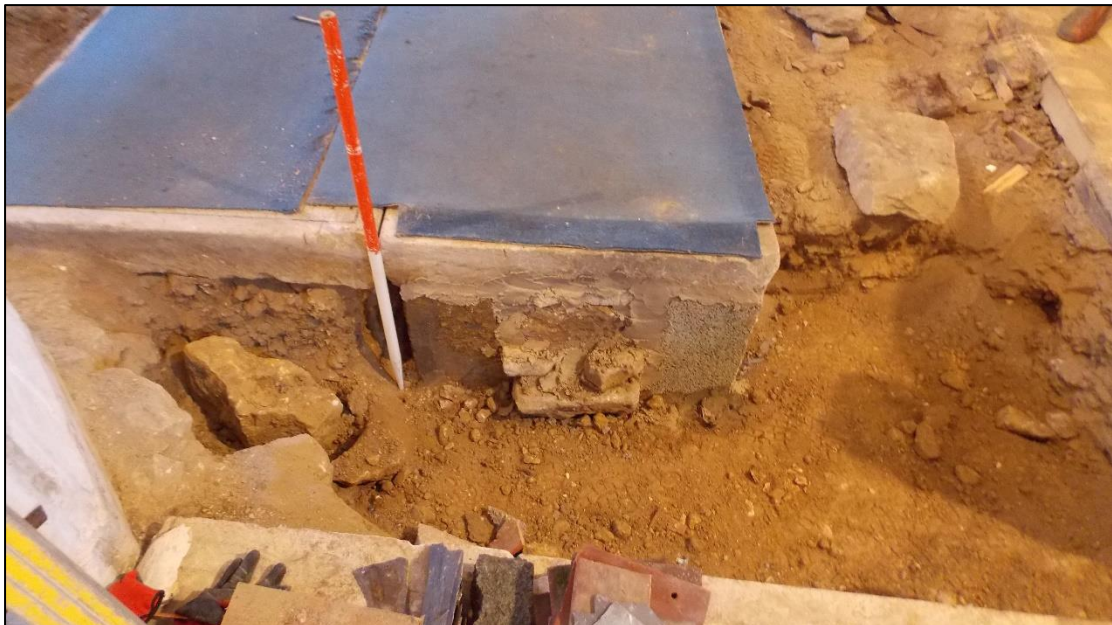
**Figure 15.** Supporting wall, W end of Ledger Stone: facing E, 1m scale

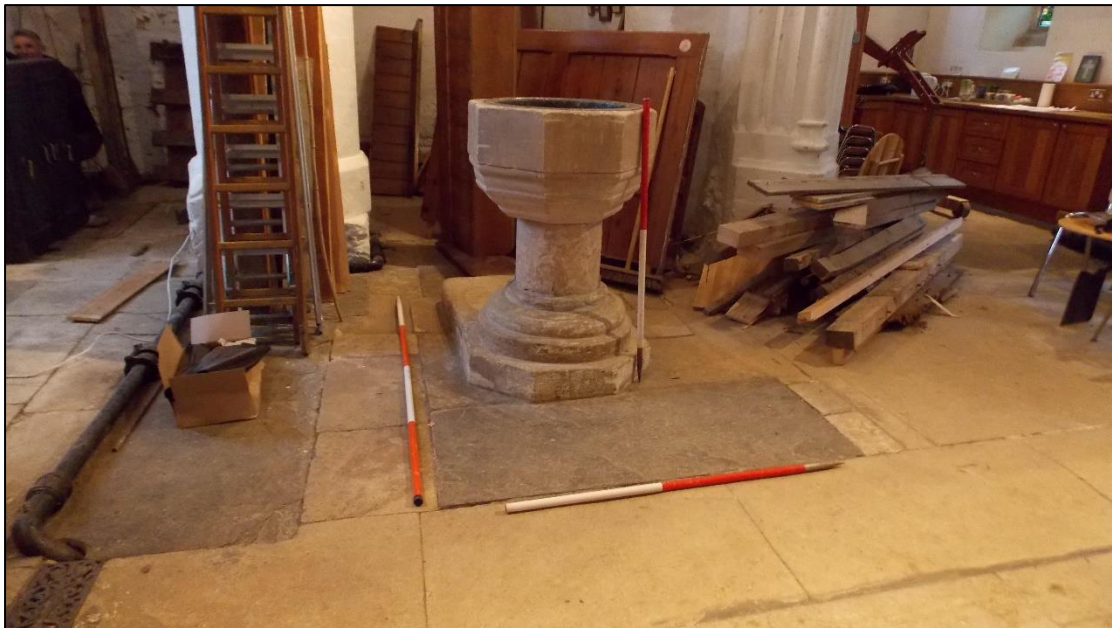
**Figure 16.** Font location: facing W, 1m & 2m scales

Part of the reordering works involved relocating the font (Fig. 16) to the south of its present position. The top section was carefully removed by hand using a small lifting device (Fig. 17) and carefully stored ready for its relocation. Removal of this top section revealed that it was bedded on modern cement mortar (Fig.18).

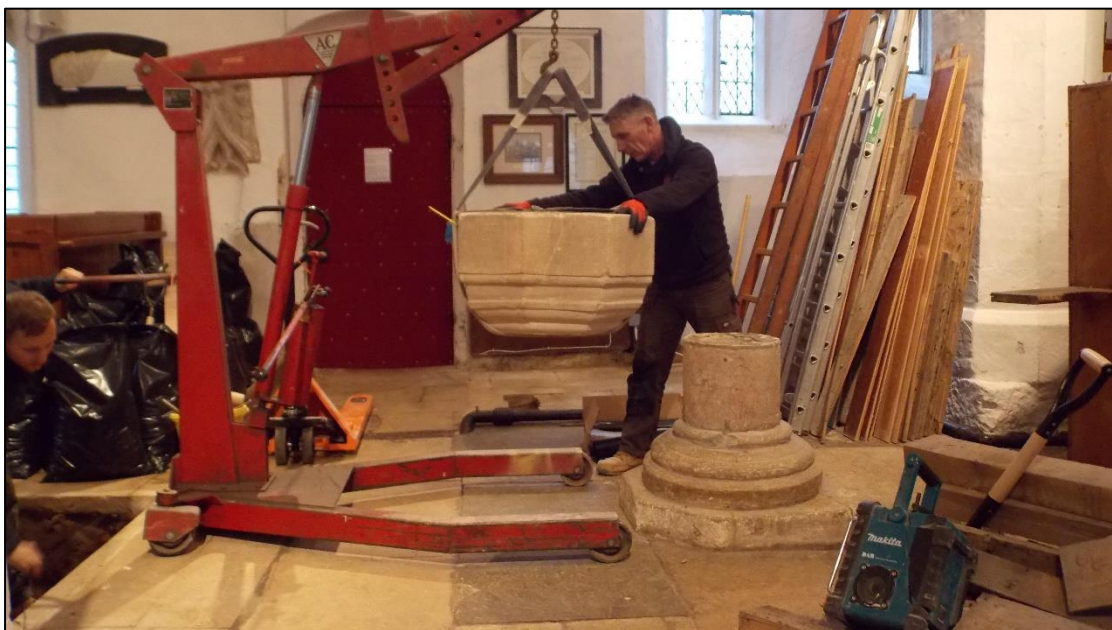
**Figure 17.** Removal of top section of font: facing S

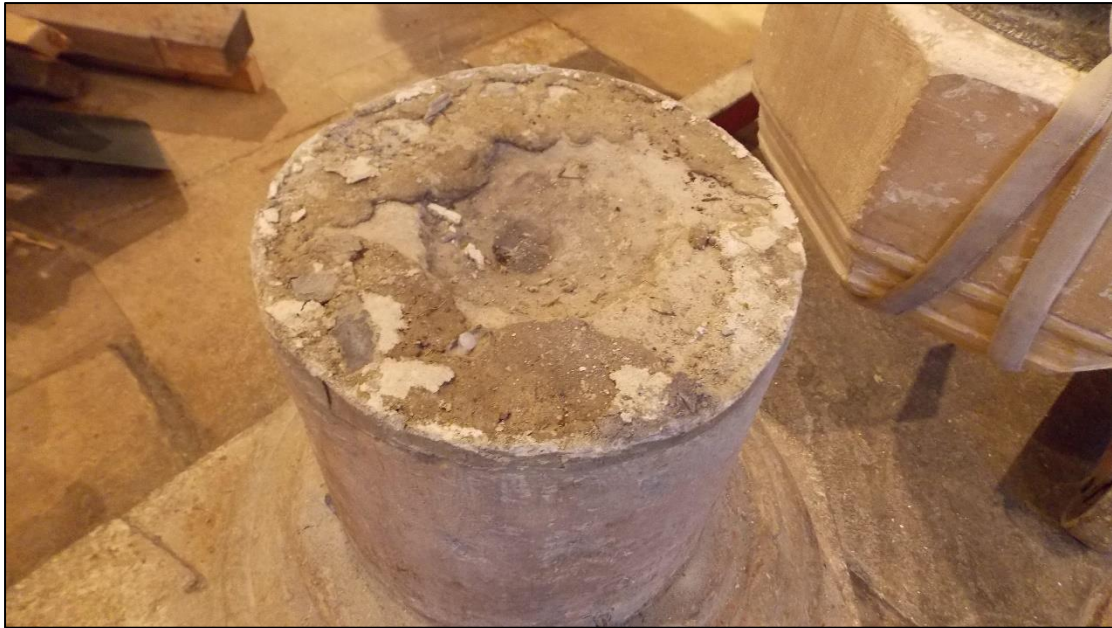
**Figure 18.** Modern cement bedding below top section of font

The cement mortar seen below the top section of the font would suggest that this has been re-bedded in modern times or relocated to this position.

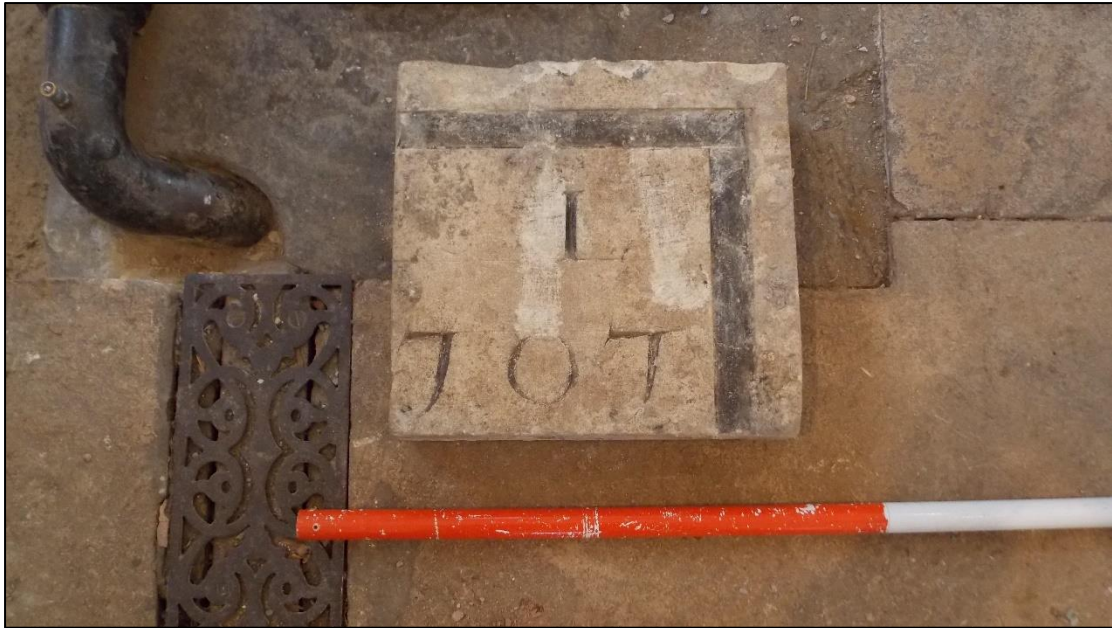
One of the removed Bath Stone floor slabs was seen to be a reused section of an 18<sup>th</sup> Century memorial, the incised letters appeared to have been painted black (Fig. 20). This stone was re-laid into the floor.

**Figure 20.** Reused section of an 18<sup>th</sup> Century memorial stone, 500mm scale

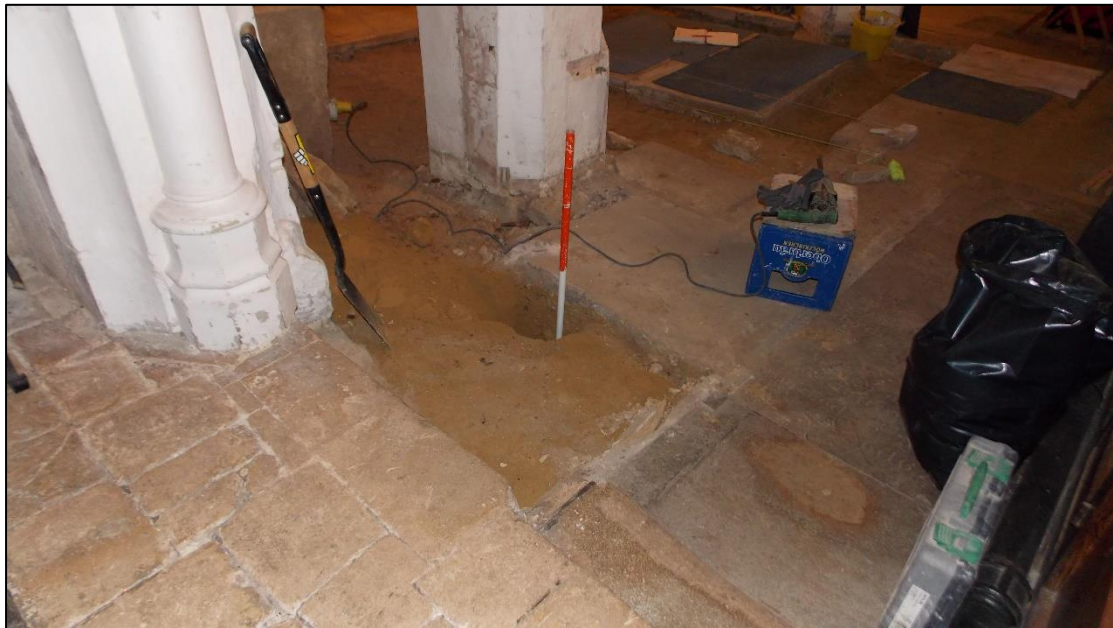
**Figure 21.** Exposed section of concrete in North Aisle, 1m scale
