**ST ANDREWS CHURCH, CHEDDAR**

Document number: **23015-ESDP-00-ZZ-RP-M-0001**  
 ESDP Project ID: 23.015  
 Purpose of Issue: Preliminary      Issue Status: S1

This report has been commissioned by the client to provide a recommended approach to the upgrade of the existing heating system with a view to meet the Church of England net zero carbon by 2030 target.

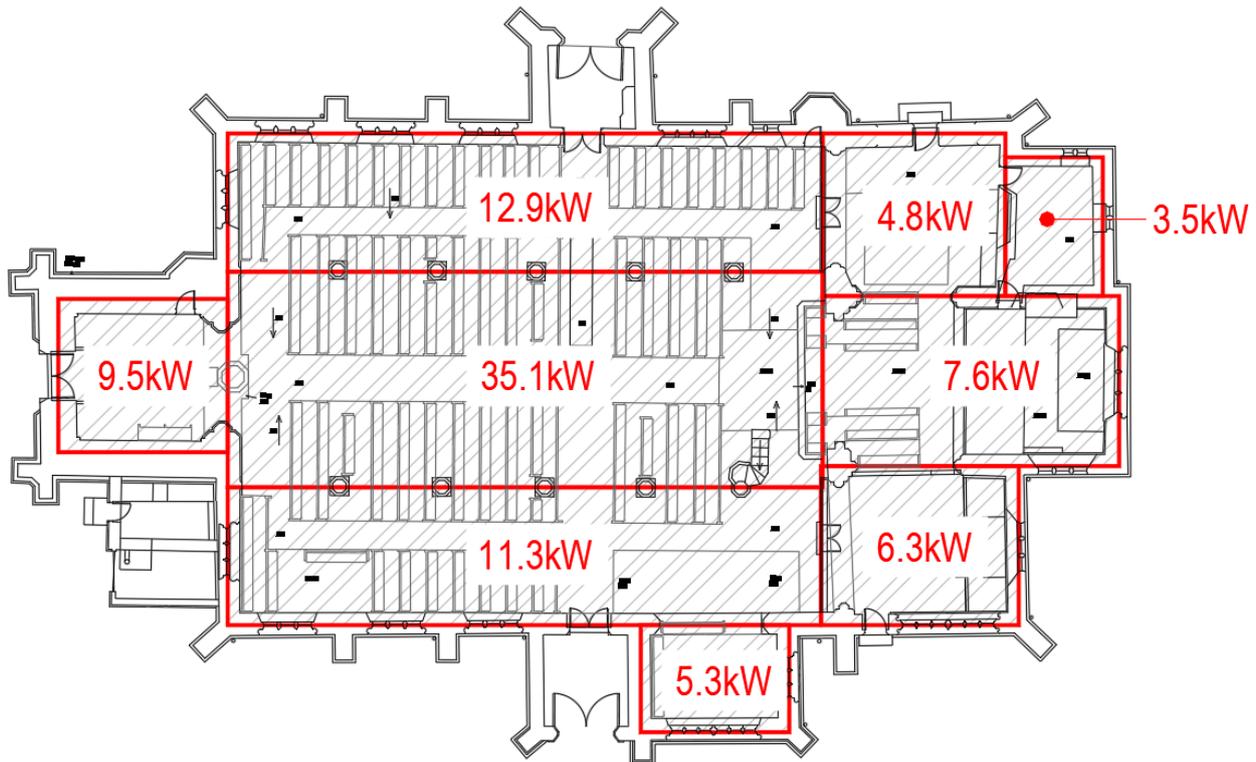
<i>Heating Stage</i>	<i>Temperature range</i>	<i>Steady State Heating Load</i>
Fabric Protection	-4°C to +10°C	61.3kW
In Use boost	+12°C to +18°C	35.0kW
Total	-4°C to +18°C	96.3kW

The image below shows pictorially the breakdown of the heat loss assessment based on heating the church from -4°C to 18°C.

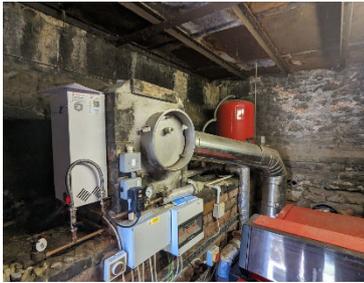
The purpose built boiler room constructed with stone walls and lead roof is located to the south side of the spire containing a 'Potterton Commercial NXR 3' pressure jet gas fired boiler. The existing flue is assumed to be a twin wall metal flue and exits from the rear of the boiler discharging into the base of a brick lined flue rising from the boiler room up the full height of the spire with a balancing damper located at the base in the boiler room.

The boiler serves a single pressurised twin pipe heating circuit with a single circulation pump installed on the return pipe. A commercial heating pressurisation unit and expansion vessel are located within the plant room serving the heating system. For the purposes of this report, we have assumed the system is running on 80°C flow and 60°C return water temperatures. Note: The system is non-condensing.

View in boiler room of existing flue arrangement and pressurisation kit.

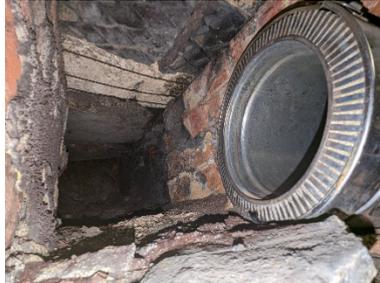
View inside base of the existing brick built chimney.

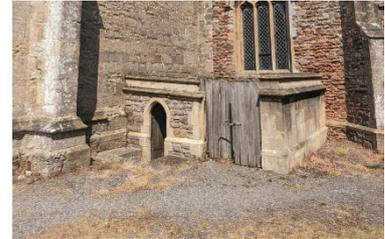
External view of boiler room on south west corner of the church.

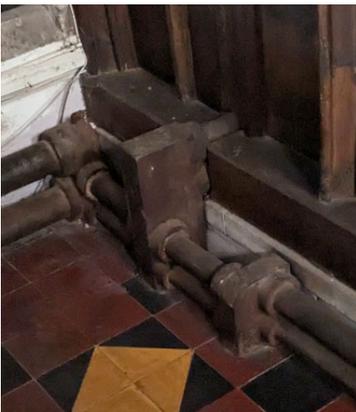
The existing heating system is a mixture of exposed caulk jointed pipe loops at low level around the external walls of the church incorporating elegant engineered manifold arrangements at each change of direction, set or pipe size change. Along with an exposed pipe loop, a limited number of traditional column radiators and 2No. custom made triangular column radiators are located either side of the entrance to the Chancel. An exposed pipe loop beneath a grille in the floor in the North Aisle adjacent to the entrance door and an exposed pipe loop consisting of 4No. pipes stacked vertically in the South Transept, have also been previously installed.

Exposed Pipe loop caulked manifolds

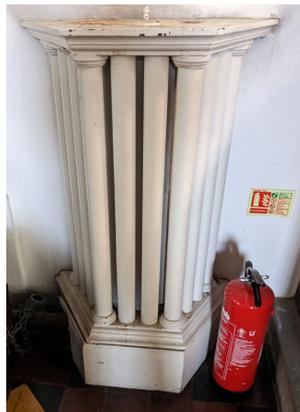
Custom radiator at entrance to Chancel

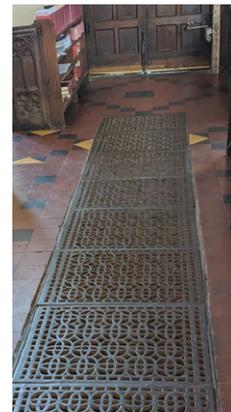
Exposed pipework below grating in North aisle

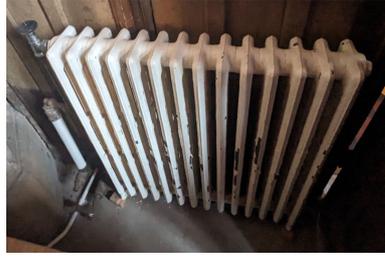
Typical 4 Column cast iron Radiator

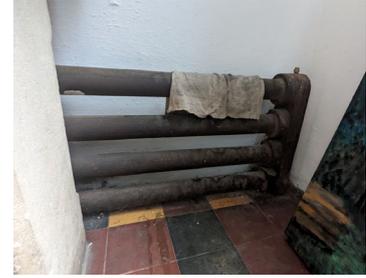
Stack Pipe loop in south transept

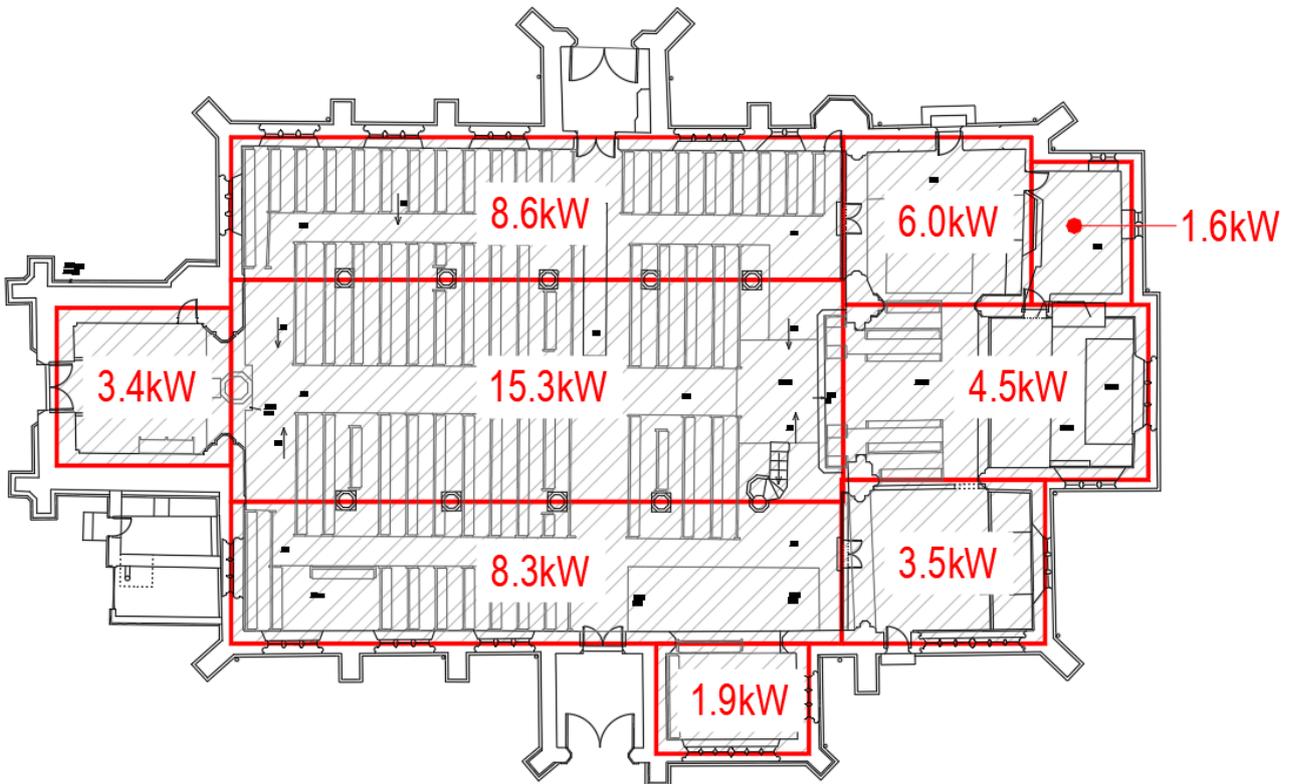
We have calculated the existing heating system is providing approximately 53.2kW heat output. This would indicate the installation has been installed to provide fabric protection only.

The image below demonstrates the heat distribution around the church from the existing heating system.

As the image above demonstrates, the existing system cannot provide enough heat output to meet the thermal comfort levels required for the space when occupied.

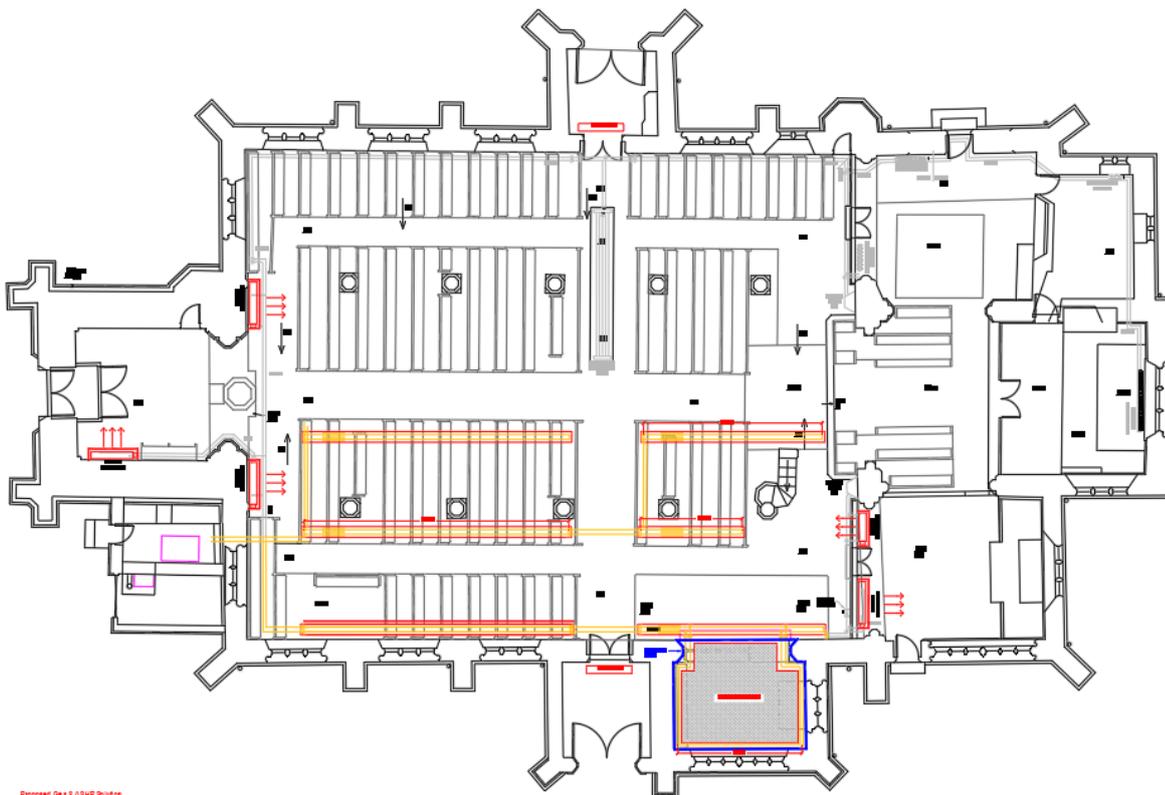
This scheme is based on the assumption the existing pipework is routed from the boiler room into the main church floor void in the south west corner of the Nave. Also the branch circuit serving the west end of the Nave, Spire, North aisle, Organ, Vestry and behind the Alter would be retained. This will require intrusive survey to determine its current state.

We propose the installation of a new 70kW net input condensing gas boiler within the existing boiler room with a balanced concentric flue discharging through the plantroom wall into the external compound adjacent the boiler room, and installation of a new 60kW air source heat pump in a purpose-built screened enclosure. Please refer to the section at the end of option 4 below for further details of the proposed screened enclosure.

This option looks to provide new heating pipe loops installed within new purpose built boxes insulated on 3No. sides with a grated timber cover within the existing timber floor section in the South Aisle and South side of the Nave.

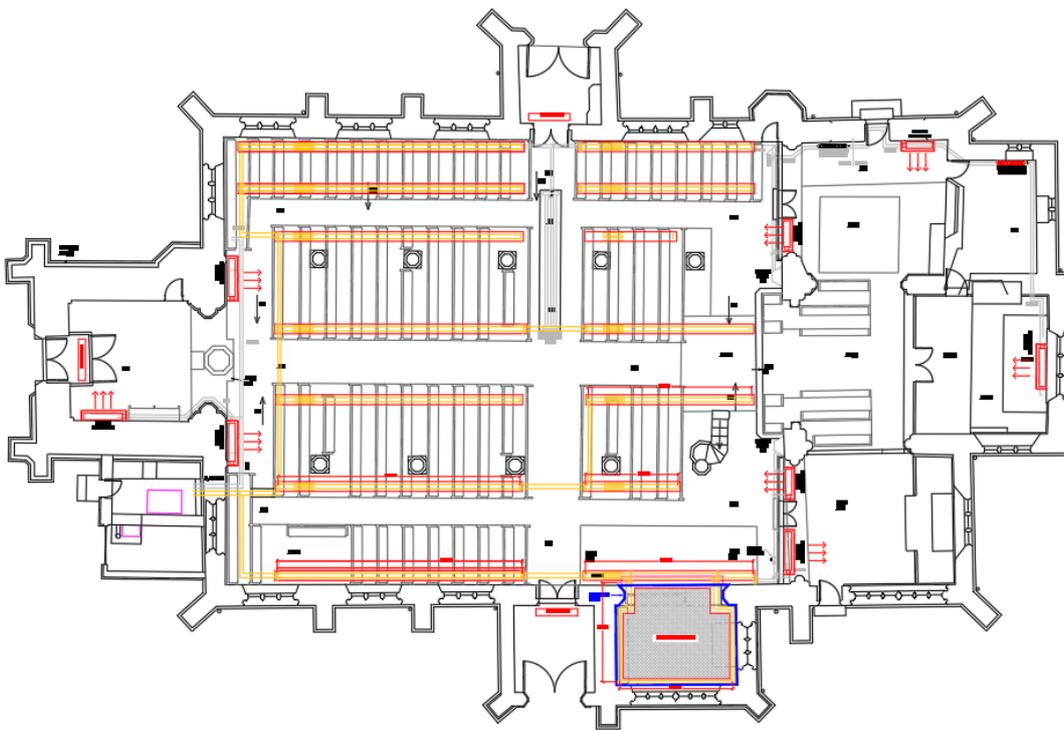
Figure 3-ASHP Solution

The existing pipe loops running down the North and South Aisle would be removed. As with the combined solution, it would provide new heating pipe loops installed within new purpose built boxes insulated on 3No. sides with a grated timber cover within the existing timber floor sections, but now covering the South Aisle, north and south sides of the Nave, and North Aisle.

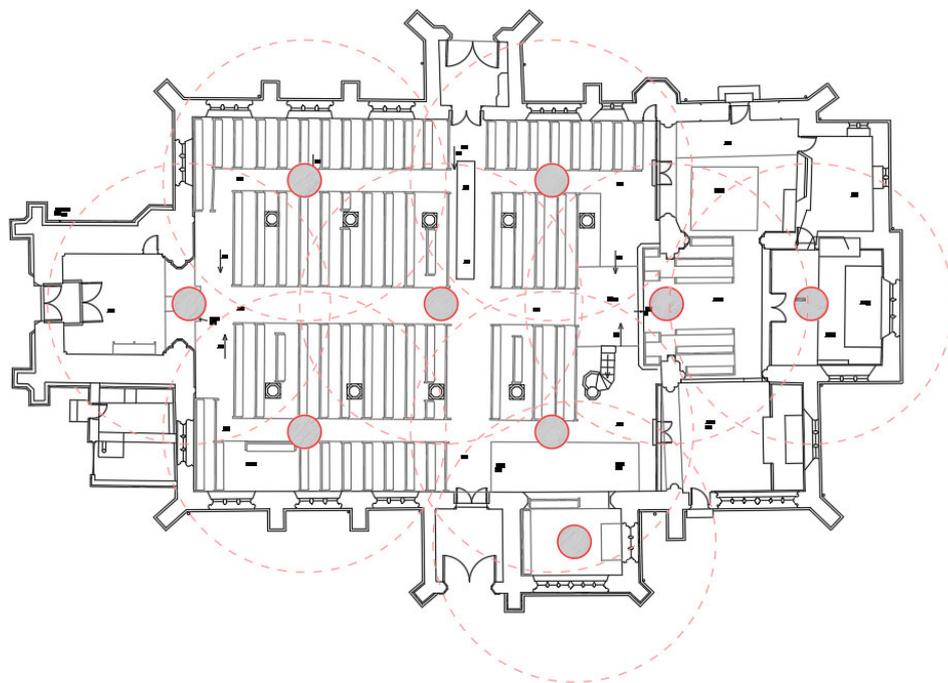
Overhead radiant heaters require line of site to work, and due to the change in heights across the church and to ensure coverage of all areas used by the congregation, this option includes a minimum of 9 no. 4.8kW units, providing 43.2kW of heat output, as indicated in the diagram below.

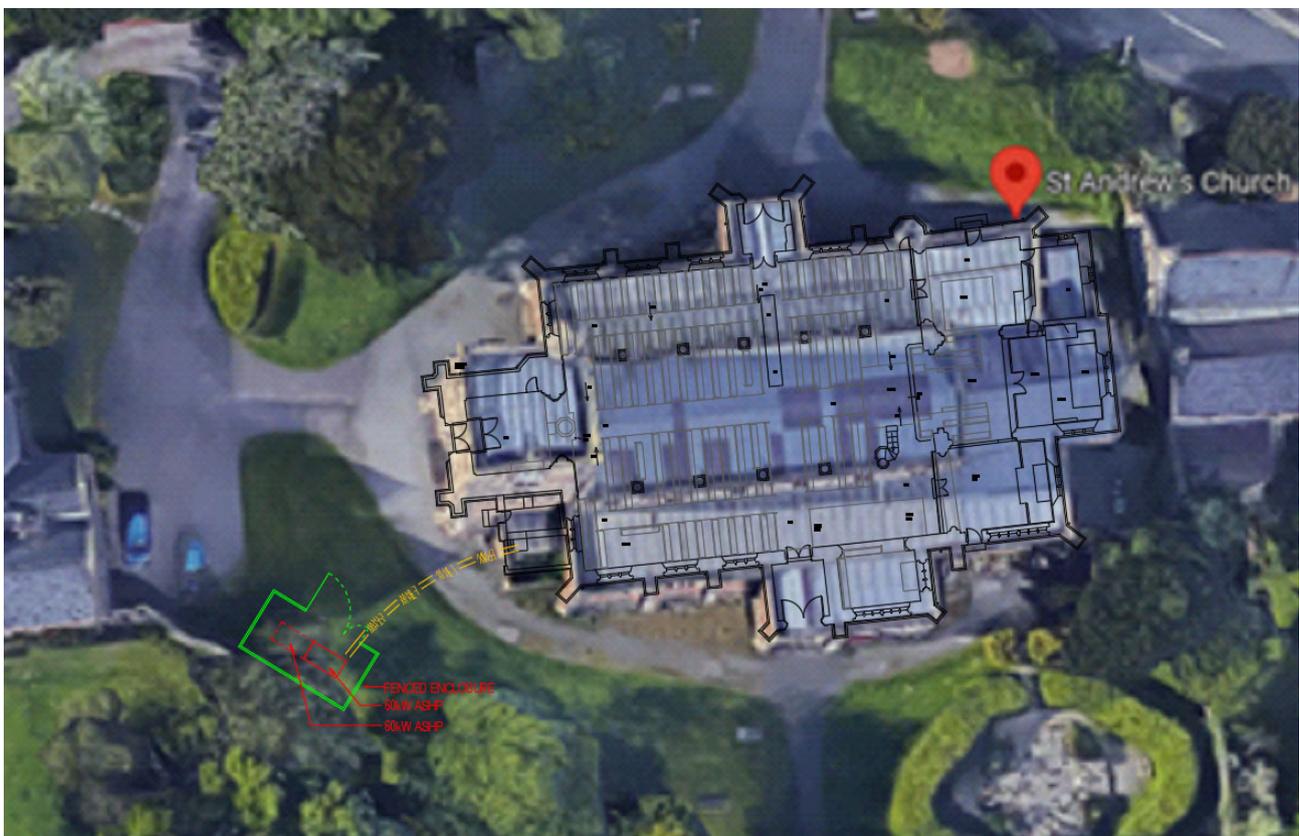
A new compound would be created with staggered panel (hit and miss) fencing to house the ASHP(s) required by options 2, 3 and 4 above. Allowance would be made for the full ASHP option (option 3) of 2No. ASHP units, each of which can provide the fabric protection load and together can provide the total load requirement for the church.

The location indicated below allows for limited length pre-insulated below ground pipework runs to link the ASHP's with the existing boiler room. The closer the ASHP's are to the boiler room, the lower the resistance in the pipework and the power required to run the circulation pump. The proposed location minimises excavation and external works. The proposed enclosure location could also potentially house an air source heat pump to serve the next door vicarage in the future.

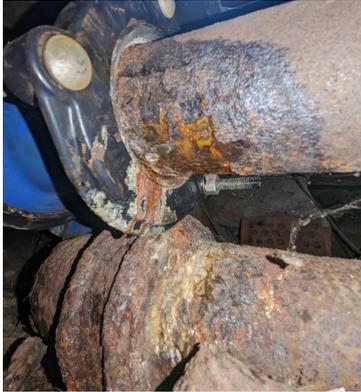
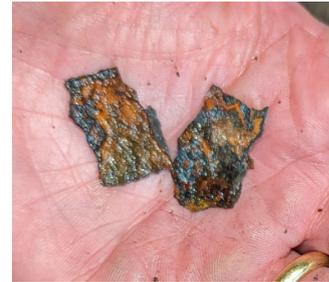
1. It was noted during the survey that the main pipework from the boiler room below the floor is heavily corroded due to a leak from the previous repair. The pipework is heavily pitted and requires immediate attention to prevent the pipework from failing and potentially flooding the void below the main church.

Please see the photo below which show visible extent of the degradation.

2. Intrusive survey of the existing pipework to determine overall condition and give an indication on life expectancy.
3. In-depth review to determine the most appropriate location for the air source heat pumps and routing of the pipework.
