Stained Glass Conservation Report

| Object Title: St Martin's Church, Low Marple, window sll (Annunciation window) | |
| General description: Two light window with 8 tracery Made by Morris, Marshall, Faulkner & Co. (figures by William Morris) 1873 | |

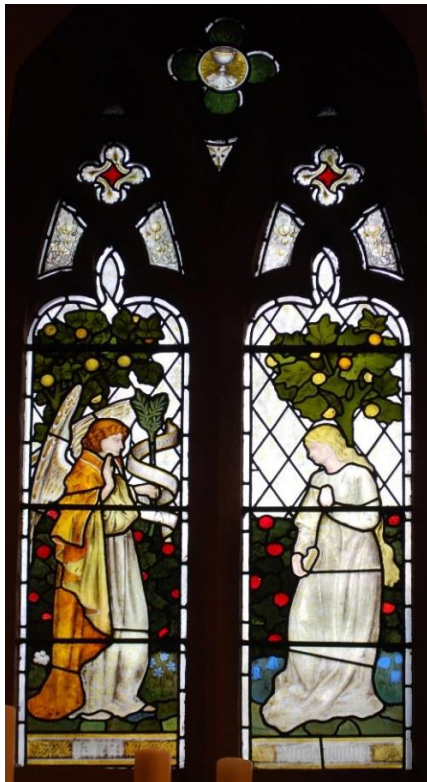
| Location: Barley Studio, York YO19 5LH Tel: 01904 489093 Web: www.barleystudio.co.uk | Photograph, in situ before removal: |

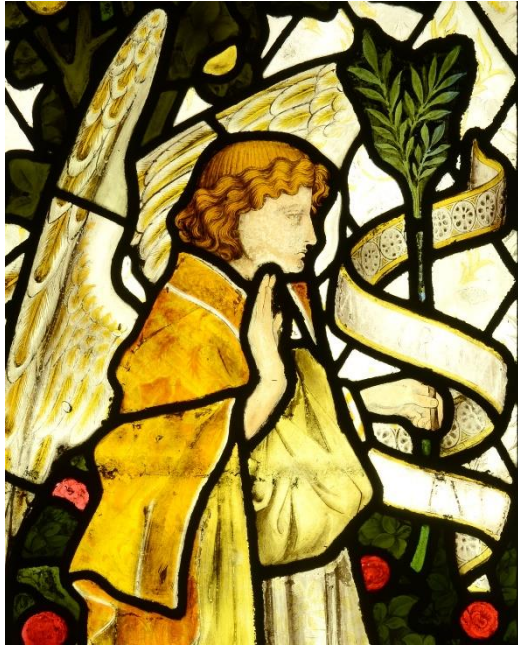
Detail, panel 1a before conservation

- No consolidation of the existing paint layers was considered necessary or desirable.
- Cold painting to restore faded painted detail to faces, hands and inscriptions was carried out using grisaille glass paint (Reusche) mixed with gold size (Handover) and distilled turpentine (Winsor and Newton) applied to the reverse (unpainted) face of the glass piece.

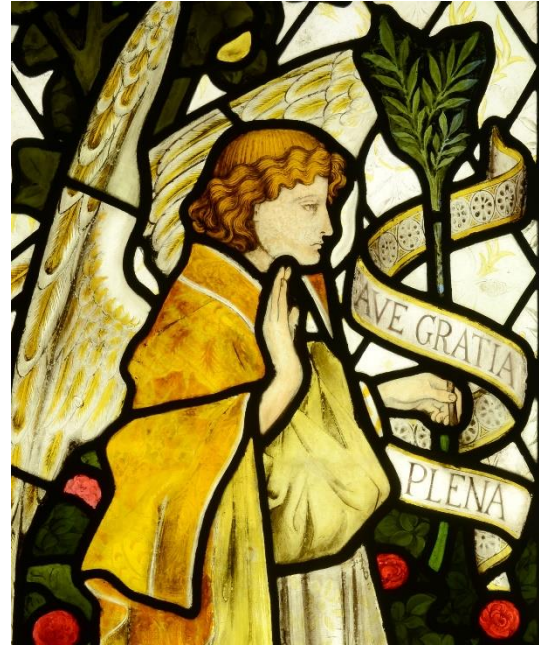
Detail, panel 1a after conservation and cold painting to restore faded detail

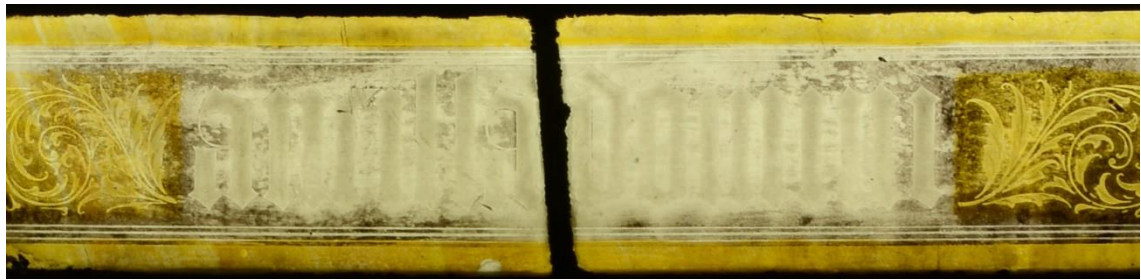
Detail, panel 1b before conservation

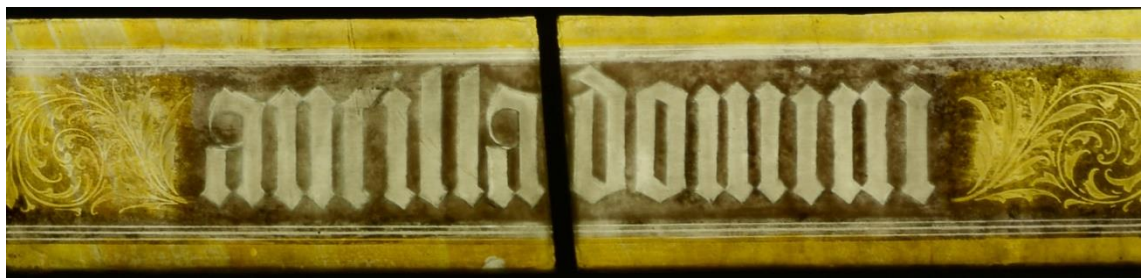
Detail, panel 1b after conservation and cold painting to restore faded detail

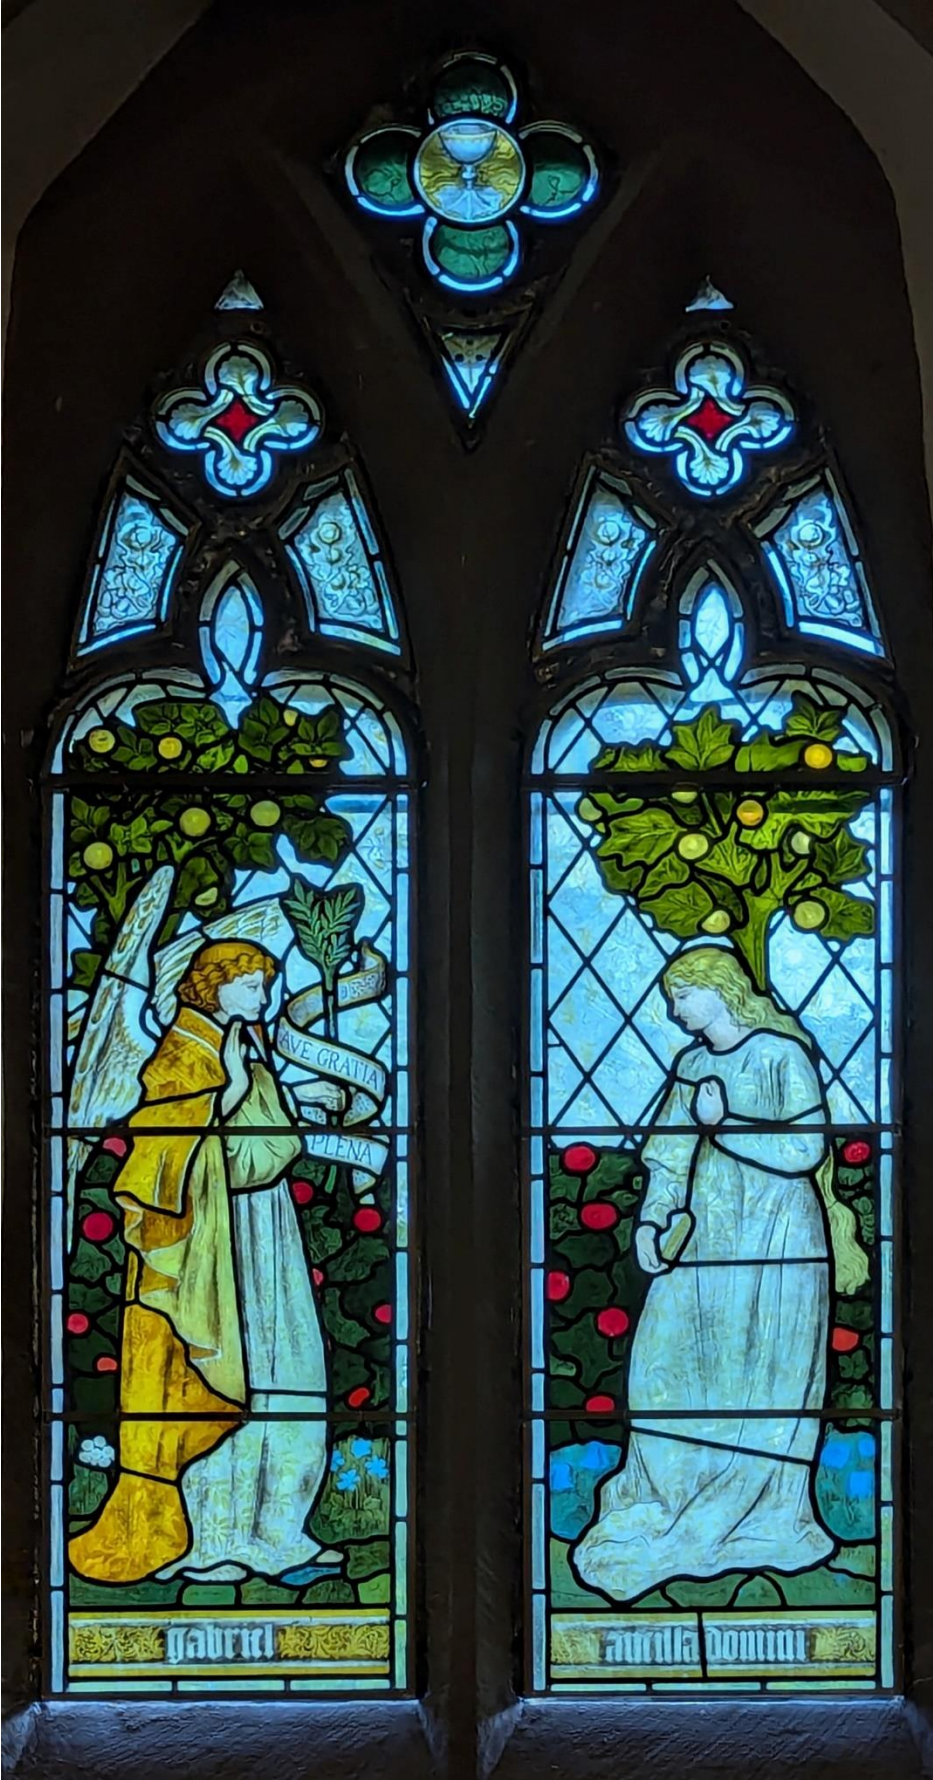
St Martin's Church, Low Marple, window sll: in situ after conservation

- The framed stained glass was fixed using non-ferrous (stainless steel) screws into drilled and plugged holes in the stone mullions to the inside of the external protective glazing.
- The lead tape around the frames was flattened back to the stonework, allowing ventilation gaps at the top and bottom of each light.

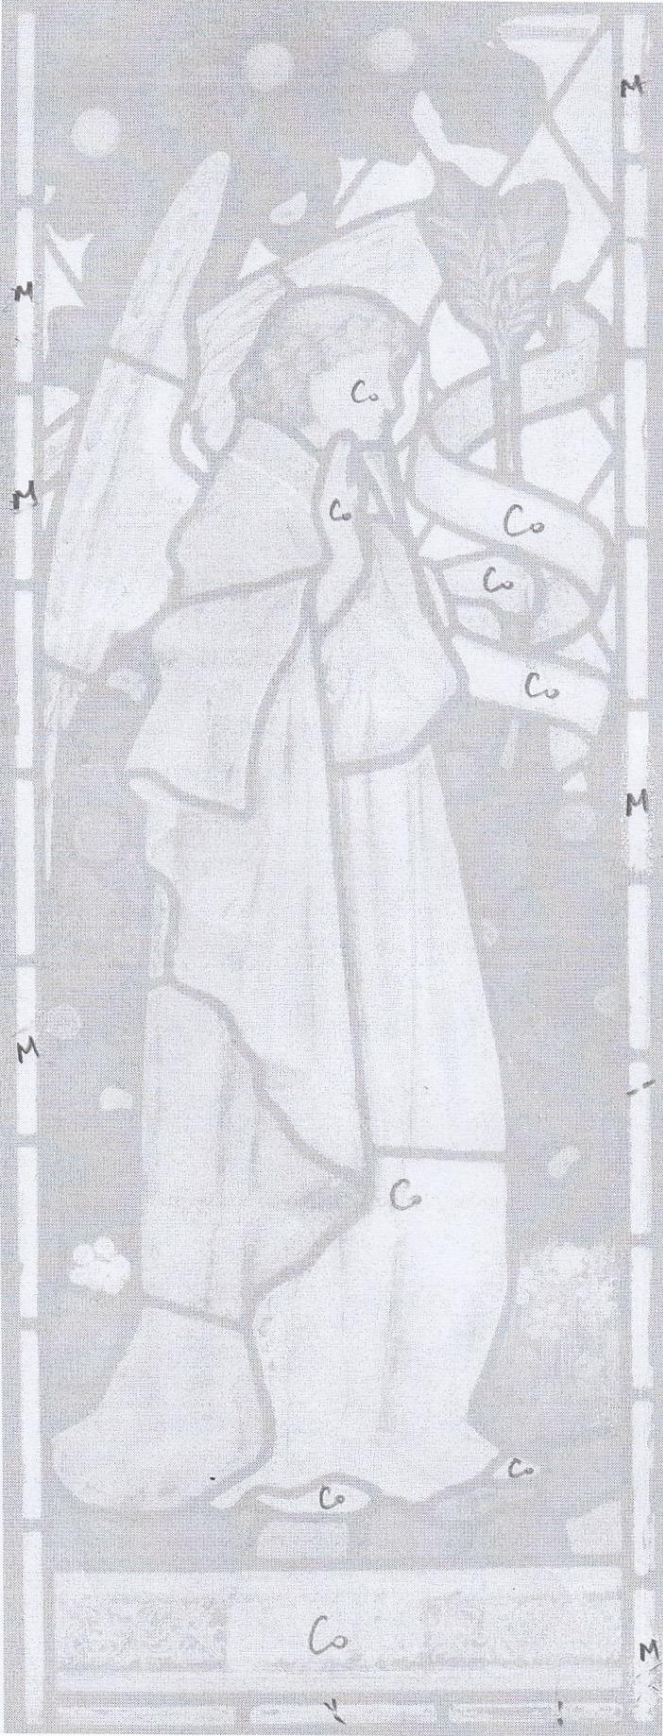
Panel 1a. Co = cold paint applied to outside face; M = modern glass inserted; dashed line = glass fracture

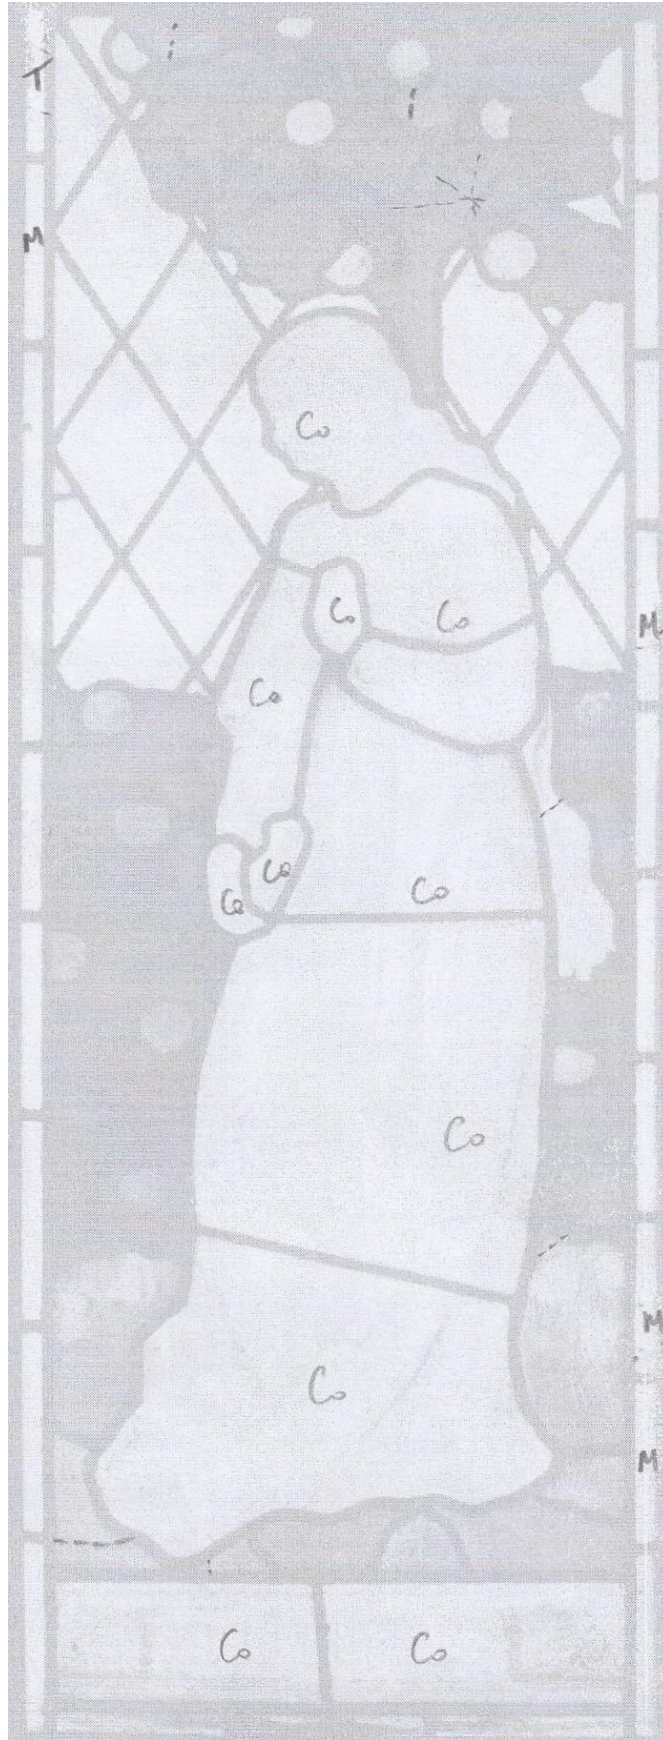
Panel 1b. Co = cold paint applied to outside face; M = modern glass inserted;
dashed line = glass fracture
