A Statement of Significance

Statement of Need

in respect of mounting AV System Relay Screens to pillars

18 July 2024

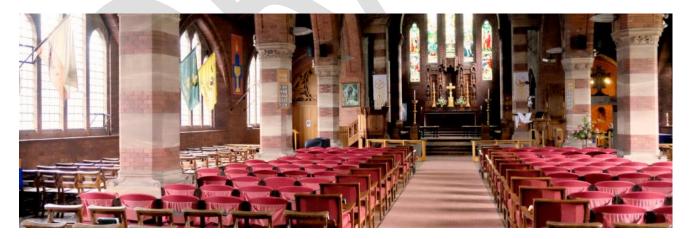
The interior as seen below is hard red brick inside with stone detailing; and wood block floors on concrete (with aisle and sanctuary carpets). As visible below, the bulk of chairs are a mixture of deep red/wine upholstery, picking out the red of the brickwork. The older wooden stock has recently been updated with more deep red/wine upholstered chairs, but in a lighter, stackable and more flexible design.

The seating in the north and south aisles, has visibility to the sanctuary steps and carpeted area immediately in front, restricted by the pillars. The single central AV screen, installed several years ago, was supplemented during Covid when it was necessary to spread people out as much as possible. This was done in a temporary manner, using TVs on wheeled stands, with cables run above ground and taped down to reduce the risk of trip hazards.

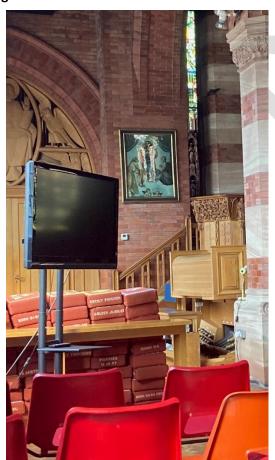
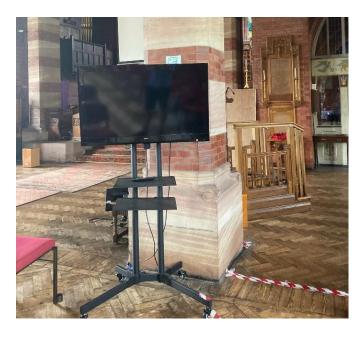
Figure 1. Current 40" screens on stands – left and right-hand side.

Surface level-cables and trolley feet act as trip hazards we would like to avoid.

The screens are also not at optimal height, especially for when the congregation is standing.

The screens also take up some seating space and the corners are painful if you stand up underneath them.

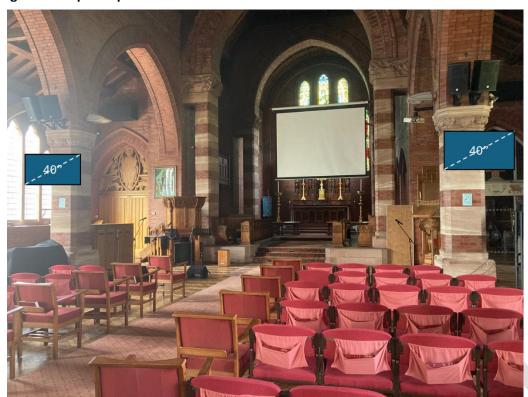
Figure 2. Proposed pillar mounted locations

Facing the front, x2 two relay-screens mounted on 1st pillar angled out to face side-aisle blind spots.

Screens would be angled out towards the sideaisles in order to maximise visibility.

The proposed brackets allow for folding away flat or facing inwards for alternate seating styles (e.g. our monthly evening Café Service).

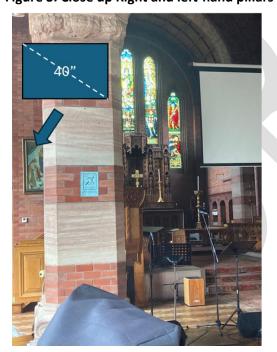
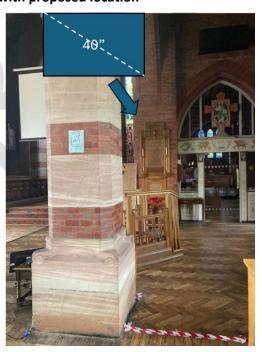
Figure 3. Close up Right and left-hand pillars with proposed location

Screen mounted at a height maximise sightlines and eliminate risk of bumping heads.

Arrow shows primary angle of screen to left and right.

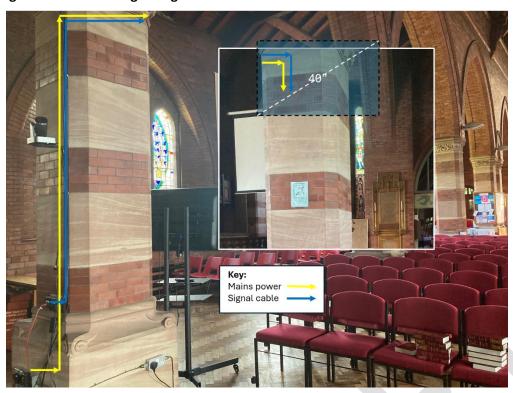
Figure 4. Cable-routing for right-hand screen

Mains power and HDMI signal would be routed up the rear of the pillar, and discretely around the lip to the mounting bracket.

Insert shows front of pillar and cable route to back of screen.

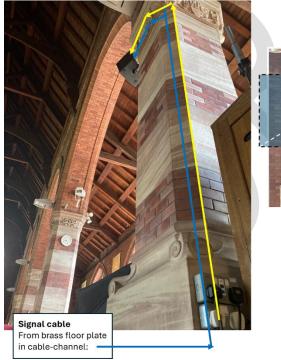
Figure 5. Cable-routing for left-hand screen

Mains power and HDMI signal would be routed up the rear of the pillar, and discretely around the lip to the mounting bracket.

The signal cable would come across the nave in a cable channel, with the cable exiting the channel the foot of the pillar.

Insert shows front of pillar and cable route to back of screen.

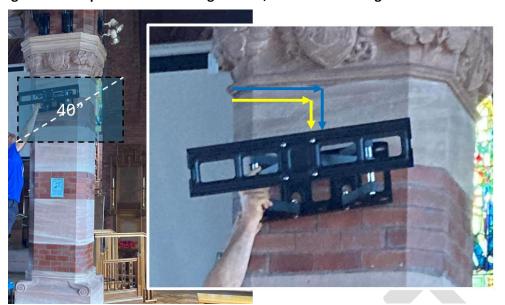
Figure 6. Example screen mounting bracket, with cable routing.

Bracket tilts left/tight, extends out on scissor arms, and can be tilted forward.

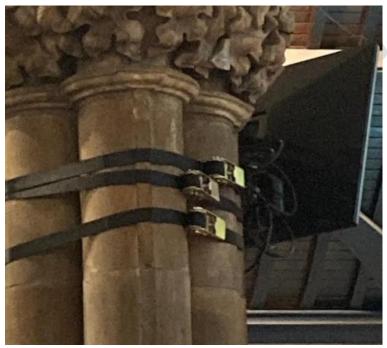
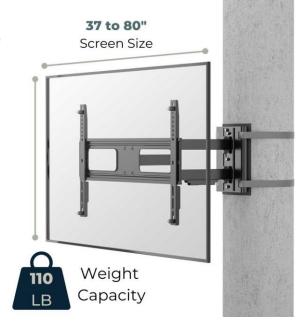
Figure 7. Alternate temporary strap mounting

In another church we have seen a solution whereby screens are mounted without permanent fixing. This has one the advantage of being able to confirm the right height/position for the screen before committing to fixing a bracket It is obviously not as safe as a fitted bracket properly rated for the weight.

There are versions of this approach on the market which use metal straps, rather than ratchet traps.

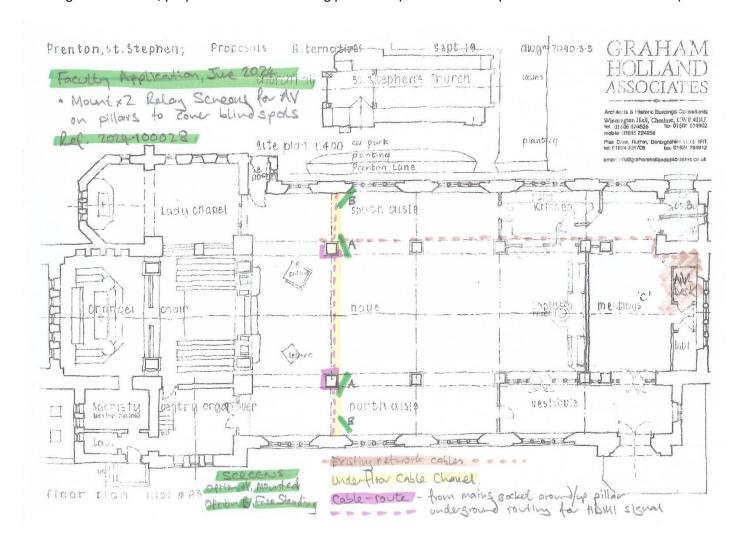
Figure 8. Marked up plan of St Stephen's Prenton

Showing cable channel, proposed bracket mounting position A (also alternate B position for Screens on stands).

- Brackets are secured into the joints of the brickwork, avoiding the brick facings themselves.
- Avoid the stonework
- Use of non-ferrous fixings
- Discreet routing of cables via the rear of the pillar (as proposed above)

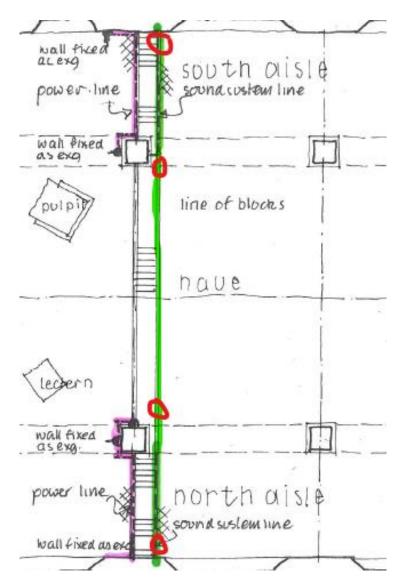
Architects plan

The highlighted green line shown the proposed route of the cable conduit. The red circles indicate the location of the flush brass plate access points.

Over all, the end result will be better/safer fitting blocks. Plus a safe cable route across church which replacement audio cables can run through. The electrician proposes running a sections of 50x50mm plastic conduit under the woodblock, set in a recess in the concrete below, so that the parquet wood-block flooring can be secured flush on top. We propose to insert x4 flush brass floor plates for trip free access. When not in use any surface cabling can be hidden from view.
