All Saints Church Grendon Warwickshire

Archaeological Monitoring and Recording

Archaeology Warwickshire
Report No 2477
July 2024

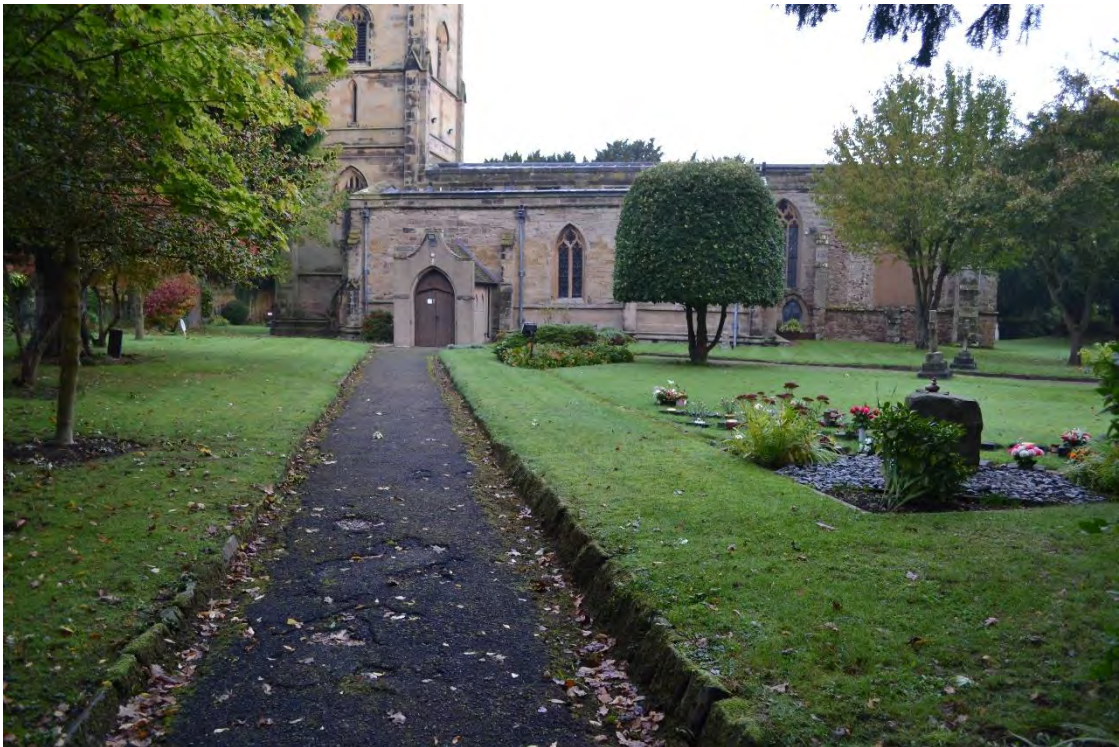
1 All Saints Church and path prior to excavation works

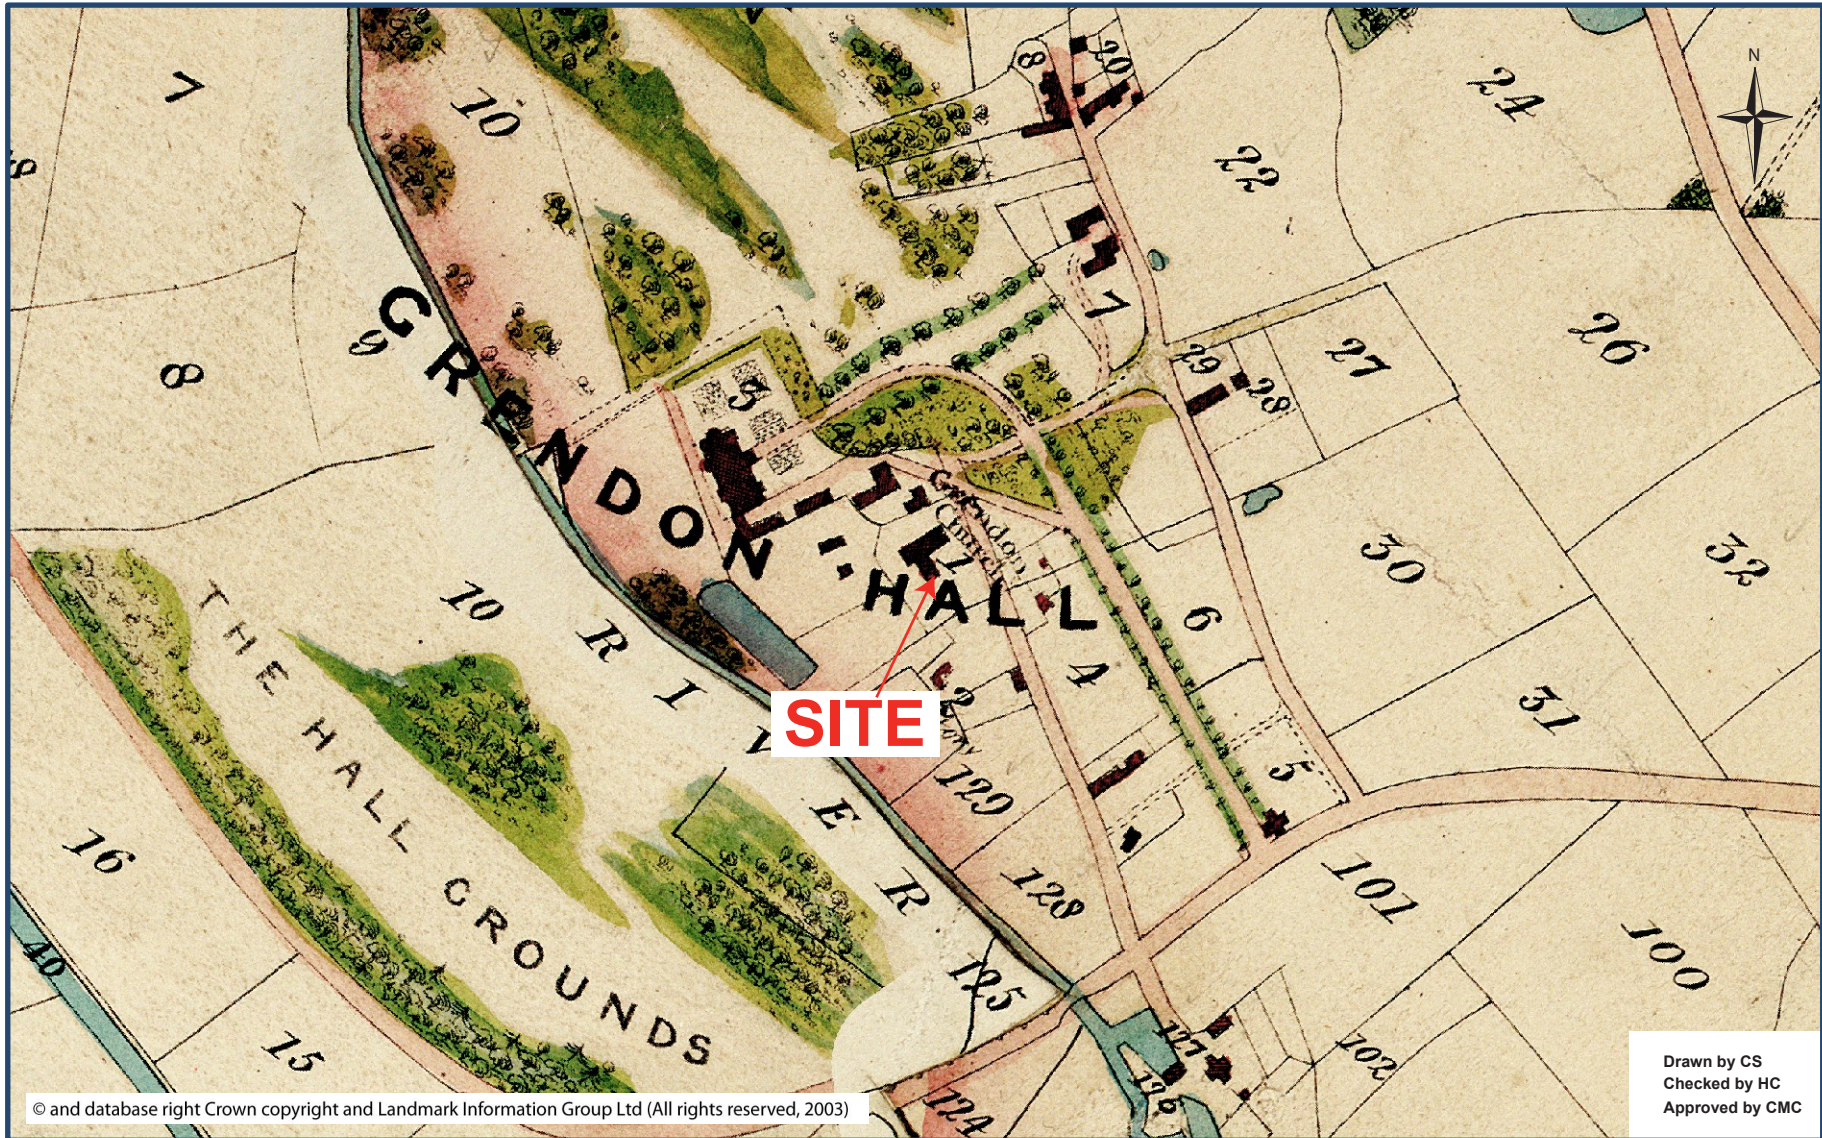
Fig 3: Detail from Tithe maps of 1850 (Grendon CR0328-18-2 and Polesworth-Dordon CR0328-36)

3.7 To the north of the church is Grendon Hall park, a post-medieval landscape park with formal avenues and gardens (MWA 10306), recommended for inclusion on the Local List by Lovie (EWA 9571; Fig 2). Grendon park Bridge lies to the north-east of the park (MWA 19995). A 19th-century Grendon Bridge, replaced an earlier form 300m south of the church (MWA 200). Grendon Ice House is a well preserved example of a brick-built ice house, located in the woods alongside Farm Lane (MWA 13363). A Blacksmith's workshop is shown on the First Edition Ordnance Survey map of 1889 (Fig 3) at Grendon Fields Cottage (MWA 6525). The site of a railway signal box is located to the west (MWA 6510).

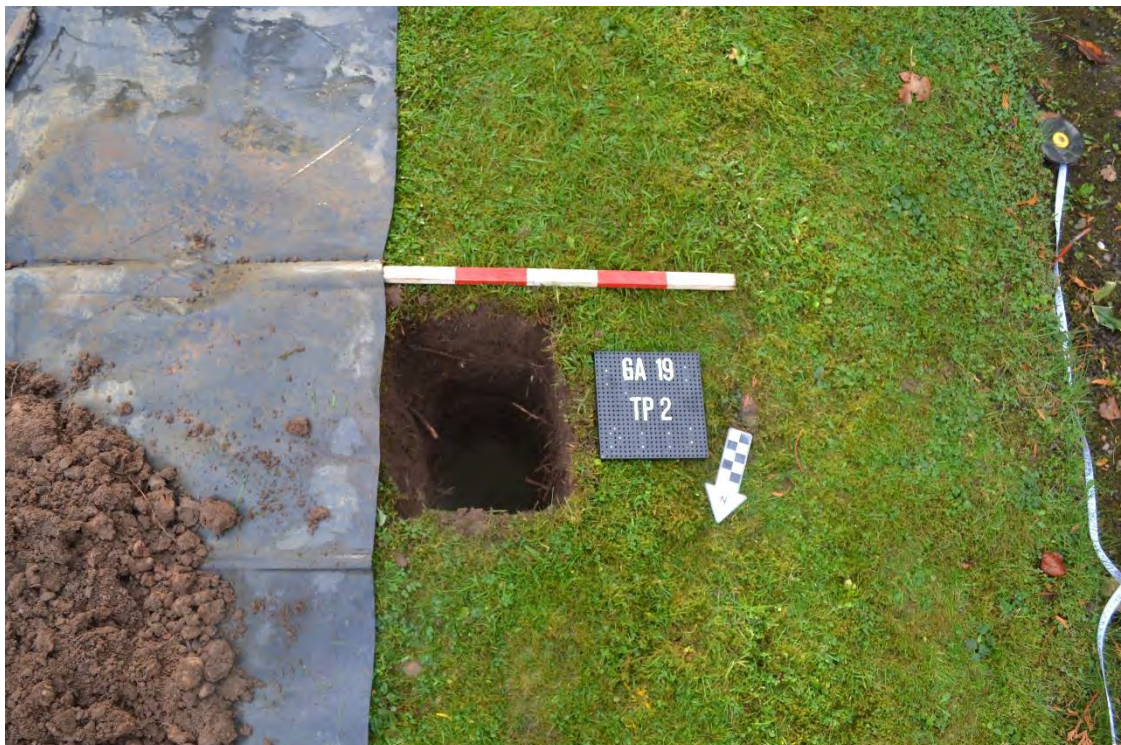
2 Test pit 2

- 5.1 Three percolation test pits were hand excavated on the eastern side of the tarmac path, avoiding the path itself, in October 2023 (Fig 4). Each pit was 300mm square; pit 1 was excavated to a depth of 0.90m, pit 2 to 0.80m and pit 3 to 0.51m. Test pits 1 and 3 cut into a greyish brown sandy clay loam graveyard soil layer containing occasional fragments of brick and sandstone (2) overlaid by c. 0.20m of brown loam topsoil (1). In test pit 2 (Photo 2), was dug through 0.80m of brown sandy clay loam (3) to the base of the pit, suggesting that this may have been within a grave fill. A spurred clay pipe bowl recovered from the topsoil in test pit 3, probably dates from the early 18th century (Broseley type 4). No human bone was recovered from the test pits.

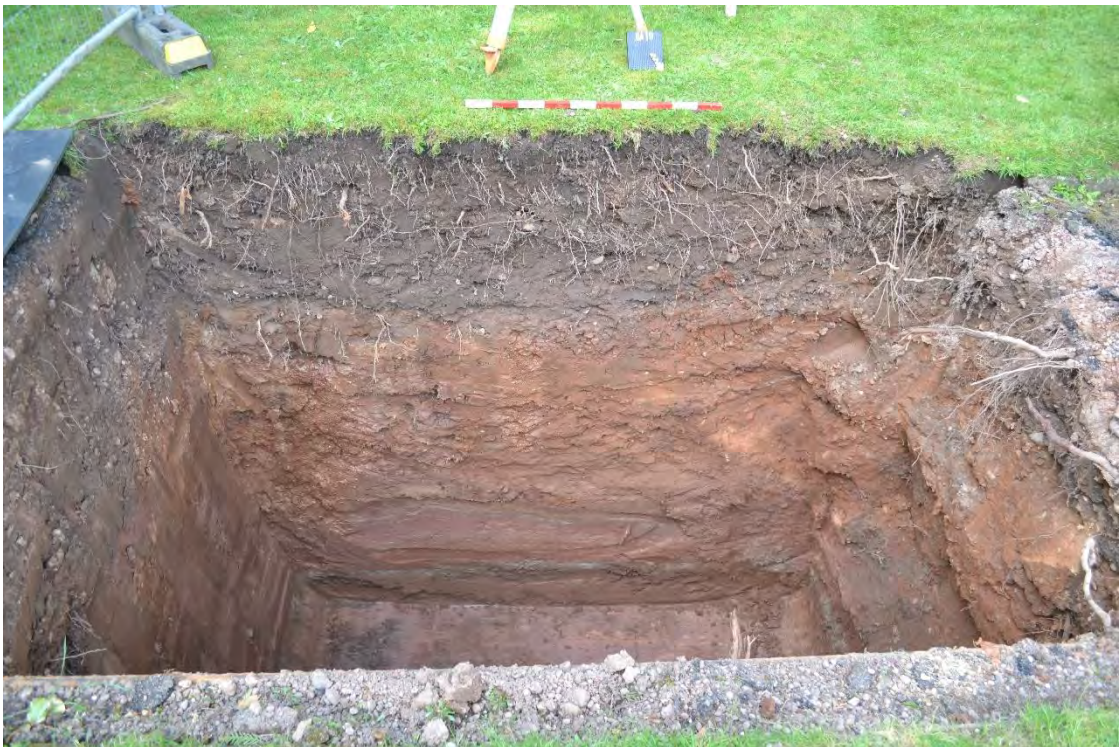
3 Excavated trench for septic tank

- 5.2 Further excavation took place in April/May 2024 when the septic tank and associated drainage works required excavation (Fig 4). The septic tank trench was located 21.20m south of the porch below the line of the path. The trench measured 3.30m x 2.25m and was excavated to a depth of 3.50m, cutting into geological natural at a depth of 2.72m (Photo 3). The geological natural comprised layers of clay and sandy clay (9), above bedrock. The geological natural was overlain by 0.78m of graveyard soil (2), itself overlain the gravel base (11) for the tarmac path (10). No finds were recovered from the tank area and no fragments of human bone were noted.

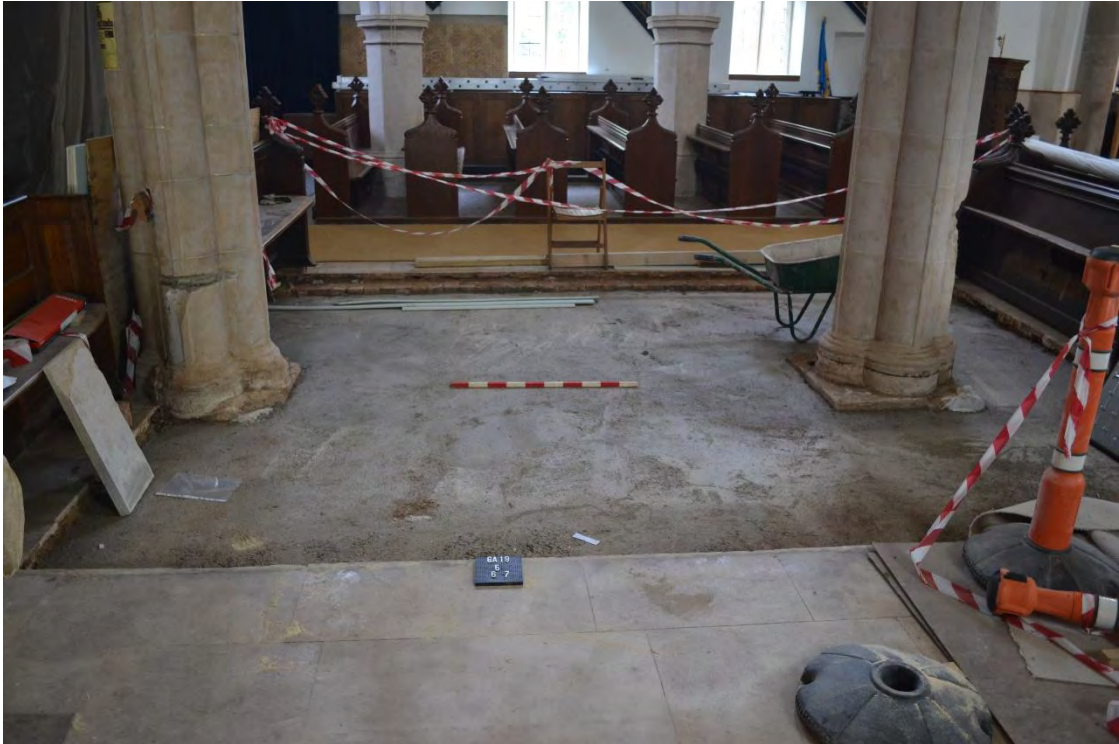
4 New concrete sub-floor within south aisle and nave

- 5.3 The internal works were carried out before the external groundworks (Photo 4) and a limestone stone floor (4), and a brick sleeper wall (5) and two pier bases were recorded (6 and 7), below the level of the former

wooden floor, along with lifting of stone floor slabs and concreting (8) the corner of the south aisle where the new toilet is located.

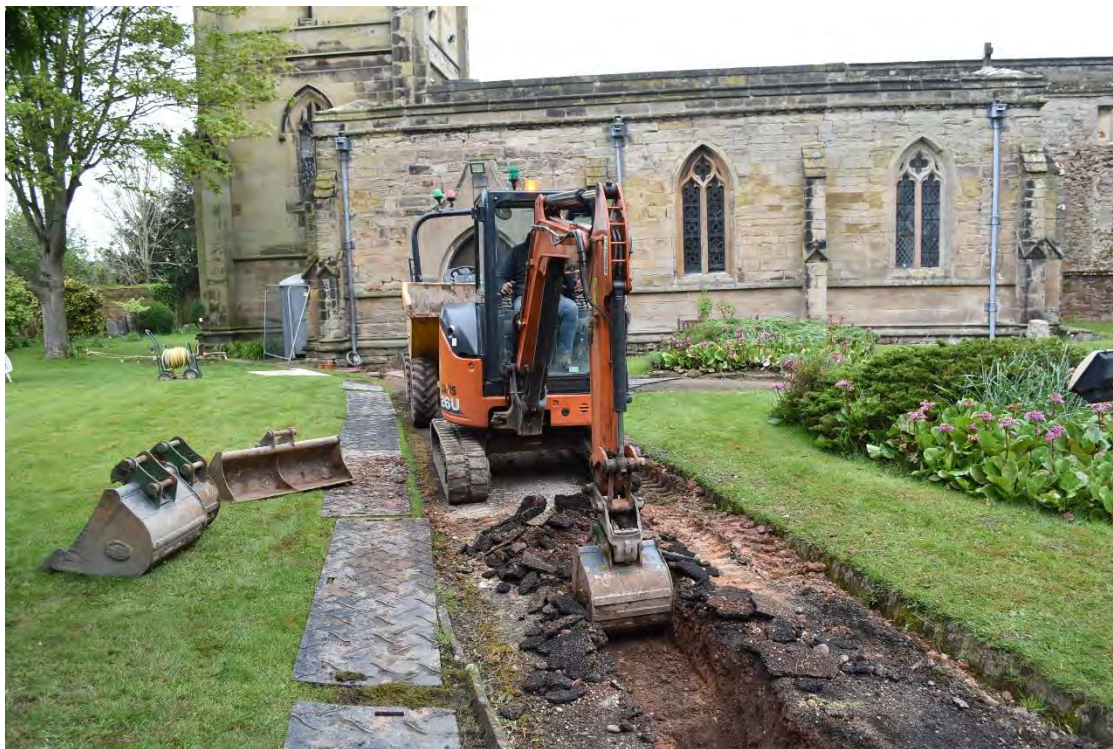
5 Excavation of the drainage trench

- 5.4 The drainage pipe trench was machine excavated from the septic tank trench to the south-west corner of the church (Fig 4; Photo 5). It was excavated into the geological natural red clay (9) between 0.85m and 1.30m deep. The geological natural was overlaid by greyish brown sandy clay graveyard soil (2), 0.51m – 0.80m thick. At the south-east end of the trench was a layer of tarmac (12; Photo 6), 0.05m deep, that extended for c. 8m north-west from the septic tank. The area was then overlaid by a levelling layer of gravel (11), 0.10m in depth, and was in turn sealed by the current tarmac path surface (10), 0.04m in depth.

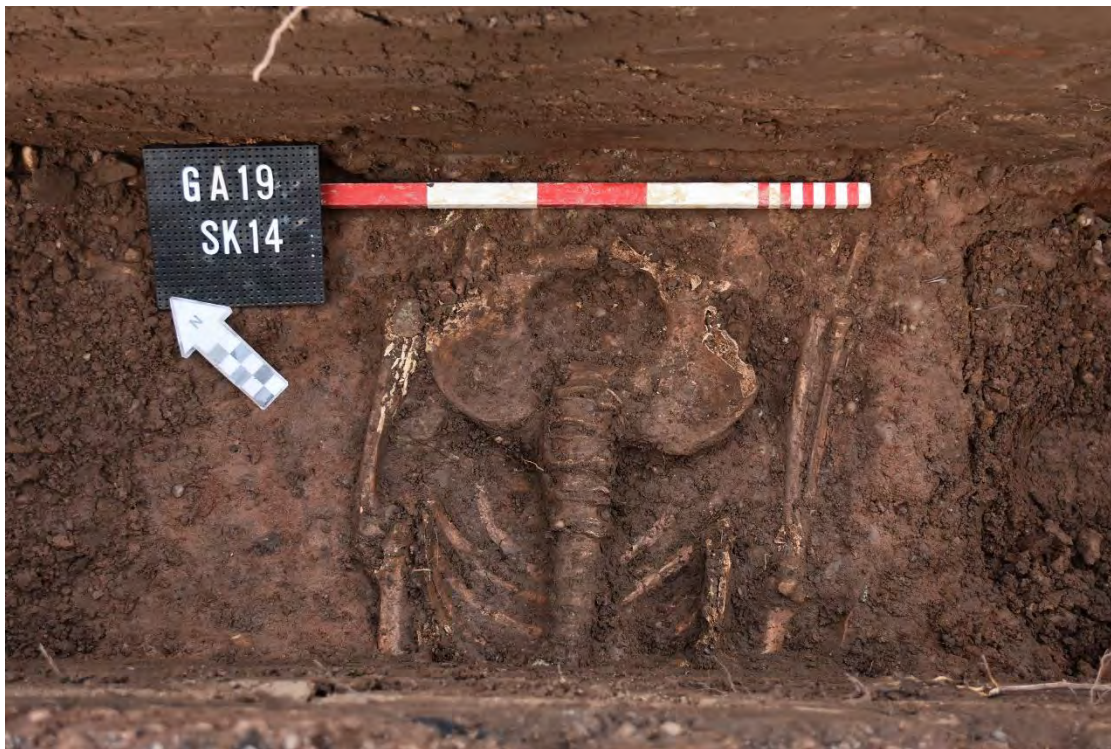
7 SK14, looking north-east

5.5 Nine articulated skeletons were exposed in the drainage trench, as well as various groups of disarticulated human bones (Fig 4; Photos 7 - 9), in a c. 10m long stretch of trench up to c. 14.50m south-east of the church; no burials were recorded closer to the wall of the church itself where the trenching was shallower. The trench cut across the line of the articulated skeletons so only part of each skeleton was visible, and all were lying supine and orientated west-east. All the skeletons, apart from SK35, consisted of the torso, arms, pelvis, top of the femurs and sometimes part of the skull. SK35 was just the skull within a clearly defined, round-ended grave cut across part of the trench (Photo 8). The position of the arms varied between the skeletons; SK14 the arms were straight down the side of the torso, whereas SK17 were bent 45° at the elbow with the ulna and radius across the pelvis and SK20, SK23 and SK39 were bent 90° at the elbow with the ulna and radius across the pelvis. The graves for the majority of the skeletons were cut into the natural geology (9; SK14, SK17, SK20, SK26, SK29 and SK35), whilst two were within the graveyard soil (2; SK26 and SK39). One sherd of pottery dated 1250-1300 was recovered from the grave fill around SK23, and another similar sherd from the graveyard soil. There was no evidence for coffin burials, suggesting they were most likely shroud burials.
