The Church of St Mary, Chalgrove, Oxfordshire (Diocese of Oxford) Conservation Management Plan

The Church of St Mary, Chalgrove, Oxfordshire (Diocese of Oxford): Conservation Management Plan

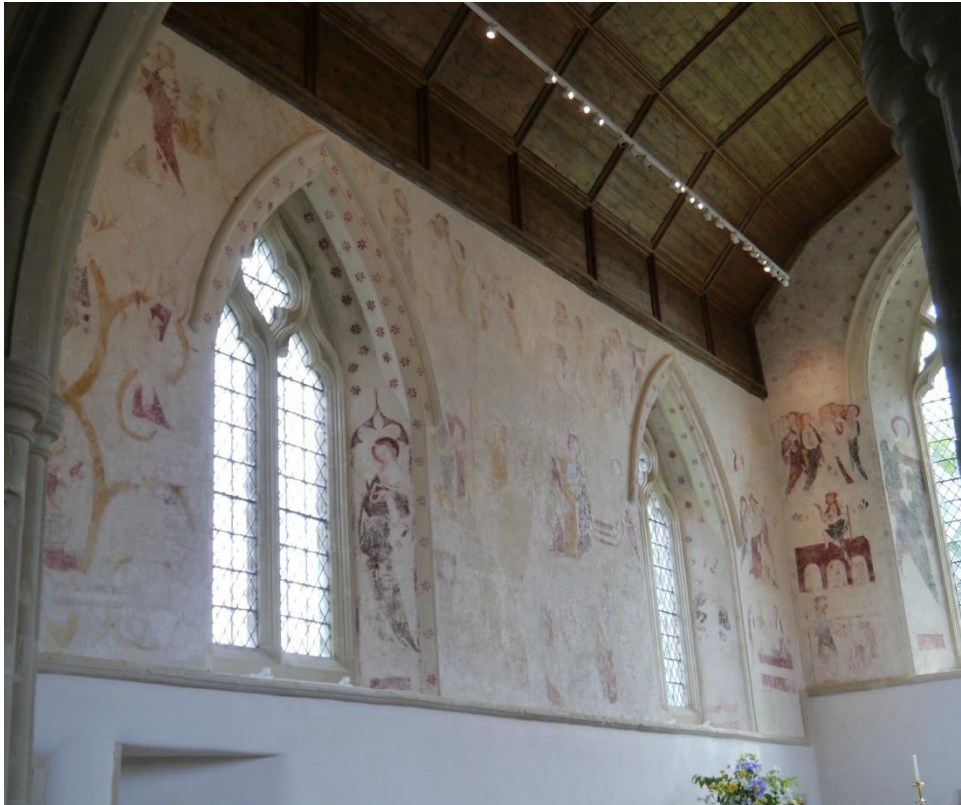
Figure 2: Medieval wall paintings on the north wall of the chancel

In 1840 pews were repaired and re painted, and new square pews were put in place. The Chalgrove Friendly Society was established. The wall paintings in the chancel were revealed in the summer of 1858 by workmen repairing the chancel. Rev'd Lawrence and his family were determined to preserve the paintings. The Keeper of the Ashmolean Museum, James Parker made tracings of the paintings at the time they were discovered and full-size tracings were also made by the Lawrence daughters. Rev'd Lawrence ensured the paintings were preserved and appealed to Christ Church for funds for the recently discovered 'very beautiful' wall paintings. The tracings of the wall paintings done by James Parker were presented at a meeting of the Society of Antiquaries in December 1858. The full size tracings made by the Misses Lawrence were probably used by Charles Buckler for his illustrations. Charles Buckler's views on the wall paintings were read to the Oxford Architectural Society and a paper appeared in the *Gentleman's Magazine* (August 1859). James Henry Parker read a paper to the Society of Antiquaries, William Burges' 'On Mural Paintings in Chalgrove Church, Oxfordshire, with illustrations by Charles Buckler' was printed in *Archaeologia* (xxxviii p431-38), and another paper was printed in the *Gentleman's Magazine* (vol CCVIII, 547-56).

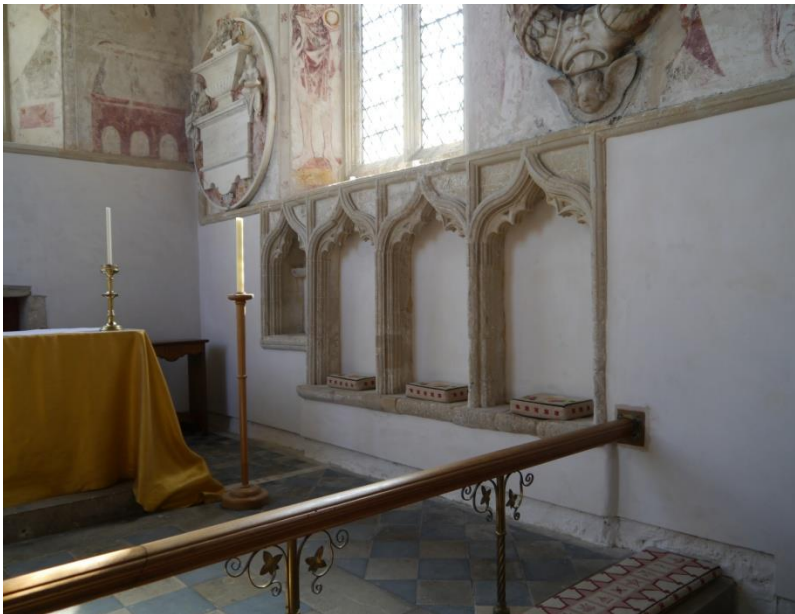
Figure 10: The sedilia and piscina in the south wall of the chancel

In c 1310-1313 the chancel of the church was rebuilt with the sedilia, lavabo, painting of the chancel and stained glass windows as part of a decorative scheme behind a new rood screen (Heath-Whyte 2003, 8). This may have been under the influence of Sir Drew Barentin II, combined with Sir William de Bereford (whose wife Margaret de Plessis was heir to the local de Plessis estate), an executor of the patron Sir Piers Gaveston, earl of Cornwall. Gaveston, as patron, had appointed the Florentine master builder, Bonacursus de Friscobaldis as rector on 31 January 1310. The chancel features remarkable wall paintings depicting scenes from the life of the church's dedicatee, St Mary. These include the Virgin at prayer, her relationship with the apostles, death and burial. The piscina, credence and triple sedilia are of a very high level of craftsmanship. It is possible that the paintings, piscina and sedilia were by royal craftsmen. Sir Drew and Sir William had royal connections and it has been suggested that Drew Barentin, as the resident lord, would have been consulted by Gaveston concerning the proposed works on the church. Drew's wife and daughters may have been included as donor figures in the scene on the south wall with the Virgin and her neighbours (ibid, 49, 60-61). The triple sedilia, which was seating for three clergy, probably the priest, deacon and sub-deacon implies sufficient wealth to afford the seating and the personnel to pray for the deceased and High Mass.

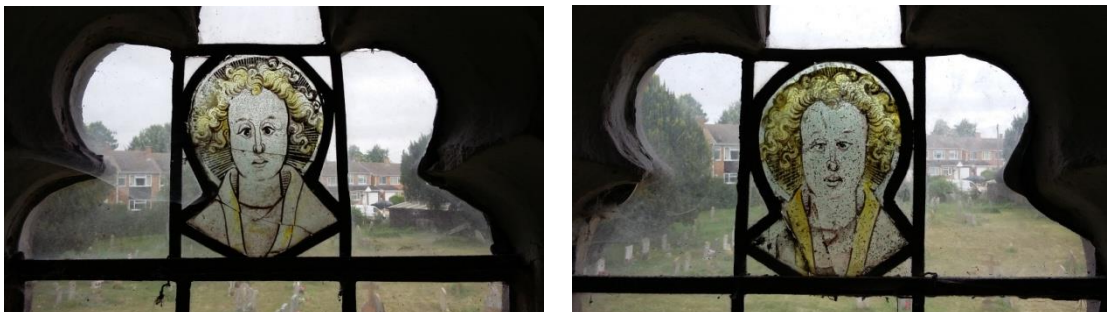
Figure 11: The painted glass angel heads.

Documentary evidence for the church dwindles somewhat in the early decades of the 15th century. From 1402, however, two churchwardens were mentioned as being at Chalgrove for the administration of St Mary's and Rofford church (VCH 2013 Chalgrove Local Government 2). Two identical angel heads were painted on window panes about this time: later, they were placed on the outer side of the glass in the eastern window of the north aisle but one is the wrong way round.

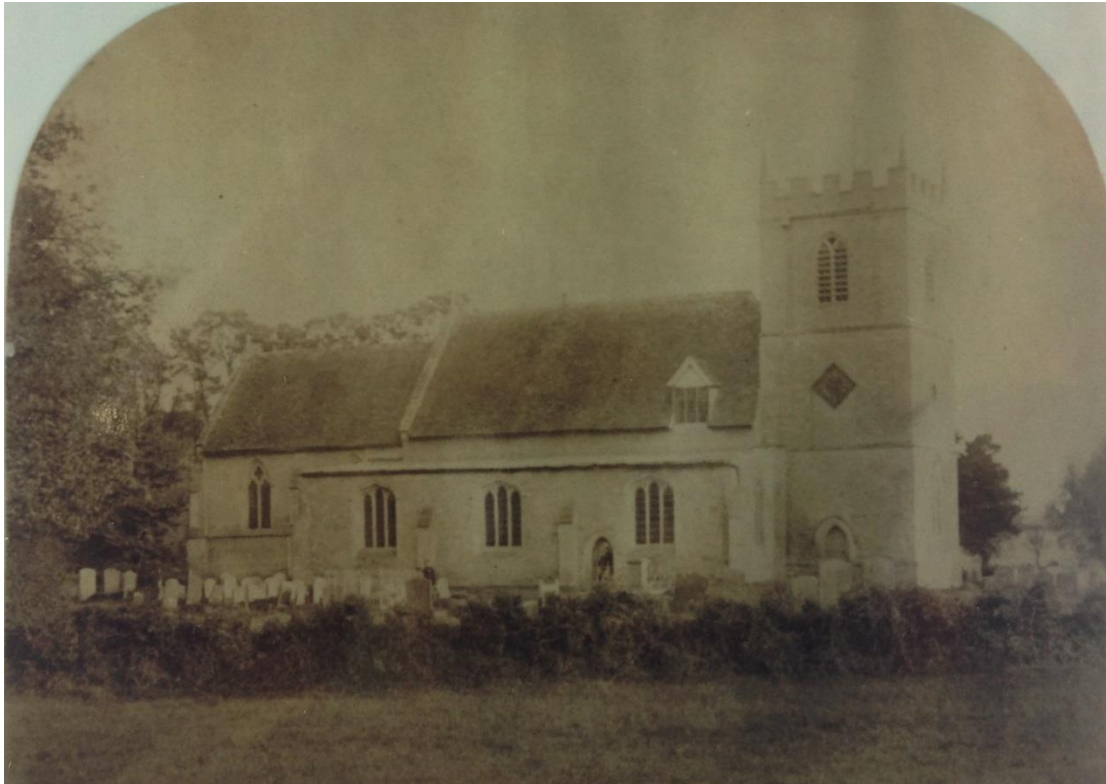
Figure 13: The north side of the church in 1869.

In 1692 the unique, painted, Baroque memorial to the Quatremain family was installed. This was originally on the east wall of the north chancel. In 1694 a wooden gallery for musicians was built at the west end of the nave, lit by a dormer window in the west end of the north aisle. Another dormer window at the east end of the south aisle may also have been put in place. The churchwardens at the time, Francis Quartermain and John Cox, had their names inscribed on the gallery. It is possible

that Gilbert and Francis White paid for the gallery, continuing in the tradition of their father. A photograph of 1869 shows the north dormer still in situ.

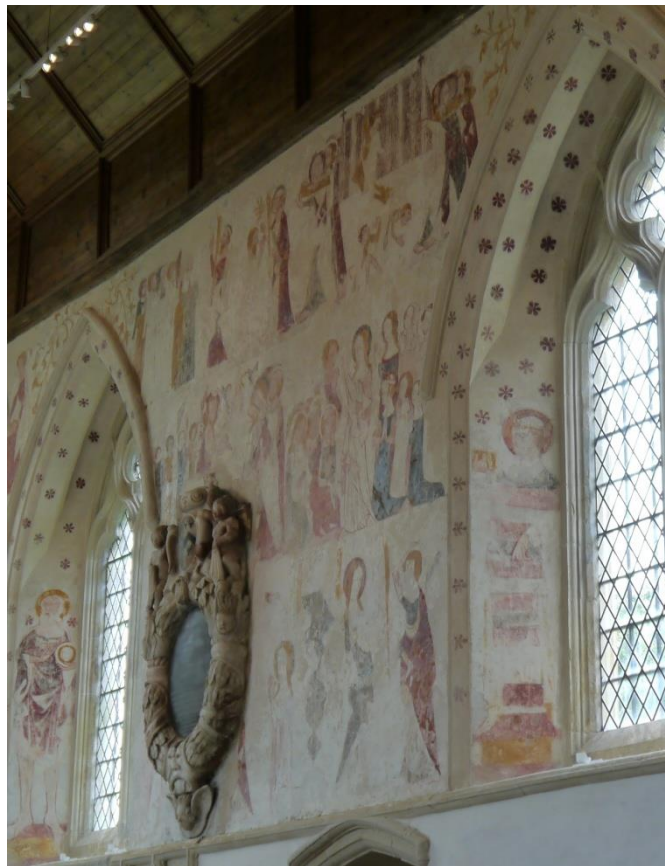
Figure 19: The wall paintings and Markham memorial on the south wall, between the two windows.

The south wall of the chancel has a 14th-century pointed moulded priest's door with studding and wrought iron hinges, and also a 15th-century chamfered window. The wall also contains the finely decorated piscina, sedilia and lavabo with cusped ogee heads and fluted sides. The south wall's paintings deal with the Death and Assumption of the Virgin Mary. These are known from the Apocryphal gospels. Paintings of Mary's final days are in the central portion of the wall between the two windows. The two bottom paintings show Mary receiving the Palm of Paradise from an Angel. The next scene is the Virgin Mary at prayer in pink robes, the gown of immortality: her normal blue robe is behind her. The Hand of God is above in blessing.

The next painted image has largely been covered by the Markham Monument. This is a baroque style memorial to the Rev Francis Markham who died in 1668 and his wife Alicia. It has a black central stone with inscription and a garlanded cartouche with angels supporting a coat of arms. The painted figures around and obscured by the monument show one female figure and part of another. Above the presentation of the palm the image shows Mary with the apostles and neighbours. Next to this is the death of Mary surrounded by Angels, but Mary is hidden behind the Markham Monument. Above is the Funeral of the Virgin with the bier supported by the apostles.

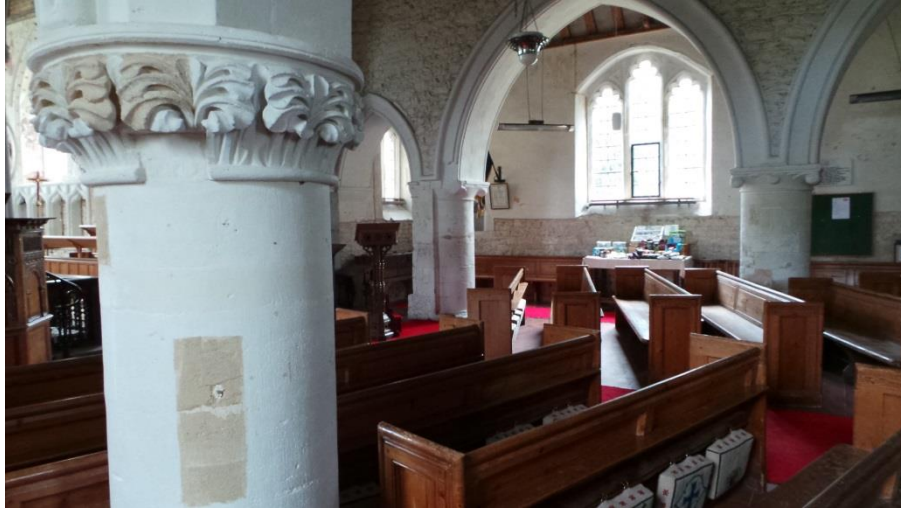
Figure 20: Nave pews, with a waterleaf capital in the foreground, prior to 2015-16 refurbishment.

The Nave is of four bays with a late 12th-century south arcade. This has small pointed and roll moulded arches on circular piers with square bases and water-leaf capitals. The early 13th-century north arcade has chamfered arches on circular piers with moulded and foliate capitals. All the dressed stone in the Nave and elsewhere including all the columns, piers and mullions are of Wheatley stone from near Oxford. The exposed limestone rubble in the lower parts of the walls is of Wheatley stone and stone from the local Portland formation (Powell 2016).

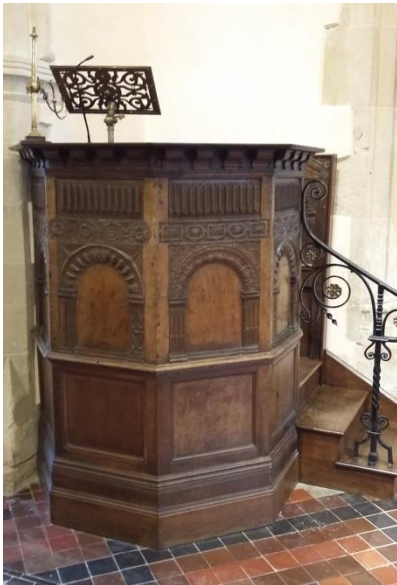
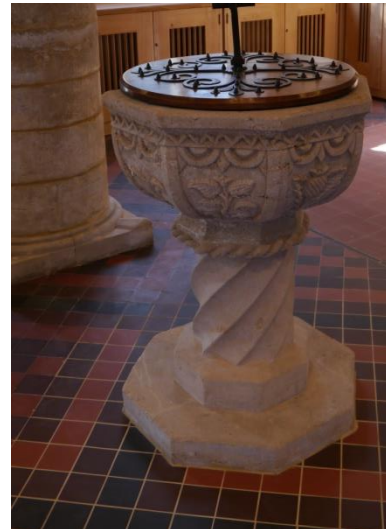
Figure 21: The pulpit (left) and font (right).

The fine Jacobean oak pulpit is slightly to the north of the chancel in the nave with the 19th-century Adeane monument nearby. The pulpit has finely carved fluted bands at the top, stylised floral and leaf carving below, and toothed arches on Doric pillars. The lower portion has recessed square panels with a double pedestal at the base. The pulpit is accessed by a series of three stairs. It has a dentilled top that supports the table-shelf for bible and other texts. No sounding board is evident. The Chalgrove Friendly Society Banner hangs at the west end of the nave. The wooden ceiling of the nave and aisles consists of a four-bay collar truss roof with curved windbraces. It is all in pine and dates to the 1881-3 renovation of the church. The church roof woodwork was cleaned as part of the refurbishment and conservation work on the church in 2015, as were the oak pulpit and chancel rail.

The cup-shaped octagonal font is towards the back (west end) of the south aisle. The bowl has carved emblems on each side under a chevron band with cup and dart detail below. The emblems include a portcullis, a fleur-de-lys, a thistle and a rose with coronet detail. The font is on a twisted spiral carved pillar over a double octagonal plinth, but was previously on a square base with bevelled corners. The

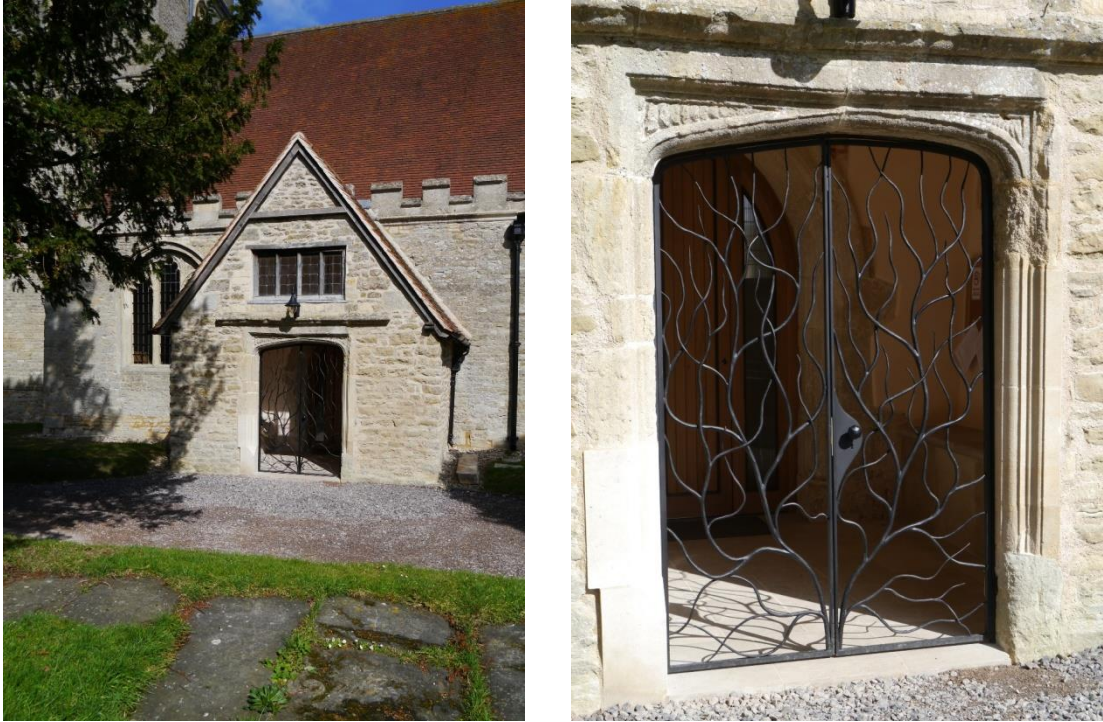
Figure 23: The Porch.

The south doorway that leads into the porch is c 1320 in date and has recently discovered painted detail above it. This comprises a ball trefoil pattern over a triangular detail with ball detail inside and between each raised triangle and trefoil. The pattern is also noted on the north door and north aisle windows and it is probable the motif decorated all the doors and windows in the nave (Heath-Whyte 2016, 96). The porch is mid-15th-century with a gabled roof, top leaded window and a four-centred arched doorway with square head and indented moulded triangular spandrels. There is a drip mould below the window on the exterior. On the interior there are large wooden support beams across the door opening and further wooden roof supports. There are new wrought steel gates with full glazing and part glazed inner wooden doors. Wall painting including a 16th century zig zag panel pattern has been revealed on the walls of the porch. These appear to be borders to text. South of the porch in the western corner of the south aisle was a wood-panelled vestry with Commandment boards on the north side of the exterior. The vestry was at one time in the south porch and another time in the north aisle. The vestry has since been removed to allow space at the back of the church for social gatherings after services and for concerts or other social occasions. The prayer boards have been removed and placed on the south wall. New cupboards have been placed against the south

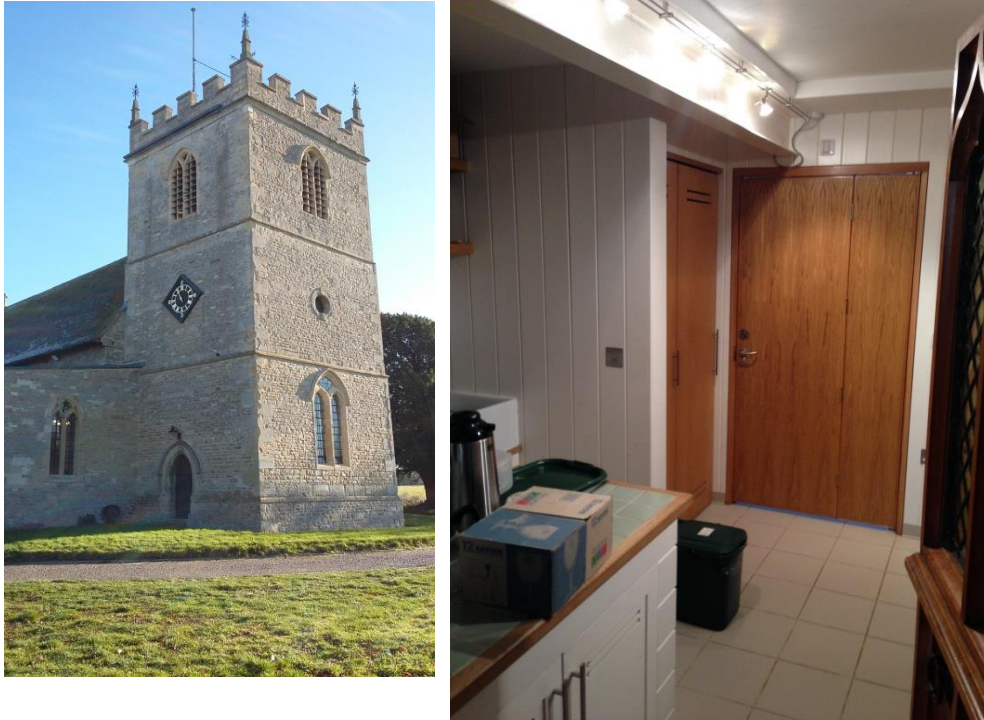
Figure 24: The Tower, with its internal ground-floor facilities.

In 2010 the seven bells in the tower were removed and restored by Whites of Appleton. The bells were 1/8 turned (they were 1/4 turned when rehung in c. 1888) on their axis and rehung on new headstocks and fitted with new clappers, ropes and bearings. These modifications enabled them to be rung more easily, and this was advantageous to attracting younger and older ringers to the Church. An original wheel and clapper are displayed in the ringing room in the tower.

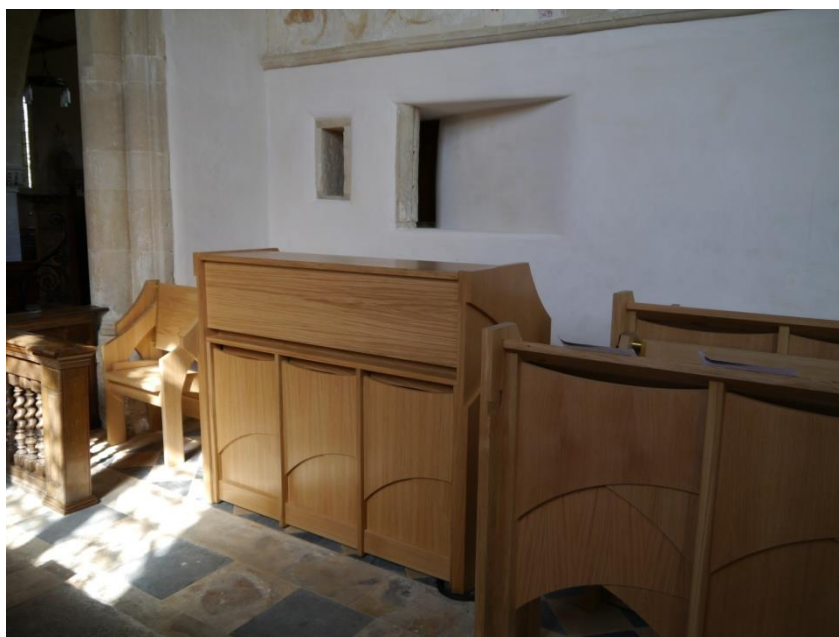
Figure 25: The medieval squints in the chancel's north wall.

The squint in the North Aisle of Chalgrove church has two points of view, a double view squint. Most squints have a view of the altar for the raising of the host. The St Mary's example allows a view of the General Resurrection wall painting in the south-west corner of the chancel as well. Double view squints are assessed as rare: another example is present at St Thomas a Becket Church, Lewes (Sussex), which is associated with a leper hospital¹⁰. This would have allowed people in the aisle and outside to see the mass. St John the Baptist, Doddington, Faversham (Kent) also has a double squint or hagioscope. There are only a few examples of double squints, and any survivals are of national importance and **exceptional significance** for evidential, historical, aesthetic and communal values.
