## Montague Tomb Bath Abbey Paint Analysis

### Report on Findings

Peter Meehan ACR

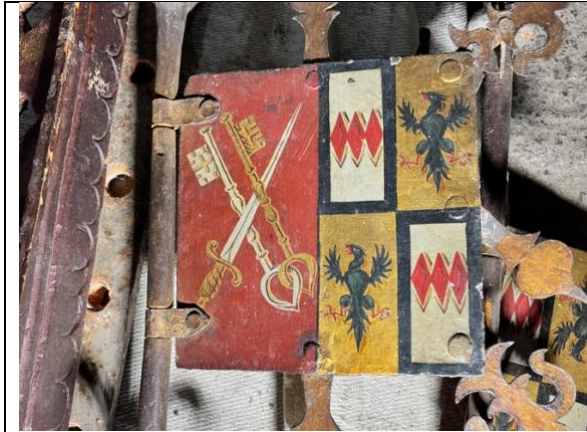
One of the flags displaying one of the family crests fixed to two corners of the tomb railings.

The paint finish to the post staff flags and plaques was not sampled for examination. This was because these appeared to be largely complete and would have been disfigured if a number of samples were taken. It is very likely that these have the original paint finishes applied as well. It is recommended that the paint finish to these be preserved through a process of conservation by carefully cleaning and consolidating them.

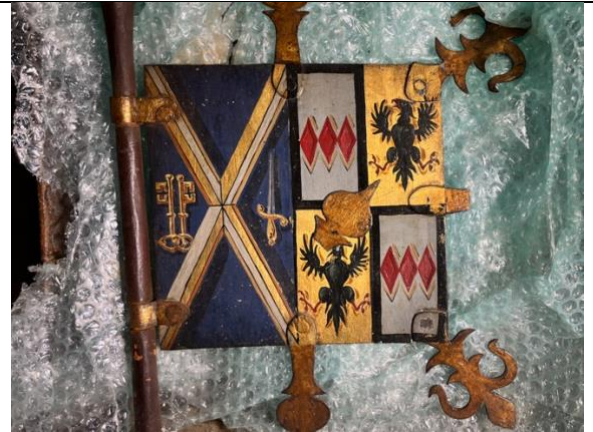
The other family crest painted onto the corner flags to the tomb railings.

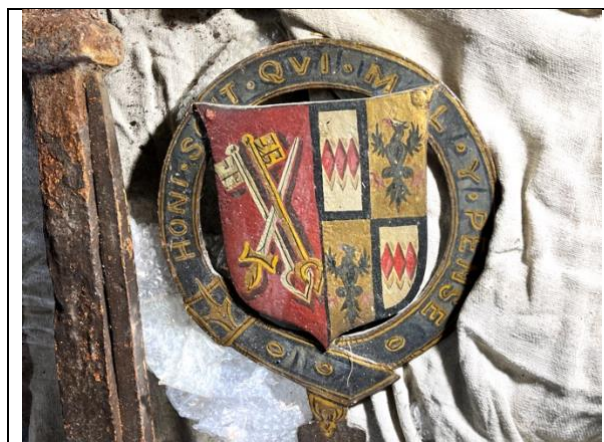
At the centre of each long side of railings is an additional post with a painted, circular plaque on top displaying the family crest set within a painted belt containing the words from the Order of the Garter.

One of the two circular plaques to the long side of the railings showing the family crest set with in the Order of the Garter.

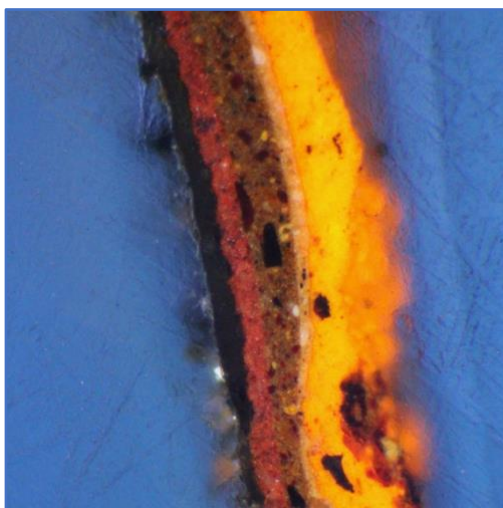
*Fig. 1: Typical paint sample cross section.*

The main purpose of the analysis was to see the extent of the number paint layers and the colour history. Examination revealed that nearly all the samples appeared to have the same sequence of paint layers and that the tomb railings appear to have only been painted once, with the possible exception of the gate panel. A typical cross-section can be seen below from a sample taken from the top rail:

On most samples the earliest paint layer is a forge paint, a thick black layer that would have been applied by the blacksmith after the railing parts had been forged. This is followed by a layer of red lead primer. There is a pink coloured intermediate coat followed by two layers of topcoat with the second one being a dark red colour. On a number of samples, a final 'black' layer is visible. This appears to be a resin varnish layer that would have been applied to give a gloss finish to the paintwork. We know this is a resin varnish layer as it can be seen to fluoresce under UV light. This varnish layer was not found on all of the samples and is probably because it has degraded over time.

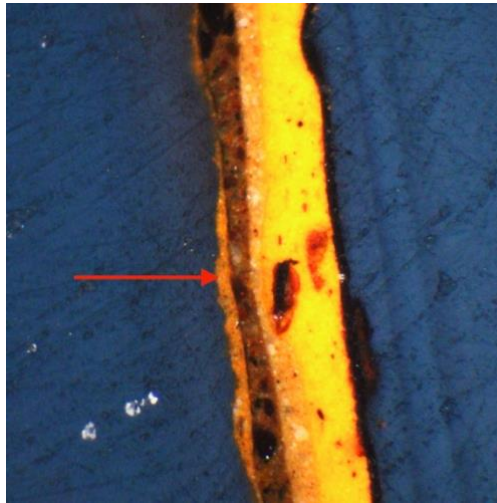
*Fig. 3: Additional yellow paint layer above the original dark red.*

The paint sample taken from the decorative 'C' section to one of the flag staffs had evidence for another paint layer on top of the dark red topcoat, a possible yellow layer. This was possibly a base coat for gilding but no evidence for this was found.
