Archaeological Observation

**Church of St Michael and All Angels
Eaton Bishop
Herefordshire**

Eaton Bishop Parochial Church Council

September 2024

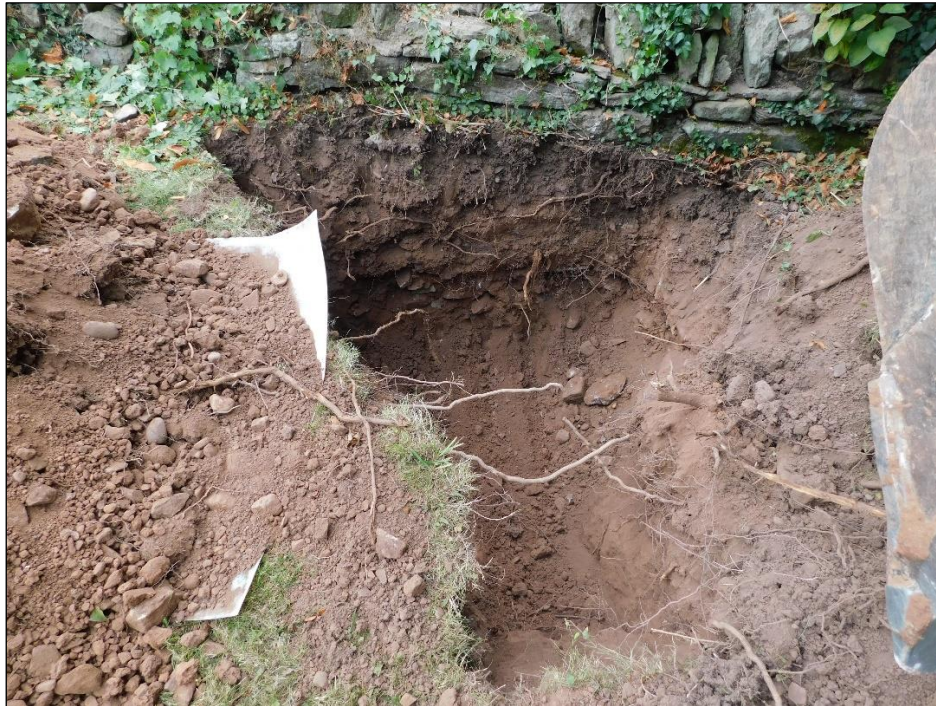
The pit for the connection, adjacent to the churchyard wall measured 1.80m E/W and c. 1m wide. It was excavated to a depth of 1.38mbgl (*Plate 1*).

A single deposit was present throughout, a red-brown silt clay with frequent rounded and subrounded stones, none of which showed evidence for having been worked. Pottery dating to the late 18th to 19th century and bottle glass were recovered from this deposit, together with scraps of brick. Very occasional fragments of disarticulated human bone were also present. These were retained for reburial during backfilling upon completion of works. Despite some evidence for human remains, no grave cuts were seen.

Plate 1: Pit adjacent to churchyard wall: view S

Although the pit, at 1.38mbgl deep, encountered some disarticulated remains and lay close to a number of headstones (*Plate 1*), the presence of post-medieval glass and late 18th or 19th century pottery suggested that the area had been disturbed. This may have been associated with maintenance of the wall. Additionally, the position at the limit of the burial ground may have meant that burial was less intense than in positions closer to the church.

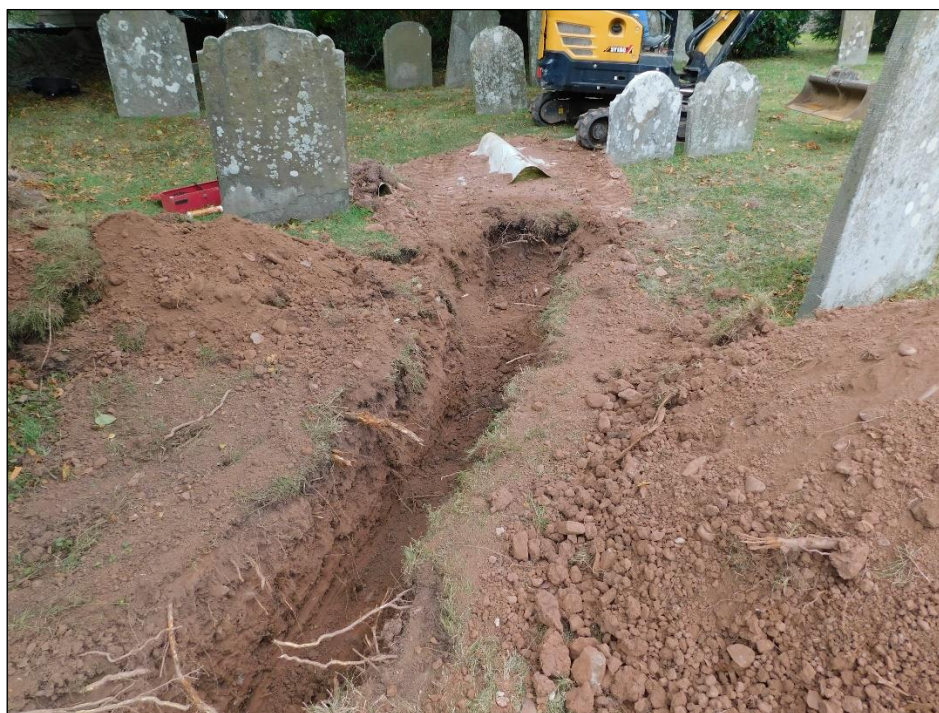
The trench to connect the pit to the existing service run measured 0.60m wide and was excavated to a depth of 0.60mbgl. It was aligned NE/SW and measured 4.60m in length (*Plate 2*). No finds or features of archaeological

significance were present and no human remains were encountered, possibly a result of the shallow depth of the excavation.

Plate 2: Trench connecting pit to the existing drain run: view NE

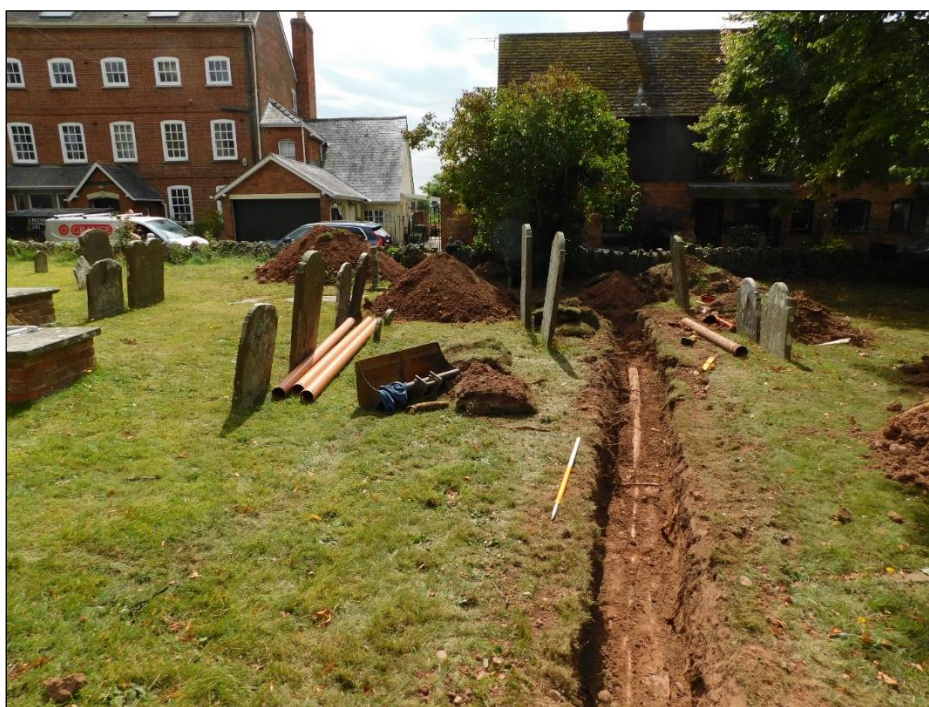
Further work involved re-excavation of the existing drain a distance of c. 9m. The trench was aligned N/S and was 0.60m wide. Upon excavation it became apparent that the pipe, encountered at a depth of about 0.45mbgl overlay water and gas services. The only finds present in the trench were the remains of salt-glazed drainpipe, suggesting the presence of previous drains or services.

Plate 3: Route of existing drain: view S

The depth of 0.45-0.60mbgl attained by the service trenches may have been too shallow to reach any burials that may have been present. The existing drain run appeared to have been in use for some time, with fragments of broken salt-glazed pipe present in the backfill.
