All Saints Trull (Taunton)

Statement of Significance

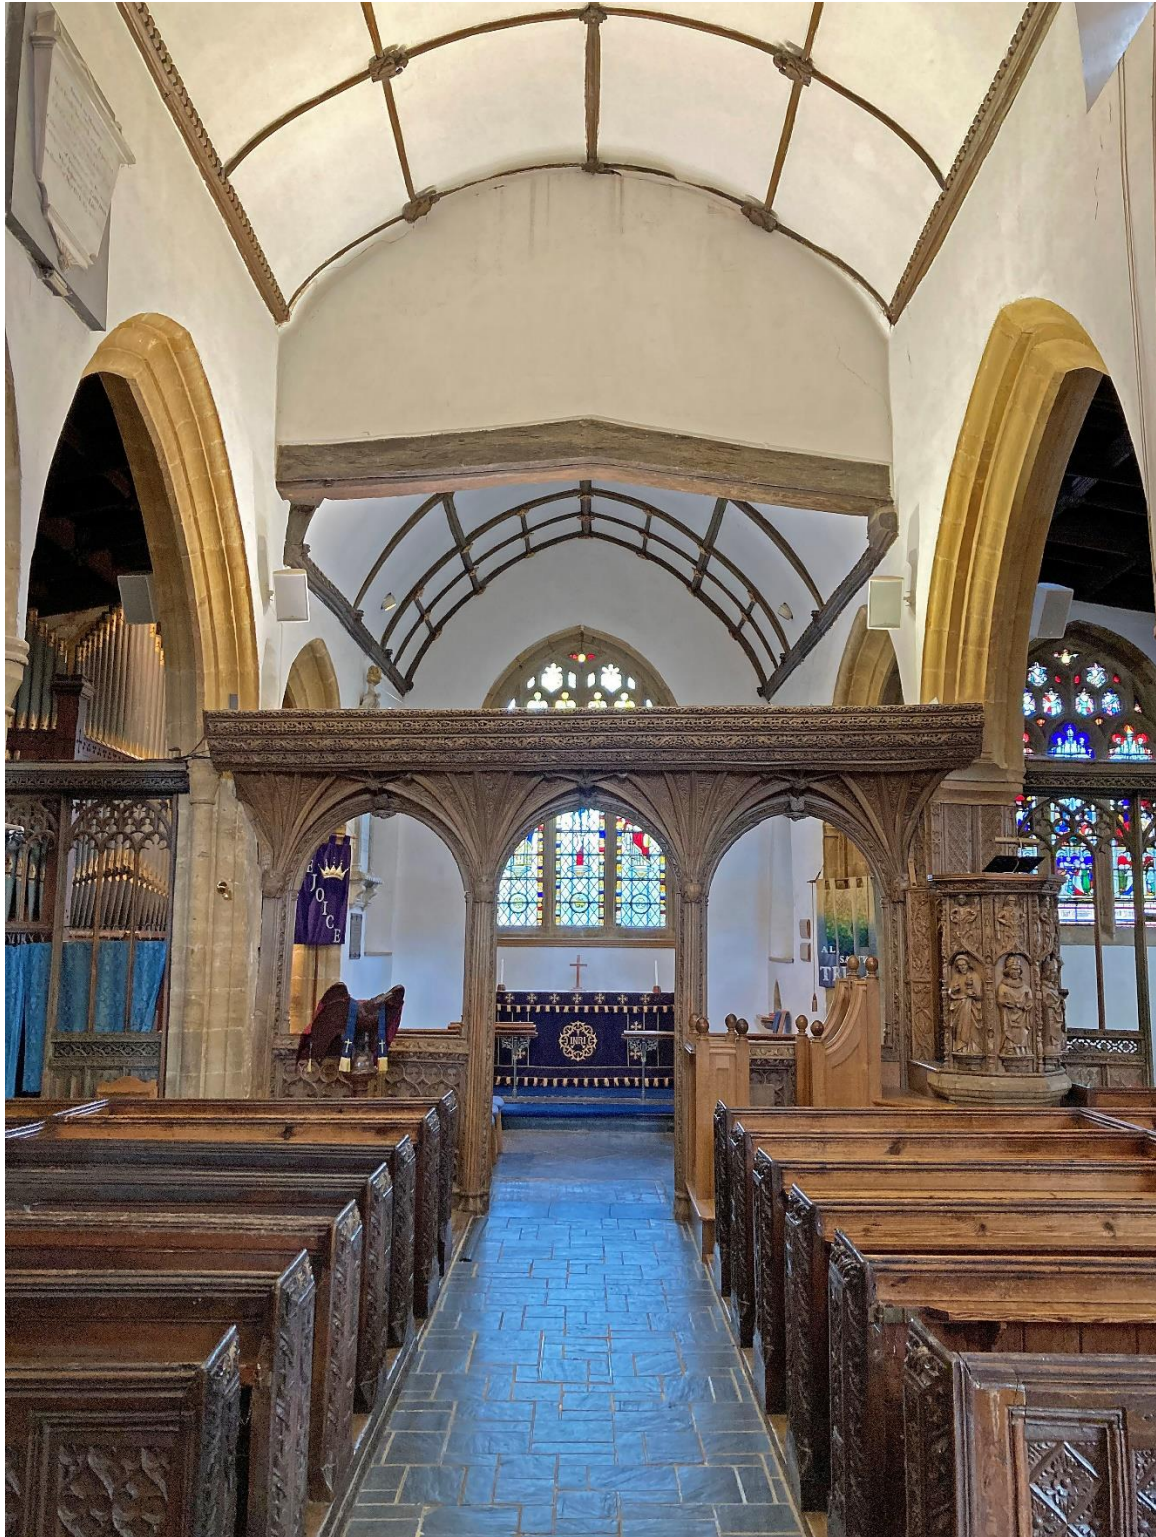
Nave (east end), Rood Screens, Pulpit & Chancel

The elaborate wooden pulpit retains undamaged figures of saints in the principal panels (St James the Evangelist and the four great doctors of the western church, SS Gregory, Augustine of Hippo, Jerome and Ambrose) that most authorities consider to be integral. Smaller angels support the canopies and have been defaced (some repaired with lead faces). The main figures may be dated on stylistic grounds to the first quarter of the C16 and, if in situ, must have been removed for safekeeping at the time of the Reformation. The pulpit is generally regarded as one of the most important in the country.

There are five screens in all. The rood screen, to nave only, has lost its mullions and open-work tracery but the traceried dado, the ribbed coving and richly carved cornice survive. The original rood screen never extended across the entire width of the church (as is normally the case). Access to it must have been via a ladder. The aisle and parclose screens are very similar in character with linenfold dados that retain much of their colour. They are likely to date from c1525 (the date of the death of Thomas Keene who is commemorated in an inscription). The linenfold to the north chapel parclose is (as Pevsner pointed out) more finely laid than the others. The remains of a timber tympanum above the former rood, an exceptionally rare feature, are c1500-60. A moulded beam above the rood screen would have helped support the rood figures and may have supported a representation of the Day of Judgement.

i) The pulpit is regarded as one of the most important in the country and possibly dates to C16. It may have been hidden during the reformation.

ii) Parts of the rood screen are of particular significance. The linenfold to the north chapel parclose is more finely laid than the others. The remains of a timber tympanum above the former rood, is an exceptionally rare feature.

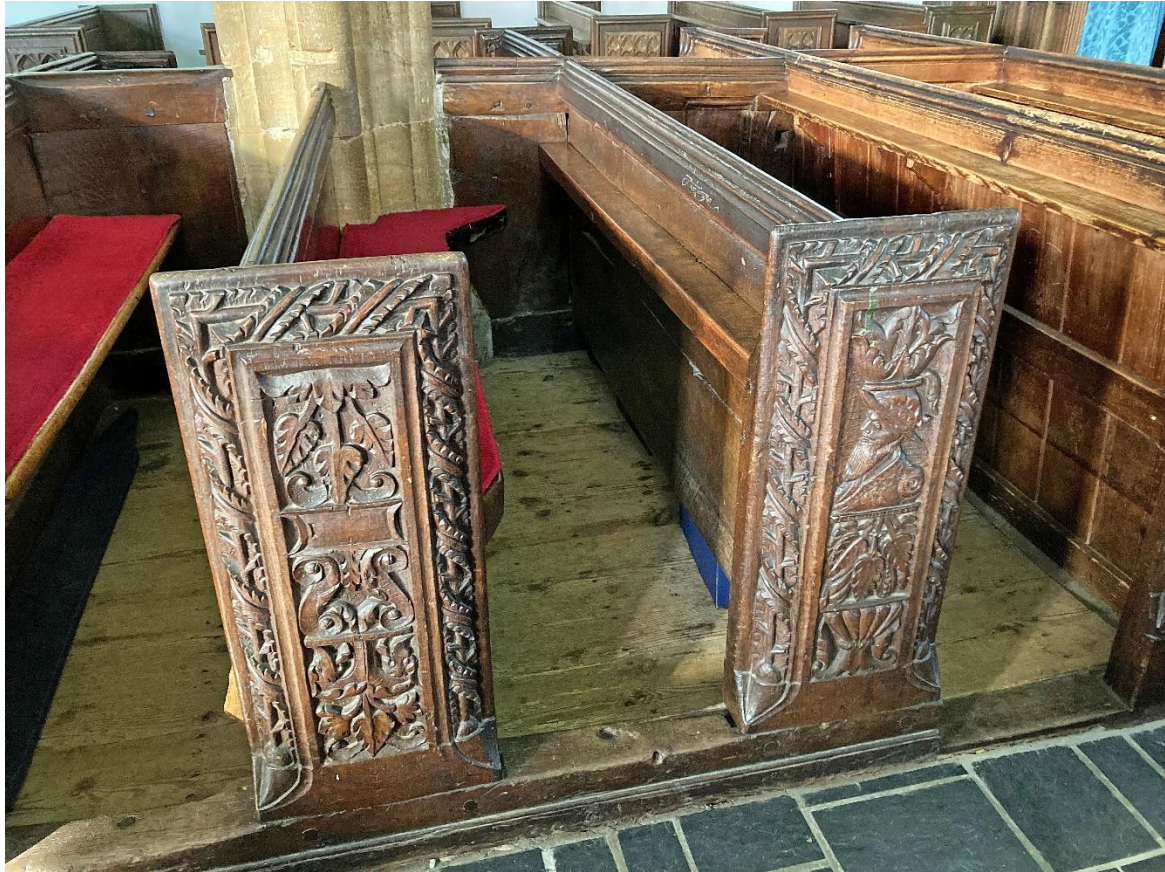
Bench Ends

The richly carved bench ends are considered to be among the most important in Somerset. They display a range of patterns including some renaissance motifs such as vases and head profiles that suggest a date of c1530-40 (although a group with linenfold at the west end are later, dated 1560, and bear the names of the carver (Simon Warman) and parish clerk (John Waye). A number of bench ends, not now in their original sequence, illustrates individuals taking part in a procession (a cross bearer, a torch bearer, a man in orders holding a reliquary or chrismatory, another man in orders

dressed in a surplice possibly a deacon, and a parson). The importance of this group has long been recognised but there are two schools of thought as to its meaning. One considers the figures to be a straight-forward representation of a church ceremonial. The other considers them to be a caricature rather than naïve work that ridicules pre-Reformation ritual. The key to interpreting the group is one of dating: the costumes could be Elizabethan when the use of holy water (not represented in the scenes) had been given up: this, if correct, would favour caricature.

Some of the benches are complete and in situ. McDermott's careful research has identified which these are (reference is given on RE11; the detailed seating plan is at p.126). They are situated to the west of the nave and both aisles and to the block situated between the nave and north aisle forward of the cross passage. Other areas are composed of C16 bench ends attached to 1863 benches and benches that are entirely of that later date. This plan and its supporting text is the key document in understanding the sequence and relative importance of the Trull benches. In situ benches of this date are rare. While the C19 benches are of less intrinsic interest, the fact that they were installed to complement the originals as part of a concerted plan to recreate a medieval interior gives them particular significance in this context.

iii) The bench ends of some of pews are dated C1530-40 and are considered some of the most important in Somerset.

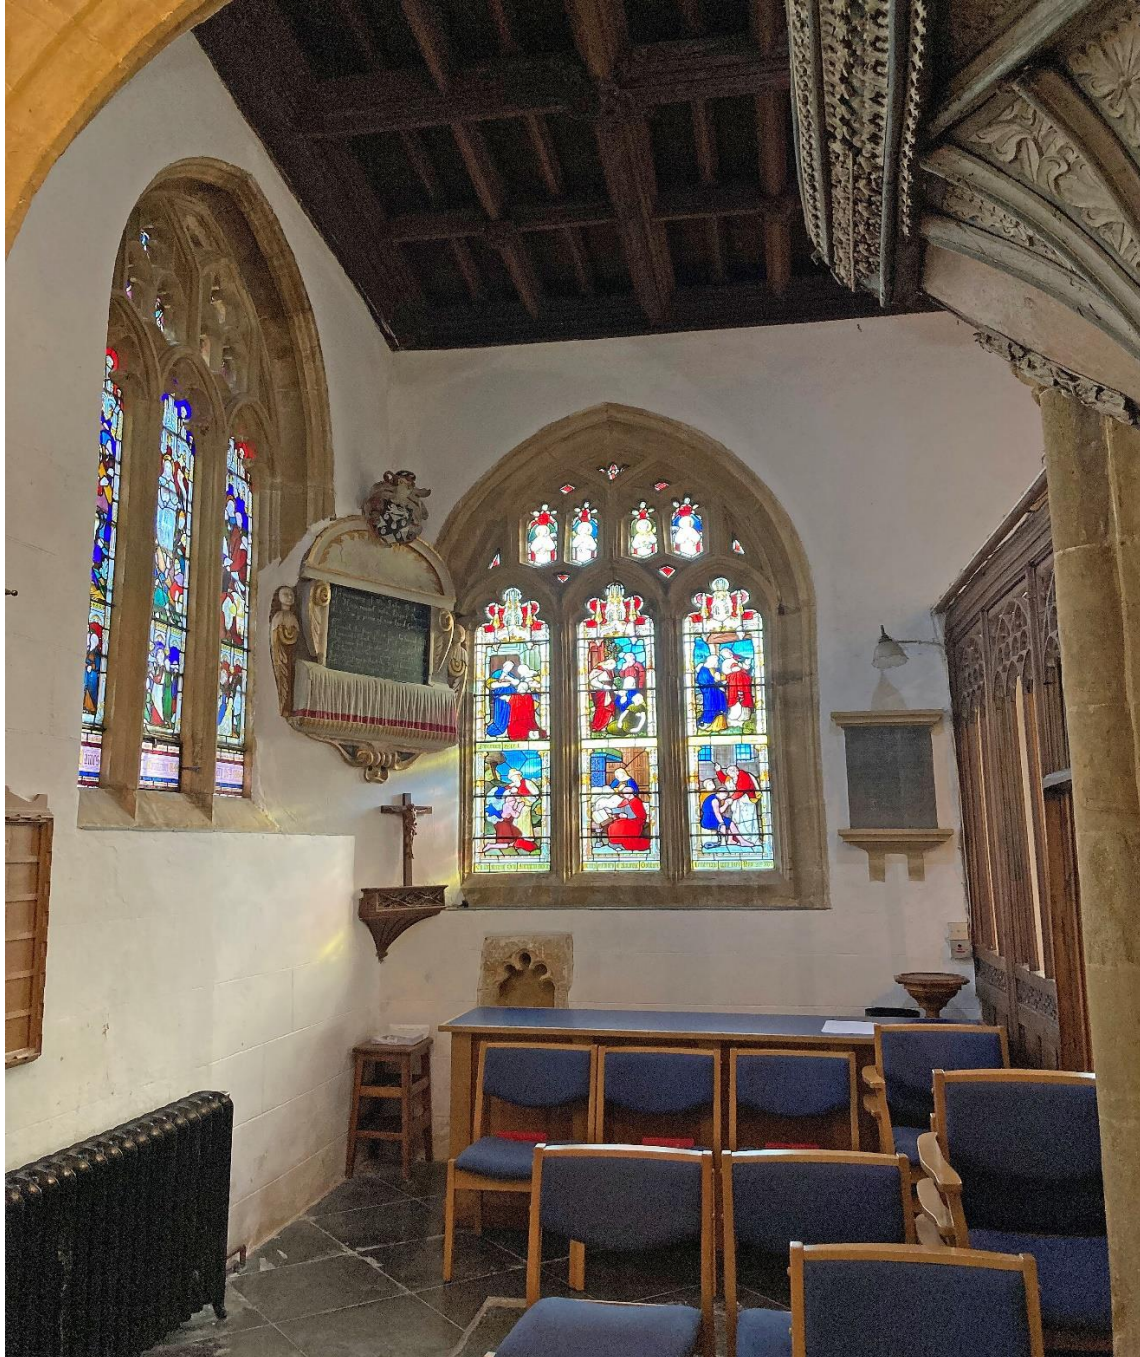
South Chancel Chapel

MONUMENTS: There are two noteworthy monuments: one (south cancel chapel) a painted alabaster tablet set in the angle between south and east walls under a pediment and flanked by terms (half figures) with a naïve representation of an altar table covered with drapery (to John Baker, d. 1677); the other a marble aedicule (a tablet flanked with pilasters with both moulded base and pediment) with an armorial achievement to Robert Lucas (d.1722). There are also some C18 and early C19 wall tablets including one to Lt Col David Smith (d.1818) by the Taunton firm of Long.

v) Monuments: two are noteworthy, in the south chancel chapel to John Baker d 1677. Another to Robert Lucas d 1722.

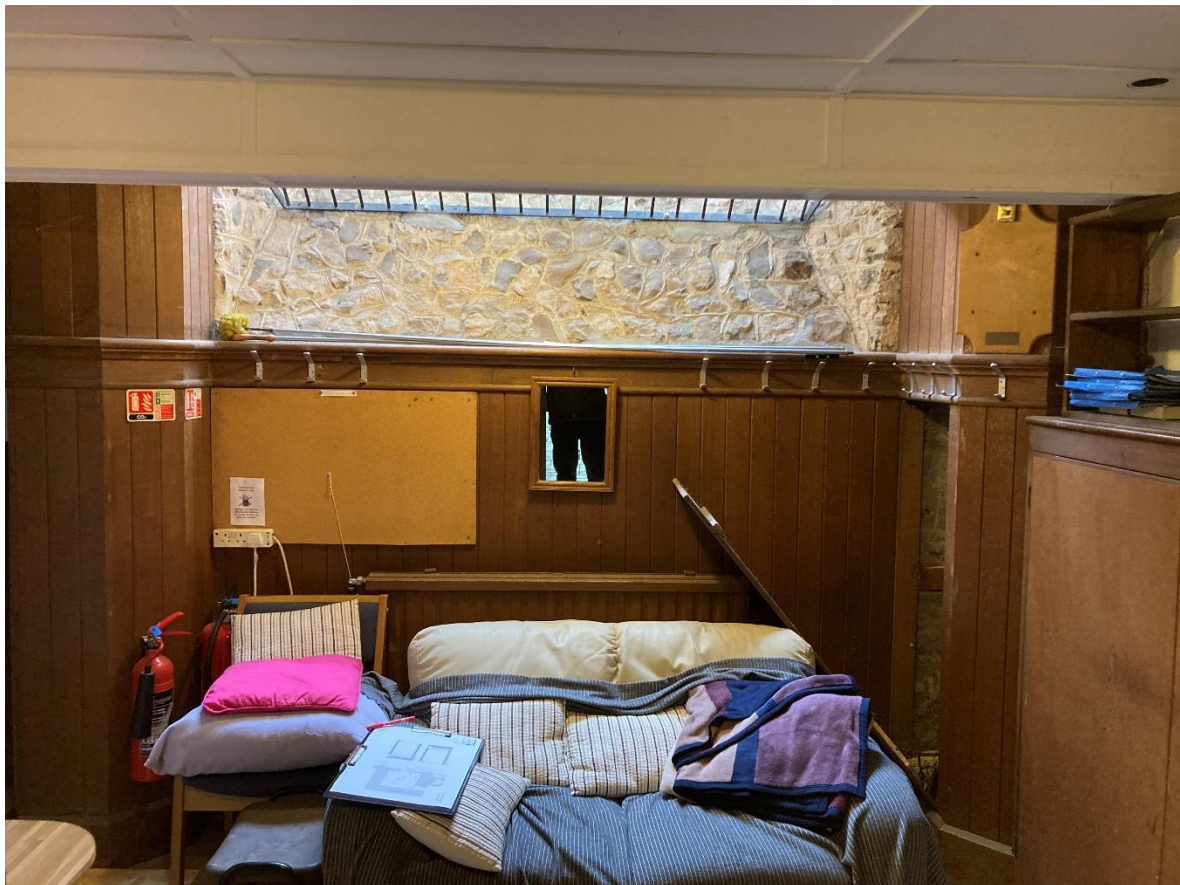
THE CHOIR VESTRY: The existing space in the tower base is largely unremarkable dating largely from 1890. The parquet flooring (currently covered over) would simply be roved as part of this proposal and replaced with a blue Lias paved floor, matching that in the chancel and south chapel, which will serve as a more practical surface in the proposed WC. The floor has to be lowered in order to form a level DDA compliant access from the Nave.

The Wainscot boarding and clock weight enclosures (Now redundant) date from 1904. The oak joinery is simple in design but of good quality. The clock weight enclosures are also a feature in the southwest and northwest corners of the ringing balcony directly above. The creation of a DDA compliant WC in the Choir Vestry requires them to be removed. The proposal would see the wainscot and boarding re-purposed within the reduced Choir Vestry/Family Room. The wainscot fitted in its entirety against the south wall to protect the plastered finishes behind the sofa. The clock weight enclosure boarding will be used to form the frontage of a new Altar Frontal Cabinet as a 'mirror' of the wainscot on the north wall.

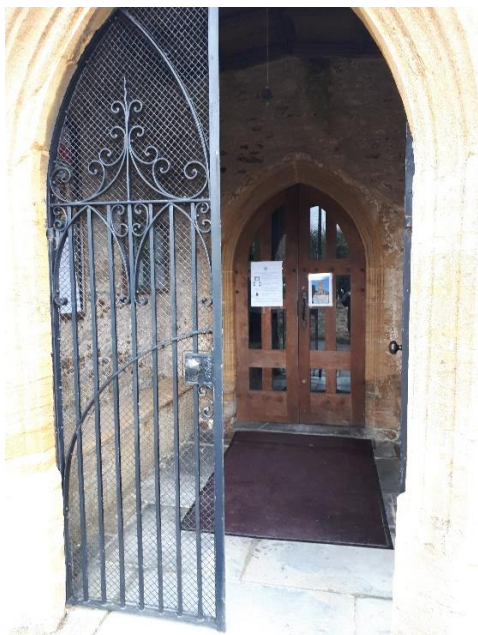
South Porch

SOUTH PORCH: The south porch doesn't feature in the listing description but likely dates from the 1863 re-ordering. The internal stone walls feature a mixture of flush and ribbon pointing and there are remnants of an earlier decorative finish. The stone benches to either side are ashlar Ham Hill stone and plain fronted. Five rows of large format Lias slabs form the floor and are most likely original. A 40-50mm shallow step up at the south door has necessitated a temporary timber ramp be installed to help improve access to the church.

The proposal would see the removal of all pointing and the walls re-pointed with new flush lime mortar. The walls will then be decorated with limewash to match the interior of the church leaving the ashlar Ham Hill stone unpainted.

It is also proposed to carefully lift the 3 rows of Lias paving nearest to the south door and re-lay these to a constant fall, flush with the door threshold to create a permanent ramp within the porch. This work would retain all historic fabric and have little impact on the significance of the south porch and represent a significant improvement to the current access arrangements.
