**CHURCH OF ST. MARY, ALDRIDGE, WALSALL  
ARCHAEOLOGICAL WATCHING BRIEF 2025**

PLANNING REFERENCE: 24/0280

Project 24/07

## ARCHAEOLOGICAL WATCHING BRIEF 2025

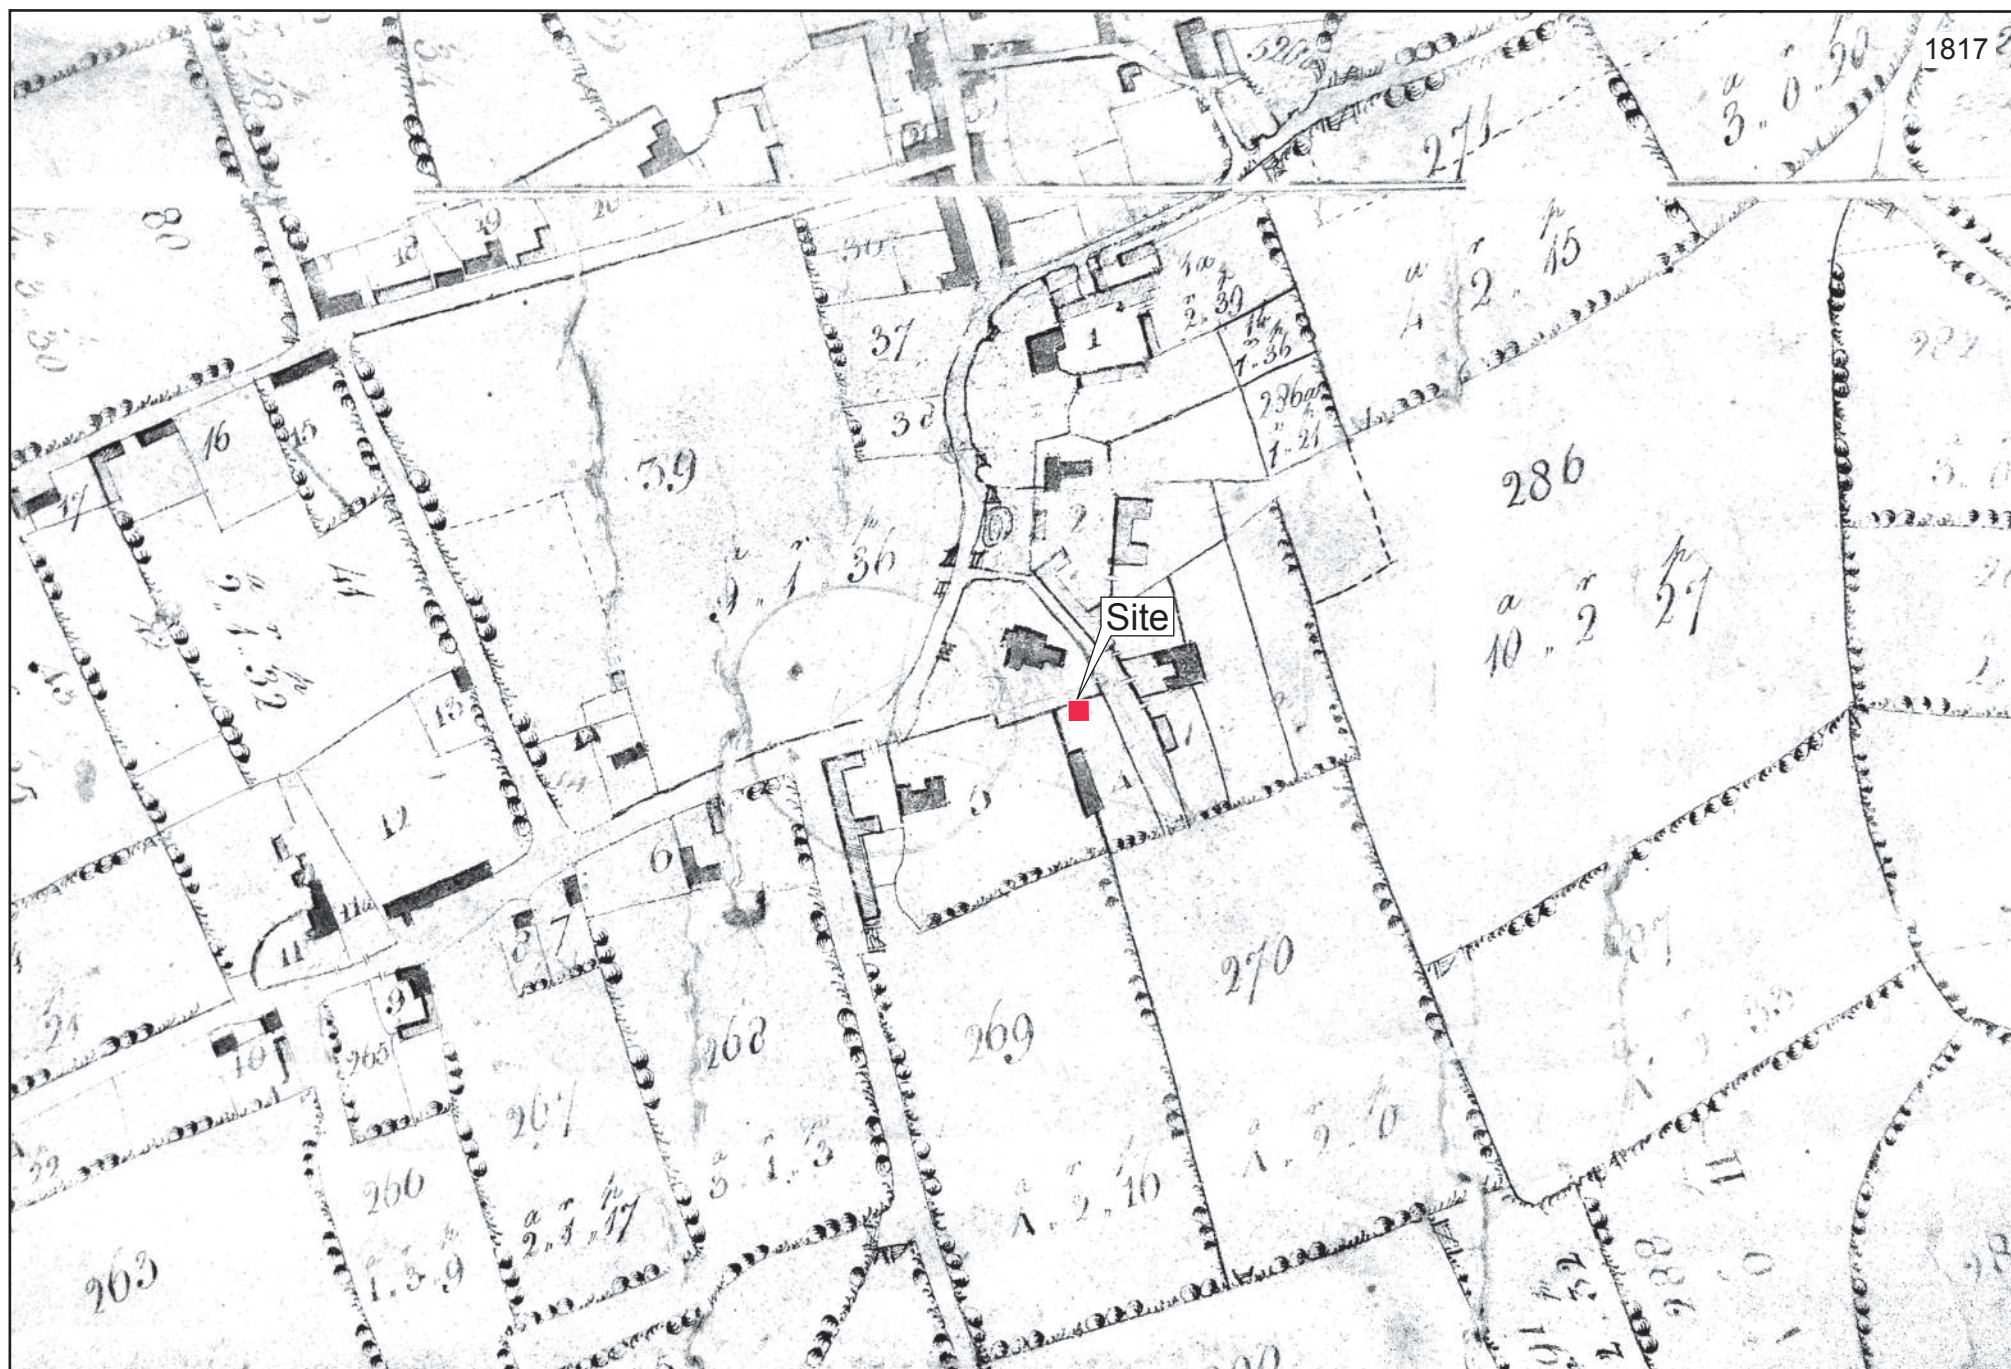
Fig.4

- 3.3.1 The earliest available detailed map of Aldridge is dated 1817 (Fig. 4). It shows The Green to the north of the churchyard, and a length of a road, now Little Aston Road, to the south of the churchyard. A further road mapped on a north-south alignment is approximately respected by modern Erdington Road, to the south of the churchyard. A number of buildings are mapped along the road frontages towards the historic core of Aldridge. Most notably the church is mapped within a roughly D-shaped churchyard. The footprint of the church suggests it has been extended on at least three sides. The mapped orientation of the church is incorrect; it is shown with a long axis aligned southwest-northeast, whilst it is orientated east-west following standard practice. The eastern boundary of the churchyard in the early 19th century was stepped, the boundary extending uninterrupted from The Green to Little Aston Road. To the east of the churchyard are two plots of land, each containing a building. The building in the southern plot is H-shaped in plan. The northern plot contains a long rectangular building which adjoins the boundary dividing these two plots. To the north of The Green is a U-shaped structure, The Rectory, and an adjoining rectangular structure, probably a barn or other outbuilding on the frontage. To the rear of the plots adjoining the road frontages are several mostly rectangular fields, presumably either in arable cultivation or pasture.

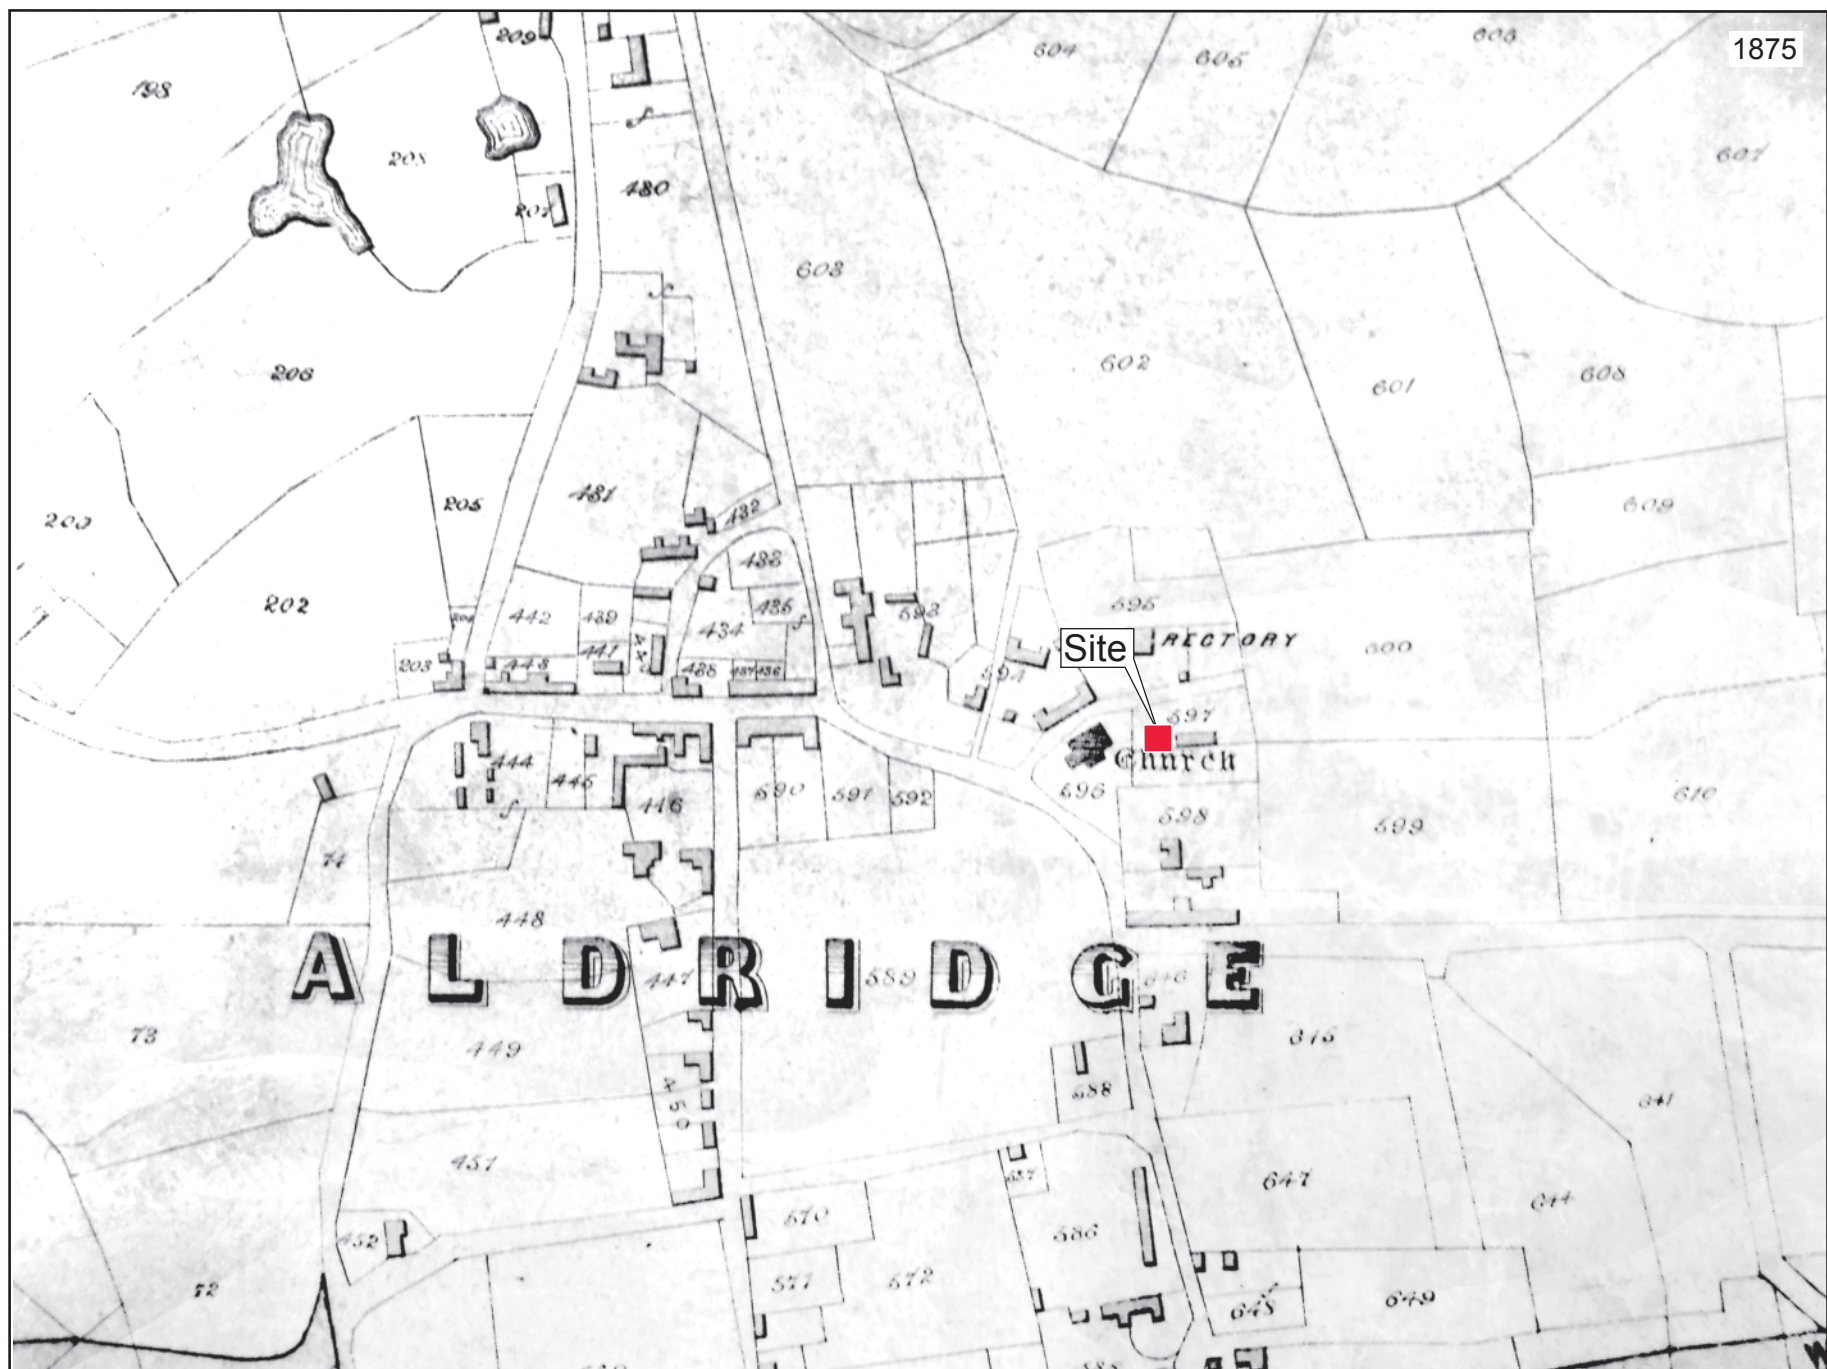
Fig.5

- 3.3.2 The Aldridge tithe map of 1875 (Fig. 5) illustrates the church on its correct alignment, roughly parallel with The Green. Although detail on this map is in places indistinct, the churchyard appears to retain its D-shaped outline, as mapped in 1817. The eastern churchyard is stepped, continuing the arrangement mapped in 1817. This suggests the map was based on an earlier survey, since the churchyard was extended to the east in

1873, unless the dividing wall was retained temporarily. To the east of the churchyard two plots are shown, the northern containing a single long, rectangular building. The southern plot includes a long terrace adjoining the Little Aston Road frontage, and two further building to the rear. To the north of The Green a Rectory building is named. Compared to the earlier 19th century map, the tithe map illustrates a number of new dwellings concentrated to the west of the church. In contrast, to the east, and north of the church little development has taken place, and the landscape is divided into roughly rectangular fields by enclosure.

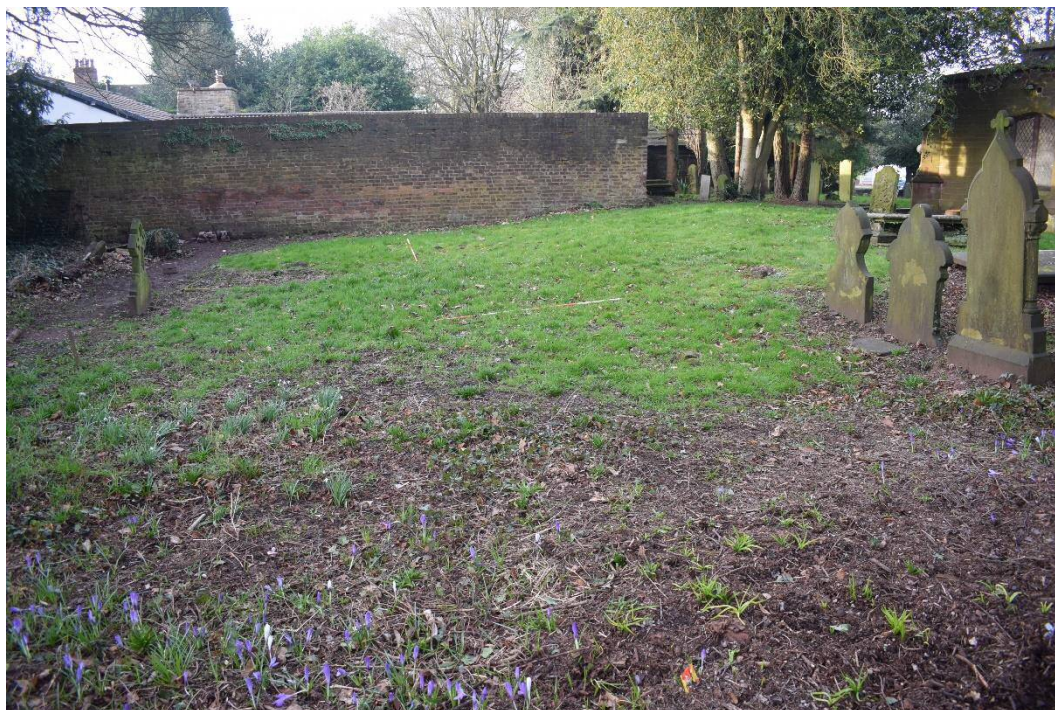
- 6.1.2 Prior to the groundworks the area of the Garden of Remembrance was laid to lawn (Plates A and C). Ground level sloped gently downwards from west to east (Plate A), reflecting the raising of the ground surface within the historic churchyard, as a result of the insertion of numerous burials.

Plate A: Eastern area of churchyard prior to excavation, view: south

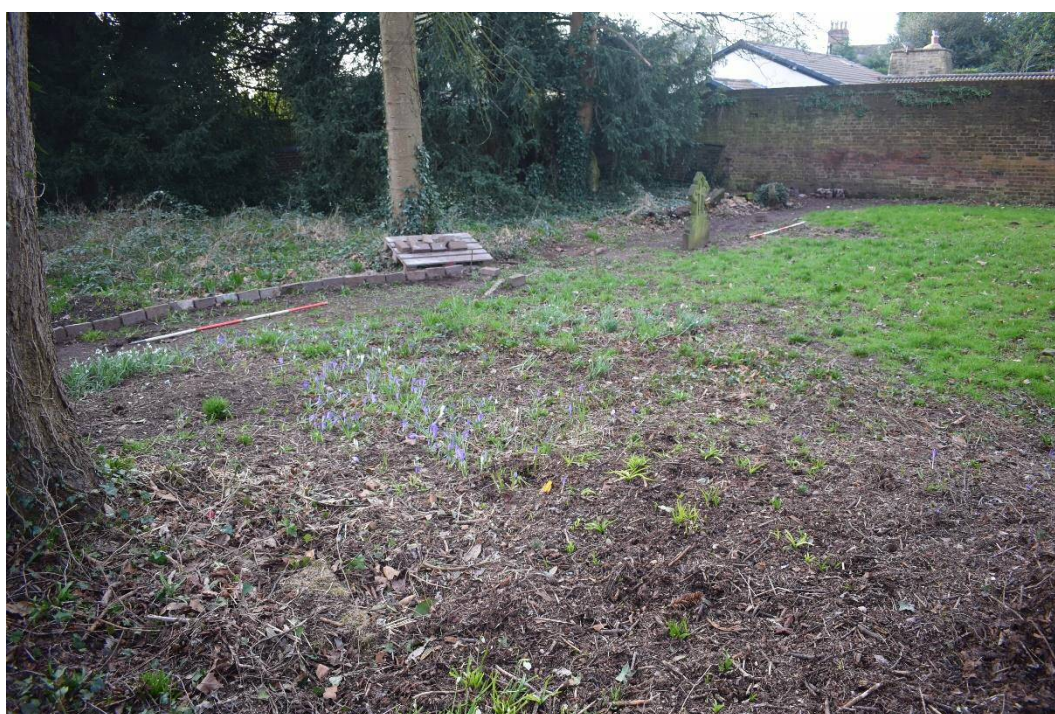
- 6.1.1 Archaeological observation and recording was confined to the Garden of Remembrance, since no ground reduction was undertaken for the new path (Plate B).

Plate B: Area of new path, view: southeast

- 5.1.1 Excavation was undertaken by mini-digger equipped with a ditching bucket, working under continuous archaeological supervision (watching brief). The northern limit of the Garden of Remembrance was slightly reduced, to avoid disturbance to upstanding monuments. Figs 2-3 show the proposed extent of the garden, and Fig. 7 shows the actual extent of excavation for the garden.
- 5.1.2 No excavation was required for the new path (Plate B), which involved slightly raising the existing ground level, to provide level access from The Green.

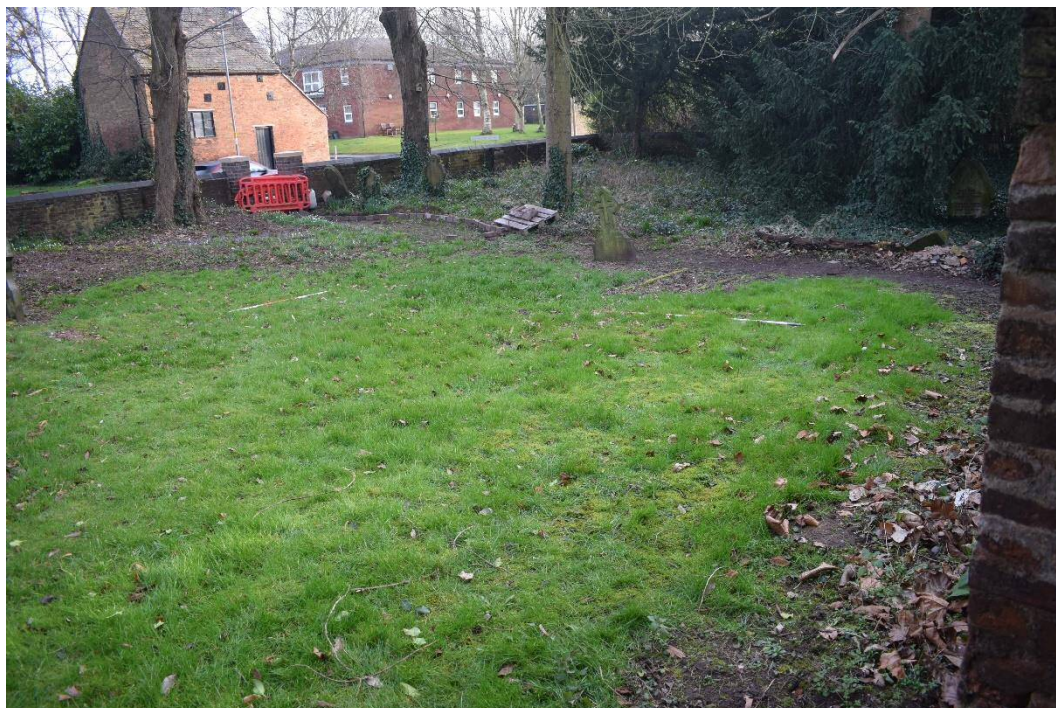
Plate C: Garden of Remembrance area prior to excavation, view: northeast

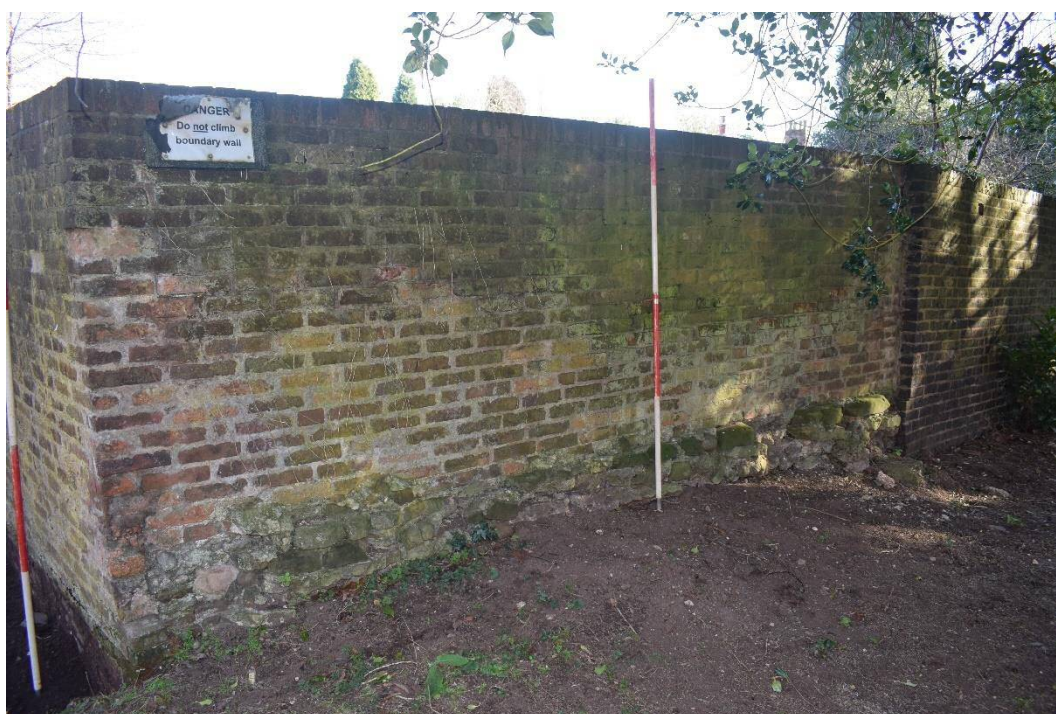
- 6.1.3 The northernmost surviving section of the north-south aligned eastern wall of the churchyard comprised handmade bricks over a rubble foundation (Plate D). The latter may represent an earlier, possibly late medieval or early post-medieval build. The northern end of this limestone rubble wall was demolished sometime after 1873 when the churchyard was extended eastwards, leaving only its foundations, which were identified in Trench 2 (Lockett 2011). The above-ground element of the east-west churchyard wall was constructed entirely of handmade bricks (Plate E).

Plate D: Churchyard wall with rubble foundation, view: east

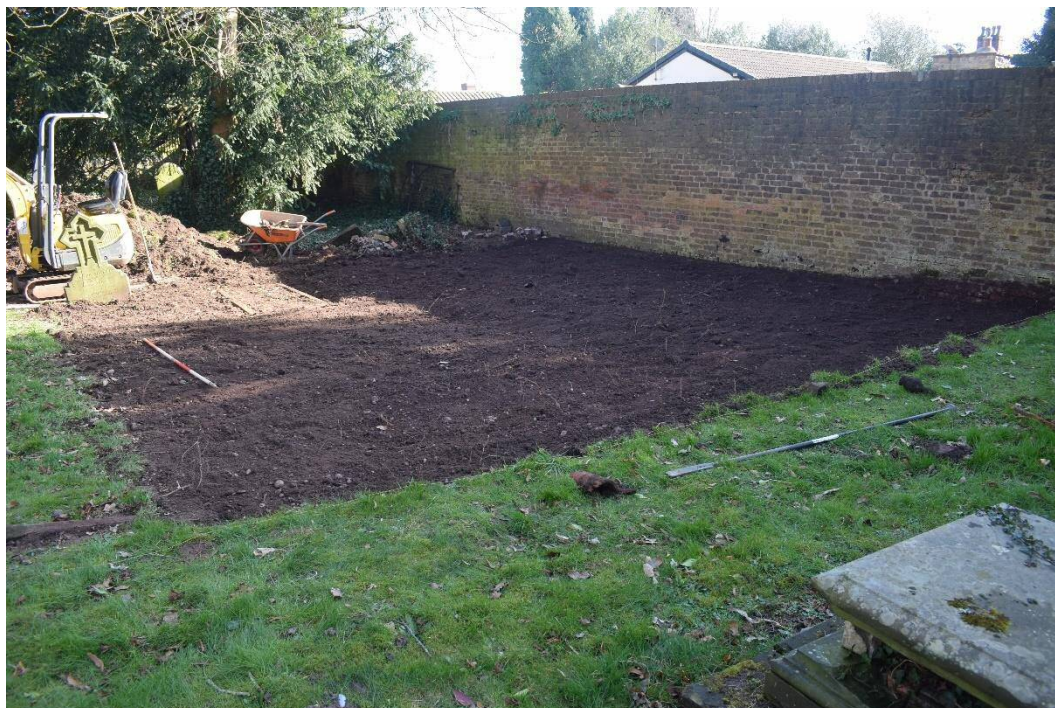
- 6.1.4 The natural subsoil was not encountered. Machining exposed horizons of very dark brown-grey clay-silt-sand topsoil (**100**, Plates E-F), which was mixed in places with brick rubble. Foundation trenches (Plates G-H) 0.15m wide and 0.1m deep were cut into the topsoil to retain railway sleepers which defined the western and northern edges of the Garden of Remembrance. The maximum depth of machine excavation through topsoil was an average of 0.2m below the modern ground surface.

Plate E: Garden of Remembrance after machine excavation, view: east

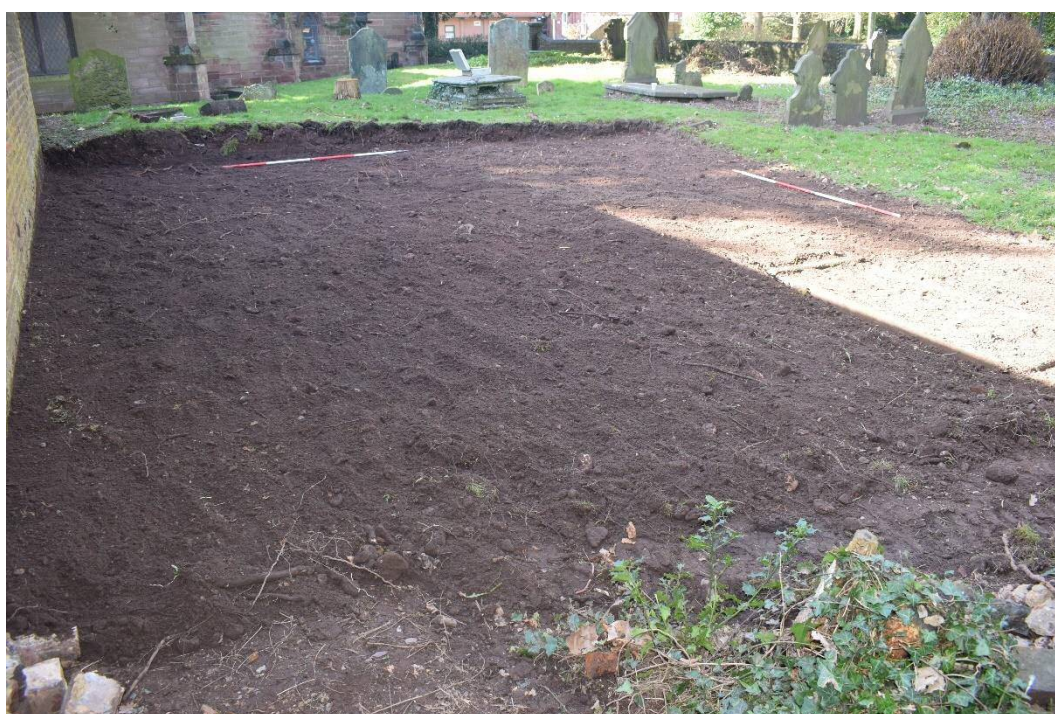
Plate F: Garden of Remembrance after machine excavation, view: west

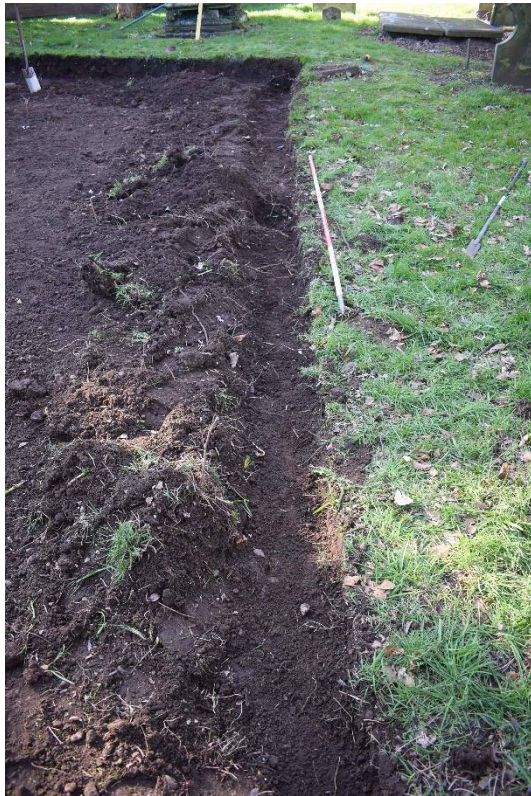
Plate G: Trench along northern edge of GOR, view: west

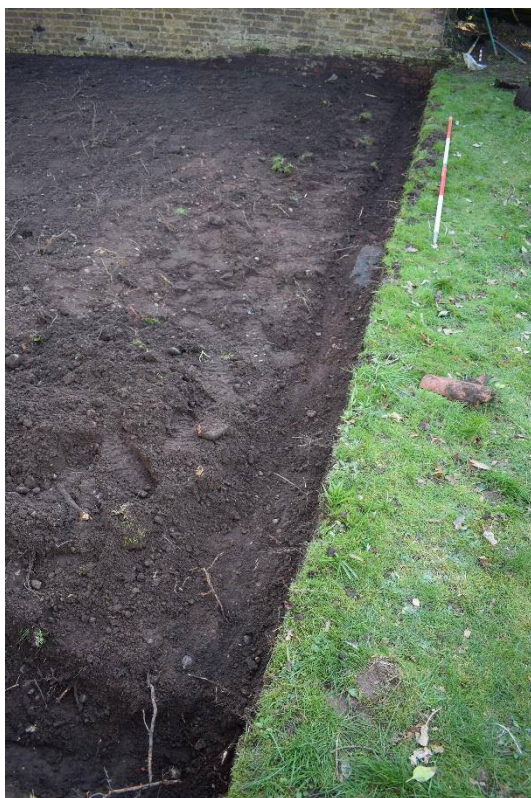
Plate H: Trench along western edge of GOR, view: north

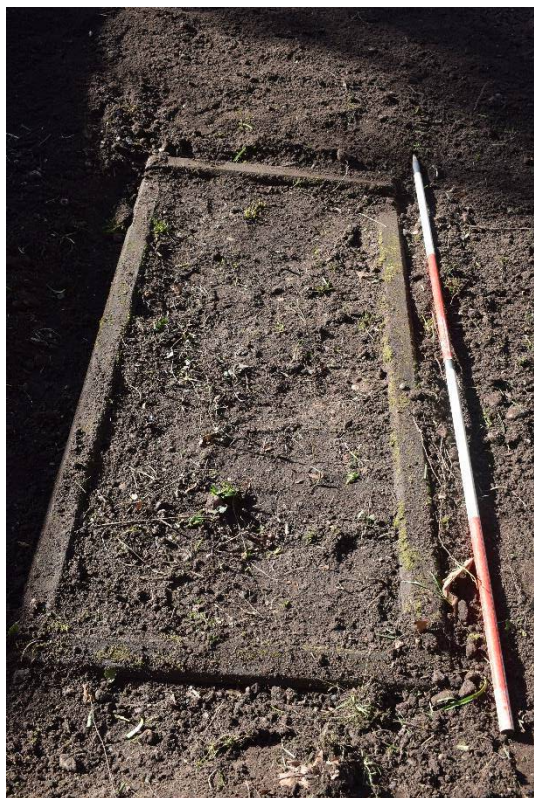
- 6.1.5 Two monuments were identified within the Garden of Remembrance. One was upright (**101**), the second was a flat monument (**102**), defined by stone edging (Plate I). Both were retained intact and *in situ* during the groundworks. The eastern edge of a possible flat sandstone monument (**103**) was also recorded along the western edge of the garden. This was also retained intact and *in situ*.

Plate I: Grave memorial in west of GOR, view: west

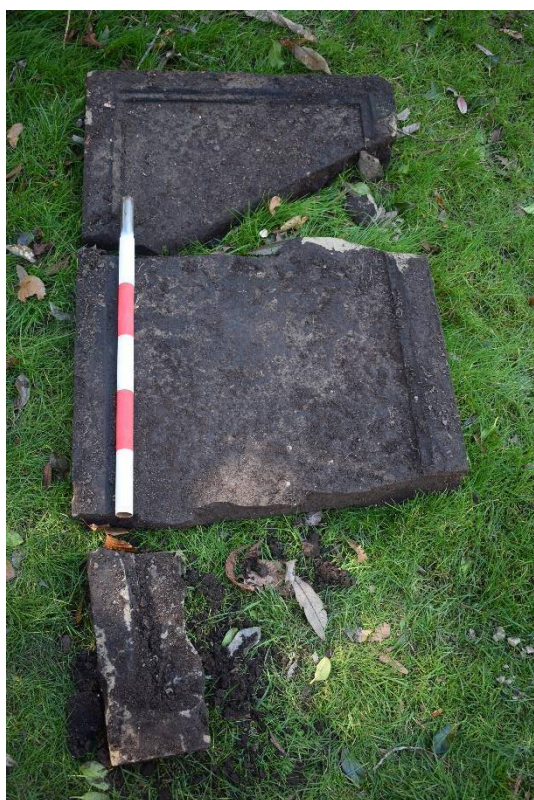
- 6.2.1 The notable finds from the excavation of topsoil comprised fragments of an uninscribed memorial stone (Plate J), and an architectural fragment (Plate K), presumably removed from the church during refurbishment or rebuilding. Both were retained on site.

Plate J: Uninscribed headstone

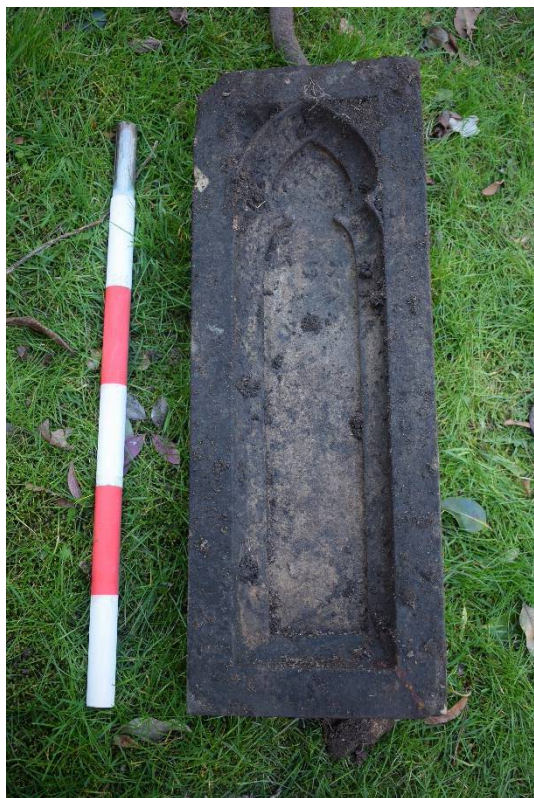
Plate K: Decorated architectural fragment.
