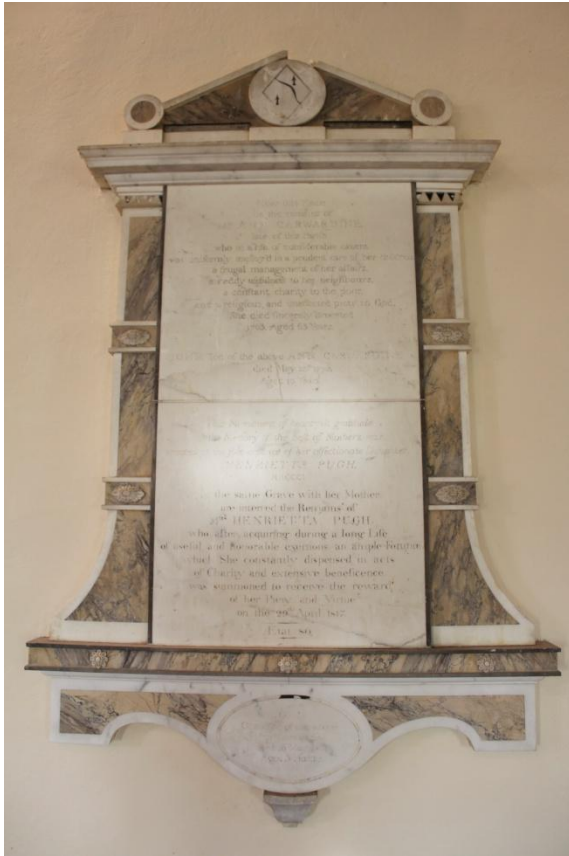
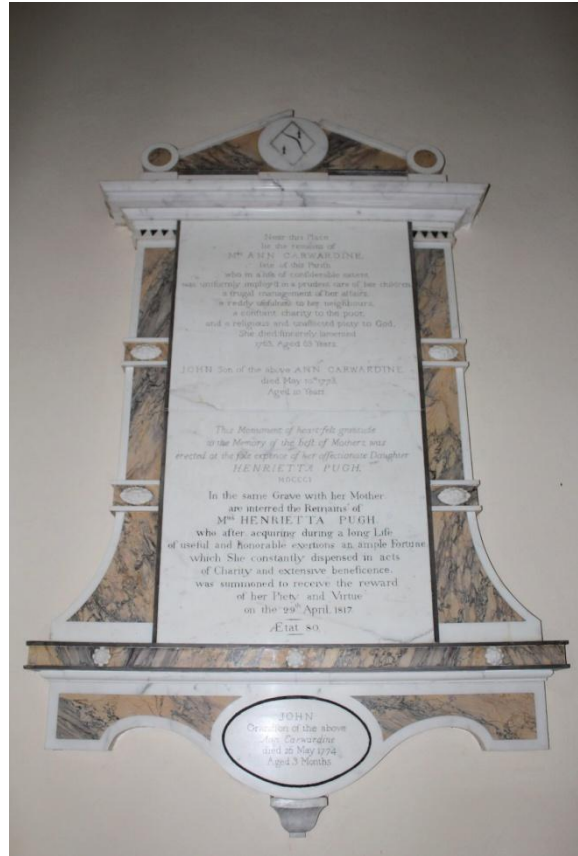
The Pugh Monument before and after conservation. On the left - the monument was lightly soiled with black airborne particulates attributable to candle burning over many decades. The in-painting to the *scratched* not carved inscriptions, was re-applied using reversible acrylic paint, after detailed cleaning to ensure a grease-free surface. The elliptical detail around the lowest dedication was also painted, the small amount of sound, residual bituminous material was left and not replaced like-for-like as it would have involved applying a hot, noxious material, that doesn't last all that long in conservation terms, due to its instability and brittle eventually nature.

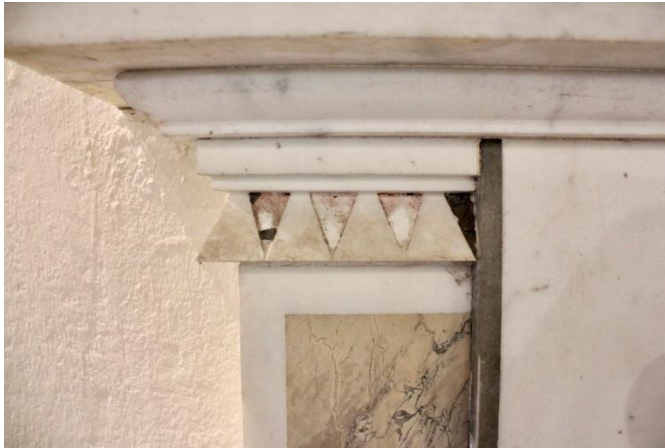
The upper, left-hand, inlaid triglyphs were also bituminous, but still well held by the substrate. The missing areas were also painted in reversible, conservation-grade acrylic paint.

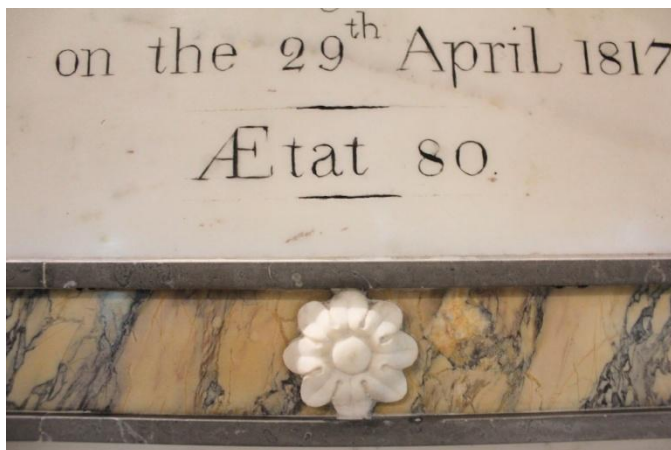
The ochre coloured, marble inlays have suffered dramatic *chromatic alteration* or loss of original surface polish. These areas were re-polished as far as possible using an abrasive softer than the host stone and treated with 2 layers of conservation-grade wax - to protect them from poor ambient conditions within the building, due to sporadic heating.

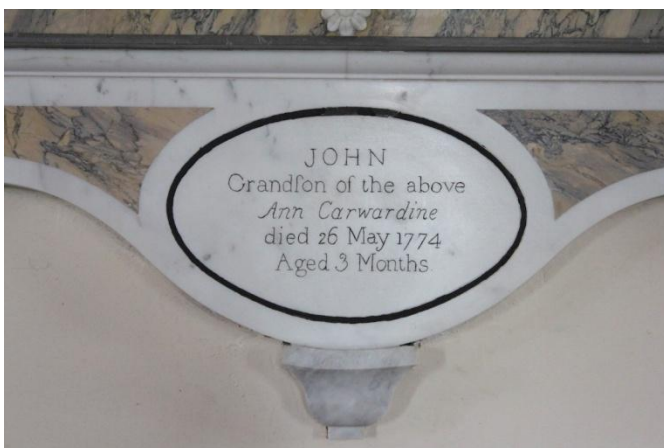
The lower dedication once again legible after being in-painted with conservation-grade paint and not bitumen, which would have been polished to the same plane as the marble.

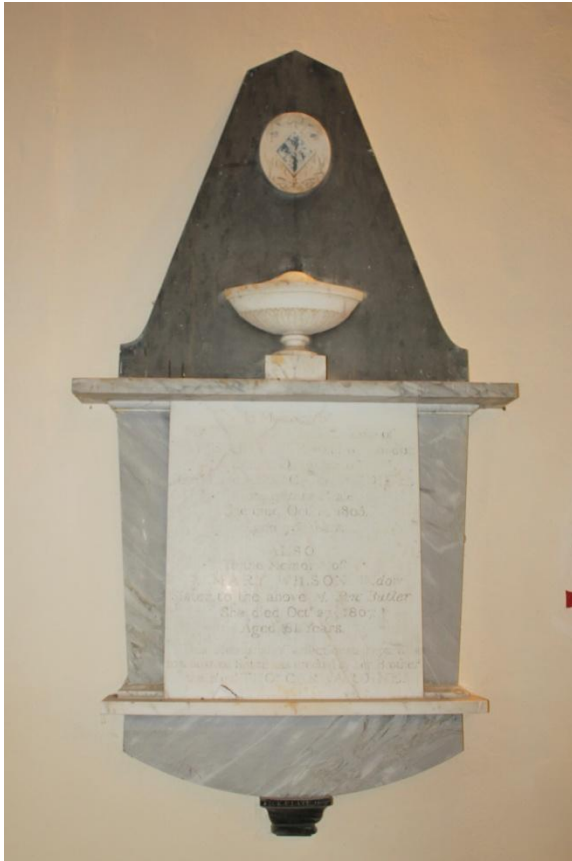
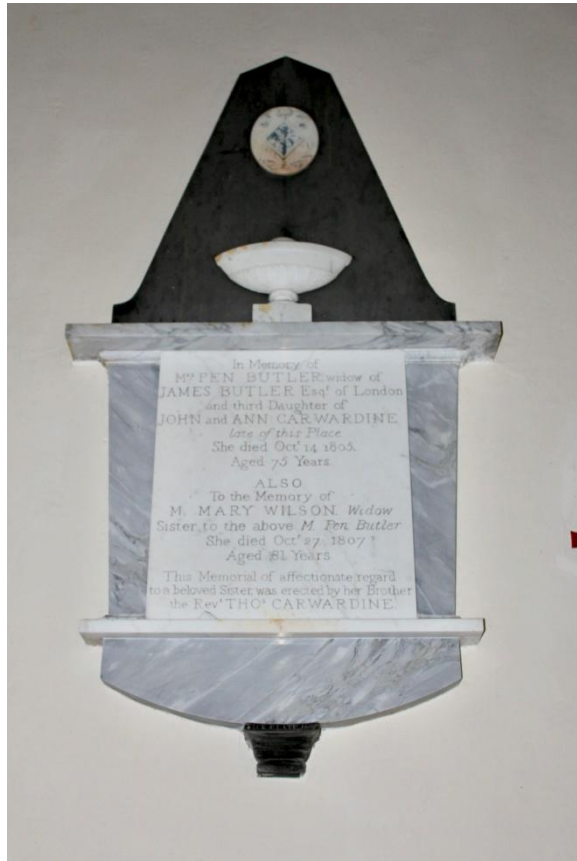
The Butler Monument before and after conservation. On the left the black carboniferous (polishable) limestone had also suffered with acute - *chromatic alteration*, this too was re-polished as far as possible by-hand, to return some of the lustre, which conversely minimises the affects of future degradation of the surface, from elevated ambient moisture levels. The lightly scratched inscription is once again readable from floor level.
