CHURCH OF ST JAMES, NORMANTON-ON-SOAR, NOTTINGHAMSHIRE:

ARCHAEOLOGICAL RECORDING OF GROUNDWORKS WITHIN THE CHURCHYARD

**Faculty Number: 2022-070002
Contractor Project Code: SJN.1
Report Number: 005/2024**

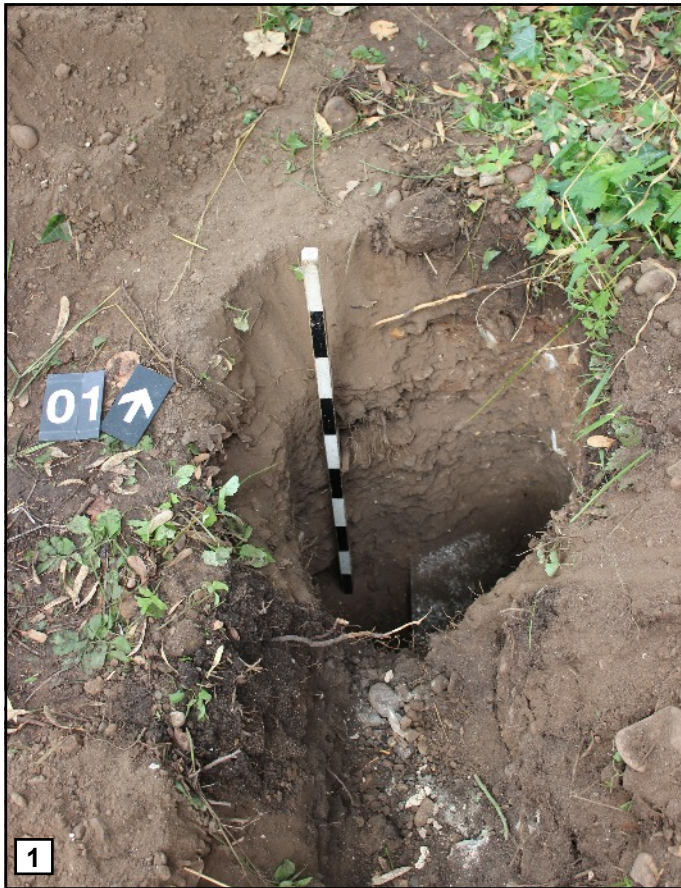
Plate 1: General view of Trial Hole 01, viewed looking north-west.

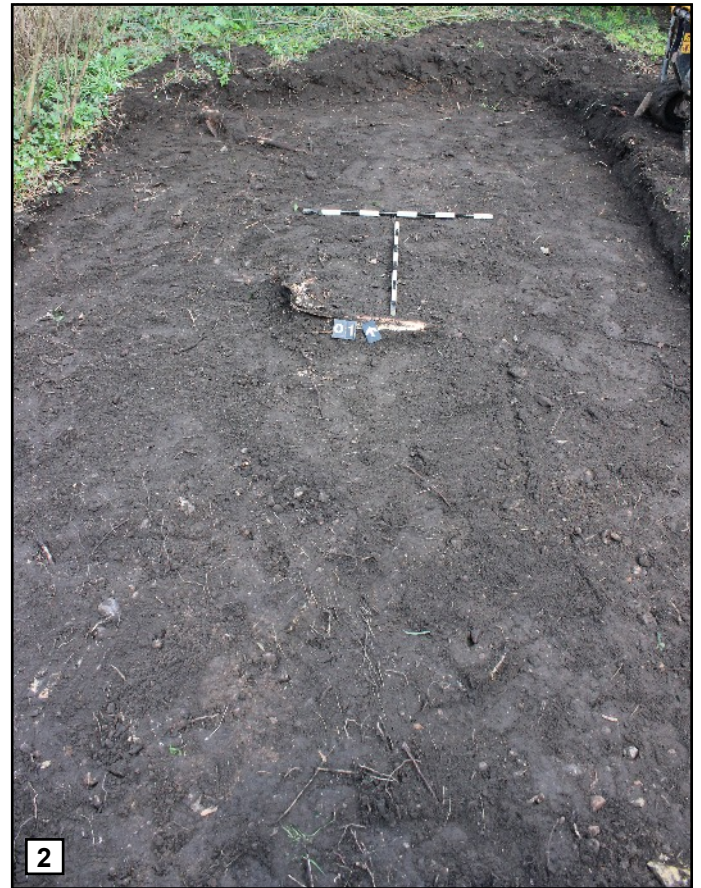
Plate 2: Area 01 post excavation, viewed looking north-east.

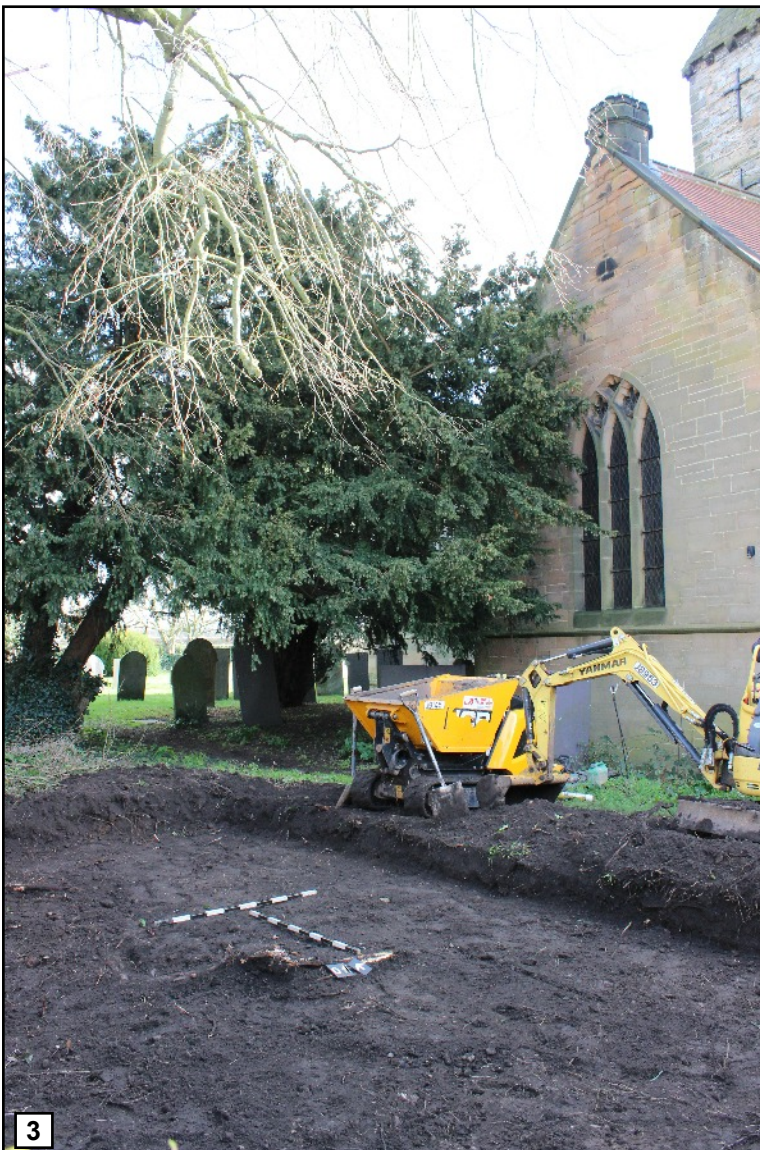
Plate 3: Area 01 post excavation, viewed looking east.
