Our ref: 5574

## ST JOHN'S CHURCH, KEYNSHAM Support of Proposed Heaters

We refer to your email of 25<sup>th</sup> June and to the subsequent site attendance of Dr Ken Falcon on 10<sup>th</sup> July, in company with Mr Graham Shaw, and confirm the following advices given verbally on site with respect to the proposal to **install suspended heaters from the centre of certain of the arches between the two aisles and the page**.

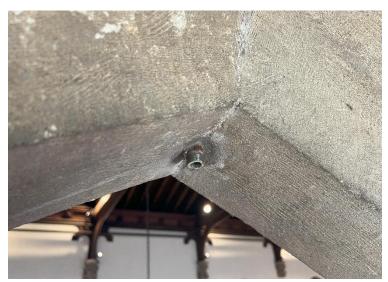
Image 1 – Hanger S7, with hook removed, before the test

In all cases, the 50kg proof test weight was supported by the hook for at least 1 minute and, upon closer observation, no movement of the embedded tube was noted, nor was any damage to the surrounding stone work noted. Images 1 & 2 below show the stonework around the hook in Arch S7 before and after the proof test.

Given that the testing was essentially opportunist, we await the comments of others as to whether, or not, our ad-hoc tests are acceptable as demonstrating that the hooks, having supported a proof test load of 50kg, are satisfactory to support a heater weighing 25kg.
