Bat Survey Report - Final

Proposed repair and renovation of St. Dubricius Church, Porlock

PCC of St Dubricius Church in Porlock

Date: 25 July 2025

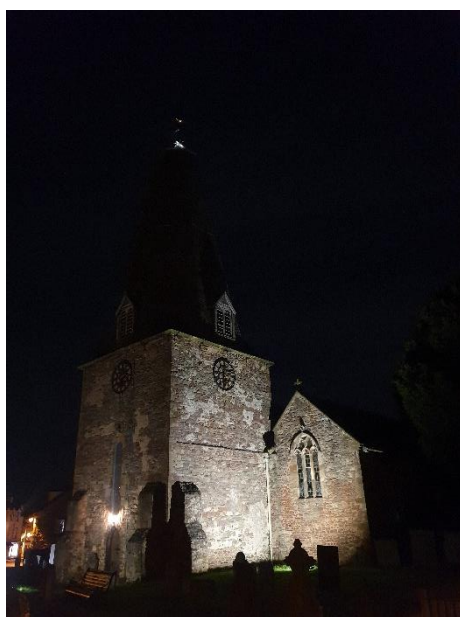
West and south elevations at night (24/08/2021)

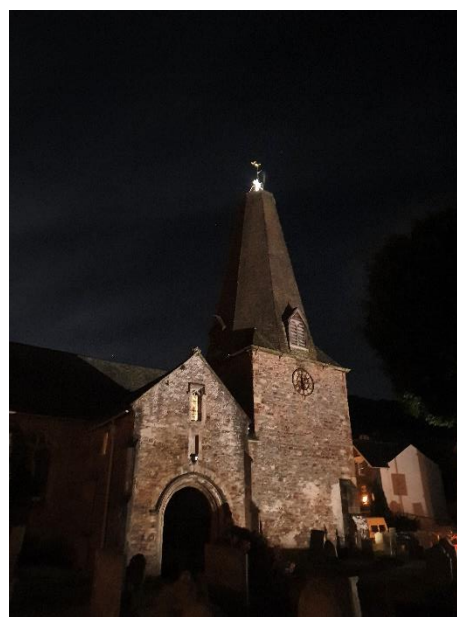
North elevation at night (24/08/2021)

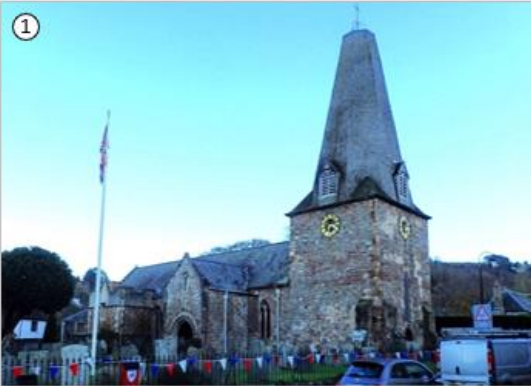
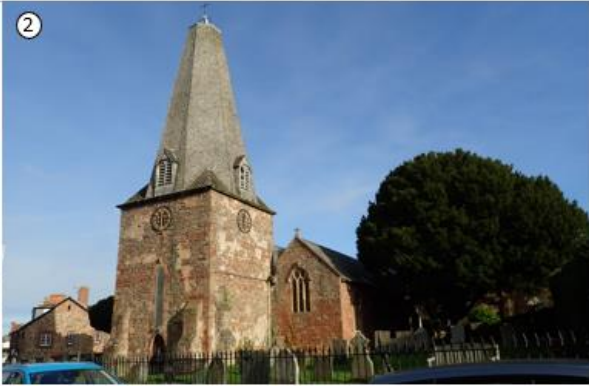
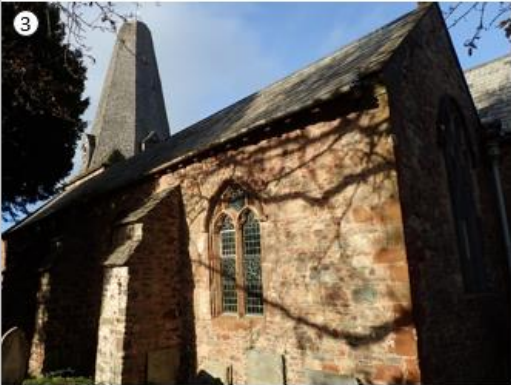
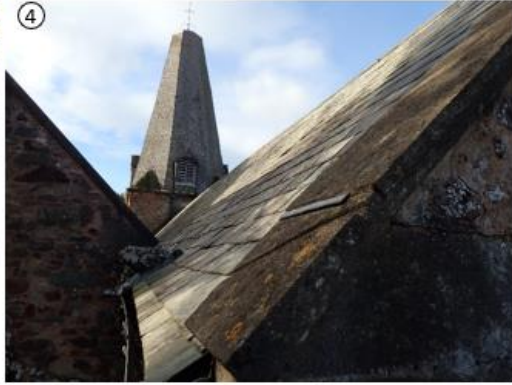
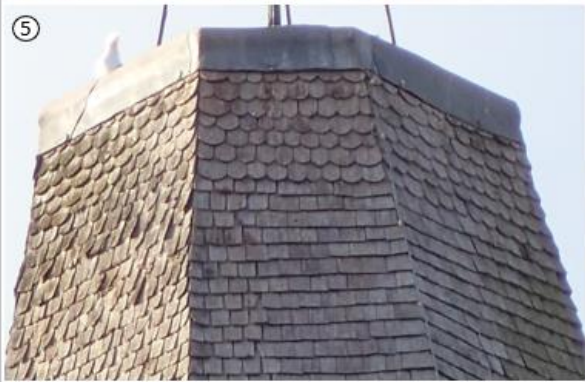
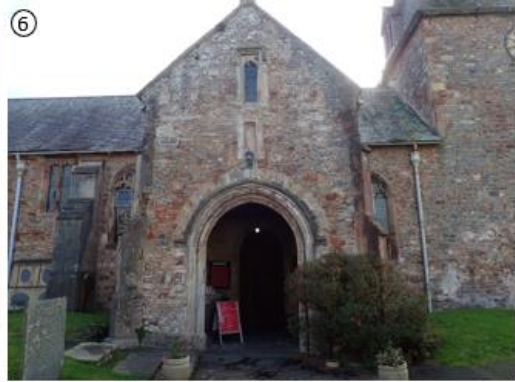
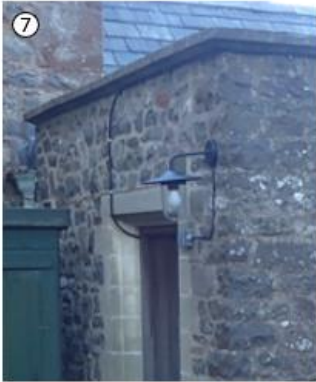
Title Figure 2. Site photographs.
(a) External

1. North and west elevations.
2. West and south elevations.
3. South elevation (east end)
4. South roof pitch above nave (proposed roof replacement and location of solar panels).
5. Detail of tower (proposed replacement of oak shingles and potentially some underlying sarking boards).
6. North porch (proposed roof replacement and glass doors fitted to the front opening).
7. External light on the flat-roof store.

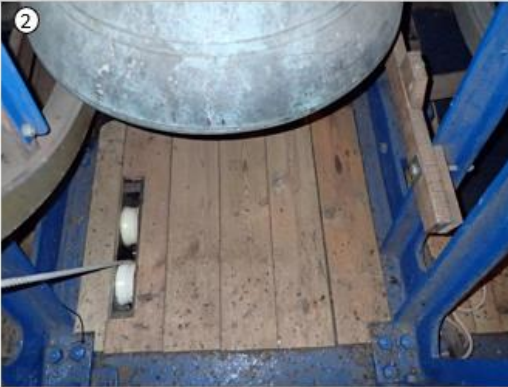
<table><tr><td>Title</td><td>Figure 4. Photographic evidence of bats and potential/confirmed roost sites</td></tr><tr><td>Site</td><td>St Dubricius Church, Porlock, TA24 8LB</td></tr><tr><td>Date</td><td>21 November 2024</td></tr></table>	Title	Figure 4. Photographic evidence of bats and potential/confirmed roost sites	Site	St Dubricius Church, Porlock, TA24 8LB	Date	21 November 2024
Title	Figure 4. Photographic evidence of bats and potential/confirmed roost sites							
Site	St Dubricius Church, Porlock, TA24 8LB							
Date	21 November 2024							
 	 	<p><u>Notes:</u></p> <ol style="list-style-type: none">1. Brown long-eared bat dropping on the knee of Harington Monument (Fig. 3a, TN4).2. Brown long-eared bat droppings scattered on the floor below a bell (Fig. 3b, TN2).3. Brown long-eared bat droppings scattered over a window ledge in the belfry (Fig. 3b, TN1).4. Potential access where the clock mechanism passes through the glass of belfry windows (Fig. 3b, TN5).5. Bat access created through bird mesh covering the spire windows. Note bat droppings on the pipe below. It's noted these access points require improvement, which will be addressed during the repair work.6. Brown long-eared bat droppings on top of a notice board in the north porch (Fig. 3a, TN7).
