CHURCH of St MICHAEL and ALL ANGELS, EAST COKER, SOMERSET

Report on Archaeological Investigations external to the West door

Prepared February 2021 for
The PCC of the Church of St Michael and All Angels, East Coker

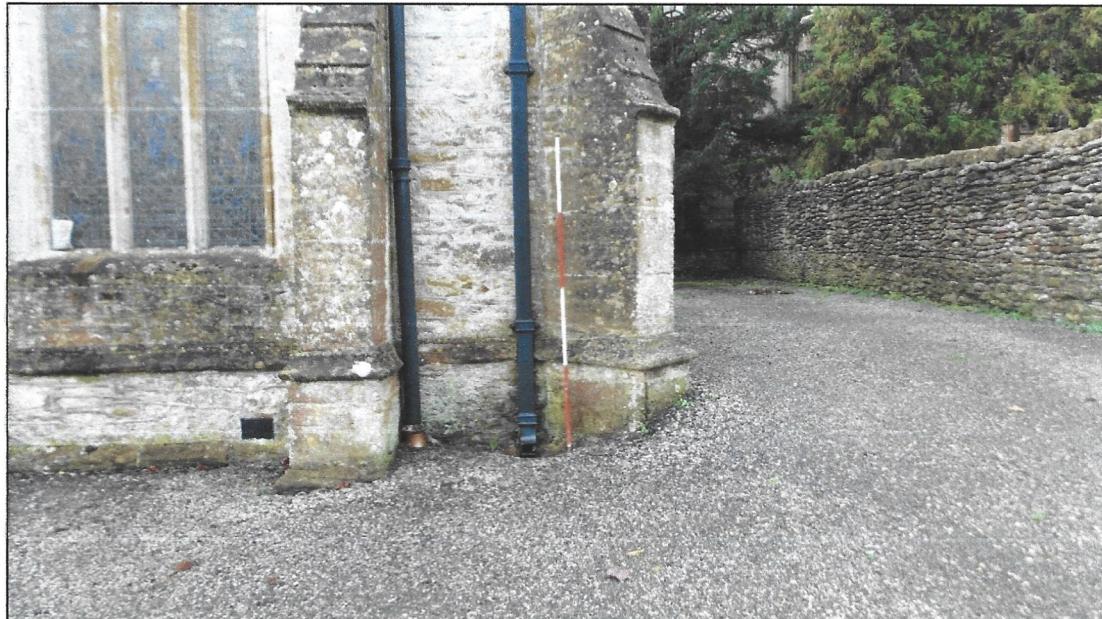
The photograph on the cover shows the variation in road surface levels at the NW corner of the church.

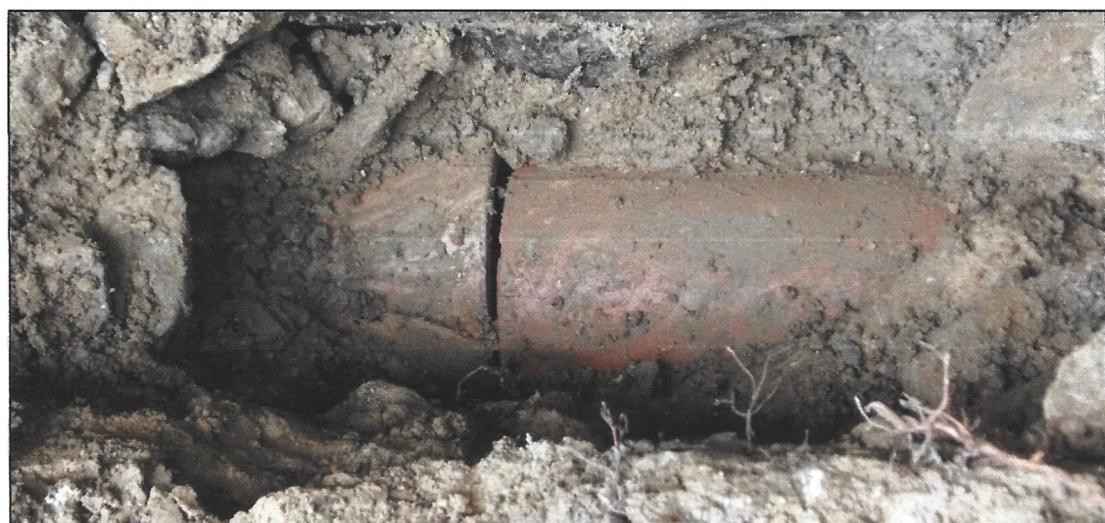
The cut contained Ham stone rubble (108), occasional modern perforated brick fragments, glazed ceramic service pipe fragments a stone roof tile fragment, and a single animal bone. Removal of this rubble deposit exposed the upper surface of a ceramic pipe (109) at least 110mm in diameter, this feature appeared to be a modern French drainage system.

Figure 7. Close up view of ceramic pipes (109): from above.

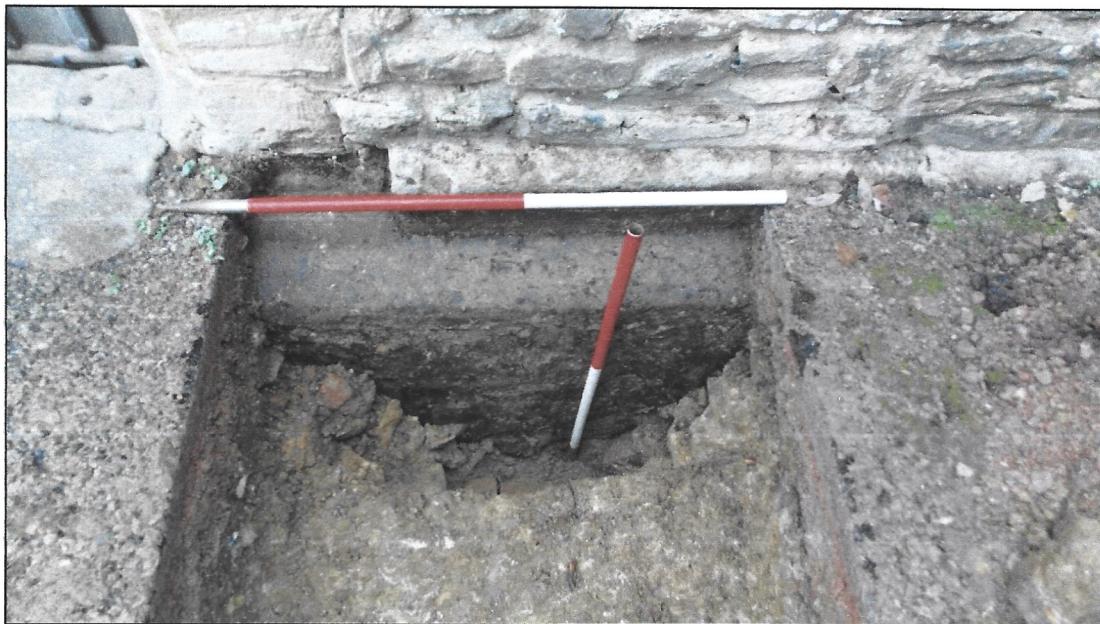
Figure 8. Chamfered plinth course/offset footings (105): facing E, 1m scales.

The chamfered plinth course/offset footings (105) are offset up to 140mm from the above ground exposed offset course of stonework and is at least 1000mm deep below the existing road surface. These foundations were not bottomed due to the drainage pipe (109) in the base of the trench. The bottom of the chamfer was 180mm below the road surface and it assumed that it was exposed at some point in the past prior to the road construction. This chamfered section of the foundations would appear to be constructed from coursed rubble which has been rendered and appears to have been waterproofed with some form of sealant.

The west door surround would appear to be a later insertion using reclaimed masonry and the Ham stone doorway jambs on the south side appear to have been constructed on top of the chamfered plinth course also suggesting that the doorway has been inserted into an existing wall. The top step must also be a latter addition as this is higher than the chamfered plinth course.

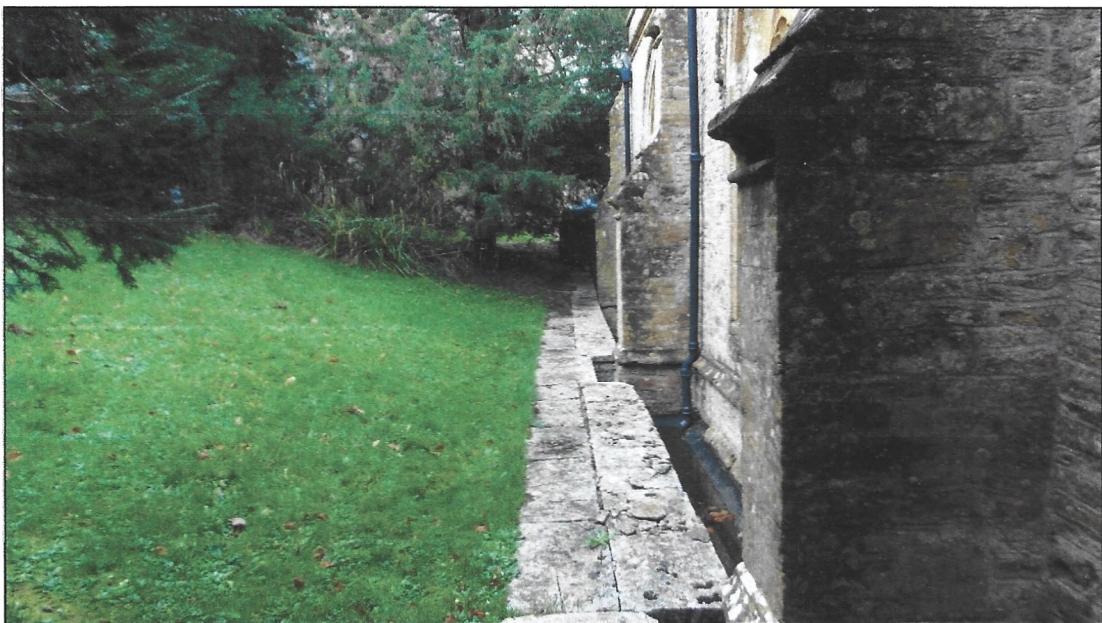
If (106) is a geological deposit, then this would suggest that the west end of the church has been terraced into the natural hillslope like that as can be seen on the SW corner (Fig. 9). No sign of a cut for a foundation trench or terracing was seen during these works but this could have been destroyed during the construction of the French drain.

Figure 9. South end of church set into hillslope: facing W.
