**CHURCH of St MICHAEL and ALL ANGELS,  
EAST COKER, YEOVIL, SOMERSET BA22 9JW**

**Report on the Archaeological Recording of minor opening  
up works on the internal tower walls for a structural  
assessment**

# **CHURCH OF St MICHAEL & ALL ANGELS, EAST COKER, SOMERSET**

## **Archaeological Assessment of the proposed Accessibility Improvements in the North Porch & Carpark**

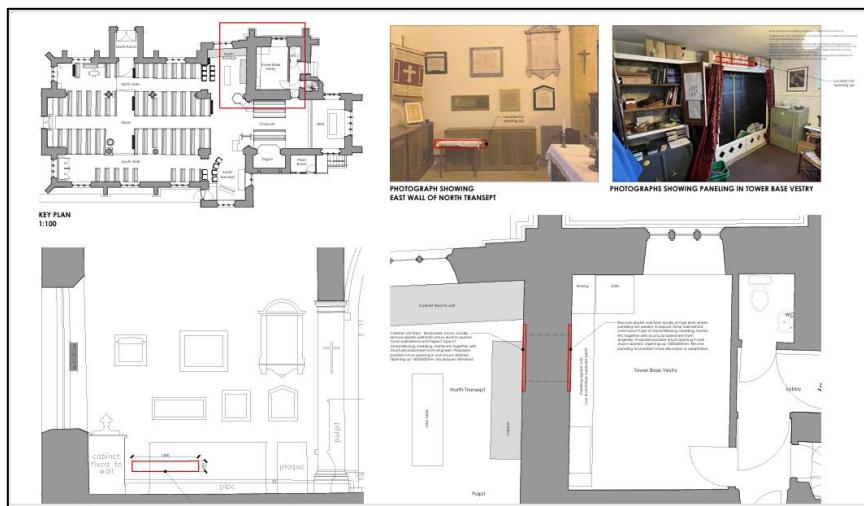
**Figure 1.** Proposed opening up works (after Benjamin & Beauchamp Architects).

Consultation had taken place between the project architect and structural engineer, and they proposed that small areas of the plaster wall finish would be removed from the North Transept east wall/tower wall and on the west wall of the Vestry in the area of the proposed doorway to make an assessment of the wall's construction (Fig. 1).

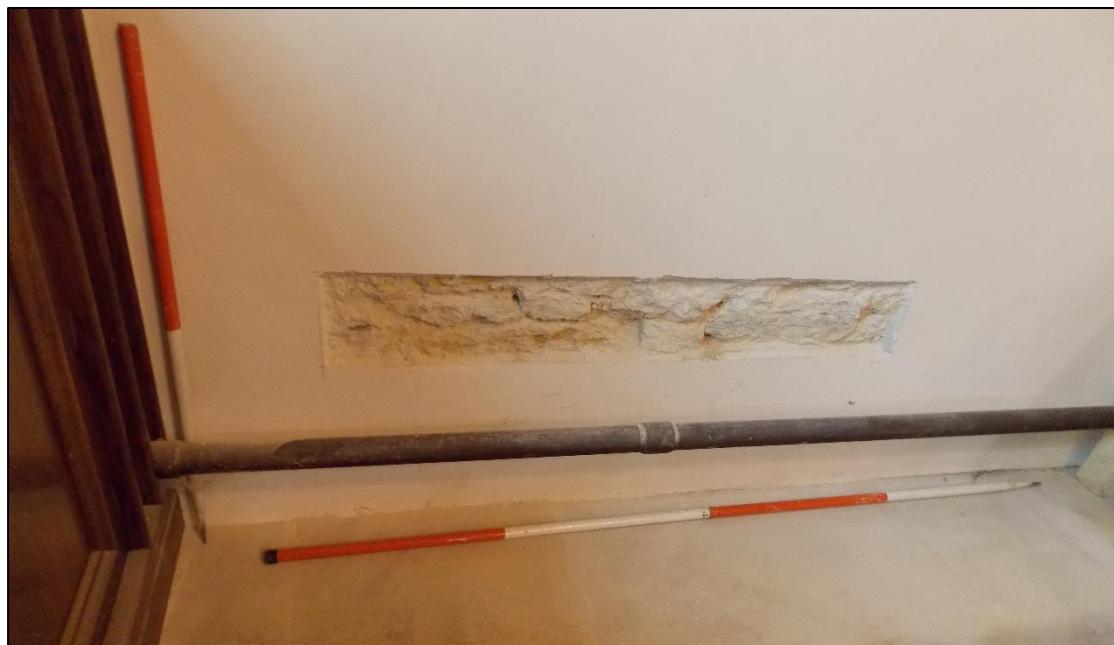
**Figure 2.** Plaster removed on N Transept E wall: facing E, 1m & 2m scales.

Staff from The Wessex Conservation Company carefully removed the plaster wall covering by hand, using a hammer and chisel over an area 1.3m long x 0.2m high on the North Transept east wall/tower wall and an area 1.3m long x 0.16m high on the west wall of the Vestry to reveal the underlying stonework construction (Figs. 2 & 3).

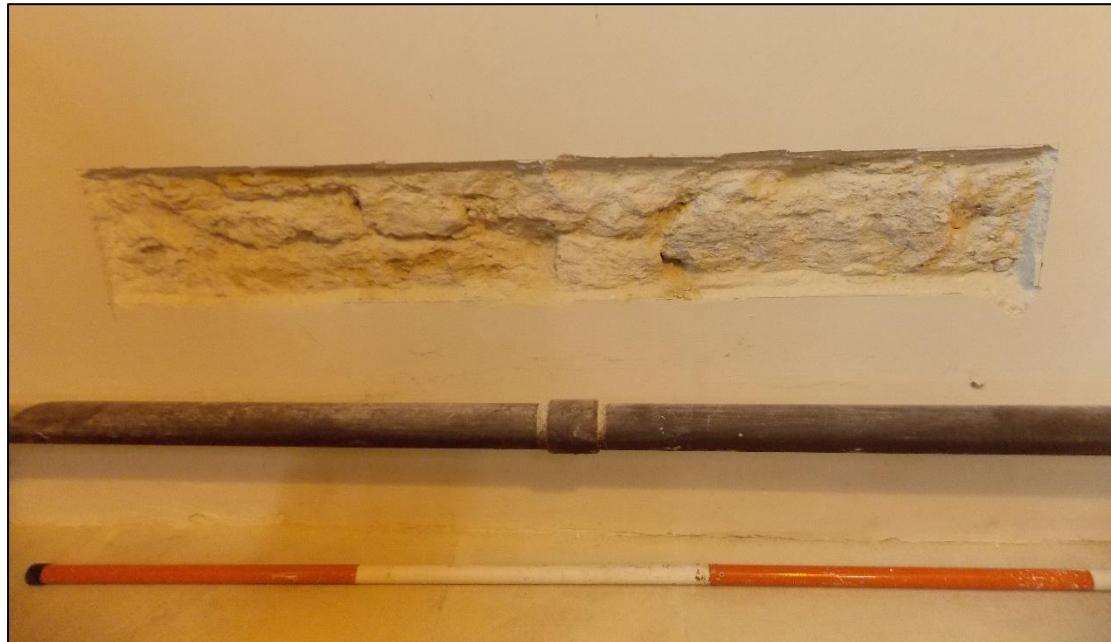
**Figure 4.** Exposed Stonework N Transept E wall: facing E, Scale = 0.5m divisions.

Removal of up to 30mm of a very fine, lime plaster revealed that the underlying stonework of the North Transept east wall/tower wall consisted of random coursed Ham Stone blocks varying in length from 450mm to 500mm and between 80mm and 140mm in height (Fig. 4). None of the original bonding mortar was observed as the joints had been raked right back to allow the plaster to key into the wall.

There was no sign of any original mortar in the joints of the exposed area in the North Transept east wall as this appeared to have been removed to key in a modern plaster covering. This wall would appear to have been replastered along its length to a height of 1.22m above the existing floor (it is thicker than the plaster above) and also continues along the North Transept wall. There has probably been a damp problem in this area at some point in the past leading to the replastering of this area.

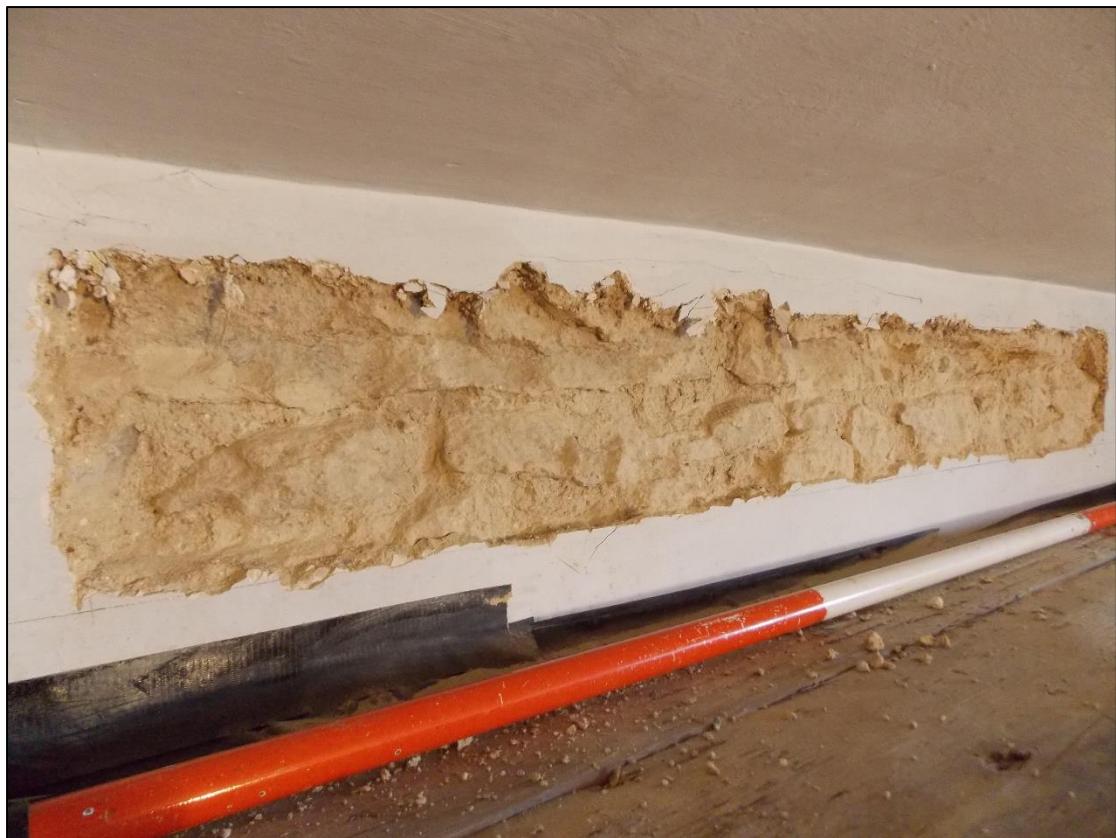
**Figure 5.** Exposed Stonework in Vestry: facing NW, Scale = 0.5m divisions.

The stonework revealed in the Vestry area consisted of random coursed angular limestone (only one piece of Ham Stone in the exposed area) bonded with a hard but crumbly mixed cream lime mortar and light brown stone dust? with frequent lumps and flecks of white lime. The stones in this exposed elevation were much smaller than those exposed in the North Transept east wall and ranged from 100mm x 60mm up to 300mm x 30mm (Fig. 5).

The plaster covering this section was between 10mm and 20mm in depth and was a lime and hair-based plaster with lumps of poorly mixed lime.

The lime mortar exposed in the Vestry section could date from any time from the medieval period to the present as lime mortar mixes vary little over time, but the presence of lumps and flecks of lime would suggest an earlier date rather than being a more modern mix. The lime and hair-based plaster removed from this area could be of an 18<sup>th</sup> Century date, but this could have been replaced in the 19<sup>th</sup> or early 20<sup>th</sup> Century as hair was still used in plaster coverings during these periods.

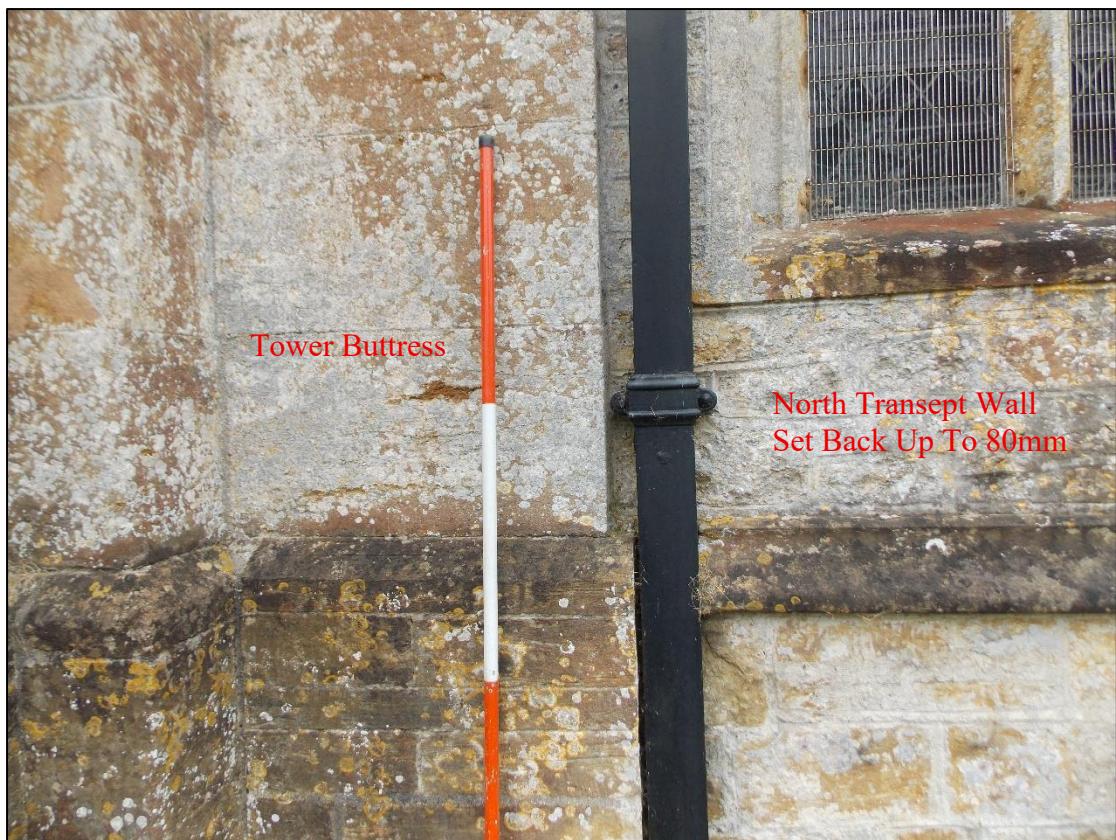
**Figure 6.** Junction of N Transept wall and Tower Buttress: facing S, 0.5m divisions.

It quickly became apparent looking at the external west elevation of the tower that the North Transept wall had been constructed against both the NW tower buttress and the North Aisle buttress so therefore must have been rebuilt sometime after the tower's construction.

The masonry lower string course detail (straight chamfer) on the north facing elevation of the tower continues around the NW corner buttress, returns southwards and then runs west onto a second buttress before returning south again. At this junction the North Transept wall butts up against the tower buttress and is set back up to 80mm to the south, the North Transept wall string course detail is different and comprises of a cavetto and ovolو moulding (Fig. 6).

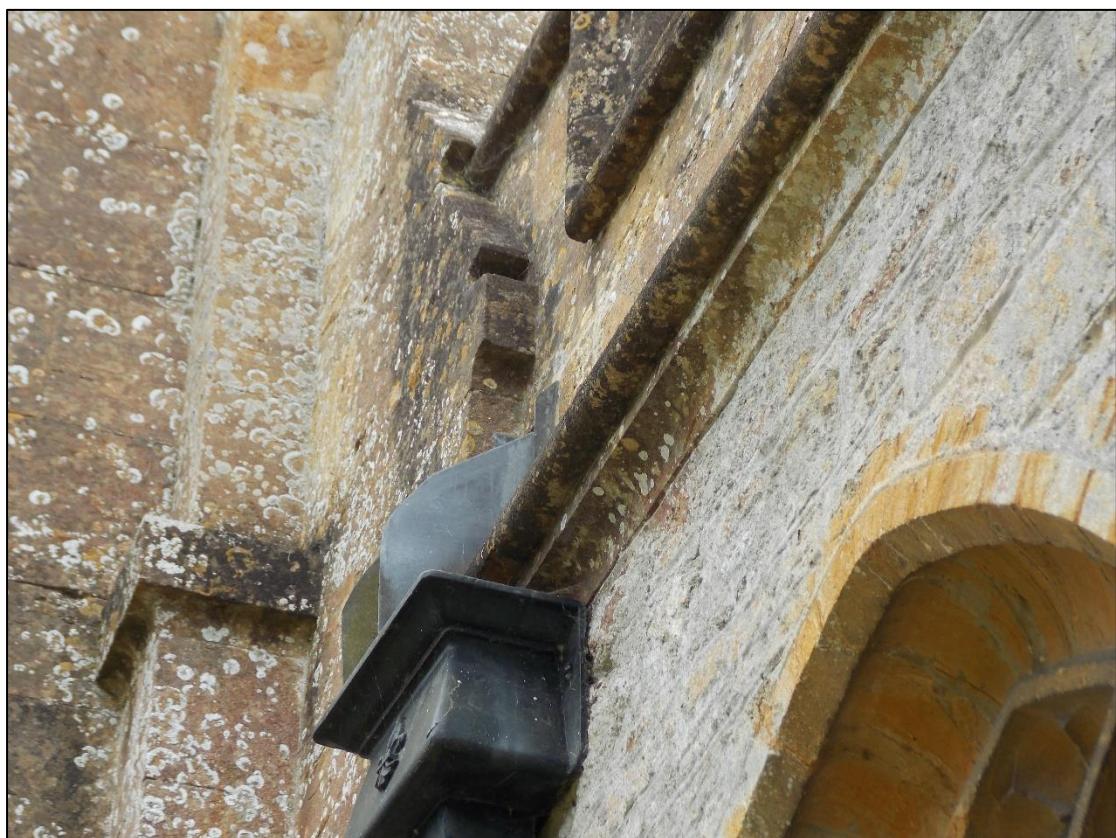
**Figure 7.** N Transept Parapet, constructed around Tower Buttress: facing E.

The parapet on top of the North Transept wall can also be seen to have been constructed around the towers buttress (Fig. 7).

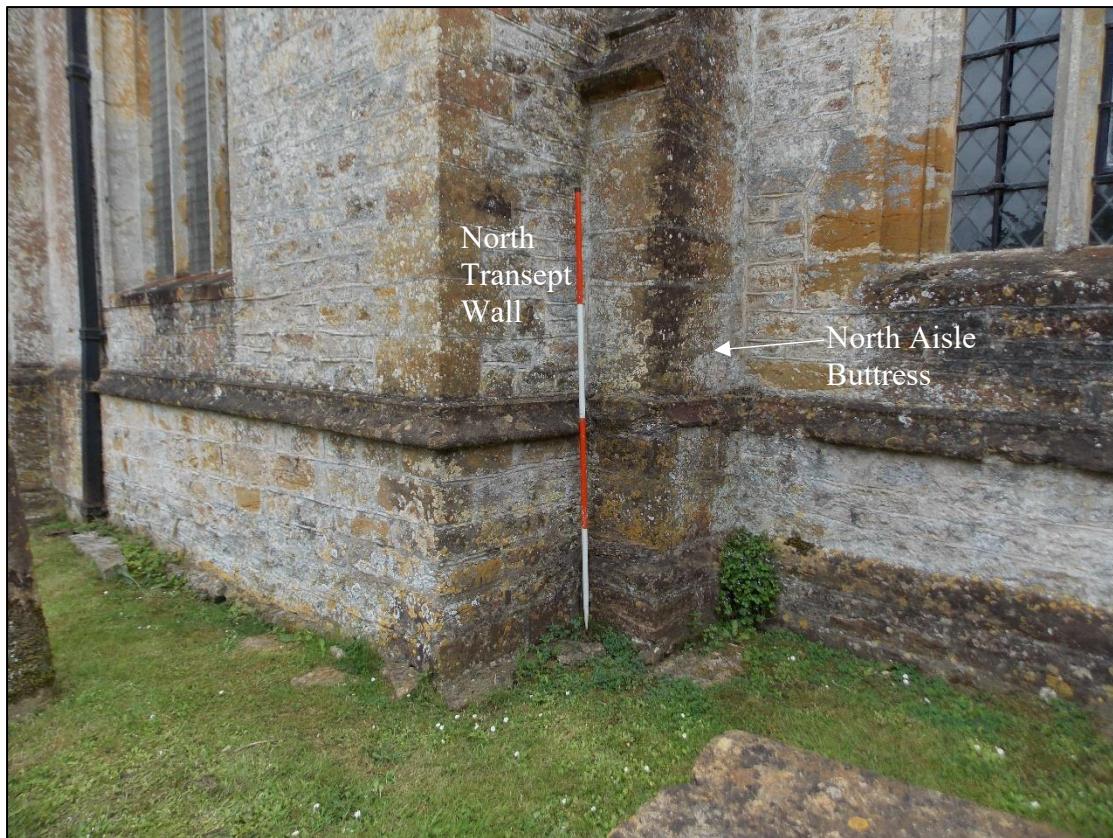
**Figure 8.** N Transept wall butting N Aisle Buttress: facing SE.

Where the west end of the North Transept wall returns south a straight joint (perpendicular) is clearly visible against the external buttress of the North Aisle (Fig. 8). It can also clearly be seen that although the string course detail on this section of wall is similar it is not as worn or as weathered as that on the North Aisle (Fig. 9).

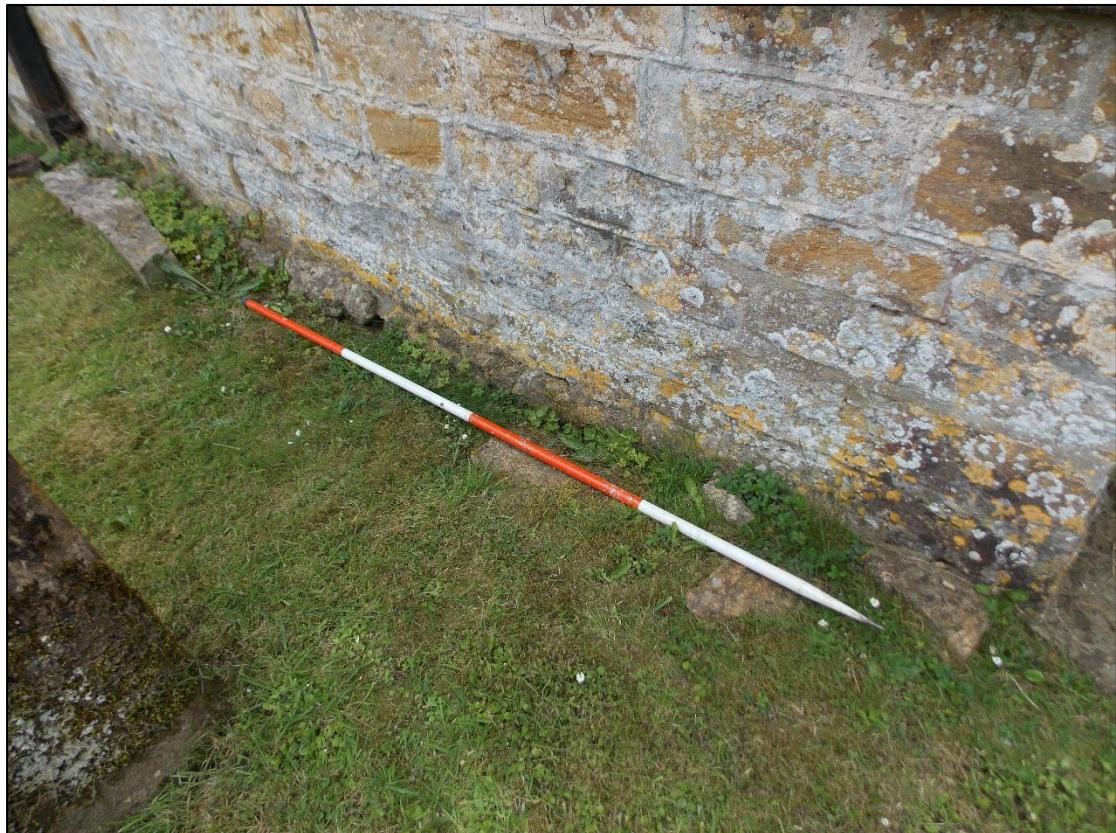
**Figure 10.** Offset footings on N Transept wall: facing SE, 2m scale.

It was also noted that the base of the North Transept wall appeared to have a slight offset footing along its north face (Fig. 10) and the return to the south had also been constructed on top of random stone slabs. It was not clear if these were part of the rebuild of the North Transept wall or if it had been constructed on earlier foundations.

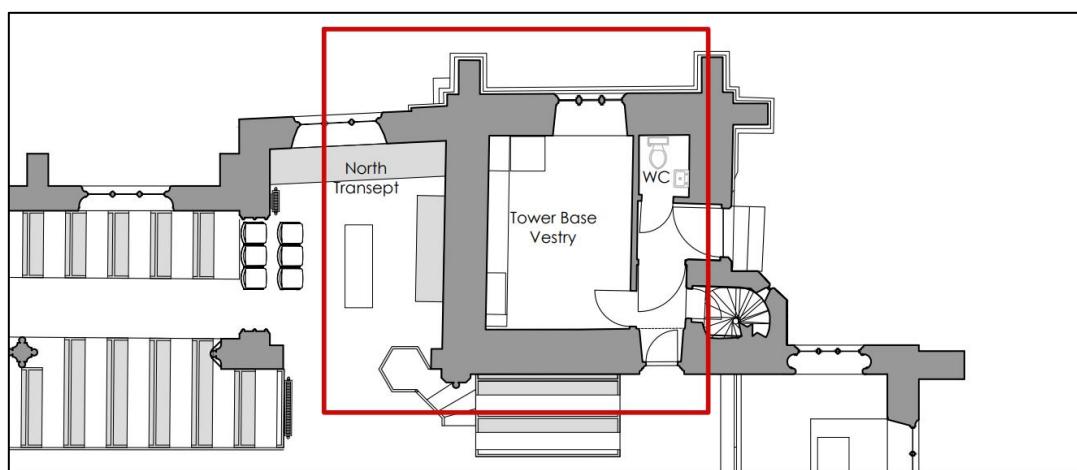
**Figure 11.** Plan showing N Transept wall alignment (after Benjamin & Beauchamp Architects).

The architects location plan for the opening up works also shows the alignment of the the North Transept wall is offset with the rest of the church which would also suggest that this wall had been rebuilt to accomodate the new tower layout (Fig. 11).

The writer has not seen any church plans that show what was in the area of the North Transept east wall prior to the construction of the tower, but the external evidence would suggest that the towers design and construction continued southwards as its NW corner buttress has been encased by the east end of the North Aisle wall and the architects drawings show a symmetrical square plan of the tower with walls of a similar thickness (Fig. 11).

It is still not clear why the North Transept wall is offset to the rest of the church but there may have been a slight miscalculation during its construction. Interestingly though this wall does not seem to be tied into the tower or the North Aisle buttress it appears to just butt up against them (on the external elevations).

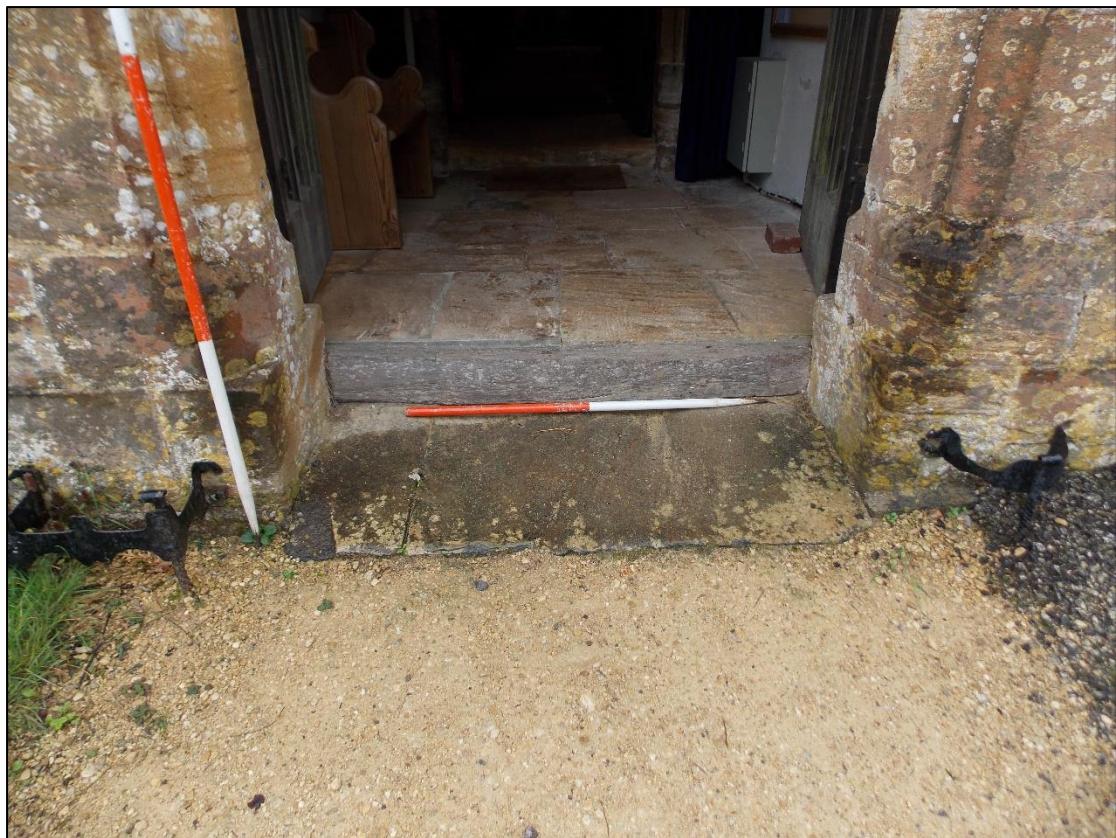
**Figure 1.** Timber step: facing S, 1m scales

A timber step circa 140mm high x 95mm deep forms a threshold into the porch and has been bedded (but now loose) on a cement fillet on top of worn Ham Stone slabs (Fig. 1). The slabs below the step probably once formed the original entrance level into the porch, with the timber step and Ham Stone slabs within the porch being a later addition.

The timber step appears to be modern as do the timber doors and are not considered to be of great historical or archaeological importance.

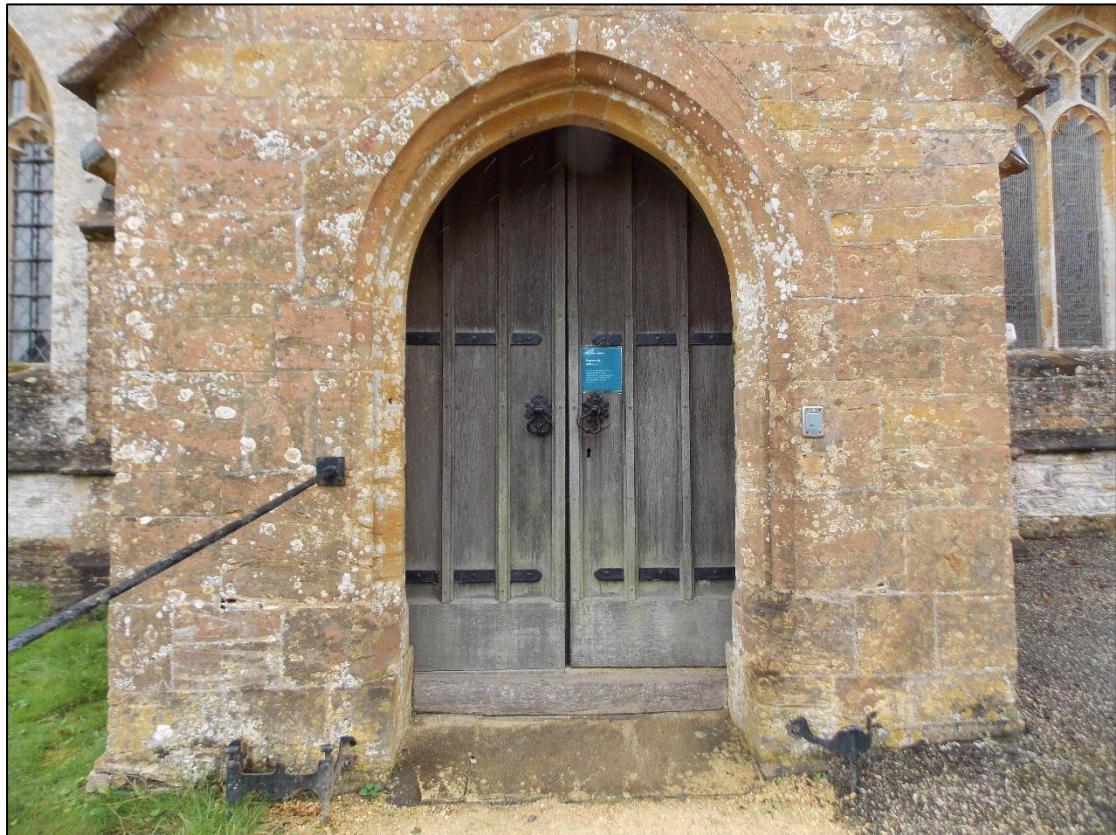
**Figure 2.** Timber doors: facing S

Two timber doors are attached to the inside of the porch entrance and sit at the same level as the timber step and Ham Stone flooring (Fig. 2). The date of the timber doors is uncertain, possibly 19<sup>th</sup> Century but appear much later, the framework for the doors has two phases of bolt fixings and one is very recent (Fig. 3).

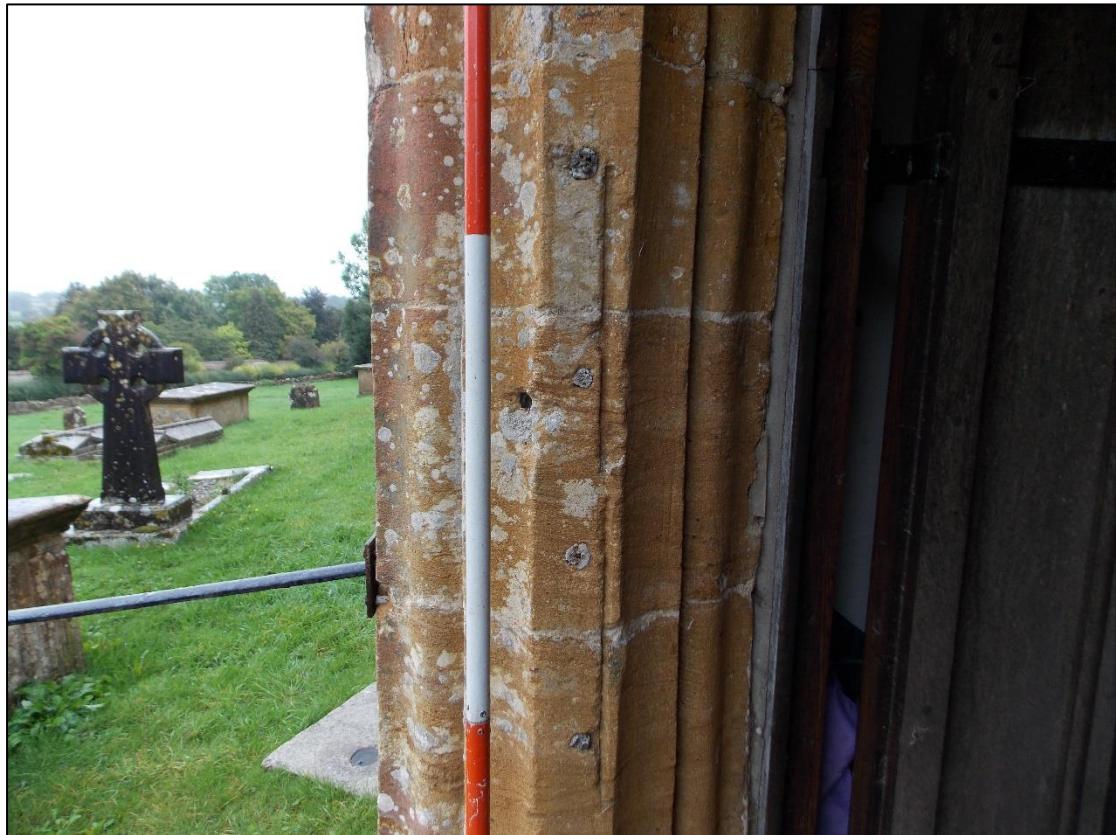
**Figure 4.** Wood dowels set within jambs, E side of porch entrance: facing E, 0.5m scale

The original doors and framework were possibly set within the arched entrance into the porch as there are a series of wooden dowls set within the face of the jambs (Fig. 4) and voussoirs.

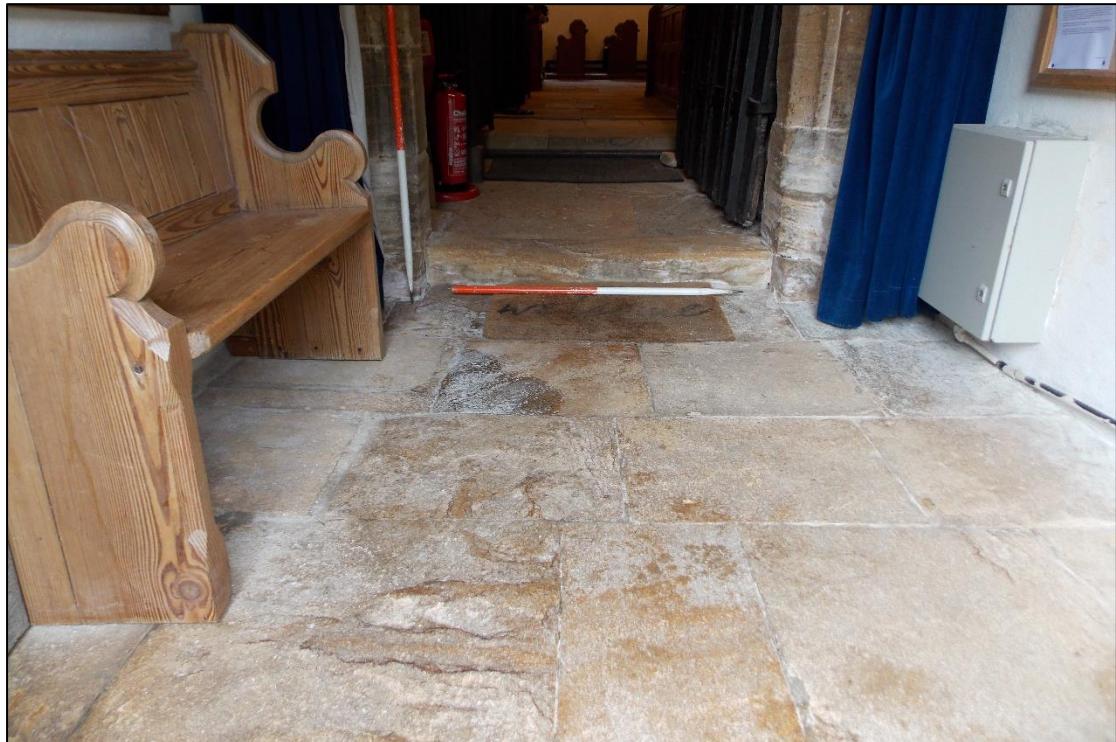
Figure 5. Ham Stone flooring within N porch: facing SE, 1m scales

A worn Ham Stone, slab floor runs south along the length of the porch until it butts a very worn Ham Stone step forming the threshold of the doorway into the North Aisle (Fig. 5). This step is up to 140mm high on its north side and up to 230mm deep (Fig. 6).

These two different levels of flooring may be an earlier attempt to make access into the church easier rather than having a single step of up to 370mm in height. Both areas of flooring do not appear to be contemporary with the porch construction as the timber step and worn stone step sit too high against the stone doorway jambs. The areas of flooring are going to be reset but the original stones will be reused.

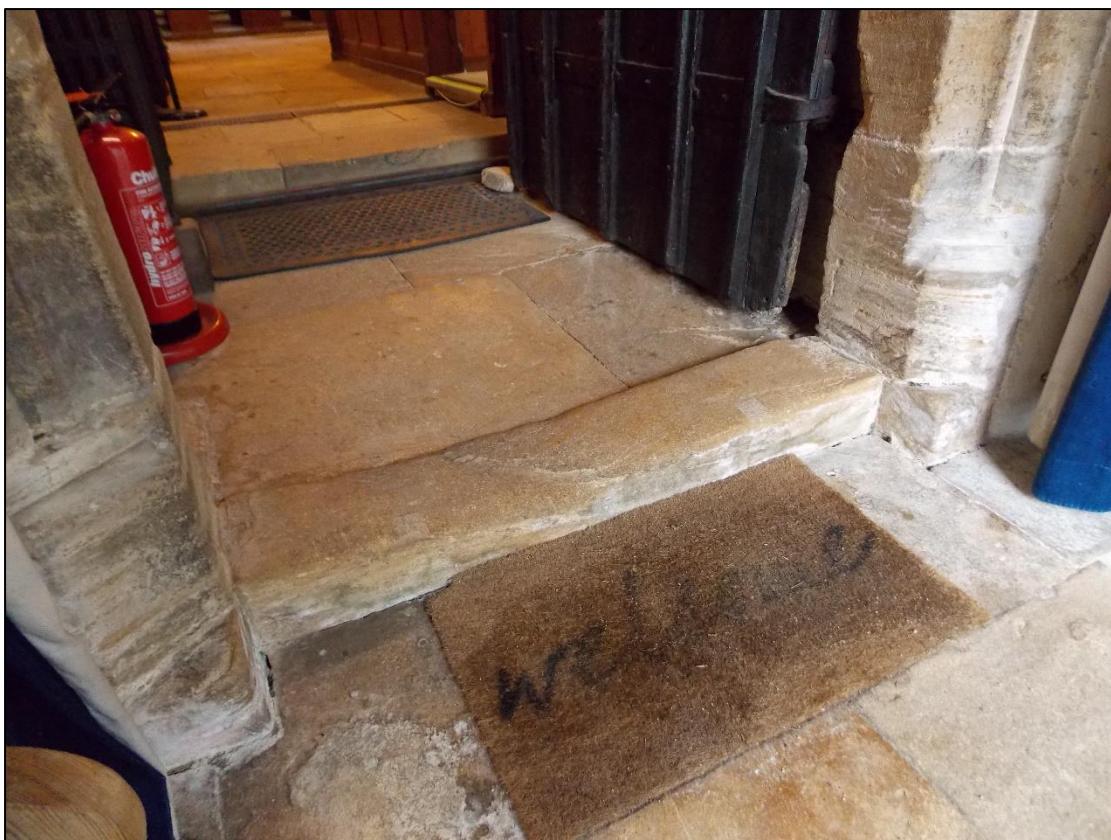
**Figure 7.** Ham Stone flooring running into N aisle: facing SW

There is a drop of 40mm on the south side of the worn step onto another section of Ham Stone flooring that runs for 1.72m southwards into the North Aisle (Fig. 7) at which point the main North Aisle flooring steps up a further 130mm (Fig. 8).

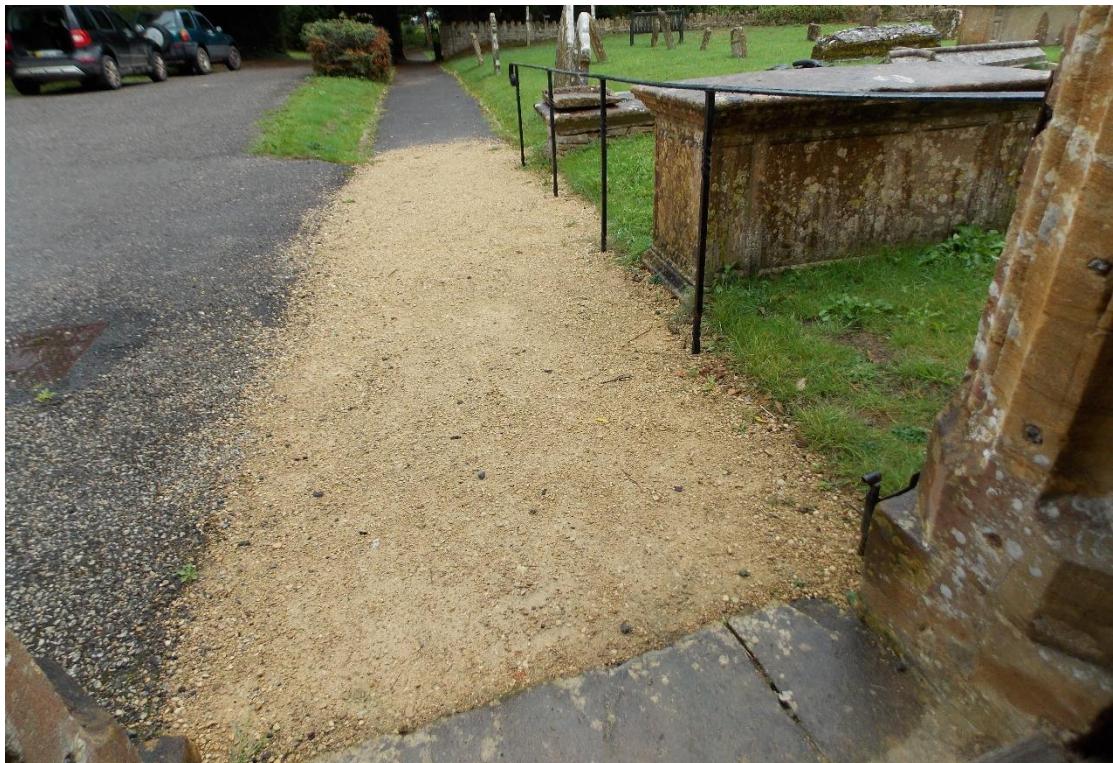
**Figure 9.** Hoggin covered pathway outside N porch: facing N

The area for the proposed raised dais and steps consists of a Hoggin covered section of pathway sloping northwards outside the North Porch (Fig. 9) and the area for regrading of existing levels to allow level access from accessible parking spaces comprises of a tarmac covered roadway and turning area (Fig. 10).
