Archaeological Watching Brief

All Saint's Church

Pocklington

Report No 2816

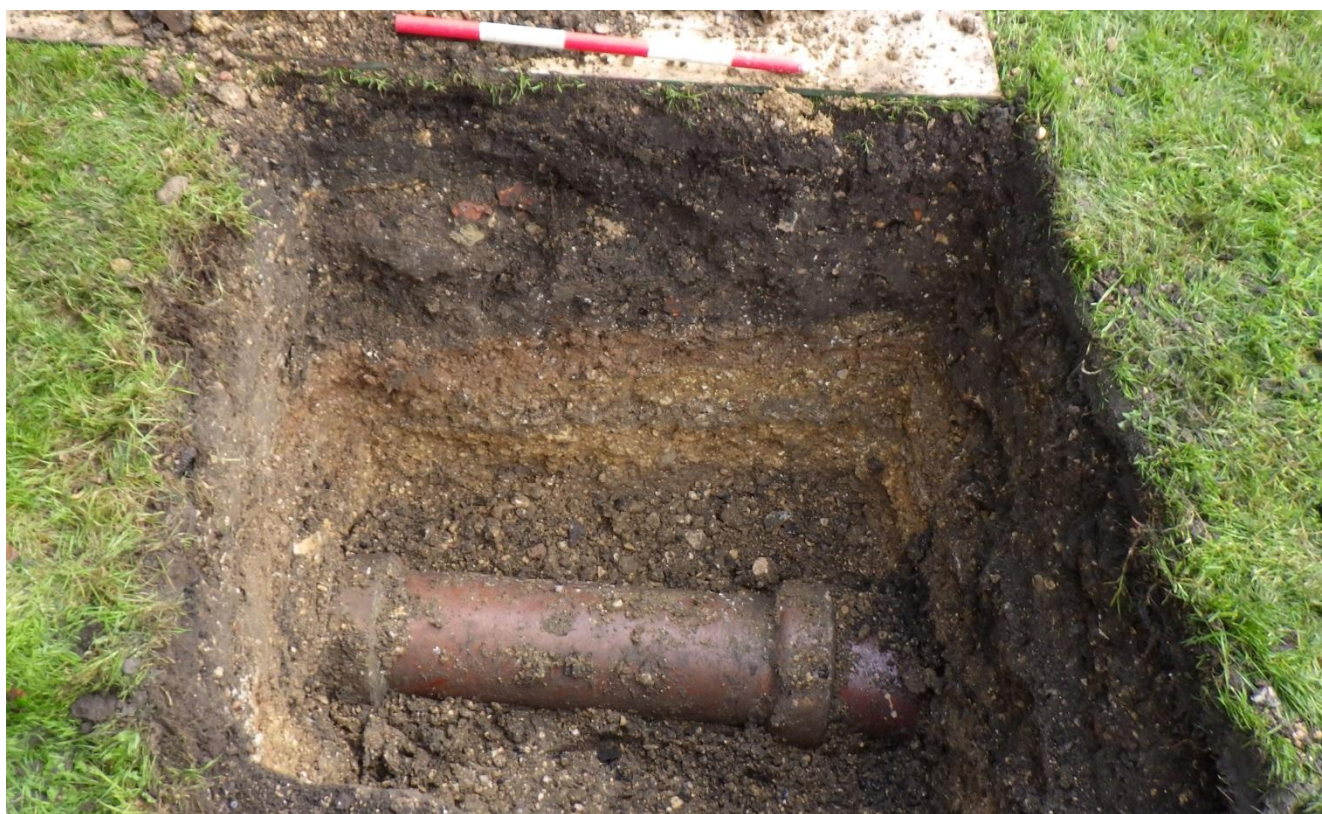
Trench 1 was located immediately to the northeast of the sanctuary (Figure 2) and measured 1.0m by 0.95m and was excavated to a depth of 0.82m. The earliest deposit encountered was an archaeologically sterile mid grey brown silty clay (107) with frequent inclusions of chalk/limestone pebbles (Plate 1). The deposit was evident across the entire base of the trench and had a minimum depth of 0.1m, which extended beyond the limit of excavation. It is likely that Context (107) was part of the graveyard soil, although an absence of human remains does not substantiate the theory. Sealing the possible graveyard soil was a layer of sandstone chippings (106). The deposit covered the entire trench and was approximately 0.32m deep. The chippings may have been the result of debris from construction of the sanctuary, or may have been an intentional deposit to form a hardstanding or pathway. No datable evidence was recovered from Deposit (106).

Sealing the stone chippings was a layer of mid brownish grey silty clay (105), with frequent inclusions of clay building material (CMB), and moderate sized stone fragments. The layer spanned the entire trench and was approximately 0.30m thick. A number of fragments of 18th to early 19th century blue and white transfer print pottery along with numerous clay pipe stems (18th-19th century) and a small quantity of disarticulated human bone were recovered from the deposit. Cut through Context (105) was a drainage trench [104] containing a 6" diameter salt glazed pipe (103), and the drainage trench backfill (102), which ran through the trench on a northwest-southeast alignment. Further fragments of 18th to early 19th century blue and white transfer print pottery, a clay pipe stem, and a small quantity of disarticulated human bone were recovered from the drainage trench backfill. Sealing the drain cut was a thin layer of tarmac, measuring 0.02m thick (101), which had formed part of a now defunct pathway that had lead from the main northeast to southwest pathway, round to the northern side of the church. Sealing the tarmac, and forming the latest deposit in the sequence was a layer of turf (100).

Plate 1 Northeast facing section of Trench 1, 0.5m scale

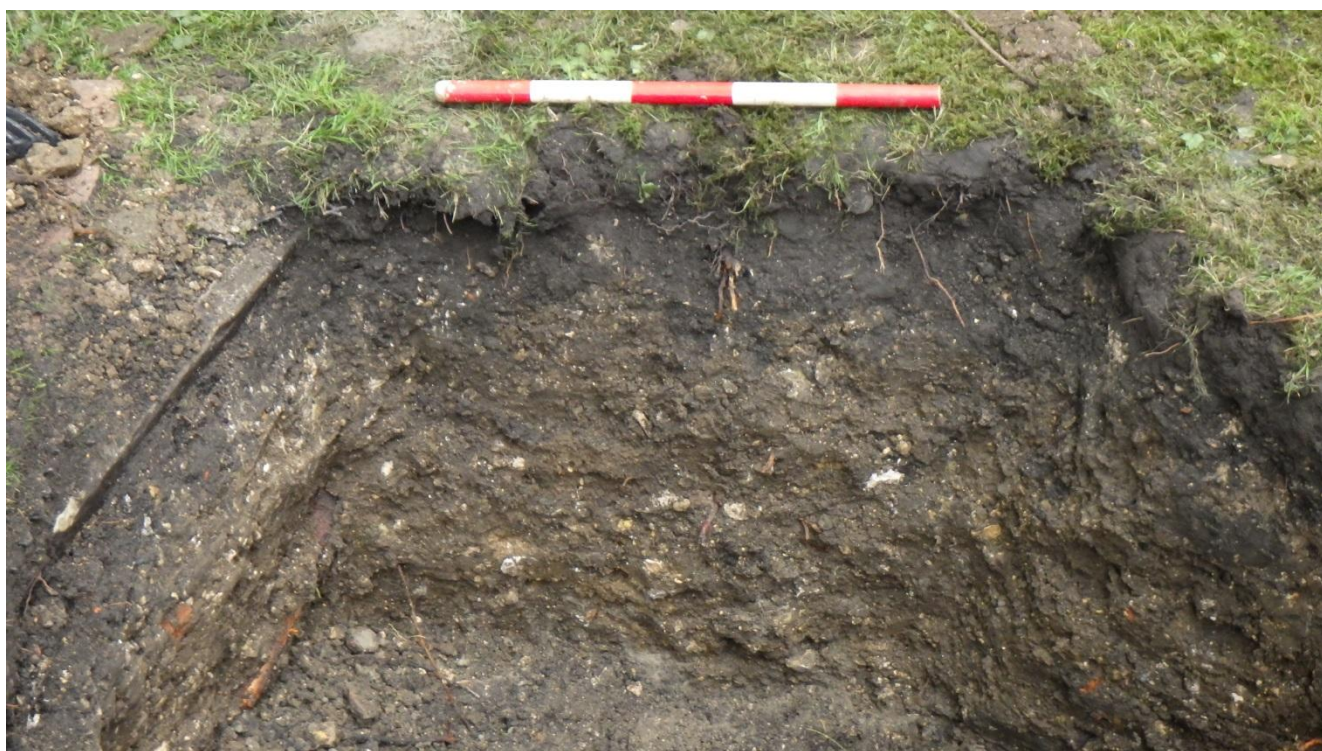
Trench 2 was located to the north eastern corner of a utility room, which was appended to the north wall of the chancel, and eastern wall of the Lady Chapel (Figure 2). The trench measured 1.1mm by 0.95m and was excavated to a depth of 1.02m. The trench had been located entirely over the junction of an existing drainage trench [204], which contained a 0.15m salt glazed drain (203). Within the backfill of the drainage trench (202) was a small quantity of 18th to early 19th century blue and white transfer print pottery and fragments of disarticulated human bone. Sealing the drainage cut was a layer of dark greyish-

brown silty clay(201) with frequent inclusions of ceramic building material and stone fragments (Plate 2). Sealing (201), and forming the latest deposit in the sequence, was a layer of turf (200).

Plate 2 Northeast facing section of Trench 2, 0.5m scale
