# St Mary's Church, Bampton, Oxfordshire

## Archaeological Evaluation Report

December 2017

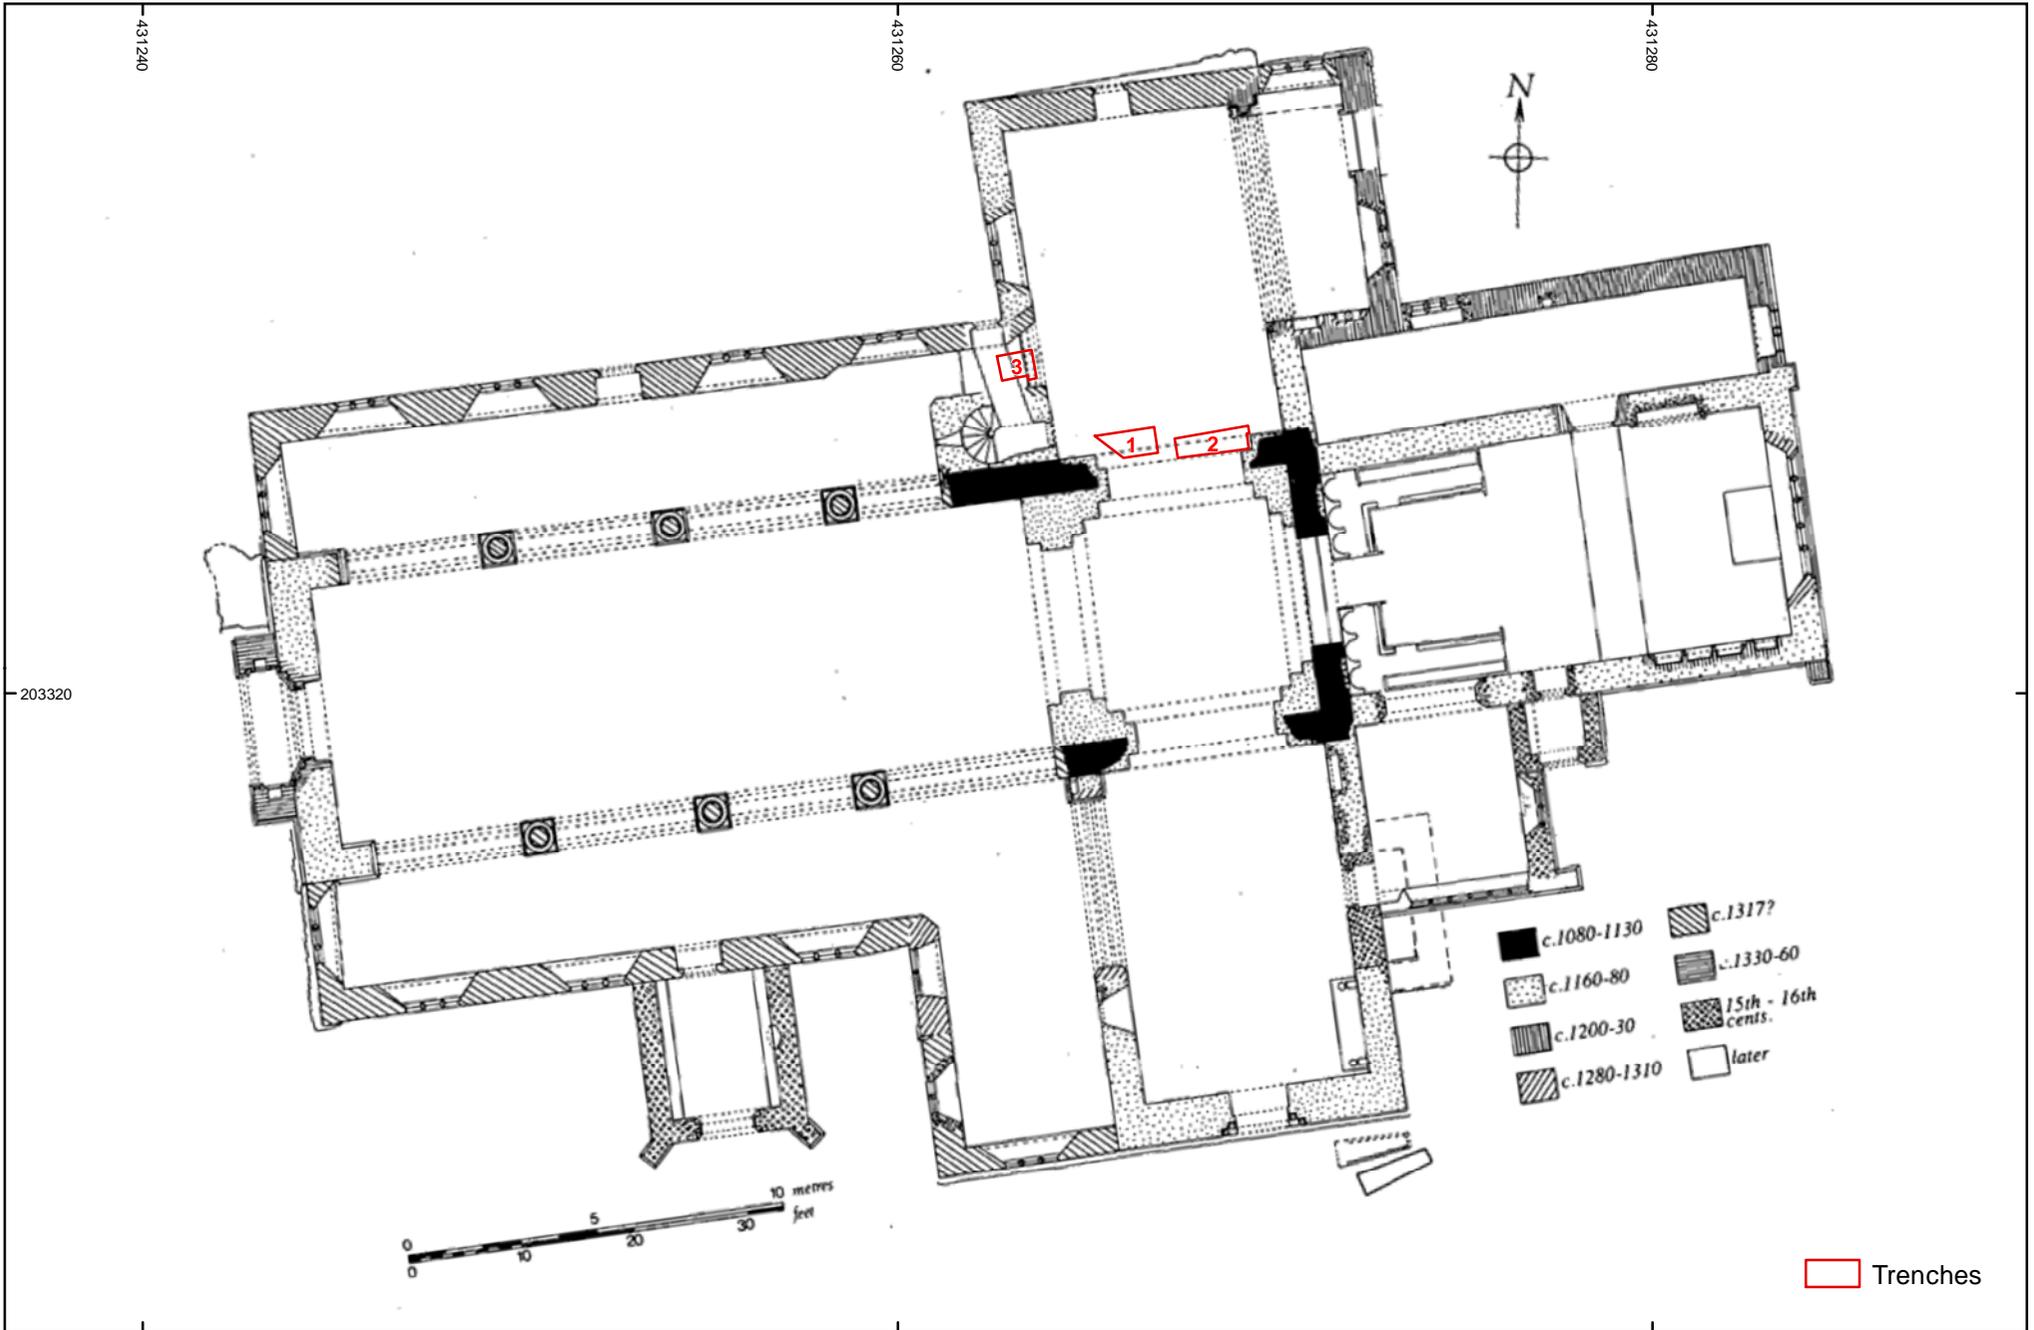
Figure 2: Trench location plan

- 2.1.2 A total of three trenches were excavated to investigate the potential for below-floor archaeological burial deposits in lieu of the installation of two glass screens in the North Transept (Fig. 2). These trenches were located on the west (Trench 3) and south (Trenches 1 and 2) sides of the North Transept, and were excavated to a maximum depth of 0.25m (Trench 1), 0.6m (Trench 2) and 0.45m (Trench 3).

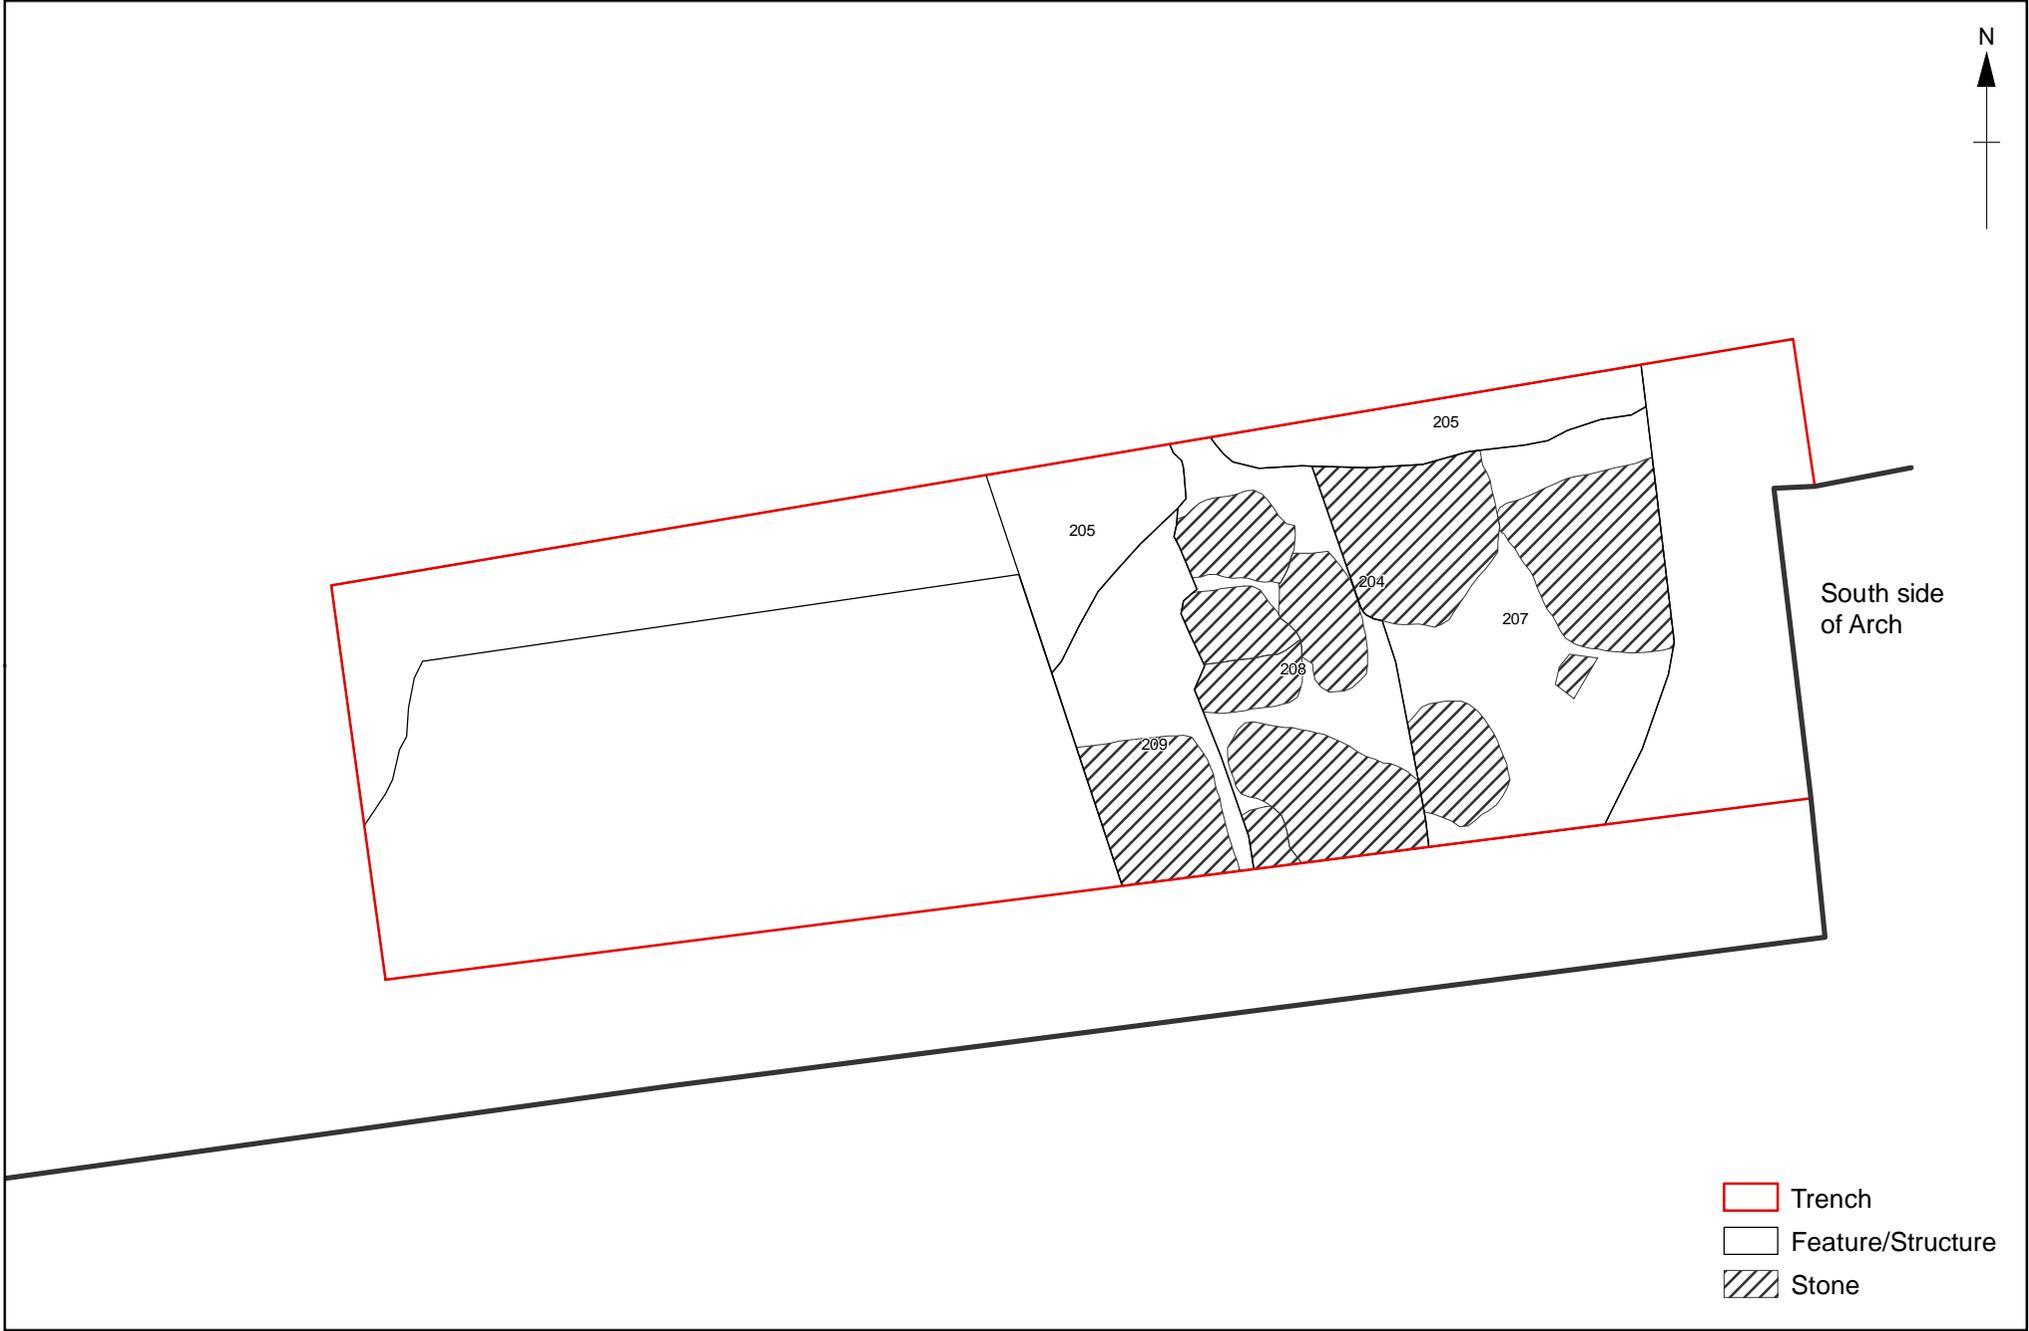
Figure 3: Trench 2

3.3.1 The earliest archaeological horizon reached was a W-E running structure comprising roughly hewn angular limestones measuring 0.15m x 0.1m (Figures 3 and 5; Plates 5 and 6). Only one course of masonry was exposed, and the overall structure measured >0.4m N-S (extending beyond the limit of excavation on both sides) and 0.26m W-E. The limited trench size meant that it was not possible to determine whether this structure ran underneath adjacent structure 207, or whether 208 butted 207. Furthermore, the date and function of structure 208 was unclear.

3.3.2 Structure 208 was adjacent to (and possibly overlain by) a N-S running structure (207) comprising irregular, sub-angular limestone blocks measuring between 0.15m x 0.1m x 0.08m – 0.25m x 0.2m x 0.12m. The west side of the structure was roughly faced. This structure was more than two courses high, but these two courses were rather irregularly placed. The limestone blocks were bonded with a coarse light brown mortar with rounded pebble inclusions. Overall, the visible structure measured 0.45m long, 0.35m wide and >0.17m deep. It is possible, but not confirmed, that this structure

represents part of the Transept's archway foundation. The structure continued beyond the limit of excavation to the north.

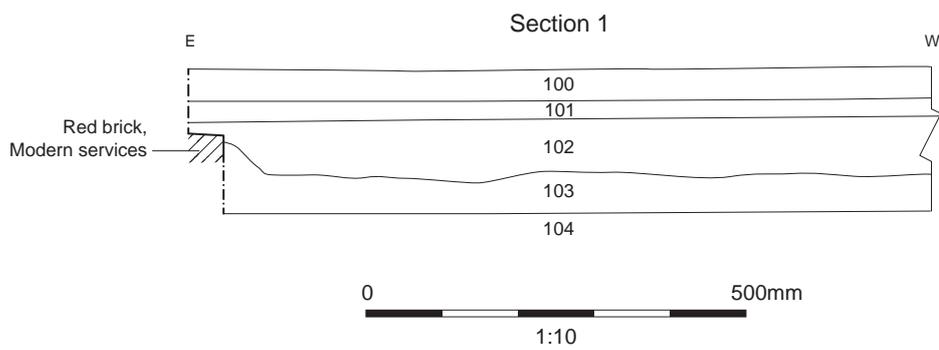
Figure 4: Sample section Trench 1

3.2.1 The earliest archaeological horizon identified was a compact layer of reddish brown sandy silt mixed with pale buff-white mortar, with sub-angular limestone inclusions measuring <30mm (104: Figures 2 and 4). Layer 104 extended beyond the limit of excavation in all directions. The compactness of this layer suggests that it may represent an earlier floor surface. No finds were present: this surface remains undated.

3.2.2 Context 104 was overlain by a 0.05m thick layer of friable pale buff-white mortar (103). This layer extended beyond the limits of excavation.

3.2.3 Context 103 was overlain by a 0.08-0.1m thick layer of friable pale reddish brown sandy silt mixed with pale buff-white mortar (102). Frequent angular limestone rubble inclusions were present, measuring <150mm.

3.2.4 Context 102 was overlain by a 0.05m thick layer of fine pale buff-white mortar bedding (101). This extended beyond the limit of excavation.

3.2.5 Layer 101 was sealed by 0.04m thick flagstone floor (100: the current church floor surface).

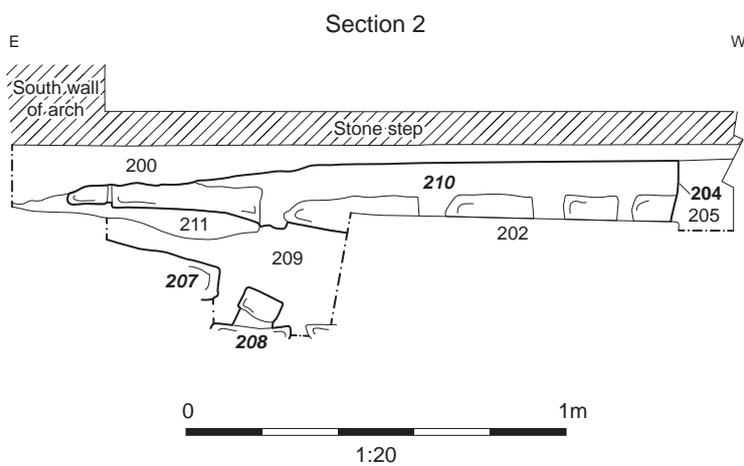
Figure 5: North facing section Trench 2

- 3.3.3 Structure 207 was overlain by a friable pale-mid brownish red silty sand layer, mixed with powdered pale buff-white mortar and frequent sub-angular limestone inclusions measuring <80mm (209). This layer was >0.25m deep and measured 0.5m x 0.4m. It is unclear whether 209 is the same as context 203, located to the south.

- 3.3.4 Context 209 was overlain by two contexts: a compact reddish brown sandy silt mixed with pale buff-white mortar with occasional rounded pebbles measuring <40mm and frequent sub-angular limestone inclusions measuring <40mm to the north (202); a coarse pale buff-white mortar layer with sub-angular limestone inclusions to the south (211). Context 202 measured 1.55m long and 0.4m wide, and was likely the eastern continuation of floor surface 104 from Trench 1, being extremely similar in both composition and depth within the trench. Service trench 204 cut through 202 on the north and west sides. Context 211 was only visible in the south facing section, measuring 0.6m in length and 0.09m in depth, and running below context 210 to the south. It is unclear whether 211 was a heavily disturbed continuation of floor 202.

- 3.3.5 Layer 211 was overlain by foundation structure 210: part of the foundation for the extant church structure. This context was only visible in the south facing section, with the north face butted by 202.

- 3.3.6 Floor surface 202 was overlain by friable pale reddish brown sandy silt mixed with pale buff-white powdered mortar, with frequent sub-angular limestones measuring <100mm, frequent chunks of sub-angular mortar measuring <60mm, and occasional red brick fragments measuring <80mm (201). This layer was 0.1m in depth, measured 1.85 x 0.5m, and was cut by modern service trench 204 on the north and west sides. This deposit was very similar to 102 in Trench 1, and may also be a levelling deposit for current flagstone floor surface 206.

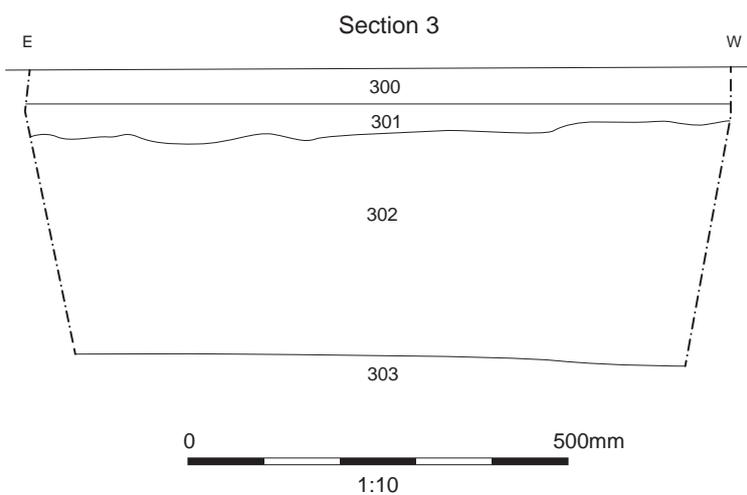
Figure 6: South facing section Trench 3

- 3.4.1 The earliest archaeological horizon in Trench 3 was a compact layer comprising flat angular limestones measuring <0.16m x 0.12m bedded into, and in places partially

covered by a coarse mortar with frequent rounded pebble and angular limestone inclusions <30mm (303: Figures 2 and 6; Plates 7 and 8). This layer was mid reddish brown in colour: it was difficult to distinguish whether this was because earth was mixed into the layer, or whether overlaying deposit 302 had discoloured layer 303. Layer 303 extended beyond the limit of excavation in all directions. Layer 303 likely represents a floor surface. No finds were recovered: layer 303 thus remains undated.

3.4.2 Context 303 was overlain by a friable mid reddish brown sandy silty containing frequent angular and sub-angular limestone inclusions <40mm and occasional rounded flint nodules <80mm. This layer extended beyond the limit of excavation in all directions and measured 0.35m in depth. Occasional fragments of disarticulated human bone were present.

3.4.3 Context 302 was overlain by a pale yellowish grey coarse mortar (301). This layer extended beyond the limit of excavation in all directions and was 0.07m in depth. This layer was the mortar bedding layer for overlying stone flag flooring 300 (same as 100 and 206).

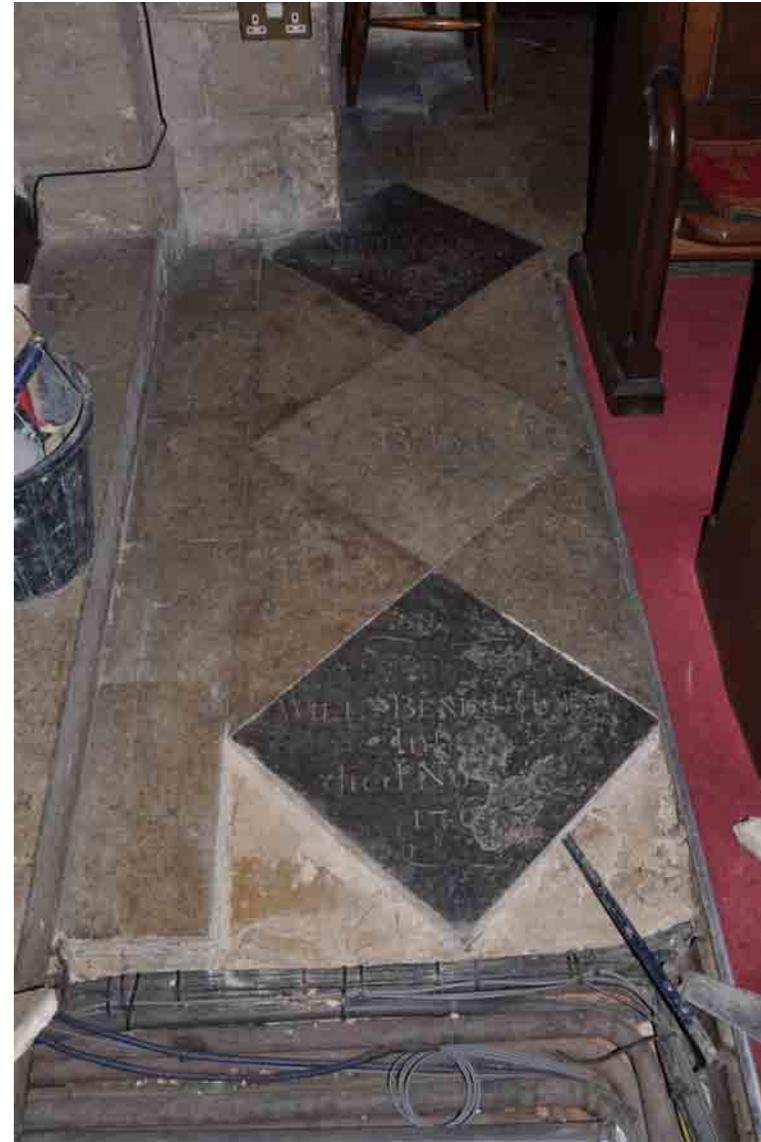
3.1.1 The three trenches were located according to the proposed positioning of the two glass screens. Trench 1 in particular was located to investigate an area where three memorial stones were set into the church floor (Plate 2). All three memorial stones were engraved with an 18th century date. It was unclear whether these stones were in their original location or whether they had been moved and re-laid during 19th century refurbishment of the church. All trenches were located in positions that would avoid disturbance of modern services.

Plate 2: 18<sup>th</sup> century memorial stones

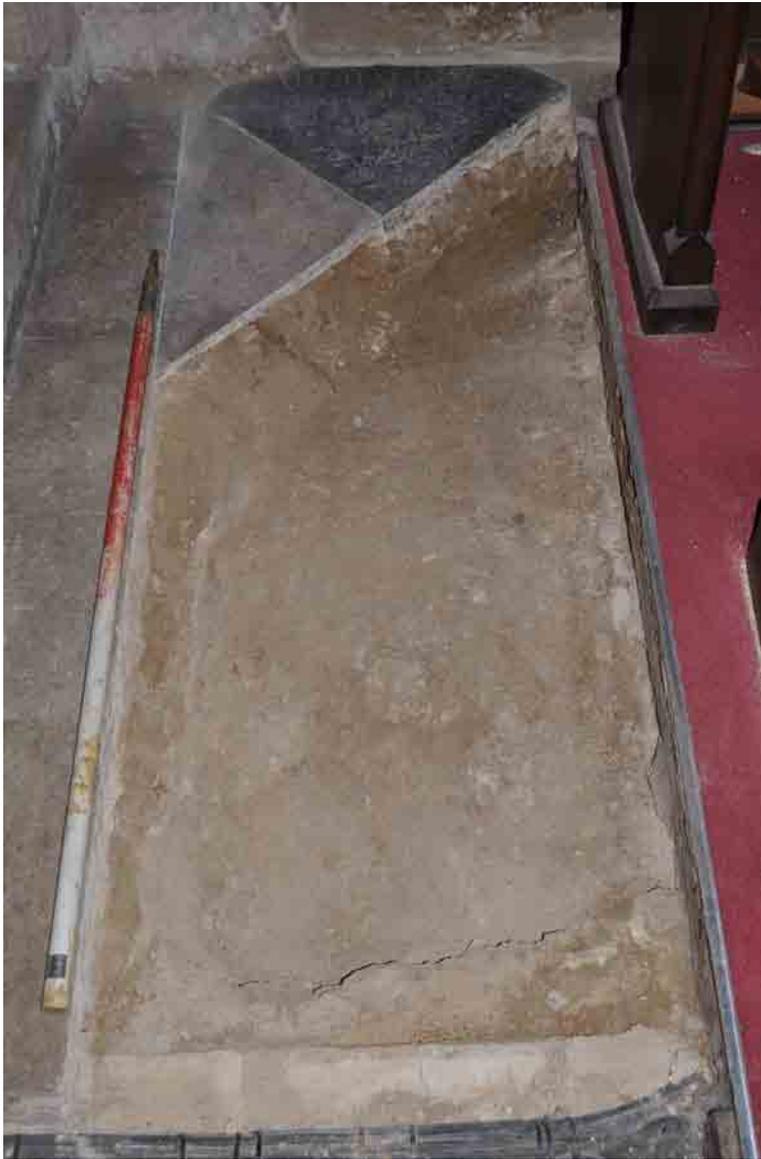
Plate 3: Trench 1 with the memorial stones removed (1m scale)

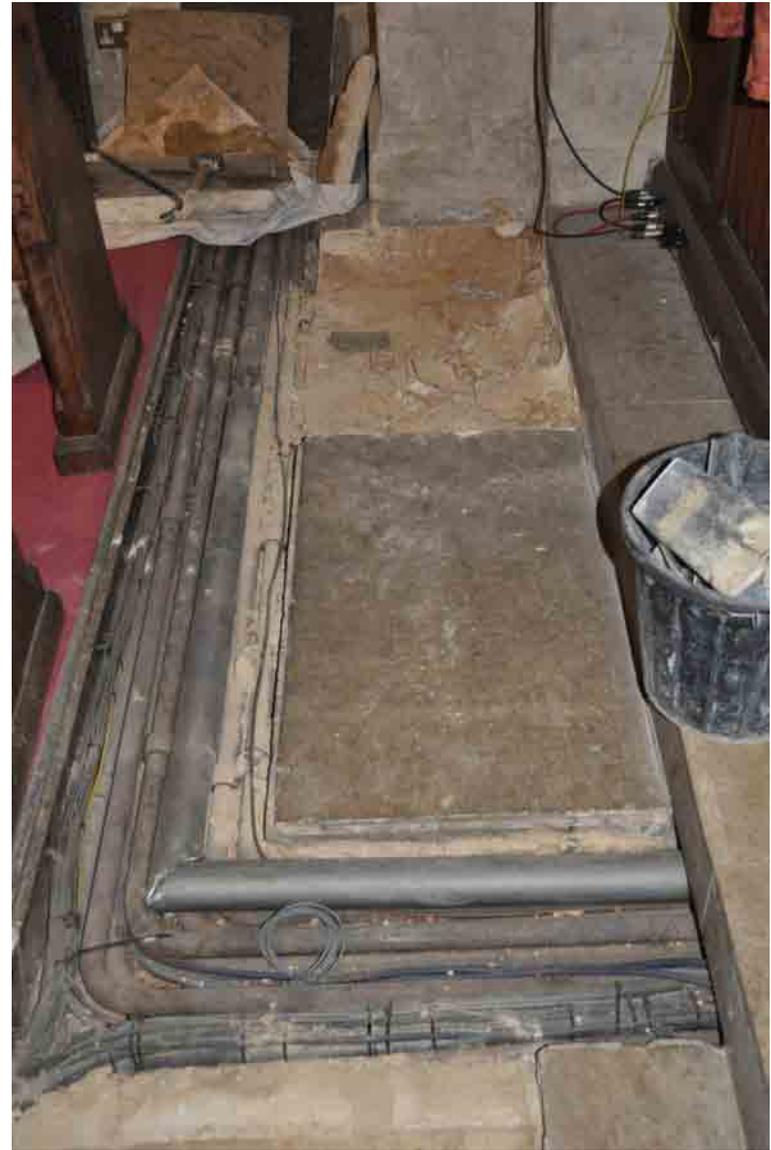
Plate 4: Trench 2 with the floor slabs removed

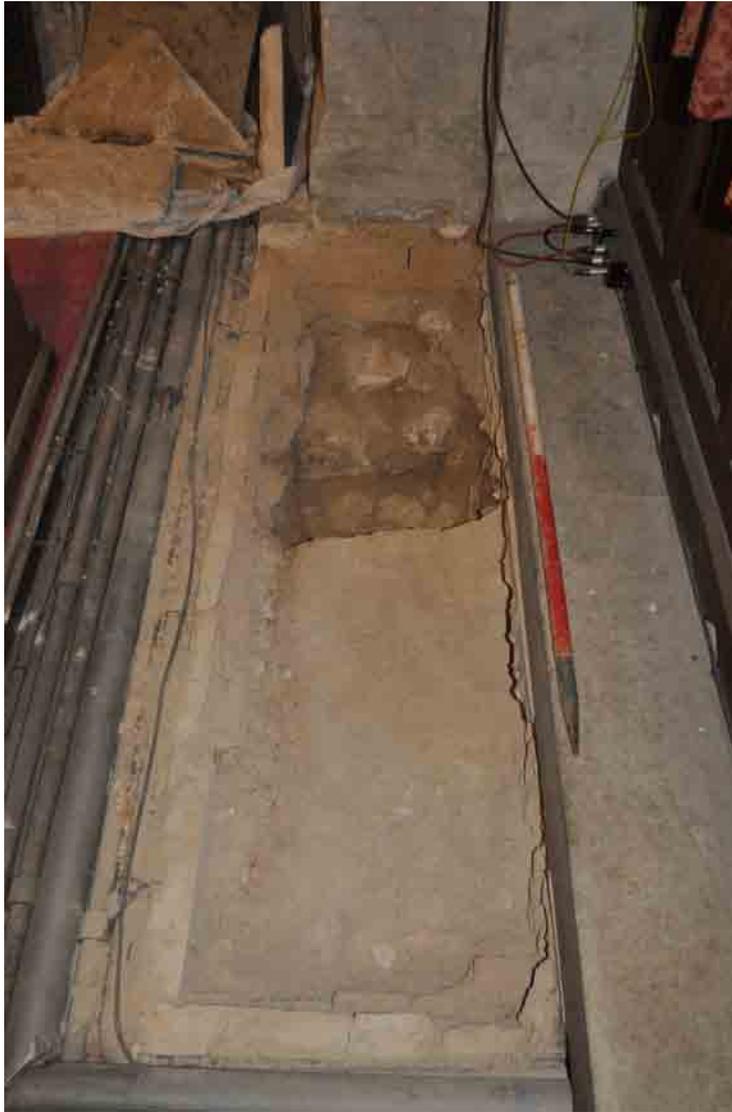
Plate 5: Excavation within Trench 2 (1m scale)

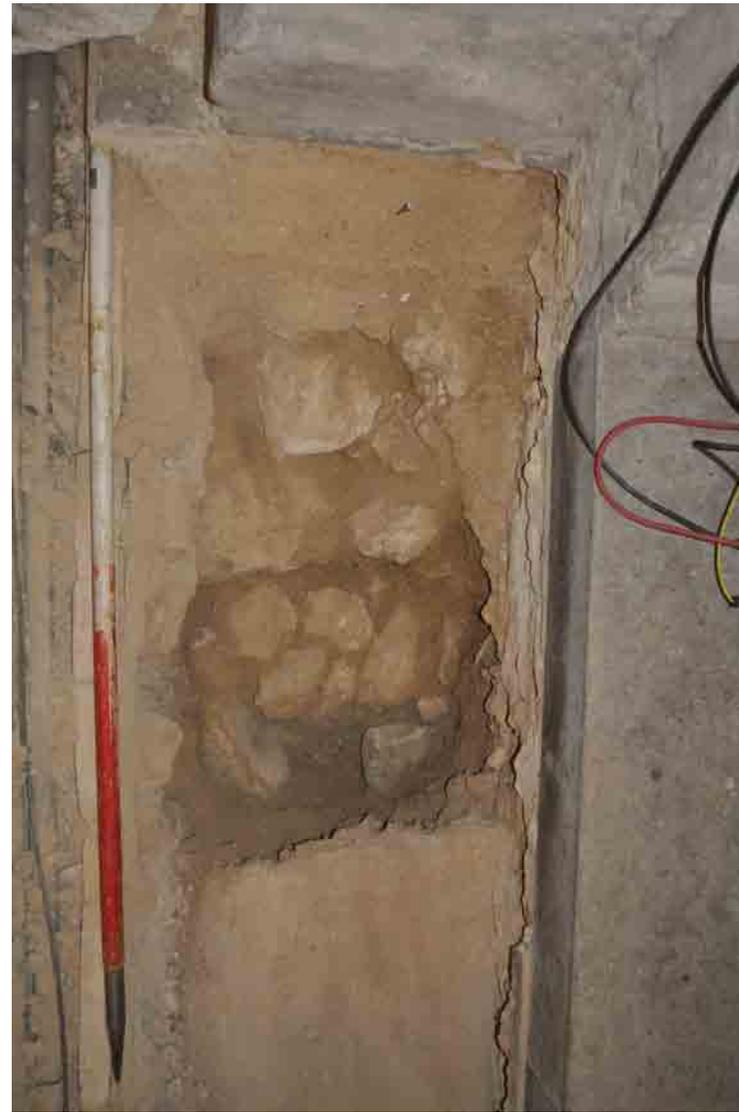
Plate 6: Earlier floor surface within Trench 2 (1m scale)

- 4.1.1 Evidence for two floor surfaces was recorded during the excavations. The surfaces observed in Trenches 1 and 2 are likely to be the same. Both this and the surface found in Trench 3 are likely to pertain to earlier phases of the church building. No dating material was recovered, thus both floor surfaces remain undated.

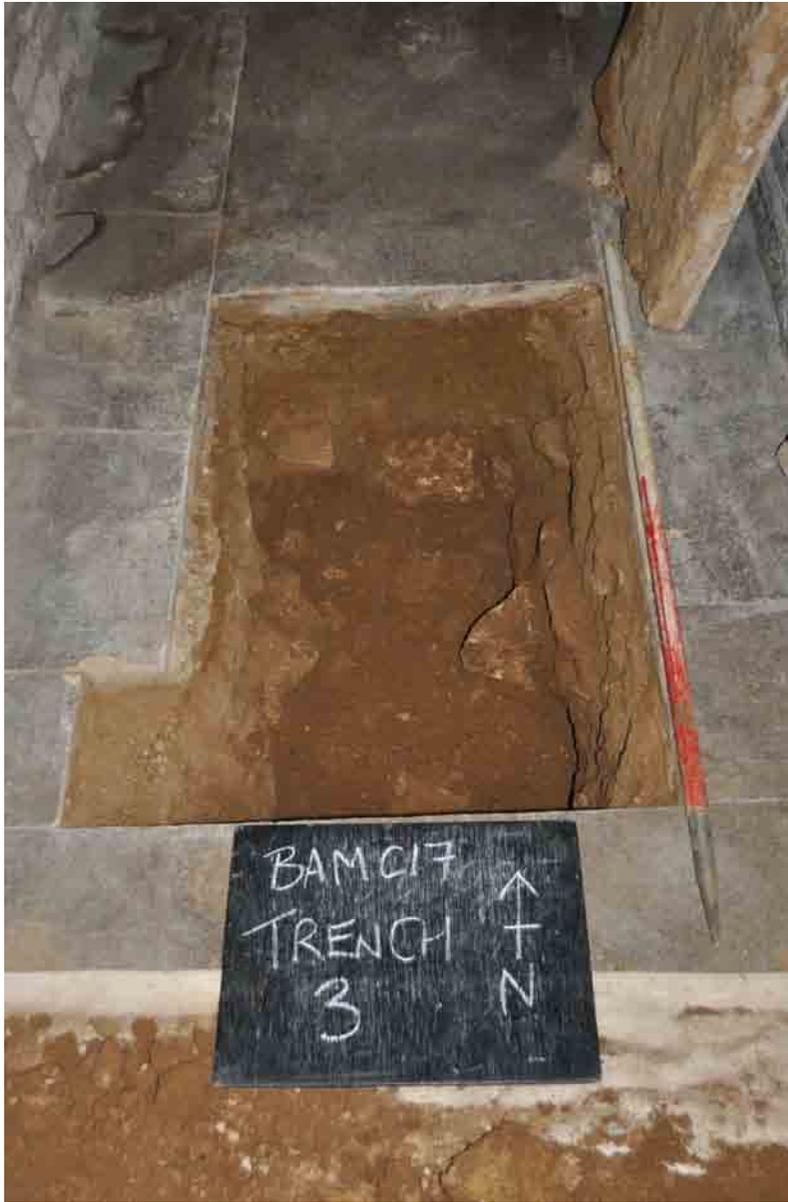
Plate 7: Excavation of Trench 3 (1m scale)

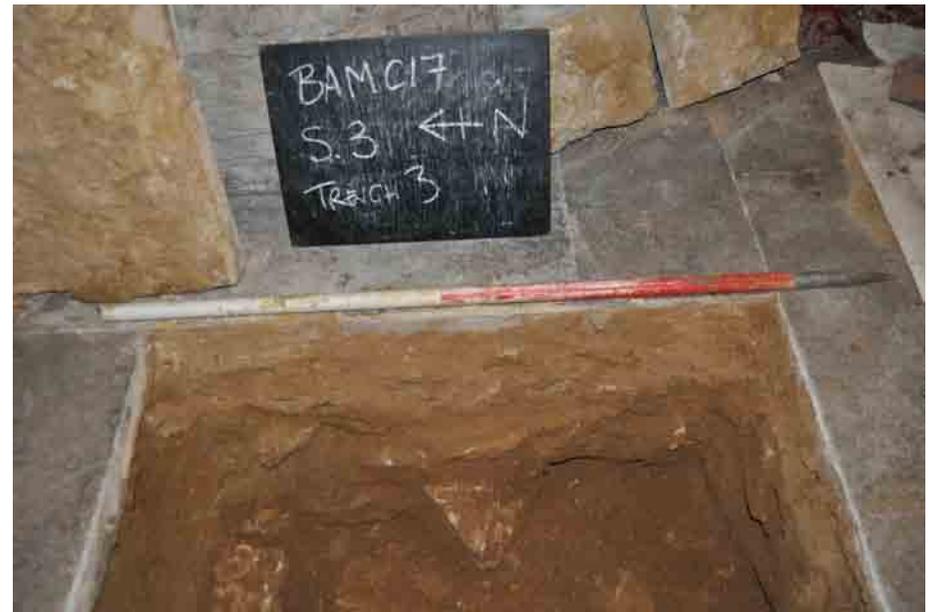
Plate 8: Trench 3 section (1m scale)
