Energy Audit Report for St. Mary & All Saints with St. John's Church

Site Address	St. Mary & All Saints with St. John's Church, Rossendale, BB4 8DD
Church Code	624372
Author	Tim Mawby Graduate Consultant
Date	19th December 2019
Version	1.0

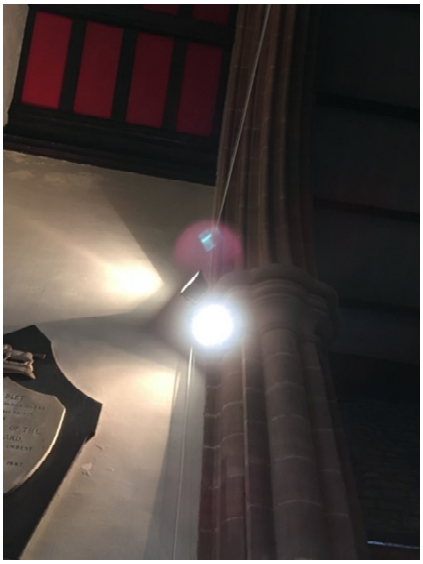
Photographs 7, 8 & 9: Church Light Fittings

Church

- 8no. lamps, consisting of 3no. 20W fluorescent lamps – recommended to be replaced with 3.5W LED alternatives.
- 12no. 100W halogen spotlights – recommended to be replaced with 12.5W LED alternatives.
- 4no. 200W halogen floodlights – recommended to be replaced with 60W LED alternatives.

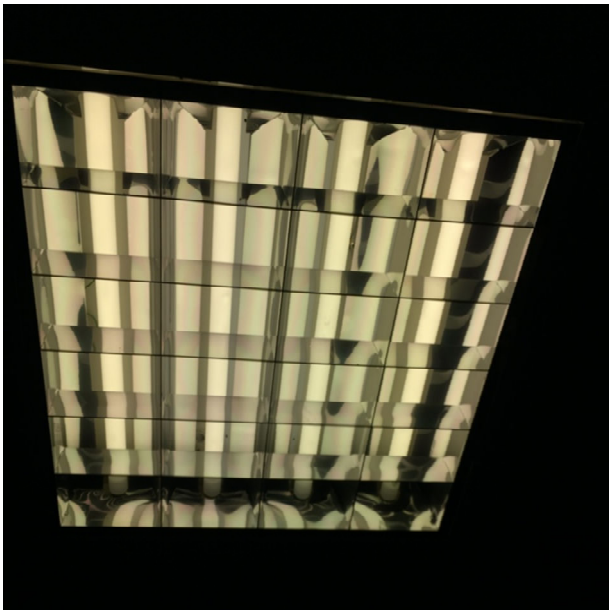
Photographs 11 & 12: Dining Room Light Fittings

Dining Room

- 11no. fluorescent panels, consisting of 4no. 18W T5 fluorescent tubes – recommended to be replaced with 8W LED alternatives.
- 3no. 25W fluorescent spotlights – recommended to be replaced with 3.5W LED alternatives.
- 3no. LED spotlights.
