Energy Audit Report for Holy Trinity Church

Site Address	Holy Trinity Church, Ashton-under-Lyne, OL6 7HD
Church Code	624021
Author	Ros Harwood, Graduate Consultant
Date	20th February 2020
Version	1.0

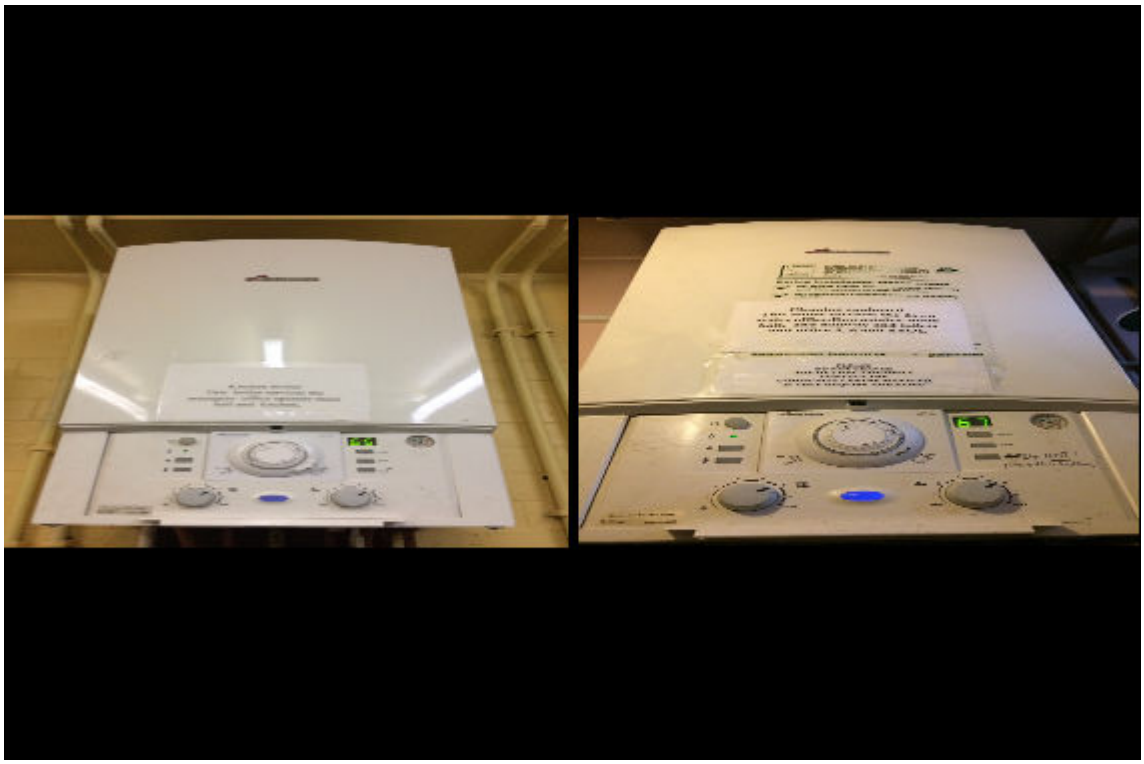
Photograph 2: Church Boilers

Heating is provided to the church via 2no. 30kW Worcester gas condensing boilers, which are 10 years old, one located int the main kitchen and one located in cleaners' cupboard. Each boiler serves a different area; the first serving the manager's office (first floor left), the kitchen and the upstairs main hall; the other serves the downstairs office, the downstairs main hall, hallway, toilets and the admin offices (first floor right). The first boiler's heating schedule is currently programmed to be active for 66.5 hours per week at 65 degrees and the second boiler's heating schedule is currently programmed to be active for 38.5 hours per week at 67 degrees. The first boiler is currently on for 9.5 hours less and the second boiler is currently on for 37.5 hours less than the building is occupied for to allow the building the be heated to the desired temperature for when the demise is scheduled to be occupied. Control panels are located on each of the boilers. The temperature and the schedule are kept the same, however manual override is possible if required so that the system can be switched on outside of the programmed hours, as well as the changing of the temperature set point.

While the boiler appears to be in good order, the Site contact stated they are currently exploring options to replace the boilers during the next 12 months. During this process, the client may wish to explore the possibility of installing an air to water heat pump heating system in order to move towards the goal of decarbonising energy consumption.

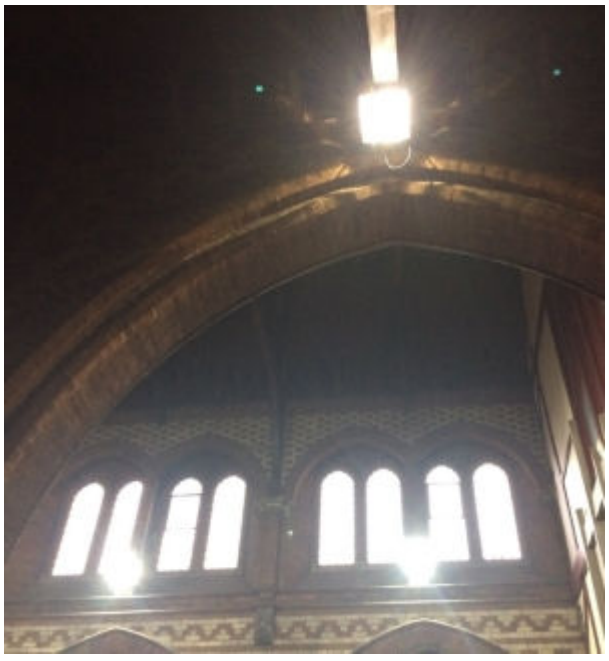
Photographs 7, 8 & 9: Church Light Fittings

- 10no. 65W fluorescent T8 tubes – recommended to be replaced with 22W LED alternatives. (2hrs per week)
- 4no. 28W compact fluorescent lamps (CFLs) – recommended to be replaced with 7.5W LED alternatives. (2hrs per week)
- 10no. 100W LED floodlights (2 hrs per week)
- 4no. 100W halogen floodlights – recommended to be replaced with 60W LED alternatives. (2 hrs per week).
- 1no. 60W LED floodlights (21 hrs per week)

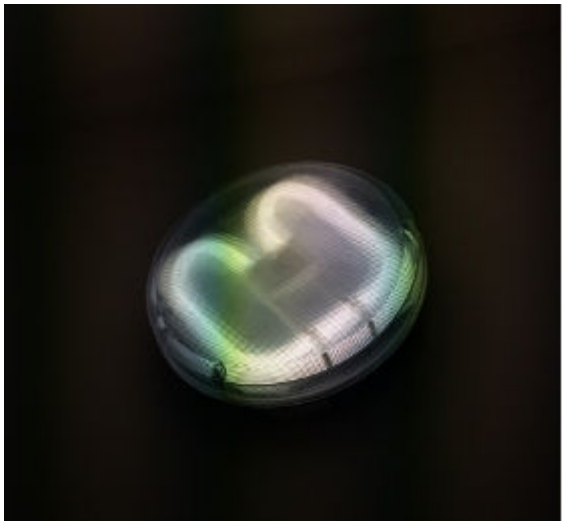
Photograph 11: Compact Fluorescent Lamp (CFL)

- 4no. 28W CFLs – recommended to be replaced with 7.5W LED alternatives. (6hrs per week)
