Job: STOCKLAND BRISTOL St Mary Magdalene's

Drg No: 002-2

Title: As Existing Ground Floor Plan 2

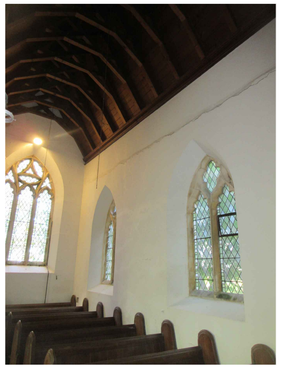
Cracking at high level on the north wall of the North Aisle

Extensive cracking and detachment of plaster and brickwork to east wall of North Aisle

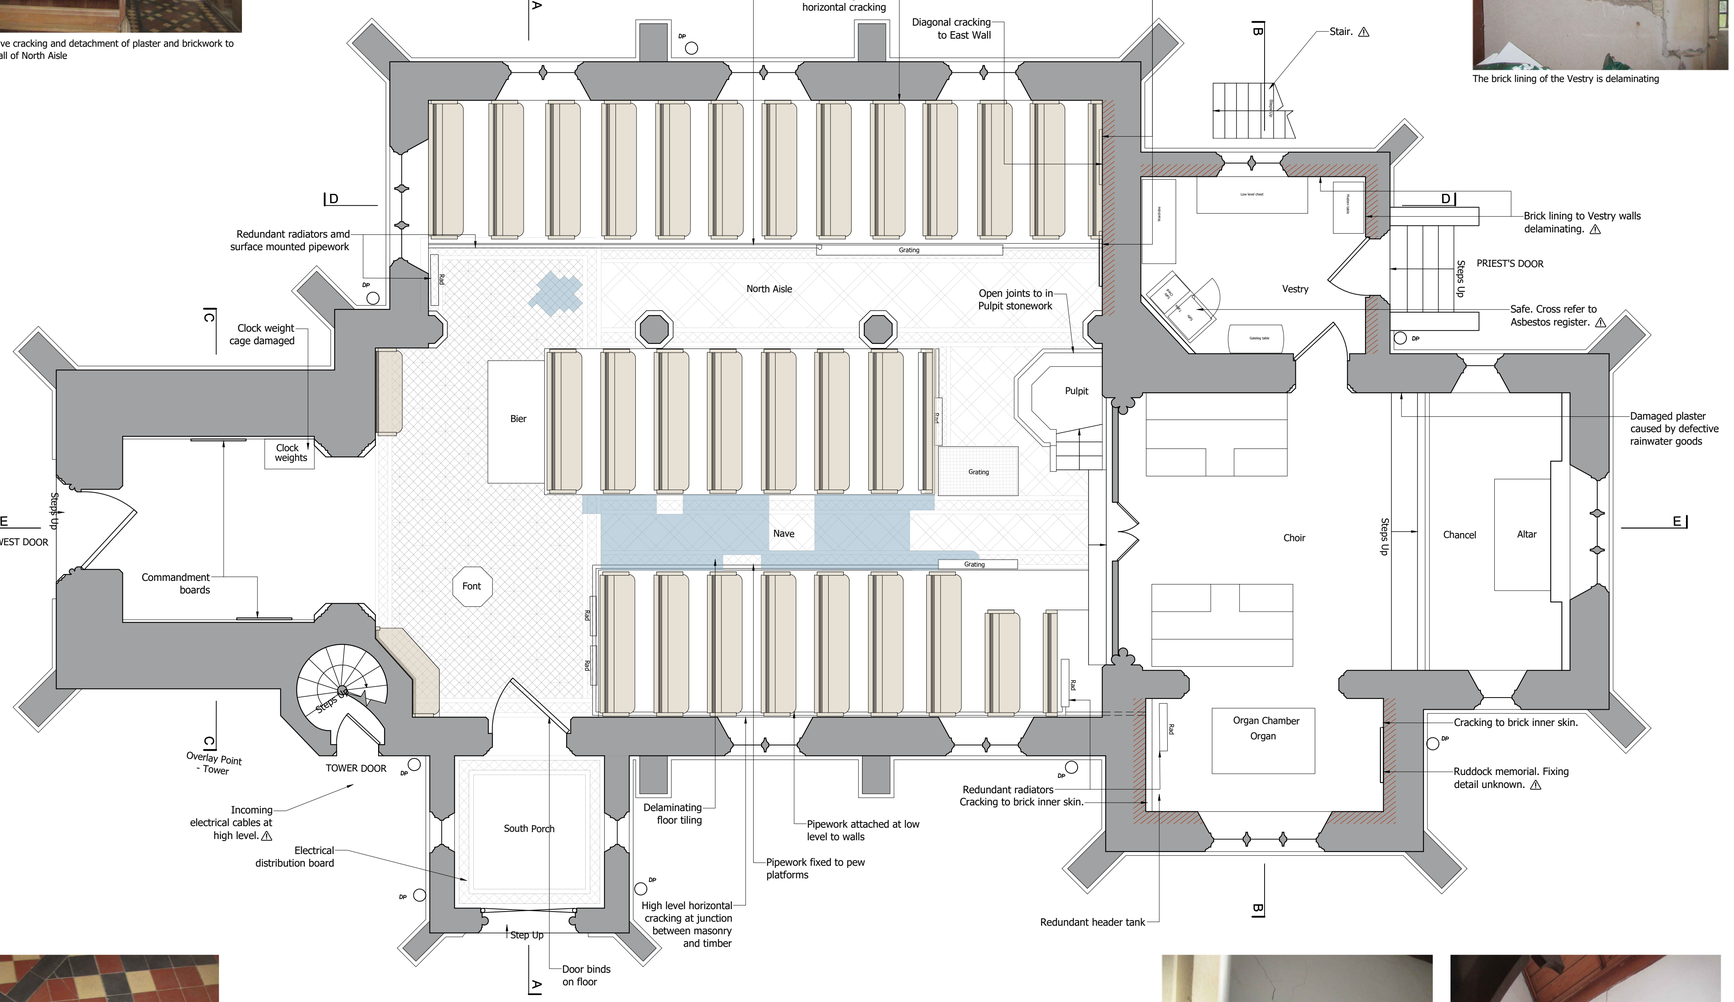
Area of tiling detaching in poor condition

Moisture damaged plaster in the Chancel (North Wall)

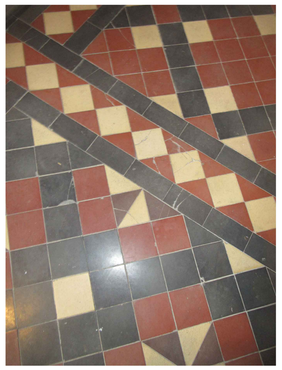
Damaged and detaching floor tiling
