Brinkworth

At last the bells have come back from Soundweld and Taylors. They were taken out early December and returned on the 3rd October, so they have been away 10 months.

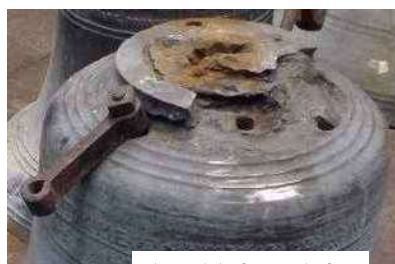
The 3rd, before and after

The 3rd had already been turned 90° and is now 45°.

As they were being winched up you could see most, if not all, had been quarter turned already and, although the clapper marks have been filled in, the bells are now turned 45°. At the end of the first day five of the

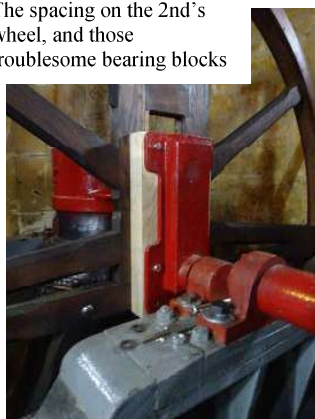
The spacing on the 2nd's wheel, and those troublesome bearing blocks

The wheel on the 2nd had to be moved over an inch or so with some wood packing between it and the bracket on

the headstock so the rope did not have to pass through a steel beam.

bolted to the wheels of two of them to make them easier to ring. However, the two's weight would not go on as the wheel had been moved over! So the weight

has gone on the other side of the wheel.
