Padiham St Leonard (Diocese of Blackburn)

**Condition report and recommendations for
restoration of south aisle east window
(John Hardman, 1870)**

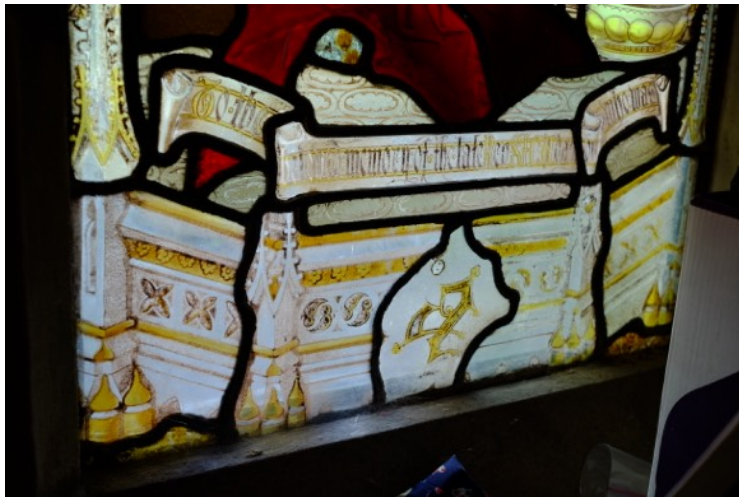
detail: former north aisle north wall, westernmost

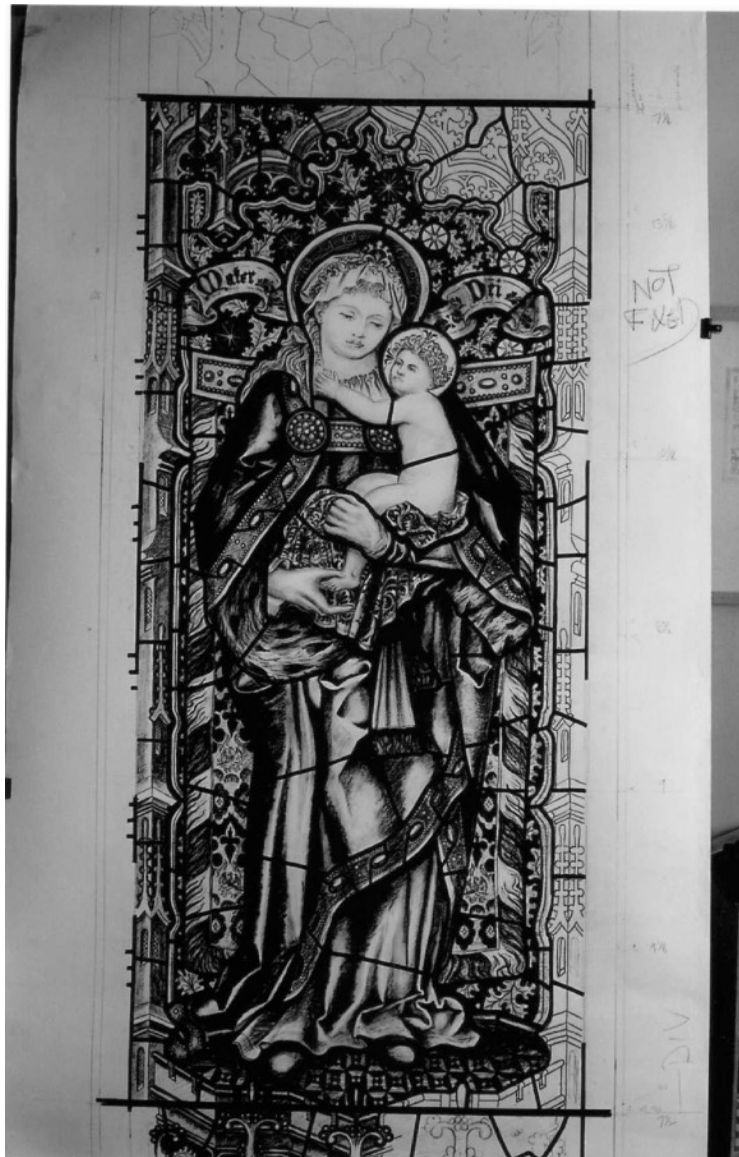
example of full size 'worked - up' cartoon, showing intended painted detail, and all lead lines

Jonathan Cooke, for replica of window destroyed by arson, Jarrow, Christchurch (Diocese of Newcastle)
