St John's Church, Ivybridge, Devon (Diocese of Exeter)

Jane Phillips monument

Conservation Report

May 2019

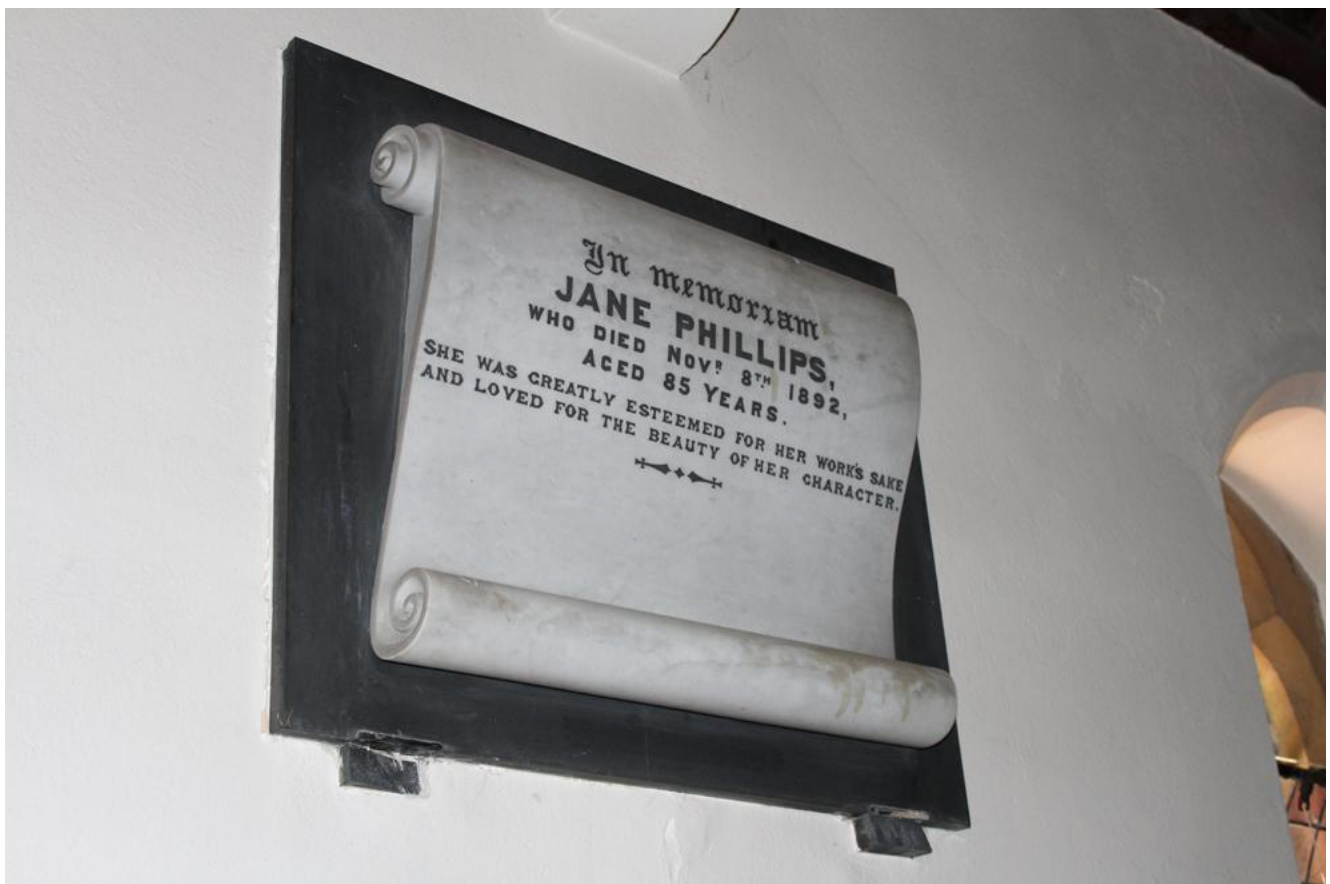
The monument consists of a scroll-shaped inscription backed on a simple rectangular backing plate, and supported on two corbels of black limestone. The corbels are built in to the wall behind and the monument is then retrained to the wall with bronze cramps. Each corbel had a rebated upper surface, so that the monument sits behind a small upstand of approximately 5 mm. The intention of this was evidently to make the monument more stable.

The monument was structurally unstable owing to the fracture of both corbels, the faces of which had broken away leaving the large plaque above vulnerable to collapse. The cause of this problem was not immediately clear (but see below).
