St John the Baptist, Bishop's Tawton, Devon (Diocese of Exeter)

Wall monuments

Conservation Report

January 2020

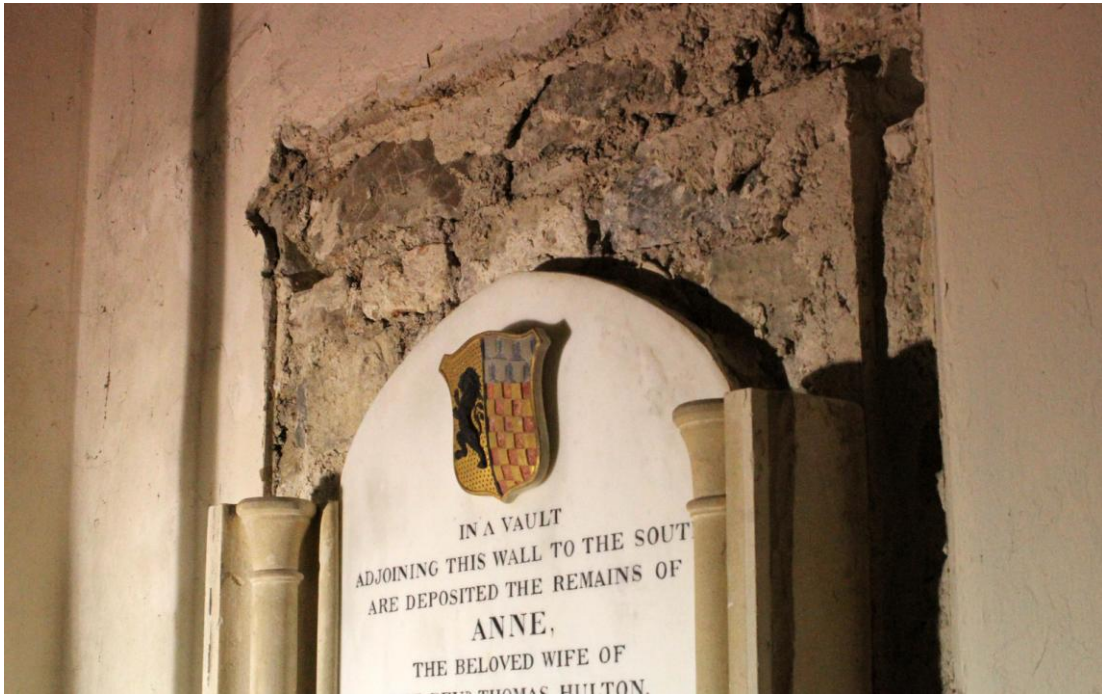
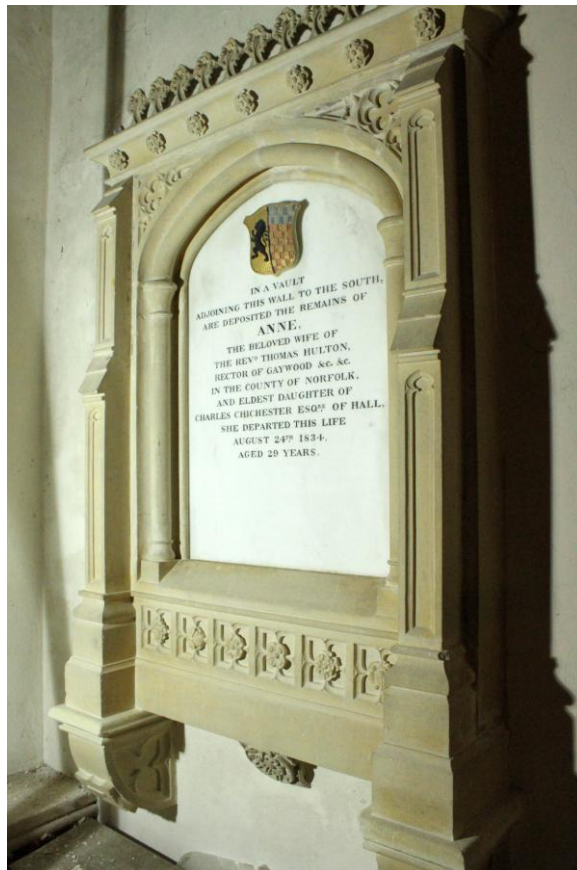
The Hulton monument after work

The arch sections had suffered widespread fracturing from the corrosion of metal repair cramps; all metal elements were removed and the shattered fragments dowed together with stainless steel pins and cramps set in epoxy resin. Gaps and losses were filled with lime mortar matched in colour and texture to the surrounding stone.

The monument was then reassembled and fixed back in place with stainless steel cramps set in polyester resin. Joints were bedded and pointed in lime mortar.
