# Report on an Archaeological Watching Brief at the Church of St. John the Baptist, Grimston, Leicestershire

Prepared for: Midlands Stonemasonry

Report Number: 023/2019

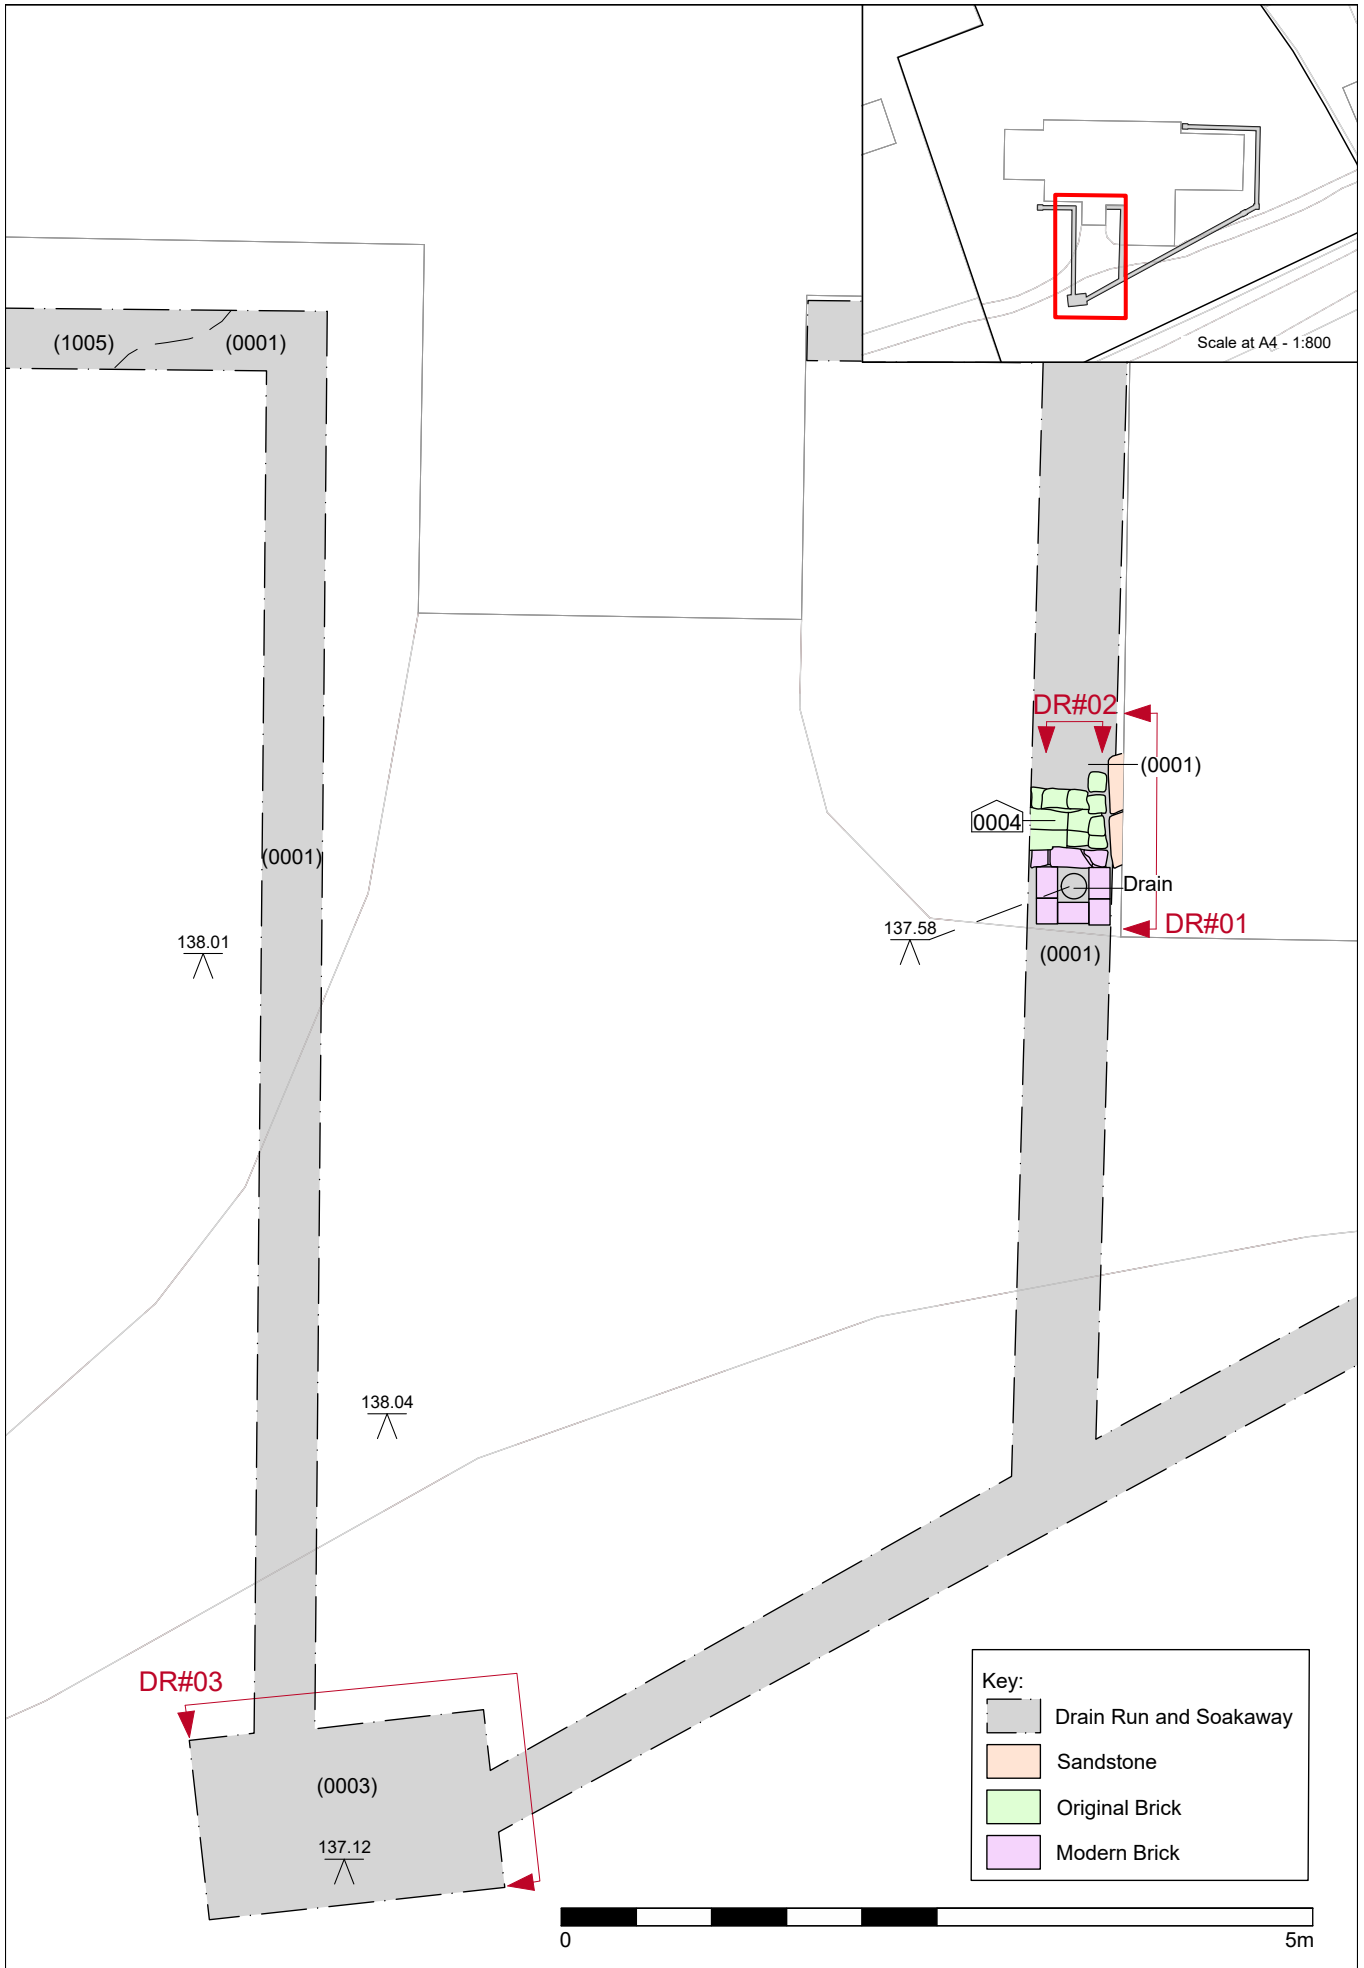
DR#01  
West Facing Section Of Church Wall Base, Drain and Structure 0004

- 6.4 **Brick structure [0004]. Figures 2 and 3 (Dr#1 and 2); Plates: 6 – 7.**
- 6.4.1 Excavation of a section of the north by south drain run immediately parallel to the southern projecting transept revealed the remains of a brick structure [0004] truncated by a modern drain. This was comprised of four courses of reddish orange bricks c. 0.18 x 0.12 x 0.06m and parts of which were seen to be bonded with patches of cement/mortar. The eastern edge of the bricks appeared to directly abut the foundation/lower stone course of the church, and removal of a single course suggested that the feature did not continue into the east facing section of the trench, however this is not clear. A 0.12 – 0.08m deep sondage was excavated by the north facing elevation which showed the
