# Energy Audit and Survey Report

## Christ Church, Ashford

Ashford Town Parish PCC

An energy survey of the Christ Church, Ashford, Beaver Road, TN23 7SR was completed on the 9<sup>th</sup> January 2020 by Dr. Paul Hamley. Paul is an energy auditor with experience of advising churches and small businesses. He is part of the Diocesan Environment Officers Energy Group developing advice for the Church of England and authored the "Assessing Energy Use in Churches" report for Historic England. He is a CIBSE Associate member and a Chartered Scientist, with experience of the faculty process gained from chairing the building committee of a Grade I listed church.

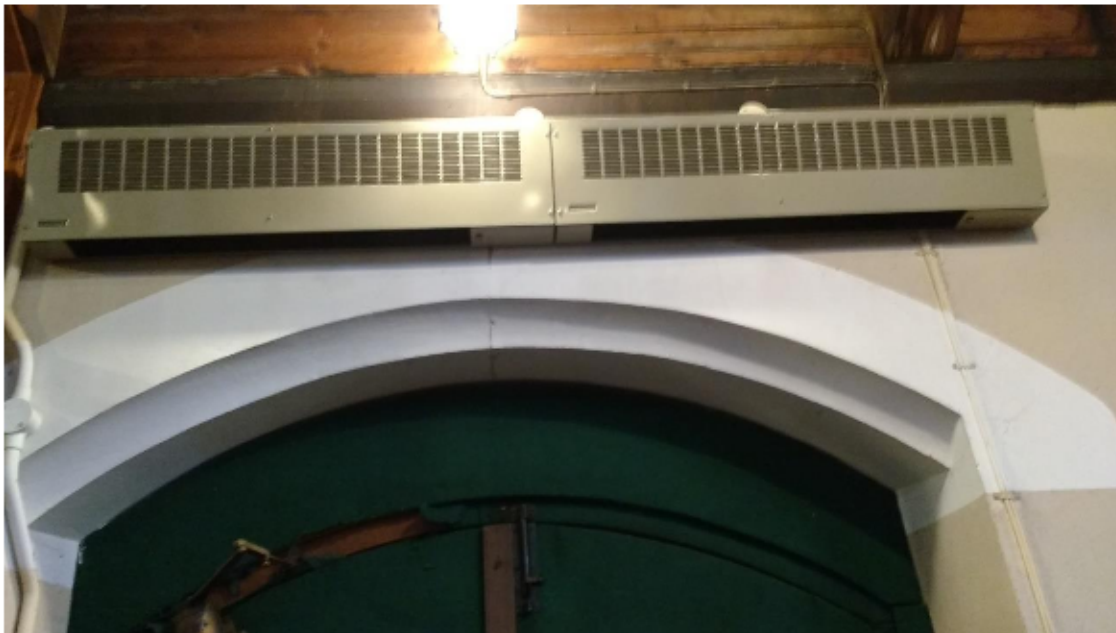
Seating in the south aisle chapel, separated by glass screens.

In addition to the central heating, two fan heaters are situated above the south entrance porch.

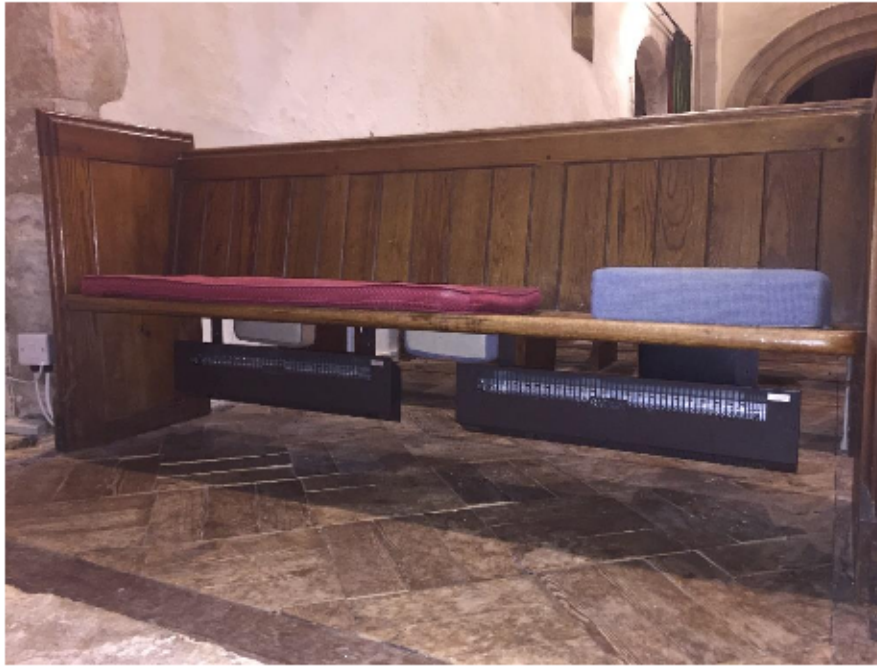
The under pew (see photo below) and panel heaters have been recently installed at St Andrews Church, Chedworth, Gloucestershire, GL54 4AJ. The church is open in daylight hours so can be viewed at any time.

A future option to replace gas fired space heating is to install under pew electric heating. Although electricity is currently more expensive than gas per kWh, this form of heating requires little preheating time and delivers heat directly to the congregation. There are three sets of eleven pews with a further nine in the south aisle separate area.

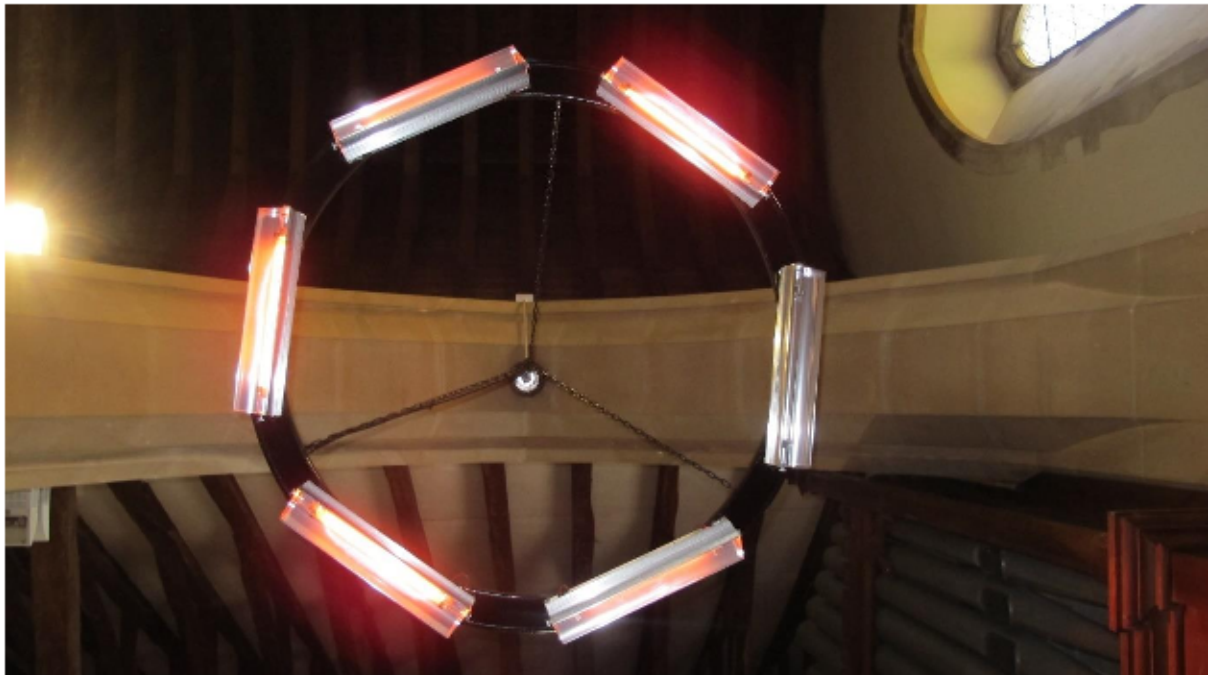
The image below is from St Catherine's, Faversham, which is heated solely by chandelier mounted radiant heaters.

Another option would be to use radiant (glowing) heating elements – these normally look unsightly when hung from ceilings or attached to walls but have been successfully deployed in churches hung from chandeliers, where they can be combined with lighting if desired.
