St. Cyr's Church

**Stinchcombe,
Gloucestershire.**

Report on the Conservation of six Churchyard Monuments.

October 2019.

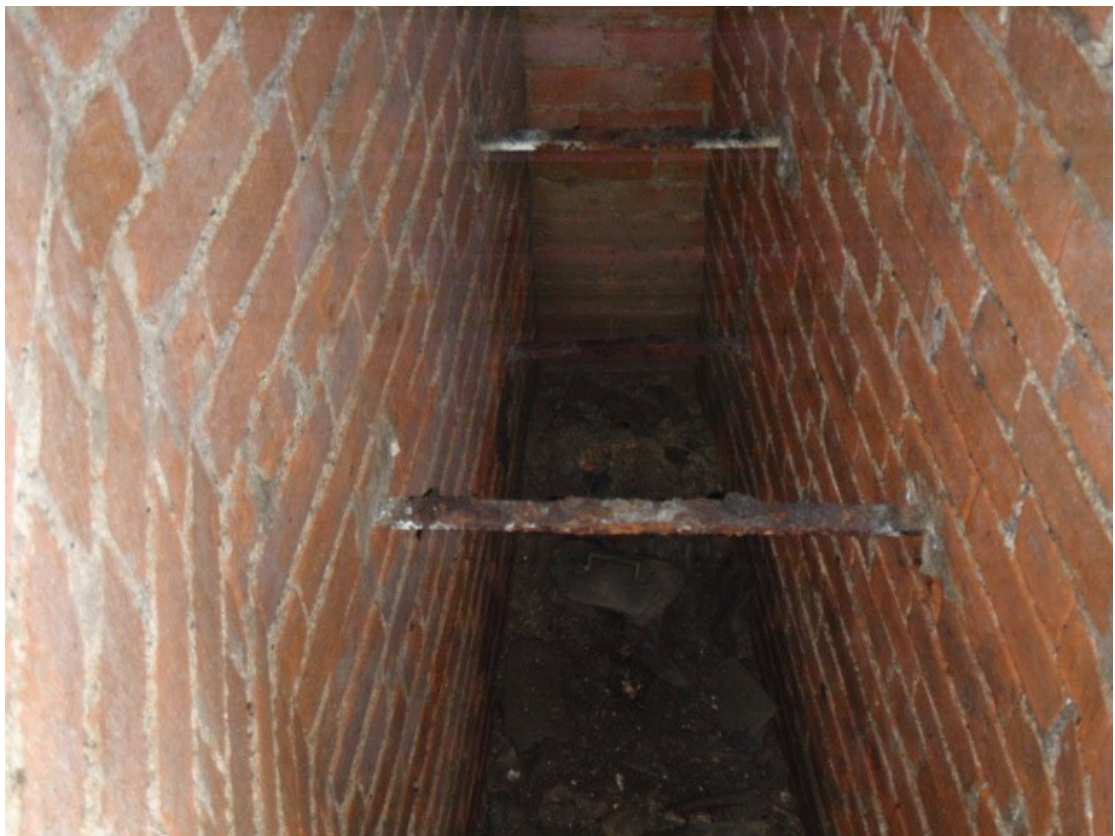
The brick-lined shaft beneath the John Marbett 1879 monument.

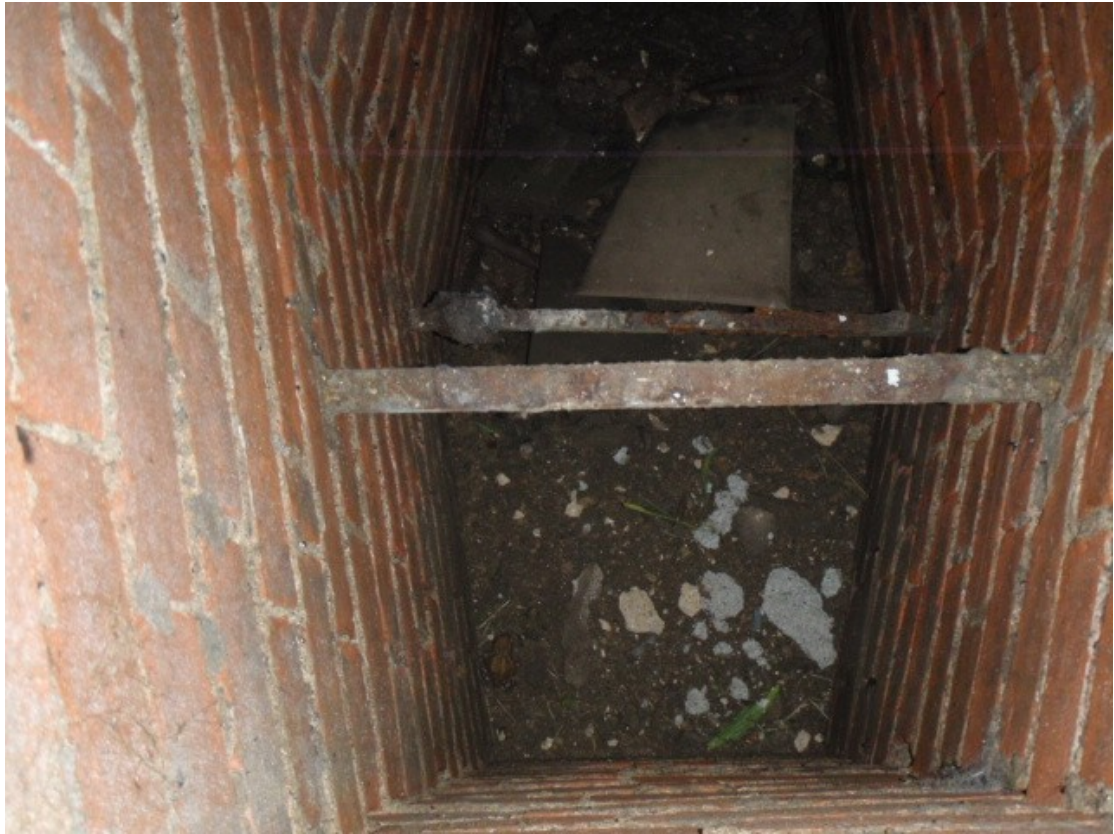
The west (head) end of the shaft.

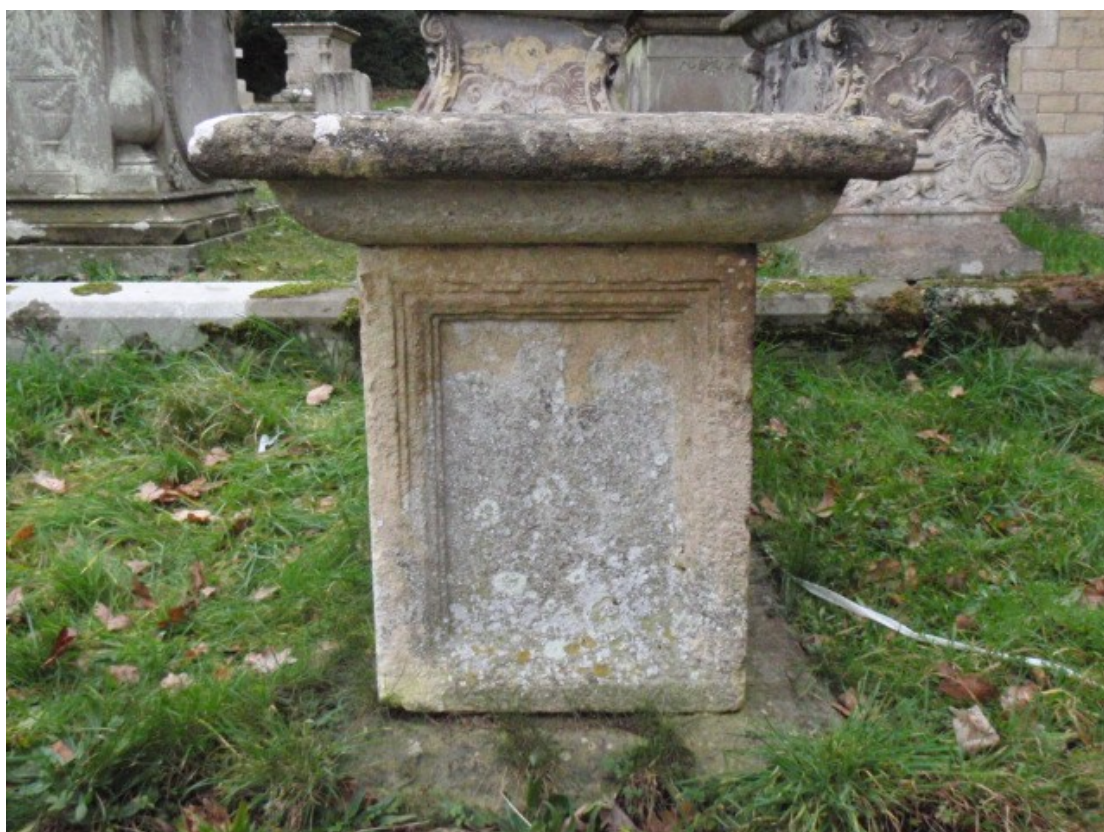
West end before conservation.

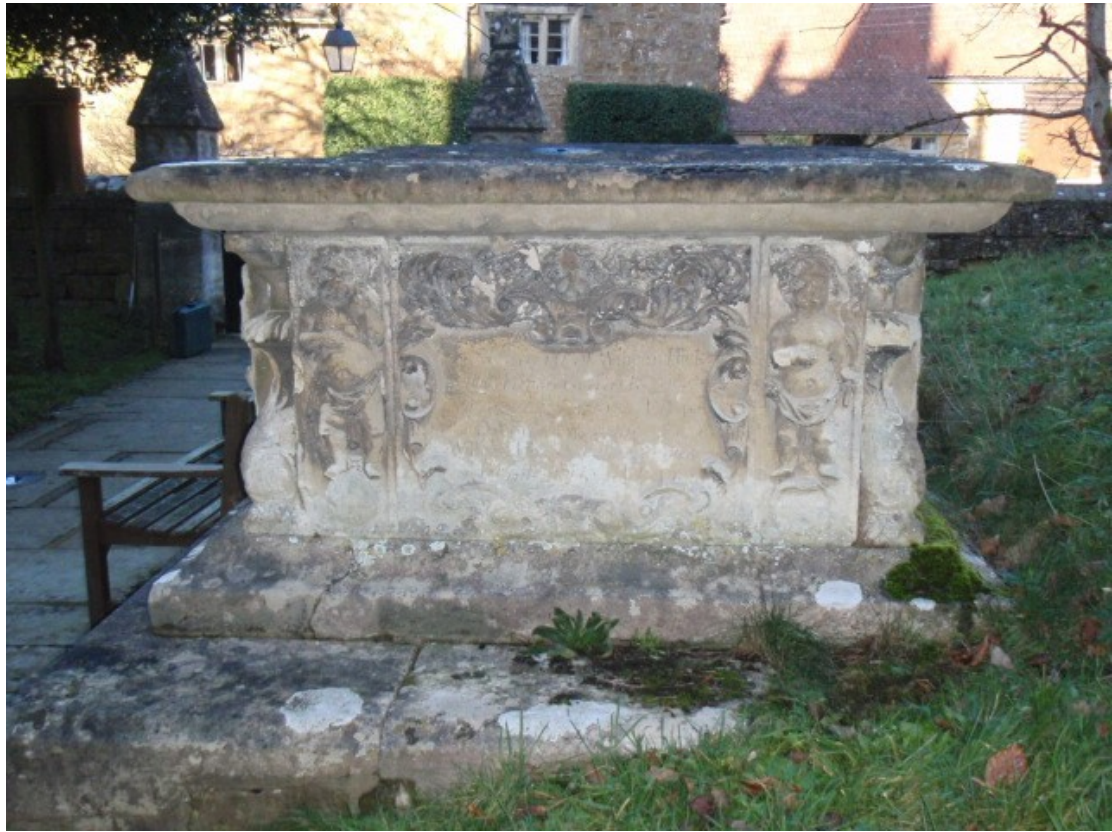
The limestone is in sound condition, with moderate weathering of the surface and some growth of lichens. Some of the lime mortar in joints between the stones has weathered back, potentially allowing more water to enter. Iron cramps present at the corners have rusted, expanded, and lifted the lid. The N side panel is broken, possibly by an iron cramp. The monument has been repaired previously using cement. The gap created by the lifting of the lid has been filled with cement-based mortar and slate wedges, but the iron cramps are still *in situ* and continue to lift the lid. The plinth has not moved on the covering slabs beneath, and is stable.

The south side before conservation.

All cement pointing was removed. The lid was lifted, and rusting iron cramps removed and replaced with stainless steel ones, before repositioning the lid on a bed of lime mortar. The broken N side panel was removed without disturbing the S panel and ends, and repaired and reinforced by setting stainless steel flat bars into slots cut with a small angle-grinder using polyester epoxy resin. The break was repaired using a lime repair mortar mixed to match the stone for colour and texture. Open joints were repointed. The very wide joint between the covering slabs and the plinth stone was repointed with a coarser mortar of 3 parts Ashton Keynes sand, 2 parts Frithend sand and 2 parts NHL 2 and Cotswold stone roofing tiles, packed in deeply.

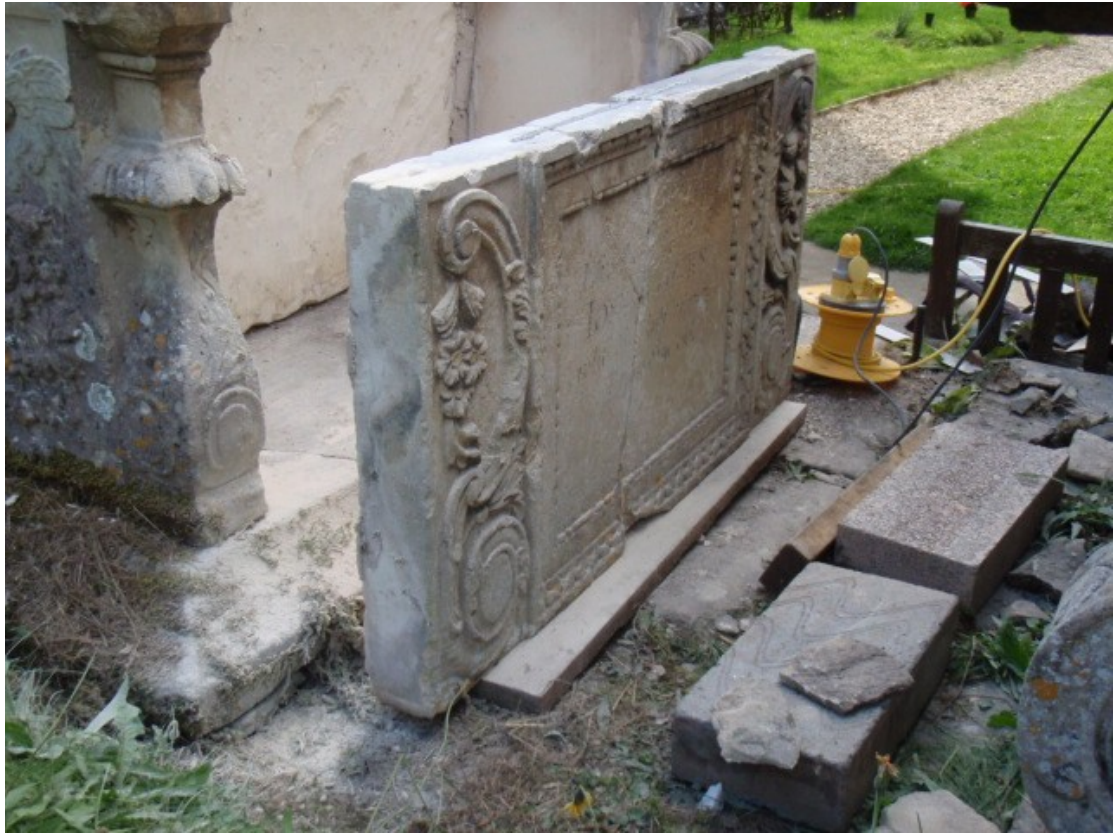
The repaired panel prior to reinstatement.

The broken panel was then reinforced using stainless steel bars set into slots.

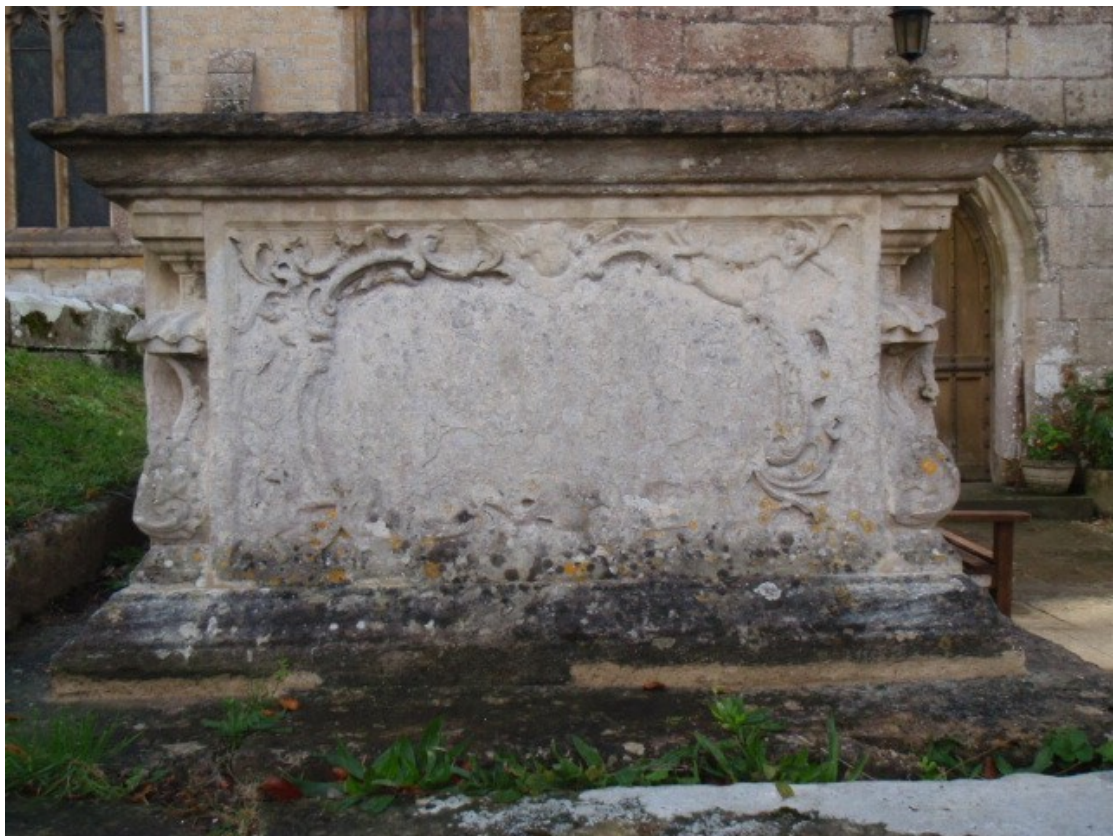
The monument after conservation. North side.
