Energy Audit and Survey Report

St Mary's Church, Buscot

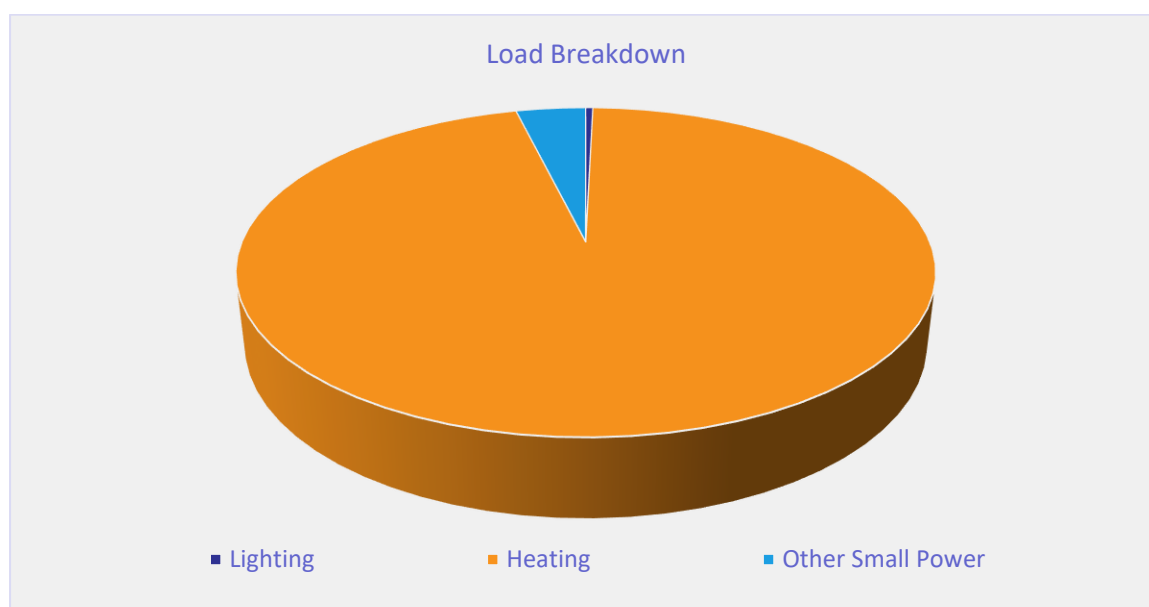
Service	Description	Estimated Proportion of Usage
Lighting	Mix of LED and fluorescent lamps	0.4%
Heating	Condensing oil boiler to underfloor trench pipes	95.8%
Other Small Power	Plug in electric heaters, kettles and the like	3.8%

As can be seen from this data, the heating makes up by far the largest proportion of the energy usage on site.
