Energy Audit and Survey Report St Mary's Church, White Waltham

DIOCESE OF OXFORD

Version Control

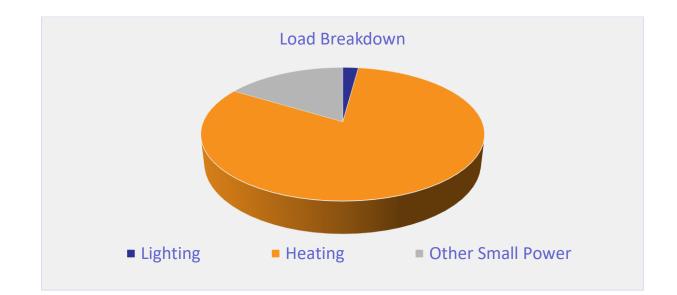
The main energy use within the church can be summarised as follows:

As can been seen from this data, the heating makes up by far the largest proportion of the energy usage on site.
