## St. Helen's church BILTON-IN-AINSTY North Yorkshire

**A record of conservation works carried out to four  
Anglo-Saxon cross fragments**

**January 2021**

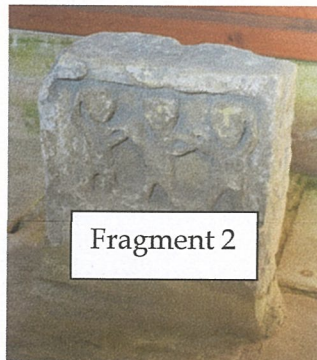
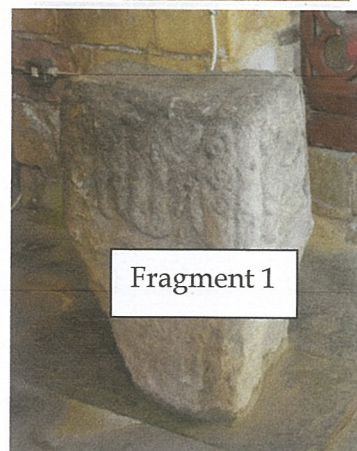
Plate 9: The frame for fragments 1 & 2. Note the additional support for fragment 2

- 5.2 The three stone fragments were to be mounted in the south aisle. Fragment 1 on a DPM (damp proof membrane) of code 4 lead sheet. The lead sheets wasa painted on both sides with black bitumen paint. This is to help prevent the oxidization of the lead. A stainless steel frame (316 grade) was designed and fabricated to sit on the top of fragment 1 and to then offer a cradle for fragment 2 to sit in. to offer support and stability to the top of fragment 2 two dog legged cramps were also fabricated. The frame and upper dog leg cramps were fixed into holes drilled into the wall which was cleaned of all debris. The steel projecting into the holes were given a fishtail detail and set into Hilti HY resin. Any areas of the steel frame or the restraining cramps that are in contact with each other had 3mm *Plasterzote* separating them. *Plasterzote* is a chemically inert closed cell foam. As a note fragment 2 was not flat on its underside but had a large, almost, 45° cut so would not sit in the designed frame without additional support. To aid in supporting this stone at the front a 25mm diameter stainless steel dowel was welded to the frame to carry out this function.

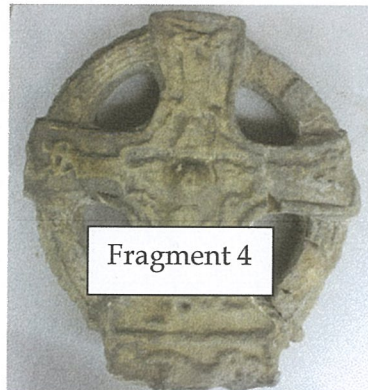
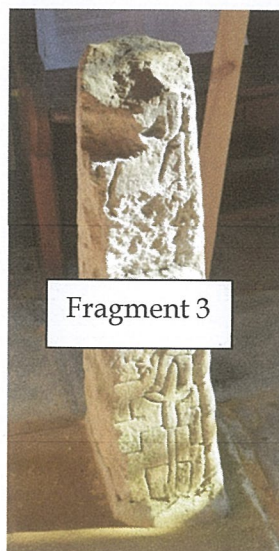
Plate 12: detail of the table for fragment 3

- 5.4 Fragment 3 had a table fabricated for it to sit on displaying the shaft fragment at an angle to make all sides available for viewing. The table has four legs as support with the foremost leg left longer and inserted in between the stone floor flag stones. This was fixed using epoxy resin. To hold the upper section of the shaft shaped stainless steel was manufactured and fixed into pre drilled holes and fixed with epoxy resin. The wheel head cross was sat on fabricated dog leg cramps with a further two cramps, holding and clamping, the top section. The steel projecting into the holes were given a fishtail detail and set into Hilti HY resin. Any areas of the steel frame or the restraining cramps that are in contact with each other had 3mm *plasterzote* separating them
