St Mary's Church, Main Road, Longfield

Archaeological Watching Brief Summary Report

Project Code: WB SMCML20
 Planning Ref: N/A
 NGR: TQ 60332 69044 (centred)
 Archive No: 4515

August 2020

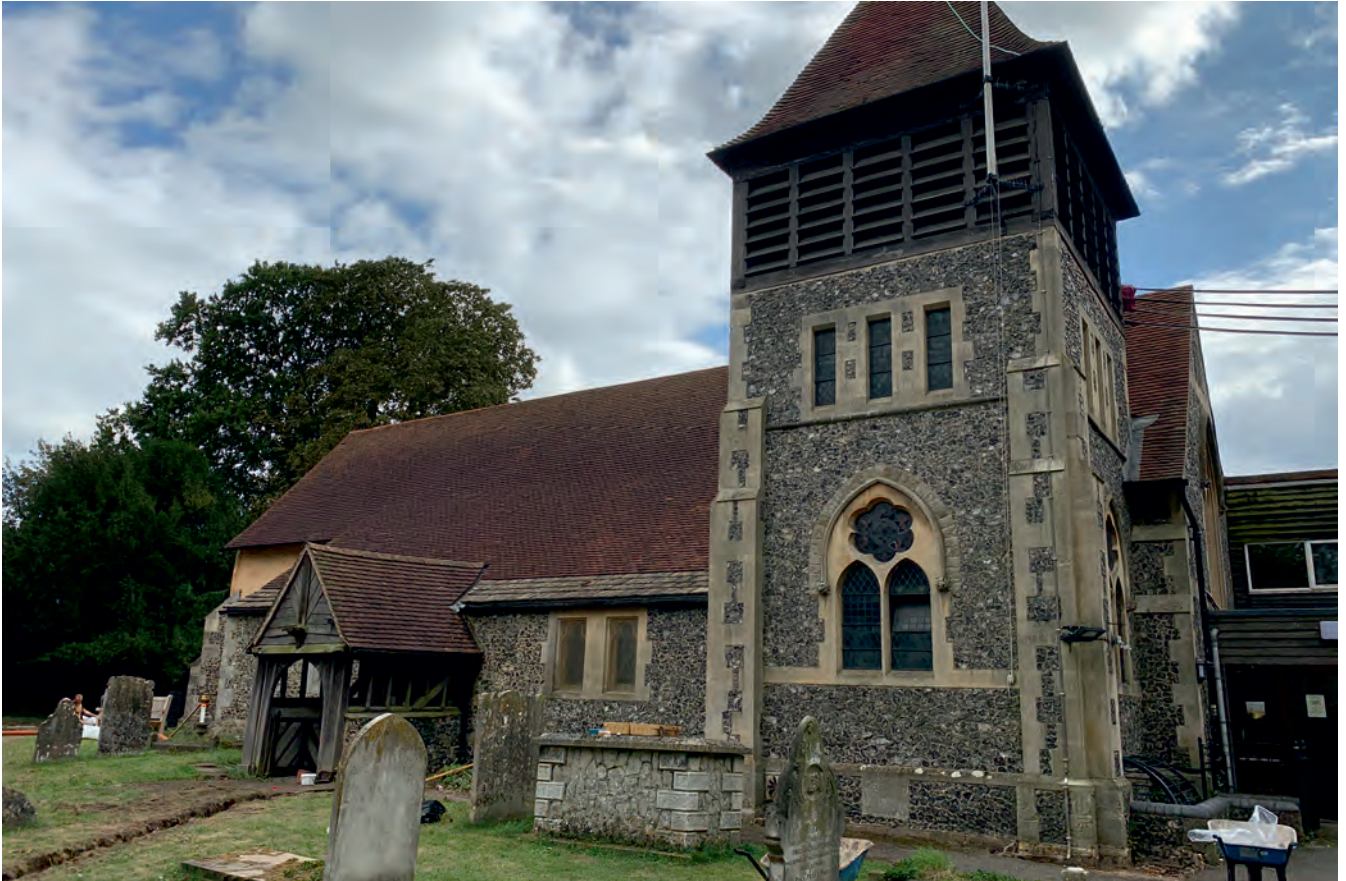
Plate 1. General of the northern side of St Mary's Church, Main Road, Longfield showing the nineteenth century additions (tower, nave and north aisle west end) added onto the earlier medieval nave, north aisle, north porch and chancel.
