St Winwaloe's  
East Portlemouth  
Rood Screen: Polychromy Report

©Eddie Sinclair ACR

October 2016

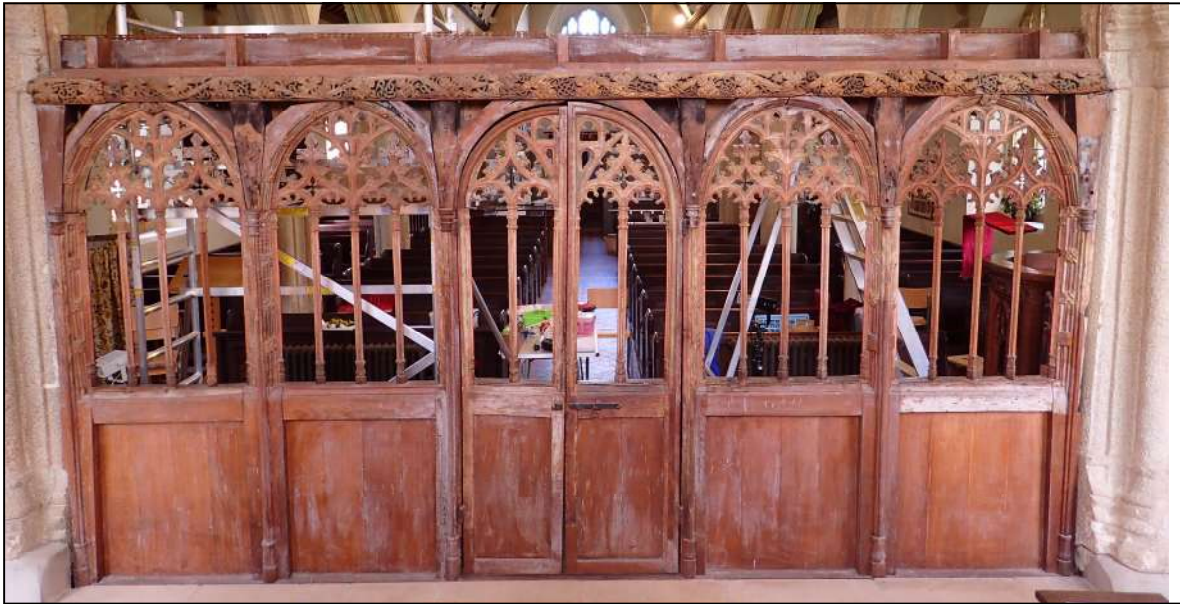
A look at the east face of the screen reveals charred wood on the structural framework, as well as carved elements that would originally have been on the west face (see detail below).

The dado of the screen has been extensively restored with new woodwork.

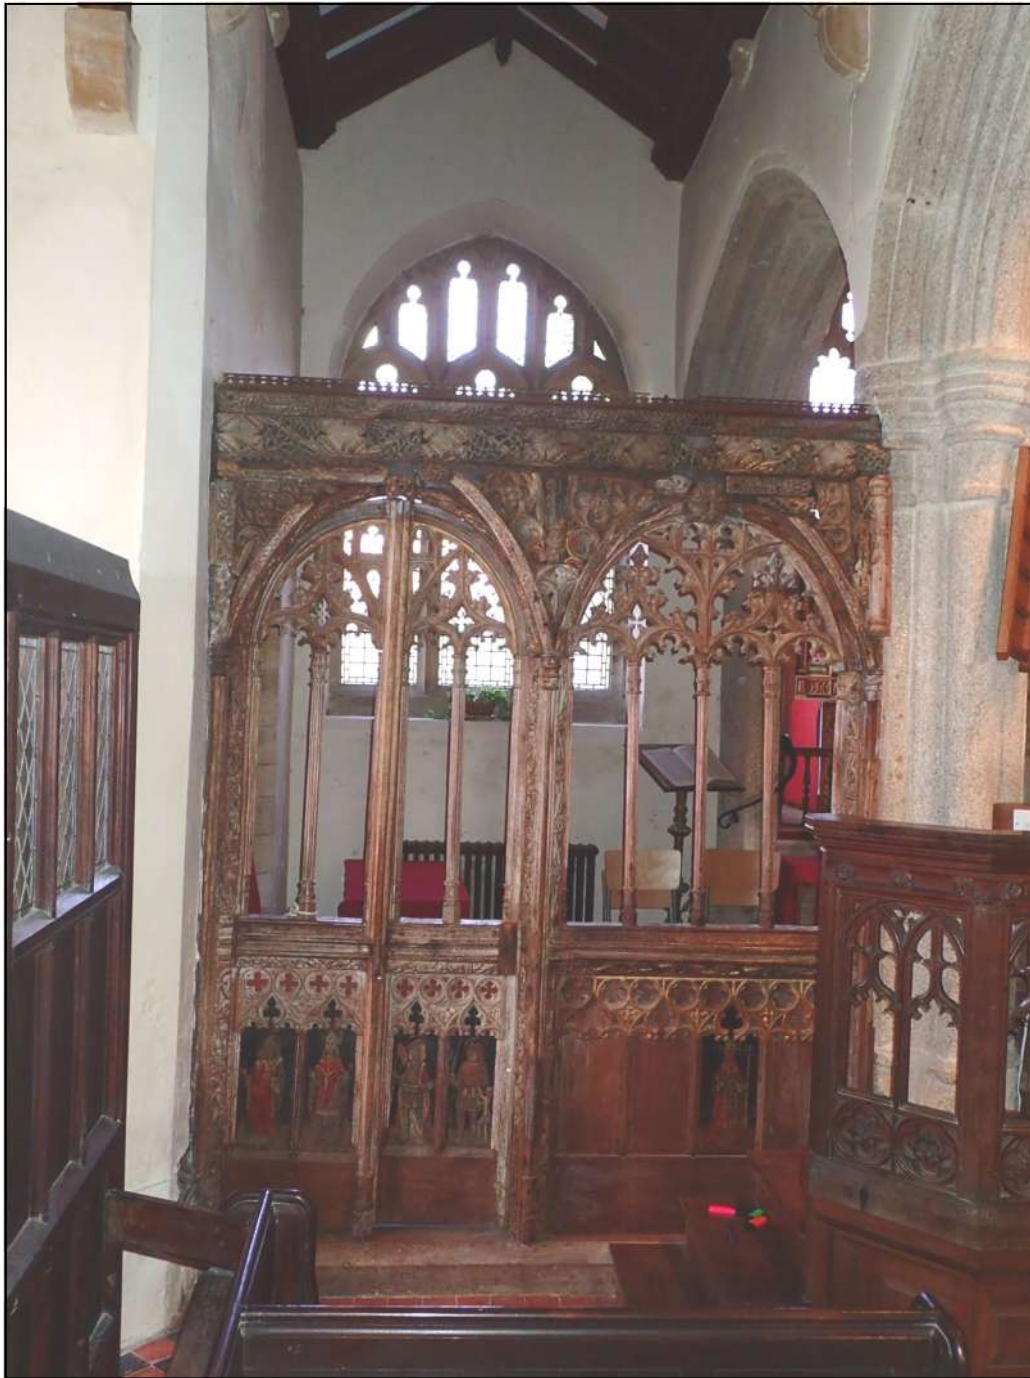
The screen is set against the walls at north and south ends, where it is encapsulated by the plaster and paint, which are acting like a bridge between the damp walls and the screen.

At the north end, seen here, the screen butts on to wall W 25, the north wall of the north aisle, as well as the east end of the north transept W24. There have been damp problems in the north transept and issues highlighted in 2014 Quinquennial Report, some of which may have been addressed, but damp and associated problems are still much in evidence.

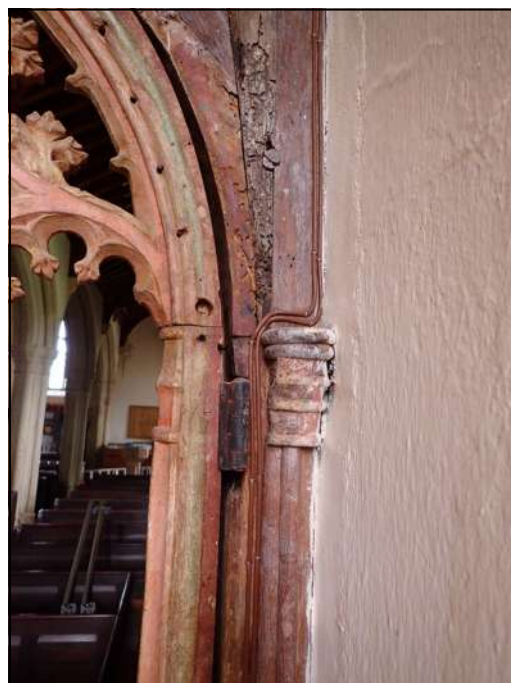
East face detail showing how wall coatings butt against the screen.

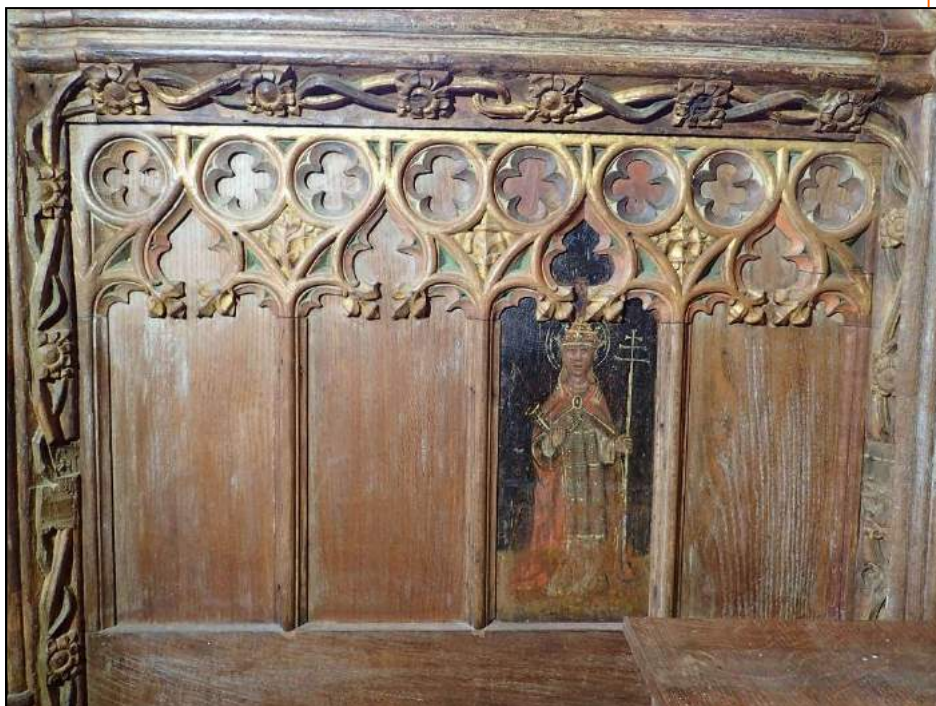
Bay 2 only retains one figure, St Cornelius. An early illustration shows this figure on the chancel screen. Paint and wood here appear particularly dusty and lack-lustre.

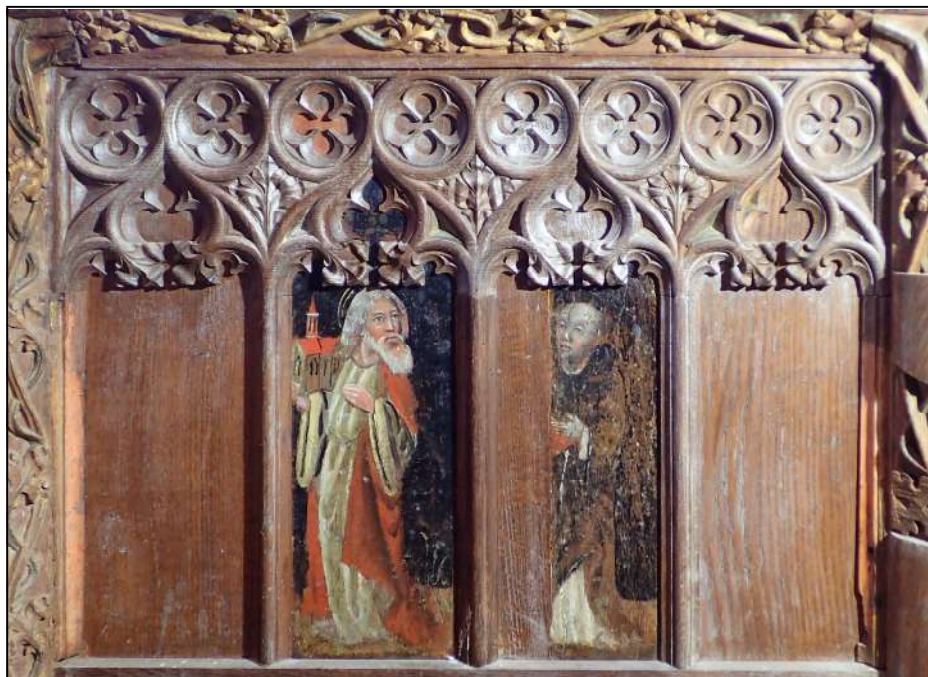
Bay 3 retains just two figure panels, two replacement blank boards and replacement upper tracery carving, probably dating from 1963 restoration.

One painting depicts St Winwaloe, the patron saint of the church and the other is a partial figure of a kneeling Dominican, probably St Dominic. An early illustration indicates that there was another figure instead of Dominic here. Documentation reveals that the panels have clearly been shuffled around at different periods and there is a reference to half a male figure (Dominic as seen here?) and a female saint in this bay.

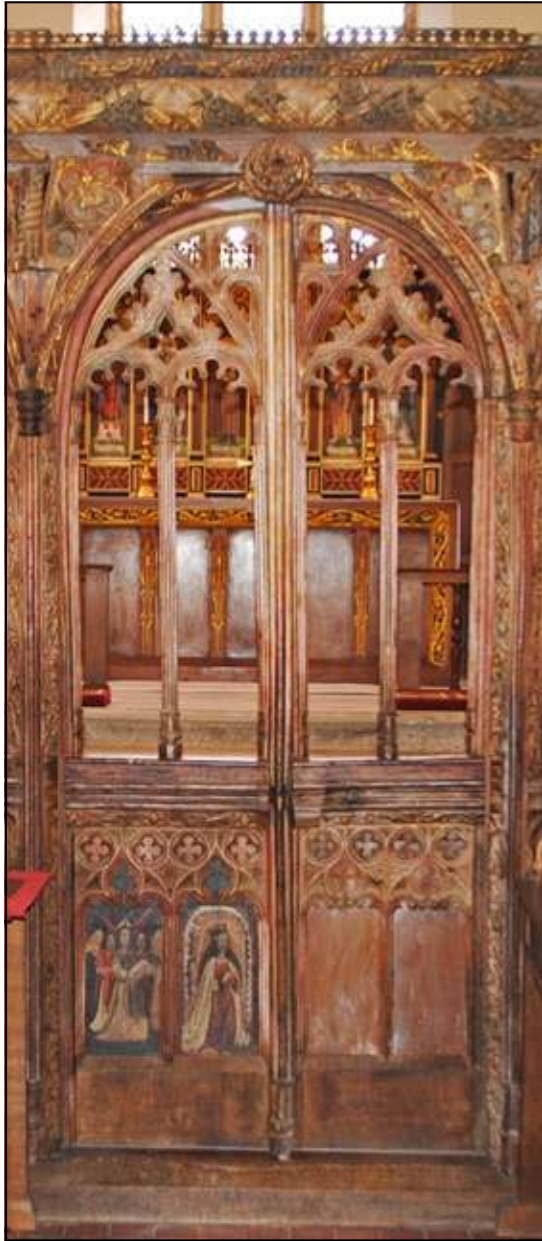
View of chancel screen doors, Bay 5, as they appear today. The surviving figure panels on the north door depict part of the narrative of The Coronation of the Virgin. (see detail above right). There are blank panels in place of figure panels on the south door.

The panels of Christ and St Jerome which historically and narratively belong here have been moved at some stage to the south end of the south aisle screen.

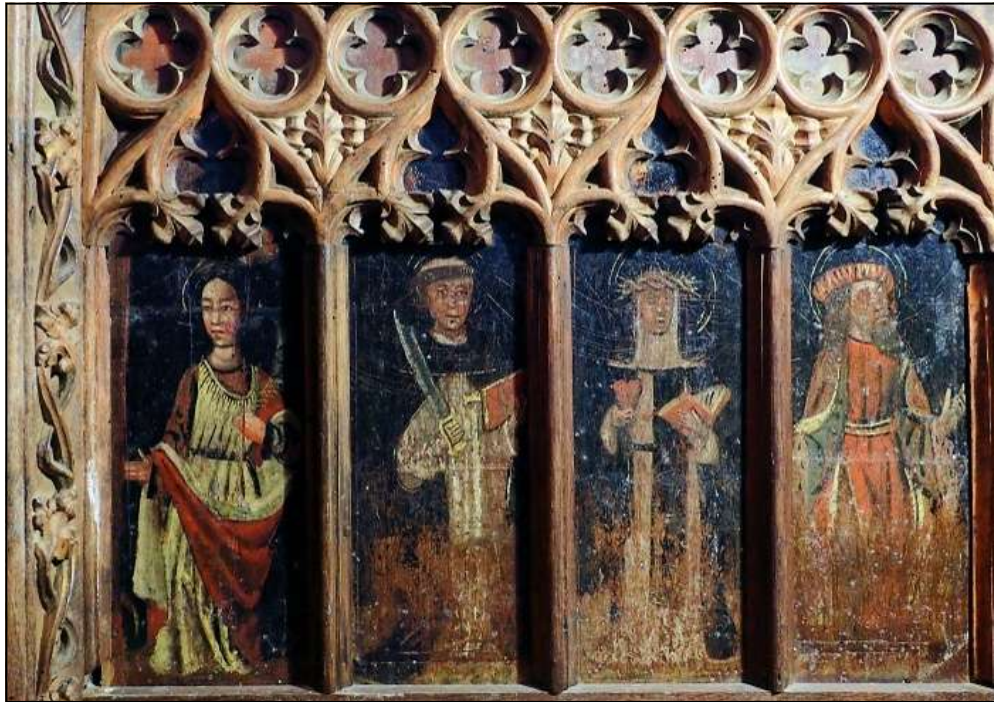
Continuing south along the screen, Bay 6 depicts a female martyr, St Peter Martyr, St Catherine of Siena and possibly St Edward the Confessor. The upper tracery here is dark and dusty but also retains extensive surviving polychromy

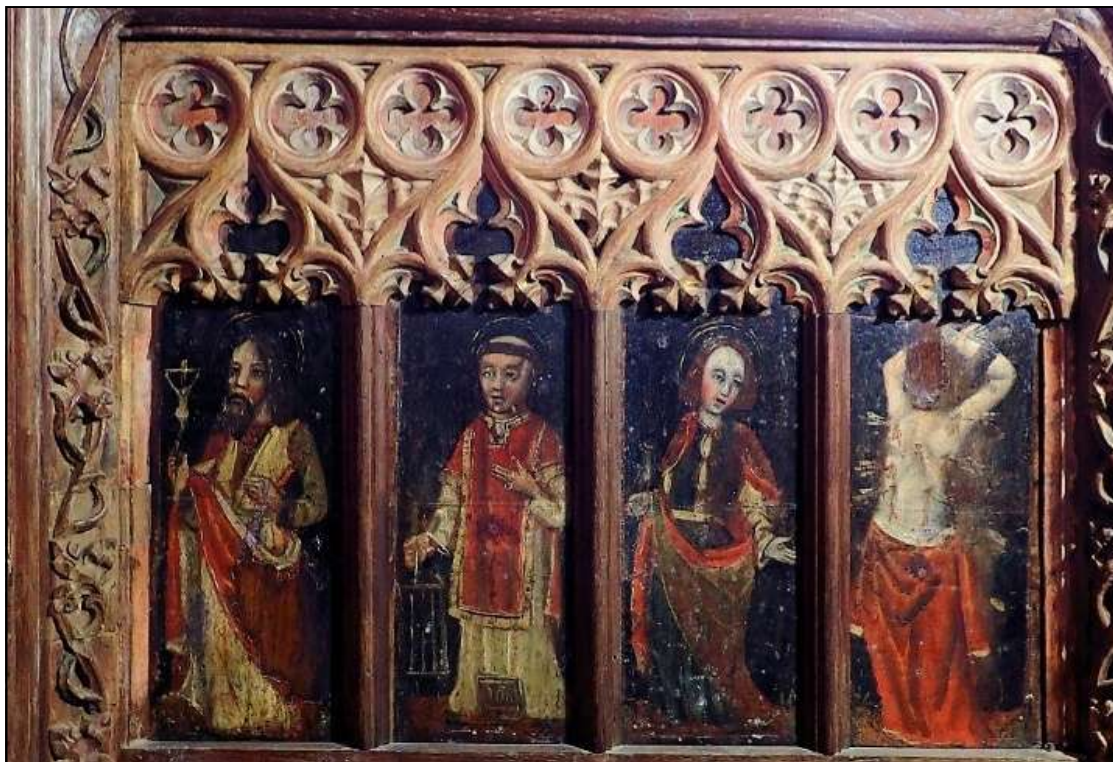
Bay 7 depicts, possibly St Eustace (there are several possible contenders for this figure), St Lawrence, St Bavon and St Sebastian. The upper tracery carving appears very blanché here due to a degraded wax coating, but extensive colour and gilt survive here.

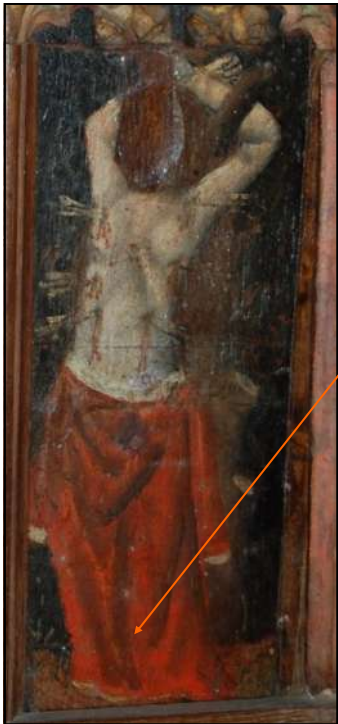
St Sebastian , Bay 7

This is the only sample taken from one of the figure panel. It was taken from the edge of a beetle-exit hole and may be missing some of the lower ground layers.

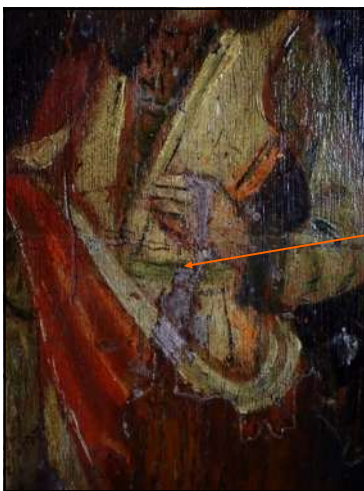
Some of the figure panels have pockets of retouching from a previous restoration. As the pigments used for the retouching have altered, in some cases these patches are now more visible than they would have been when new. For the most part this is a superficial matter and as these are largely not noticeable, they are best left alone.

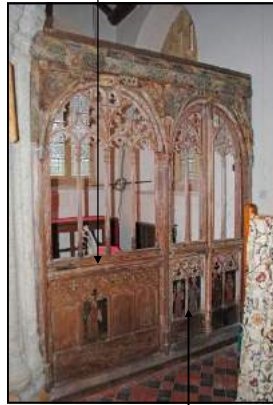
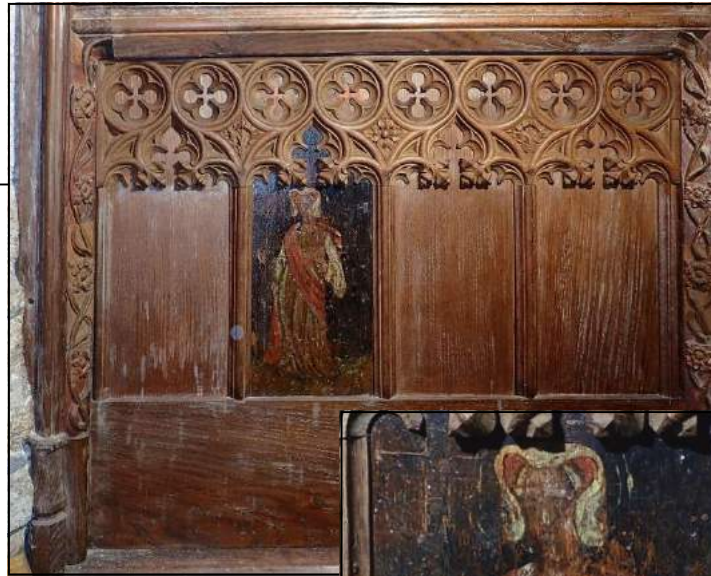
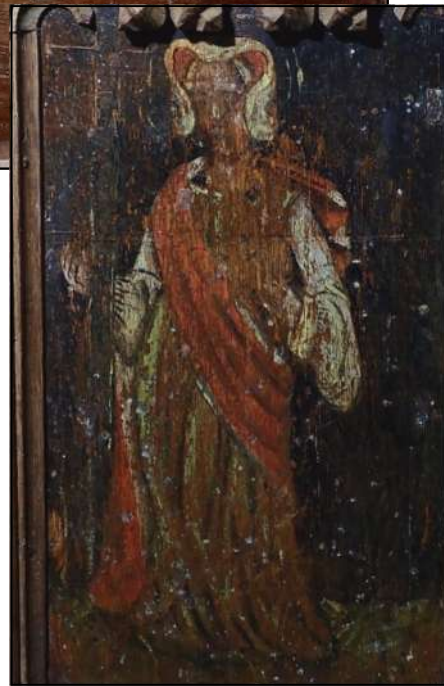
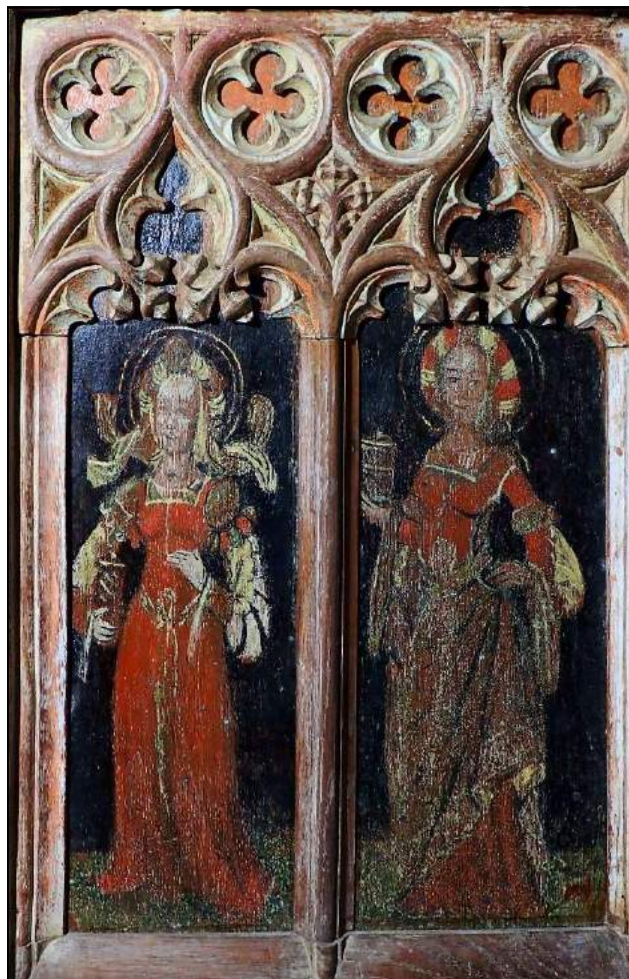
Bay 8 only retains one figure panel and the surrounding carving and blank panels probably date from the 1963 restoration.

The figure panel depicts St Helena, with an elaborate headdress, holding the cross. This panel shows extensive evidence of active beetle.

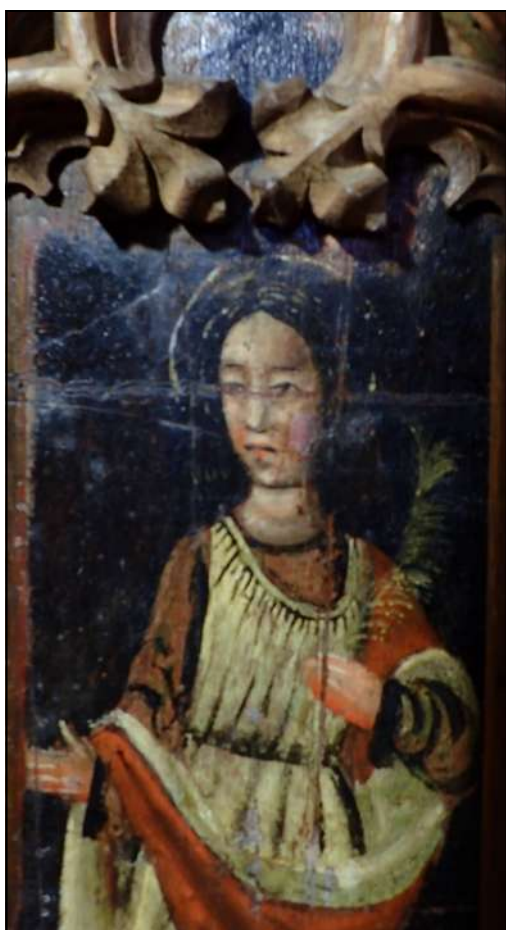
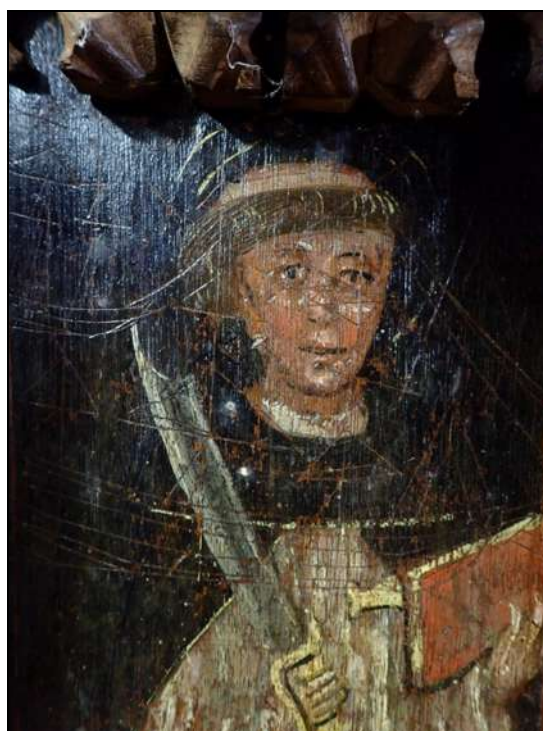
The figure panels display varying degrees of iconoclasm, where the faces or eyes have been scratched, although the damage is limited, compared to what is often found.

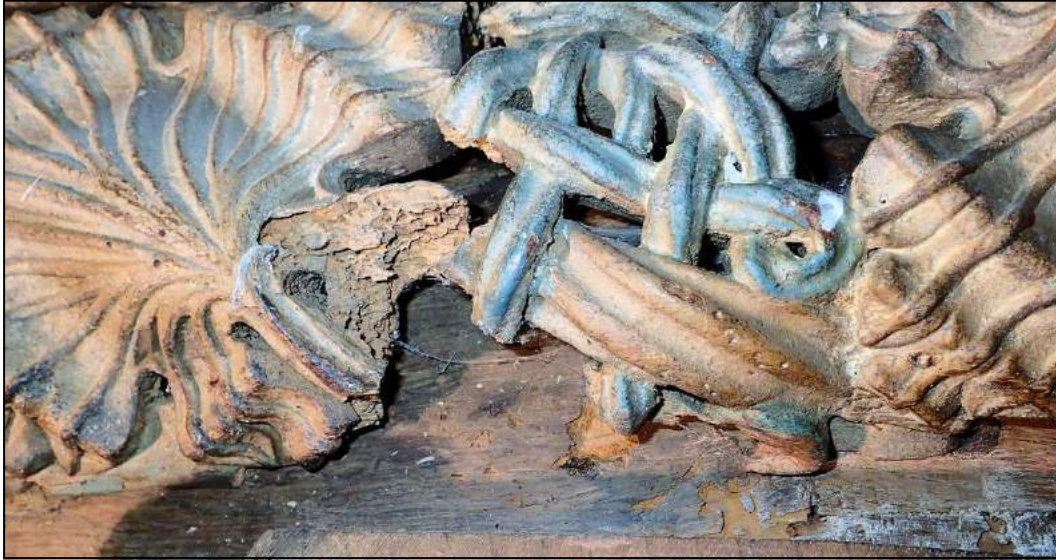
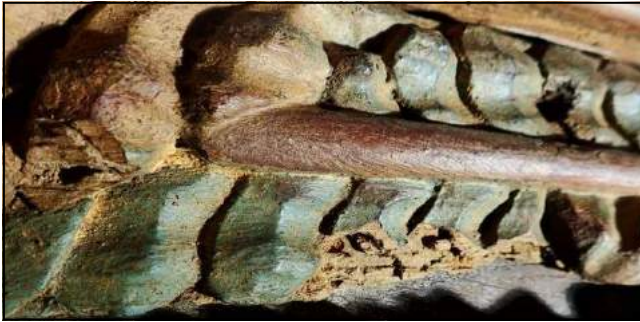
Death-watch beetle damage. Much of this is historic but there are signs of recent activity where the wood is crumbling and the surface of carving, sometimes with paint, is in danger of being lost.

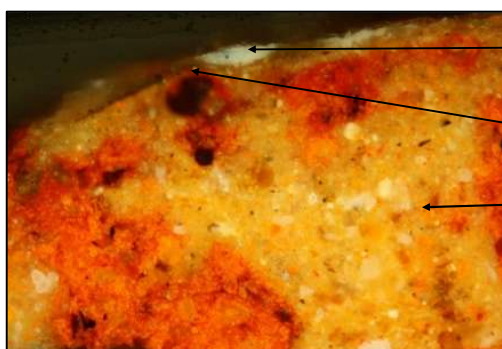
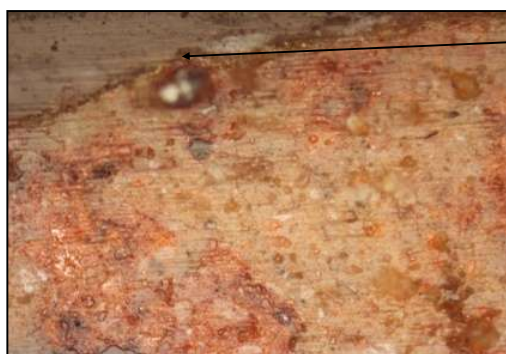
North screen arcade. Above left, view and location of sample 6 (see arrow). Above right, detail of carved post, north screen, showing pale blue overpaint which in places is flaking. The appearance of these surfaces would be considerably improved if the overpaint were removed.

pale blue overpaint of lead white and Prussian blue

In this case the blue is directly on top of the wood, with some wax overlying. I therefore think it is overpaint. PLM suggests it is lead white and Prussian blue. The PLM sample may have picked up some of the original red ground as some red earth was noted in that sample.

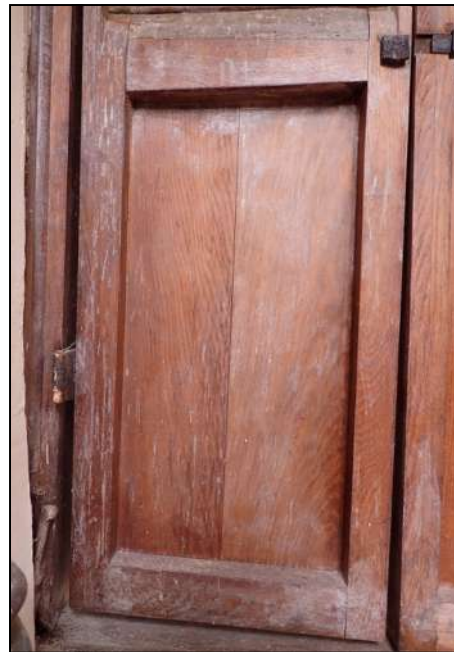
Arrow above indicates where the pared-back painted panel is separating from the backing board.

The figure panels were pared back in the 1960s restoration to make room for new backing boards (see above), onto which they were glued. Unfortunately there is active beetle infestation in some of the panels, with the glue presumably acting as a food source for the wood-boring beetle. This is not extensive, but poses a dilemma; normally access for treating beetle would be from the back, but the new backing board makes access impossible.

The panels are thin and in places they are delaminating and breaking away from the support .

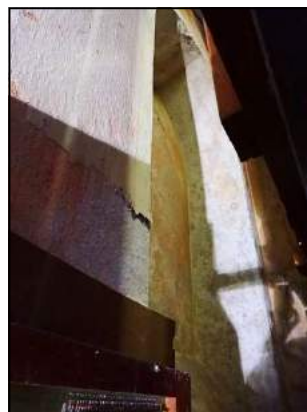
The window in the east wall has been blocked and dampness in the wall is causing adjacent paint to detach in sheets (see details above and below).

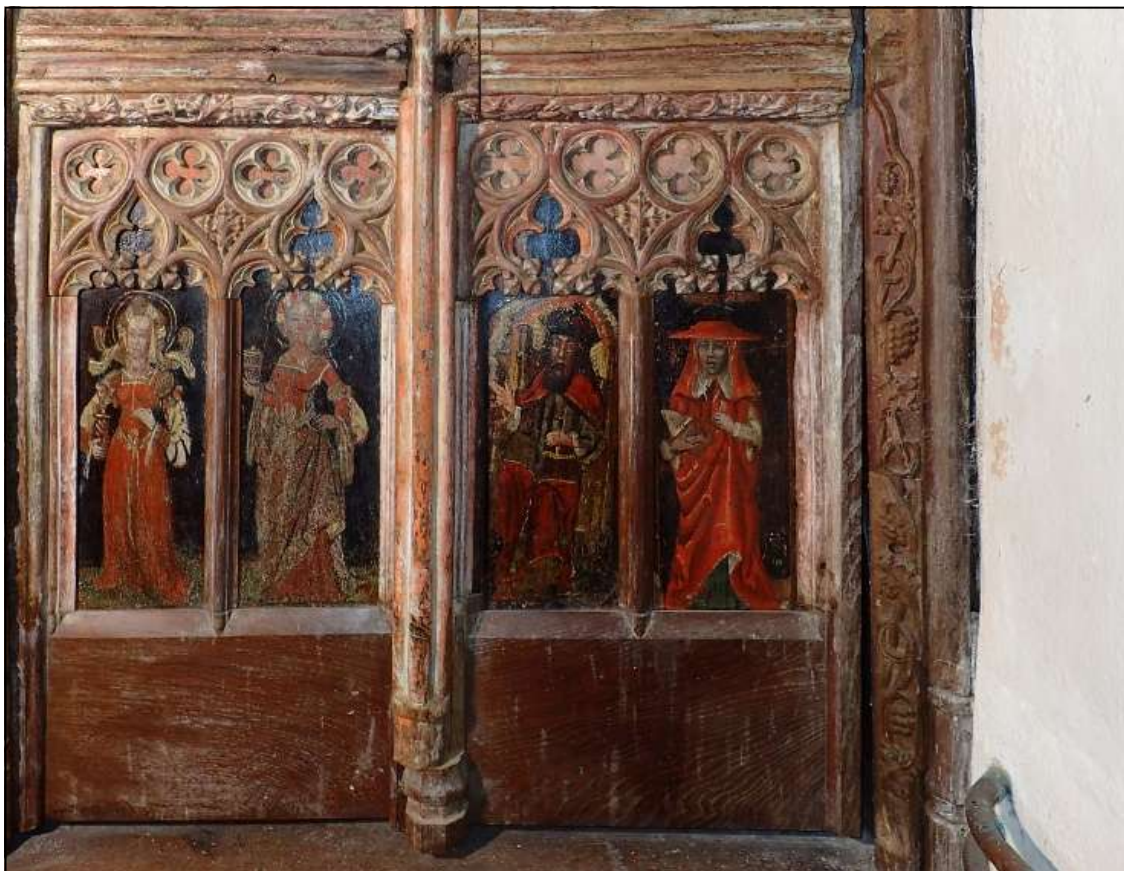
The screen is encapsulated by the plaster and paint at north and south ends, which are acting like a bridge between the damp walls and the screen. A timber specialist needs to advise on the best way to isolate the screen from the walls. Furthermore as the panels were pared back in the 1960s and glued onto new timber, normal treatment for infestation via access from the back is no longer possible. I strongly suggest that the advice of Hugh Harrison FSA is sought..

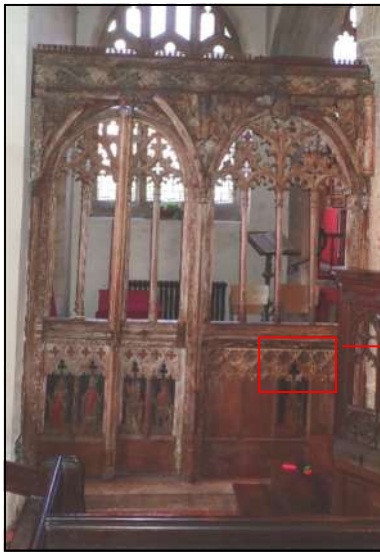
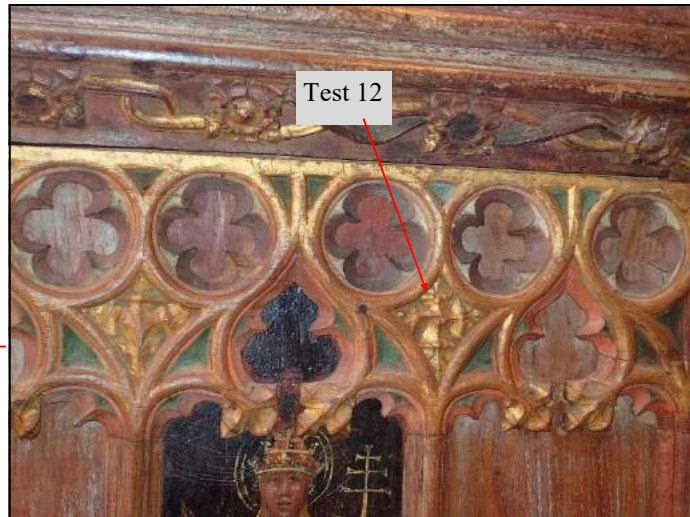
Upper tracery, Bay 2, showing fine carving and extensive surviving original polychromy. The colours and gilding appear matt and dulled, partly due to the presence of dust, but also probably due to the leaching out of some of the oil binder during the process of the caustic soda treatment in the 1960s.

**Test 12:** Wetting-out revealed that it is possible to retrieve the original polychromy and restore life and vitality to it. It also revealed the delicate lustre work on bunches of grapes and feathers of birds. Here (see below) beneath dust and wax, crimson glazes can be seen over gold leaf.

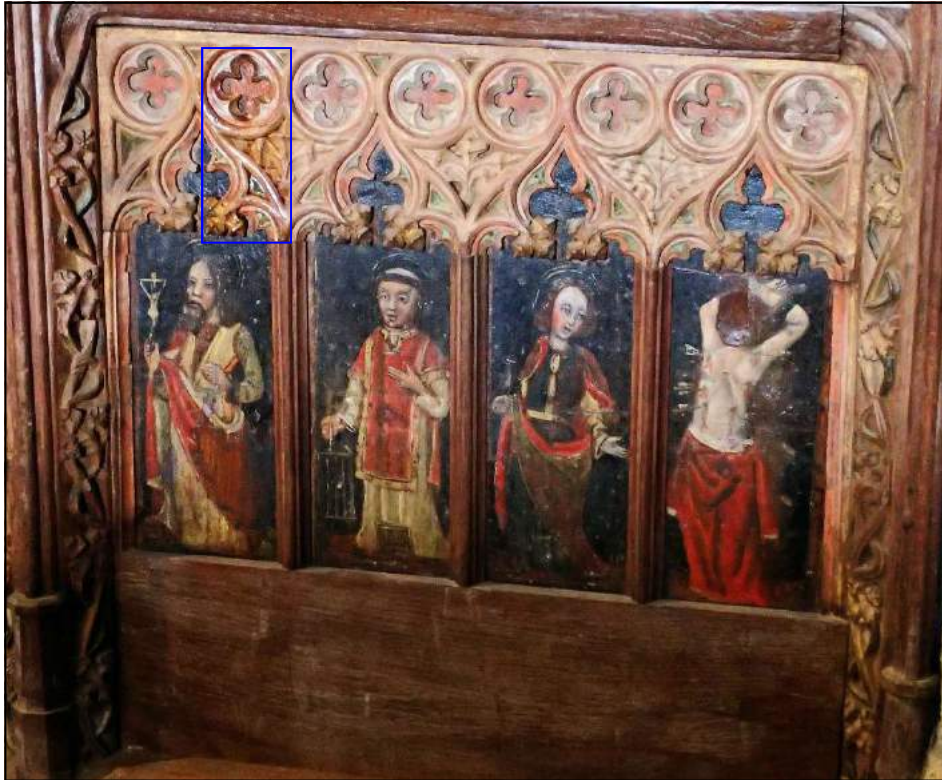
The original upper tracery overlay survives in Bay 7, but appears muted, dull and lifeless and isolated from the figure panels. Close examination and a series of tests (see below) reveals a thin residue of over-paint and wax, and remnants of thick linseed oil, beneath which the sixteenth century colour remains largely intact.

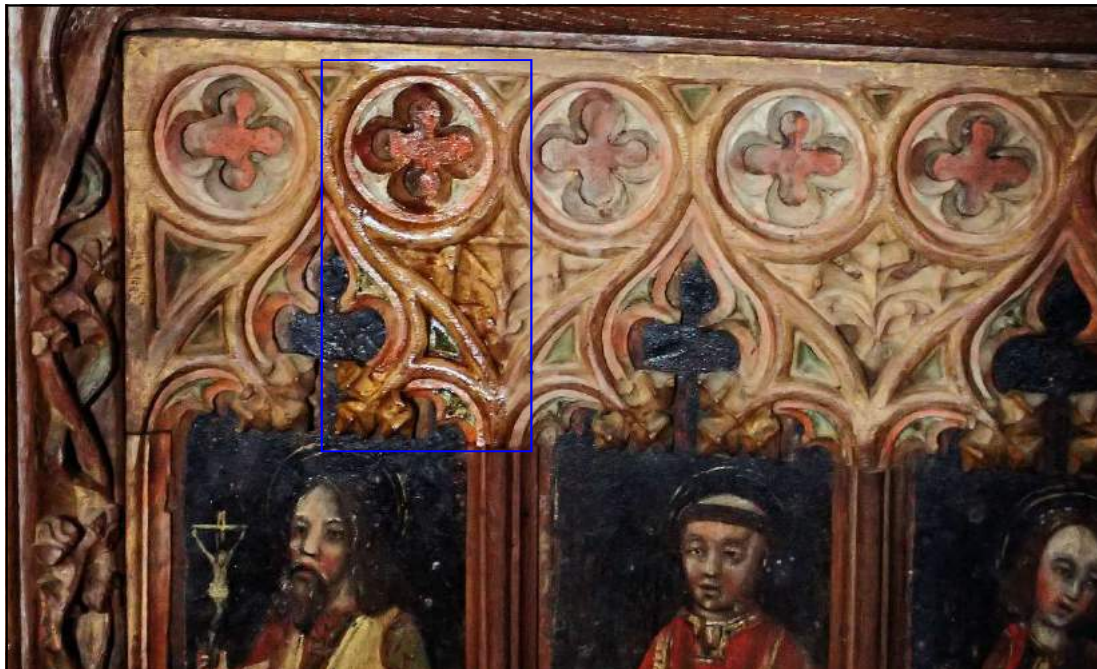
**Test 3:** Detail of cleaning tests on quatrefoil, spandrel, foliate cusps and mouldings. Tests show that the quality of the original oil paint surface is 'alive' and saturated. Removal of coatings will unify the architectural elements with the figure panels.

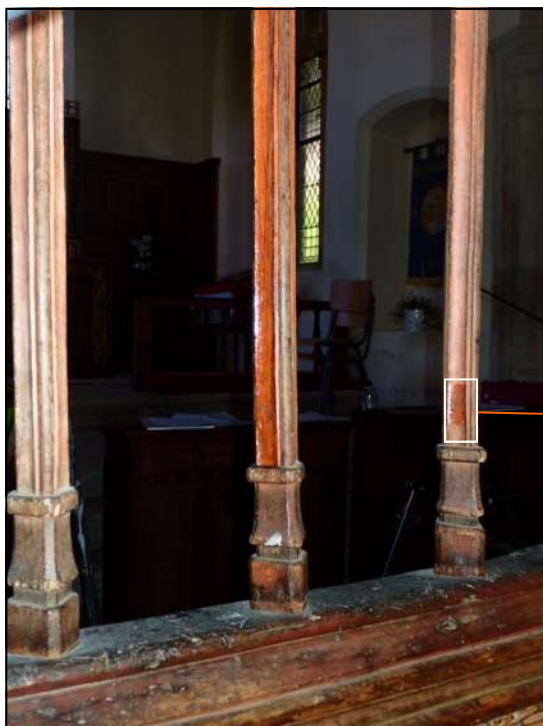
Stencilling along the mullions. **Test 5**. The stencils are alternate gold and silver leaf, although the silver has oxidised to black. The detail on the right shows residues of overpaint, which analysis dates to post 1704.

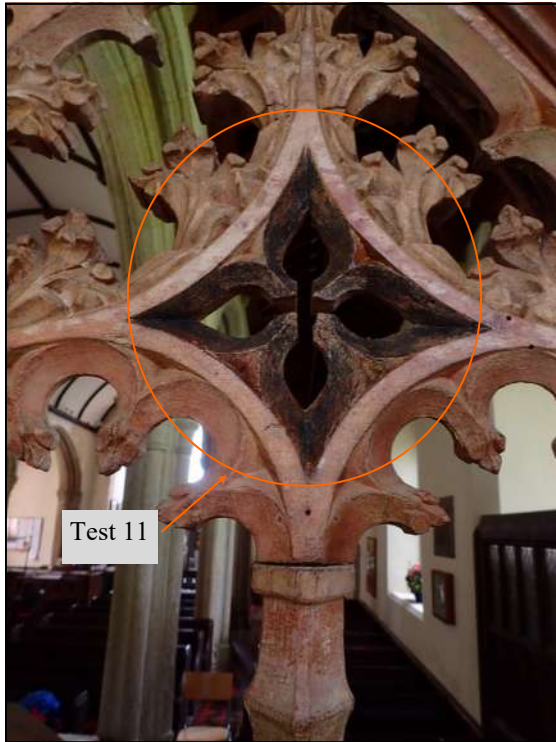
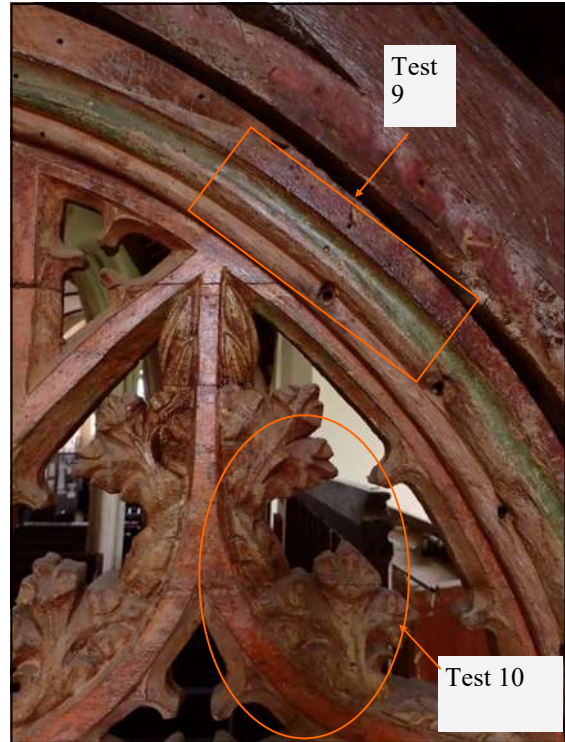
East face, Bay 1, showing extensive colour survives here too, visible clearly after wetting-out tests. Further tests were followed by the application of Paraloid B72 in Acetone/IMS, where poorly bound paint needed isolating before varnishing

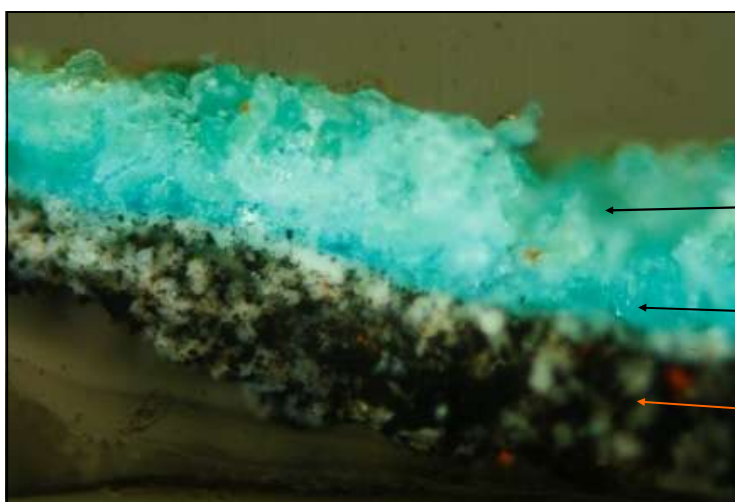
Photomicrograph of sample 11

Location of sample 11 (see arrow above), taken from the blue background of a quatrefoil in a spandrel on Bay 5 arcade.

The lower layers of red ground are missing in this sample

It is notable that the grey underlayer, seen in the cross-section above, has been used to try and make the azurite more impactful as a colour, a technique which is often found with azurite, for reasons of economy. Azurite is a costly mineral pigment, largely imported from Hungary/north Germany at this period. The pigment here is not a strongly blue example, which might suggest it is of lesser quality. It could also have degraded through the caustic soda treatment.

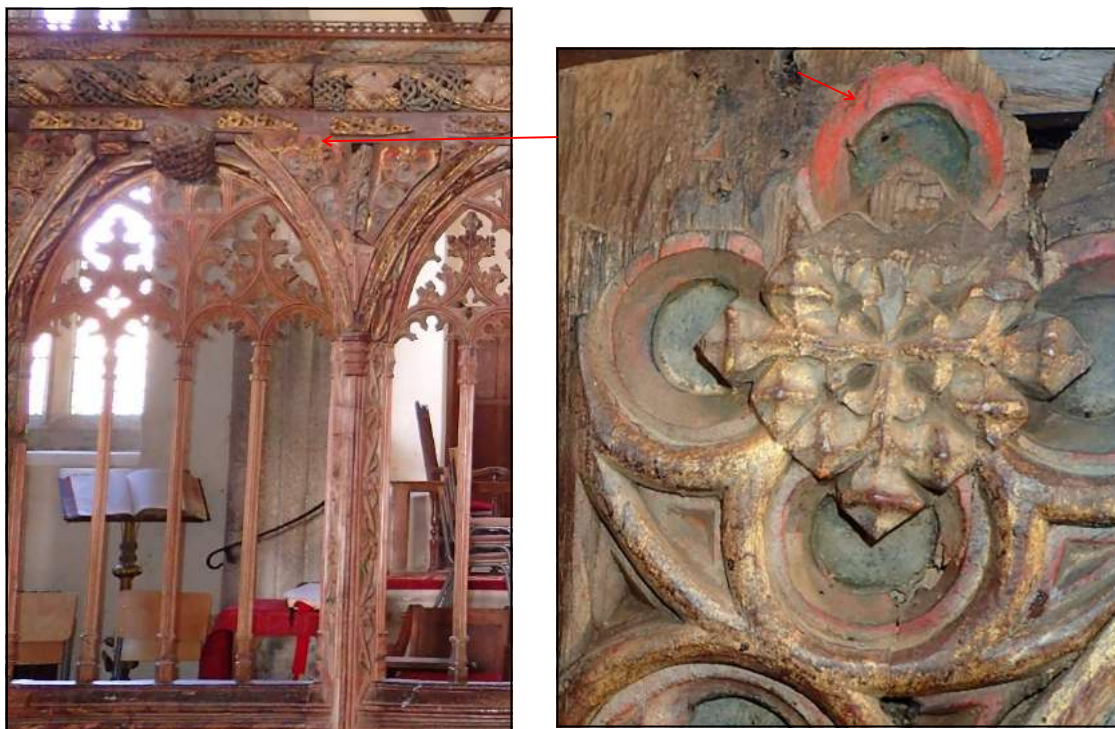
Bay 4, arcade and location of sample 8 taken from the red on a quatrefoil (see arrow above).

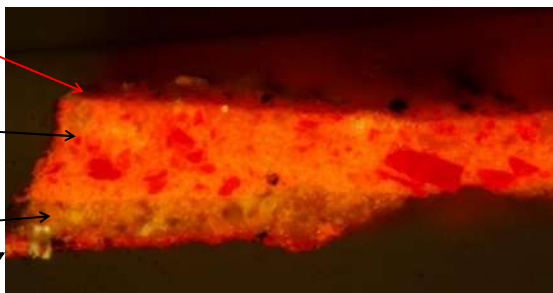
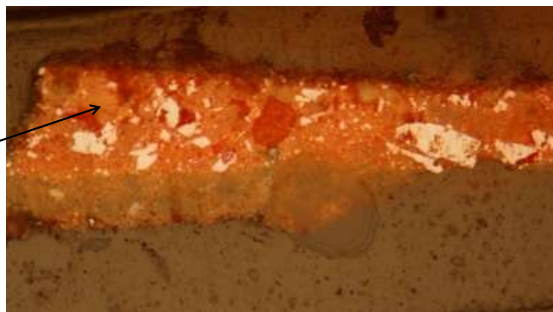
### Photomicrograph of cross-section from sample 8

darker top, including char black.  
Probably just the imbibing of dirt  
and coatings

yellow ochre, red lead,  
with some silicates,  
chalk, red earth

thin red ochre ground,  
with some char black  
and chalk

The red lead and particularly the  
vermilion, which together make a  
vibrant red, show up well in the  
bright field image.

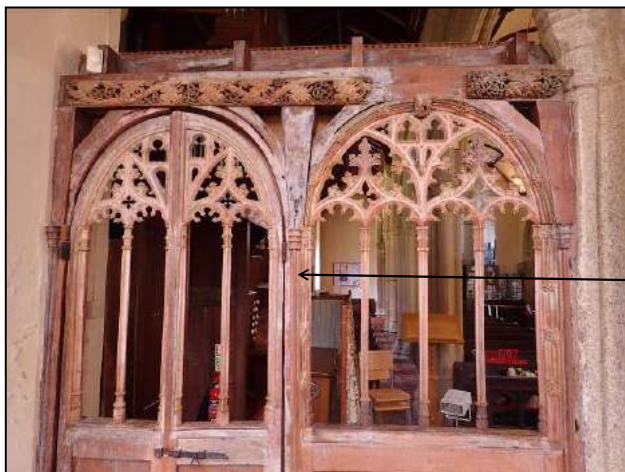
The east face of Bays 8 and 9, south screen.

A considerable amount of colour survives here (see above and far left) though much of it appears muted or blanched. The paterae, of which one is shown above, are painted with lead tin yellow. This is often found on the east face of Devon screens, where it was used as a substitute for the gold on the west face.

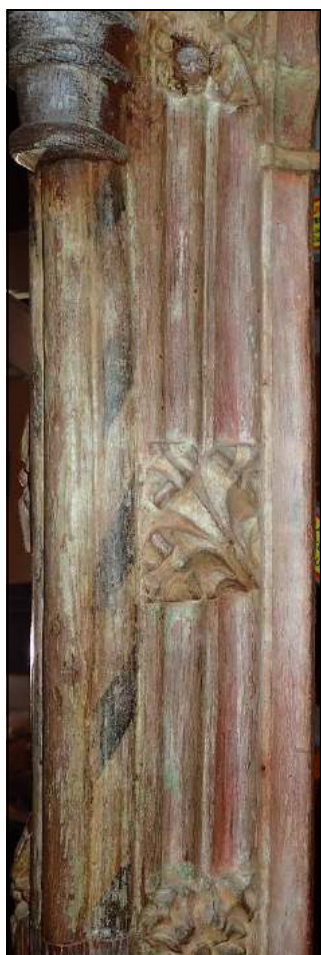
As can be seen above, the east face retains extensive decoration, with striped barber's-pole, in black and yellow and adjacent mouldings in red and green.

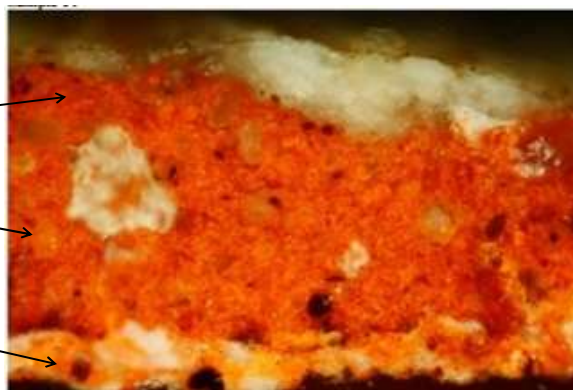
Location and photomicrograph of cross-section of sample 14, from carved patera on post, east side of screen.

lead white and lead tin yellow

thick red earth layer, some red lead

ground of lead white, red lead, some red earth

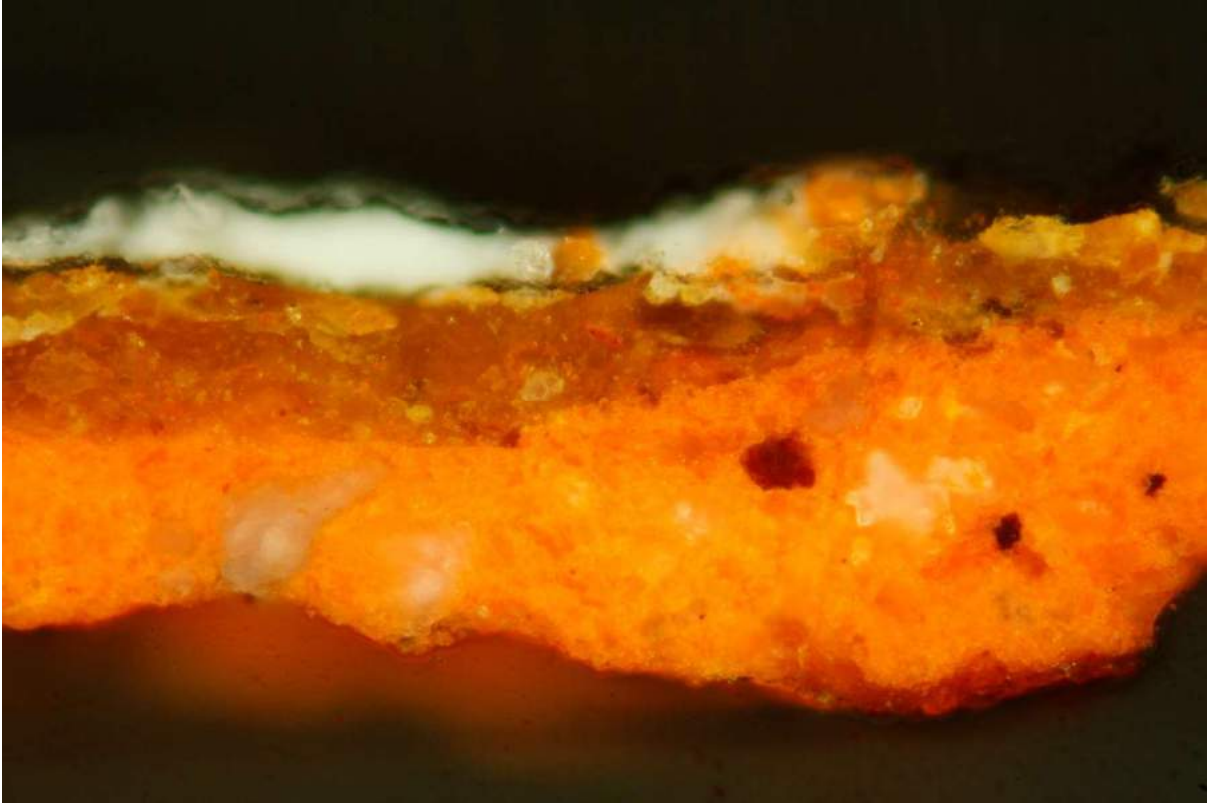
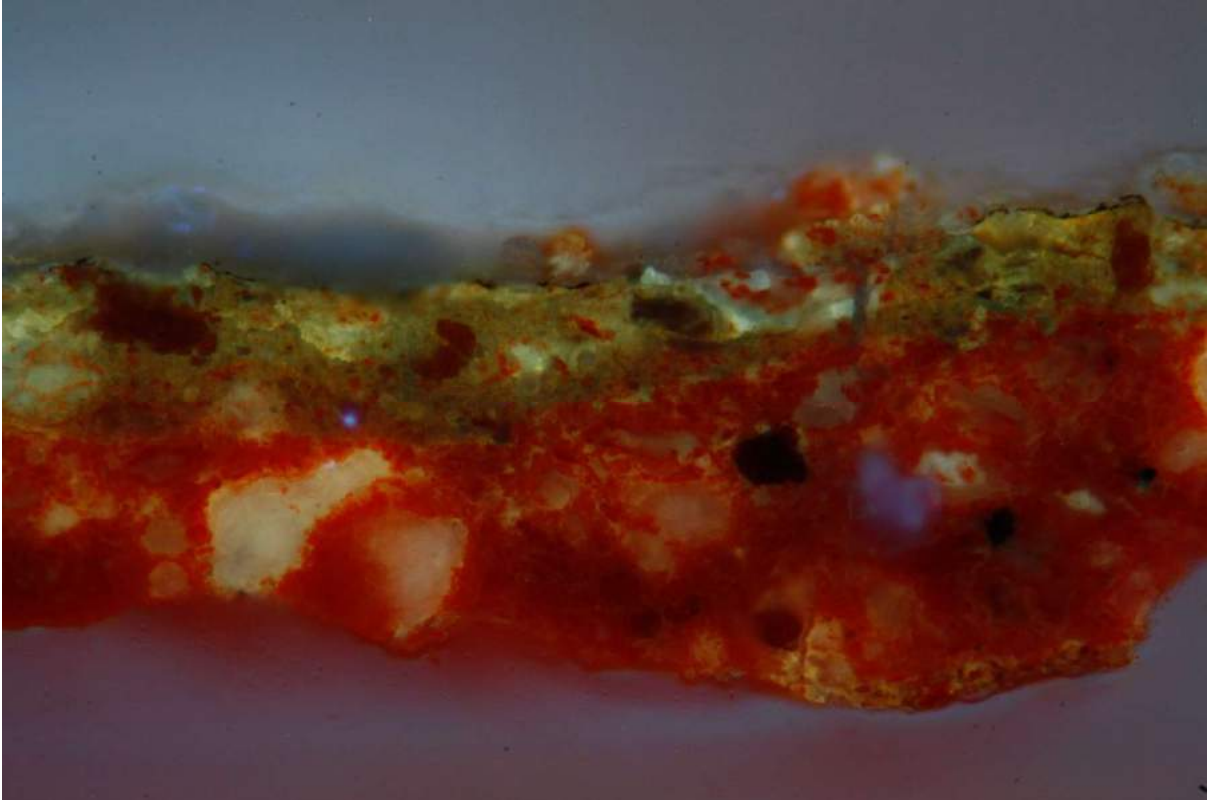
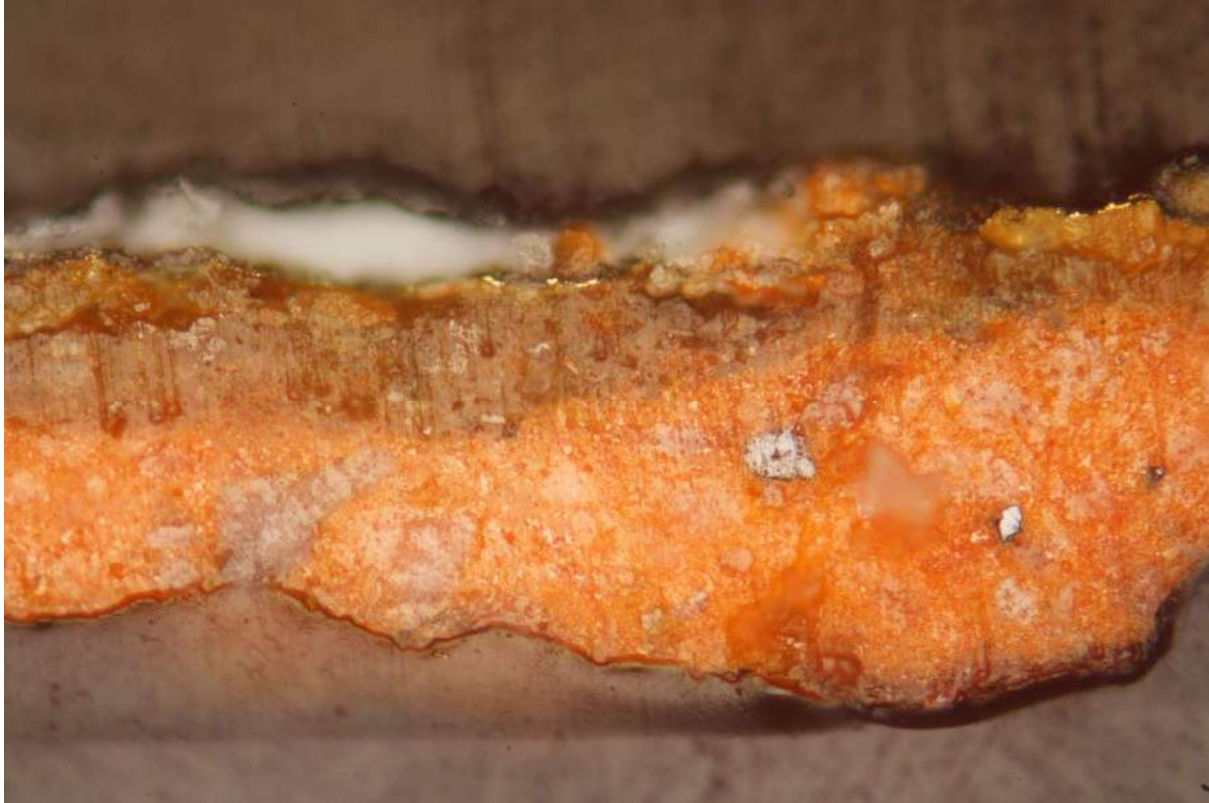
**Sample 1**

1. Thin red ground, mainly red earth, some bits of char black and chalk
2. Thick red lead layer, with some silicates, chalk, some red earth, occasional lead white
3. Mordant, mainly red and yellow ochre, but also lead white and some chalk and red lead The fluorescence in UV here is interesting and may indicate a resin content in this layer
4. Gold leaf (best visible in the bright field image)
5. Blue/white layer containing lead white and Prussian blue
6. Some surface dirt

The upper part of this sample is out of focus, as it has been more eaten into by the process of sample preparation including grinding in water. It appears to be materially the same as that found in other samples and consists of lead white and Prussian blue, indicating that this overpaint postdates the early eighteenth century and the invention of that pigment.
