St Winwaloe's  
East Portlemouth  
Rood Screen: Polychromy Report

©Eddie Sinclair ACR

October 2016

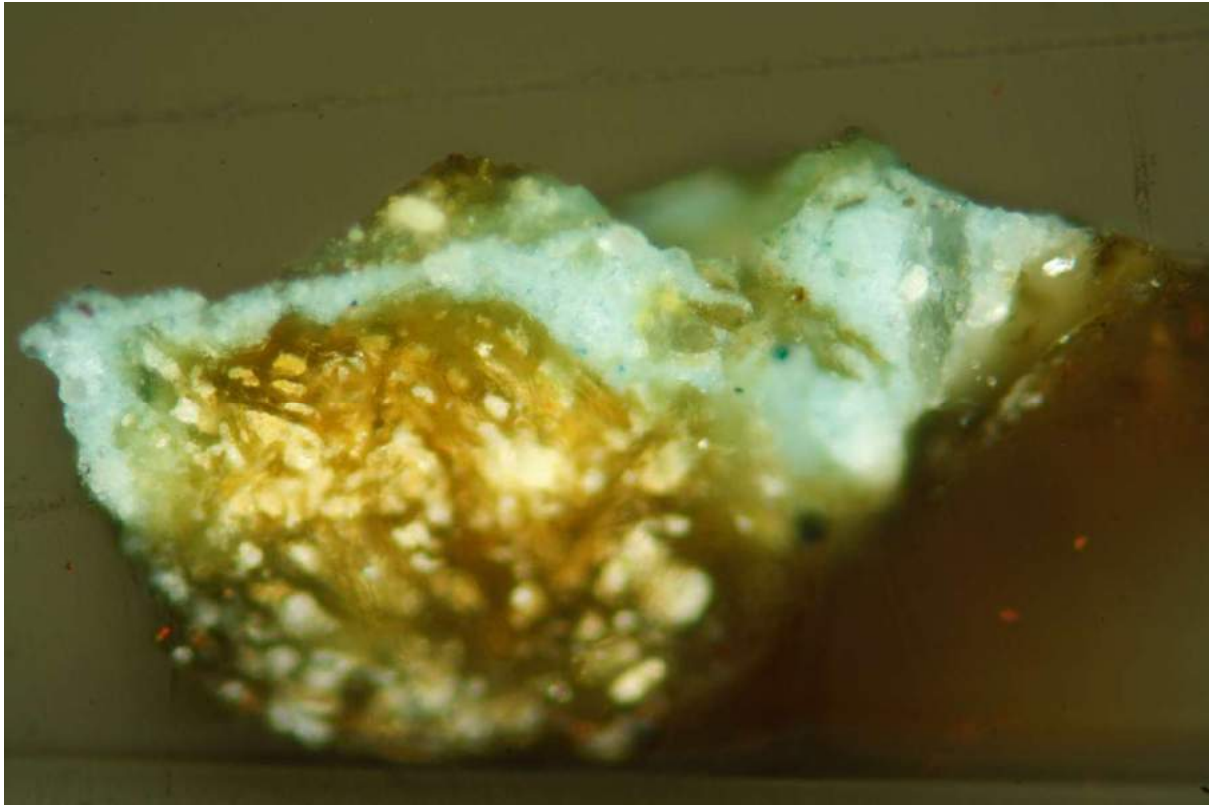
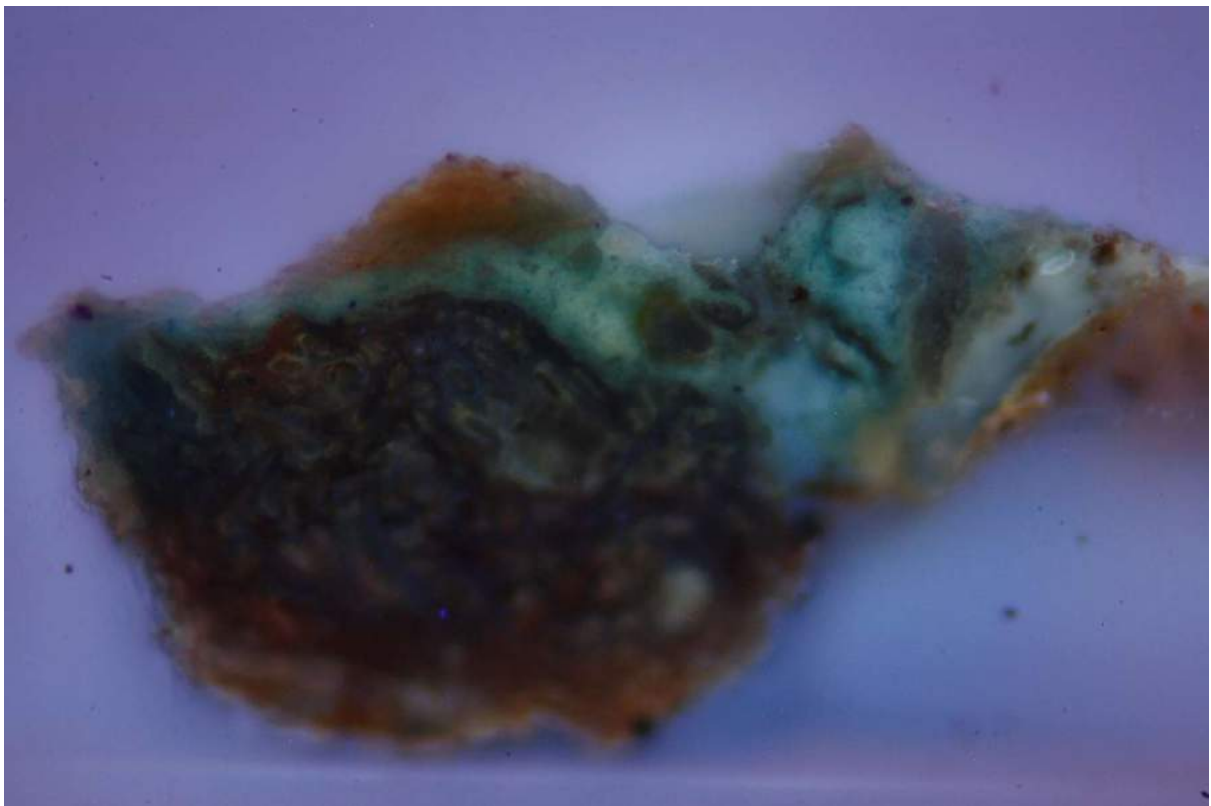
Sample 4

1. Wood
2. Blue and white layer of lead white and Prussian blue
3. Greenish layer, possibly including waxy top coat

In this case the blue is directly on top of the wood, with some wax overlying. I therefore think it is overpaint. PLM suggests it is lead white and Prussian blue. The PLM sample may have picked up some of the original red ground as some red earth was noted in that sample.

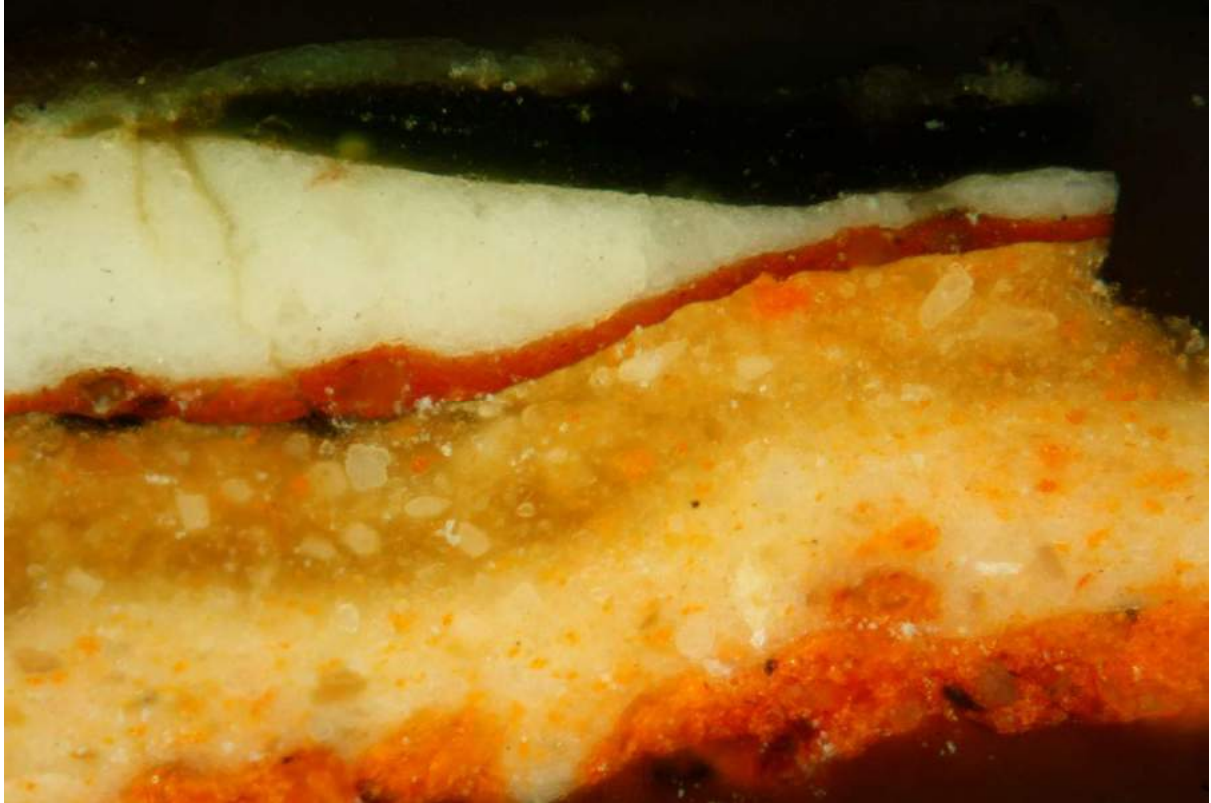
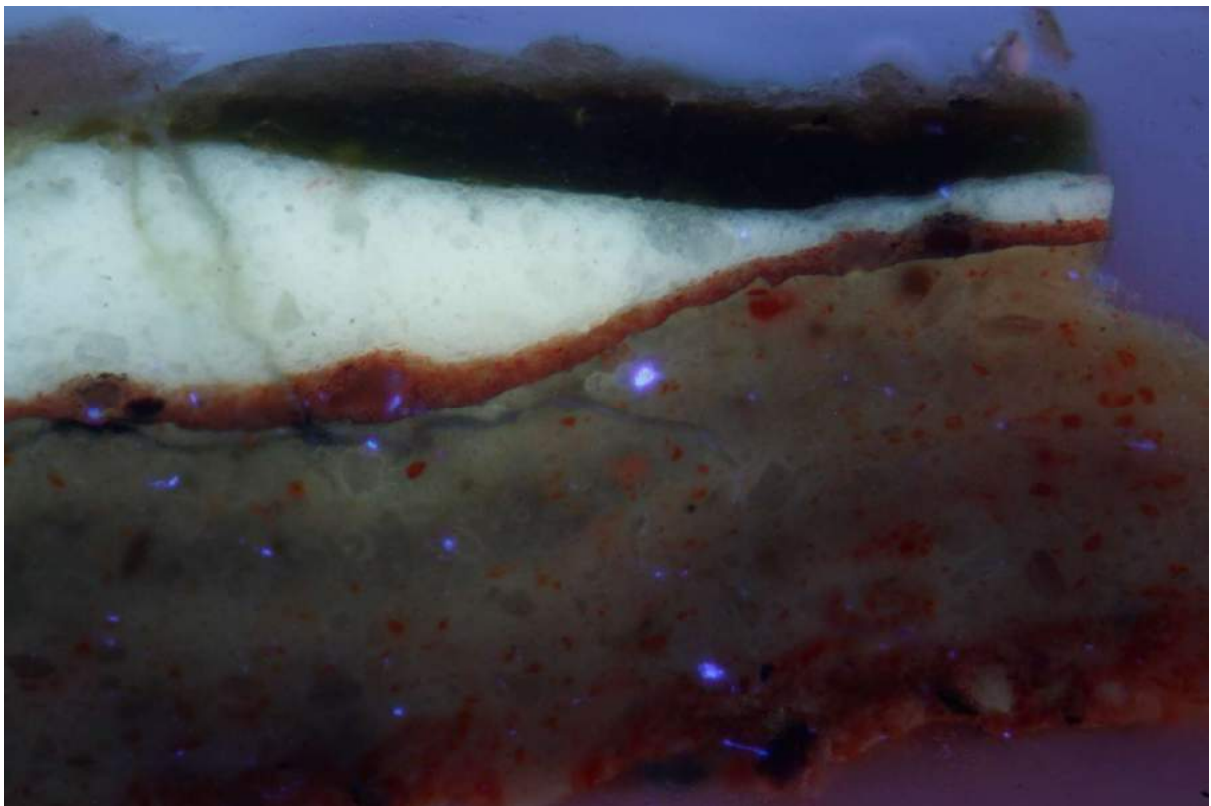
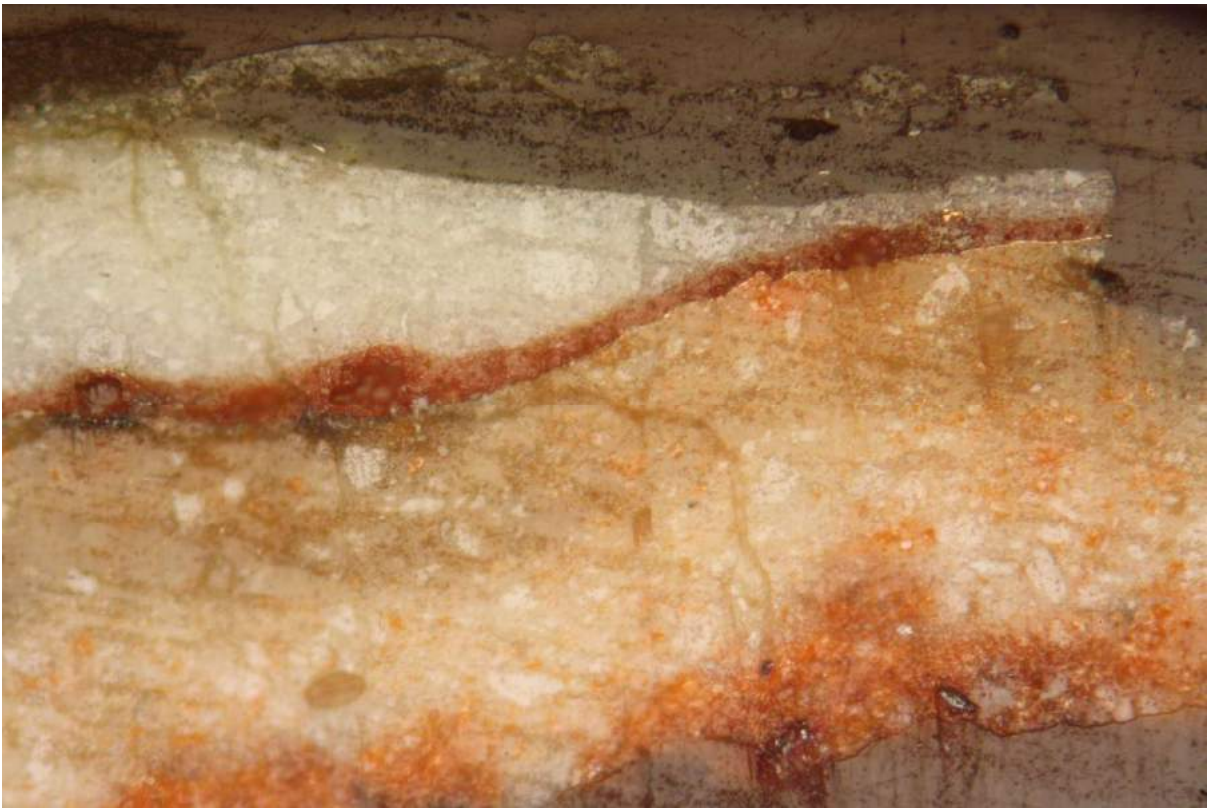
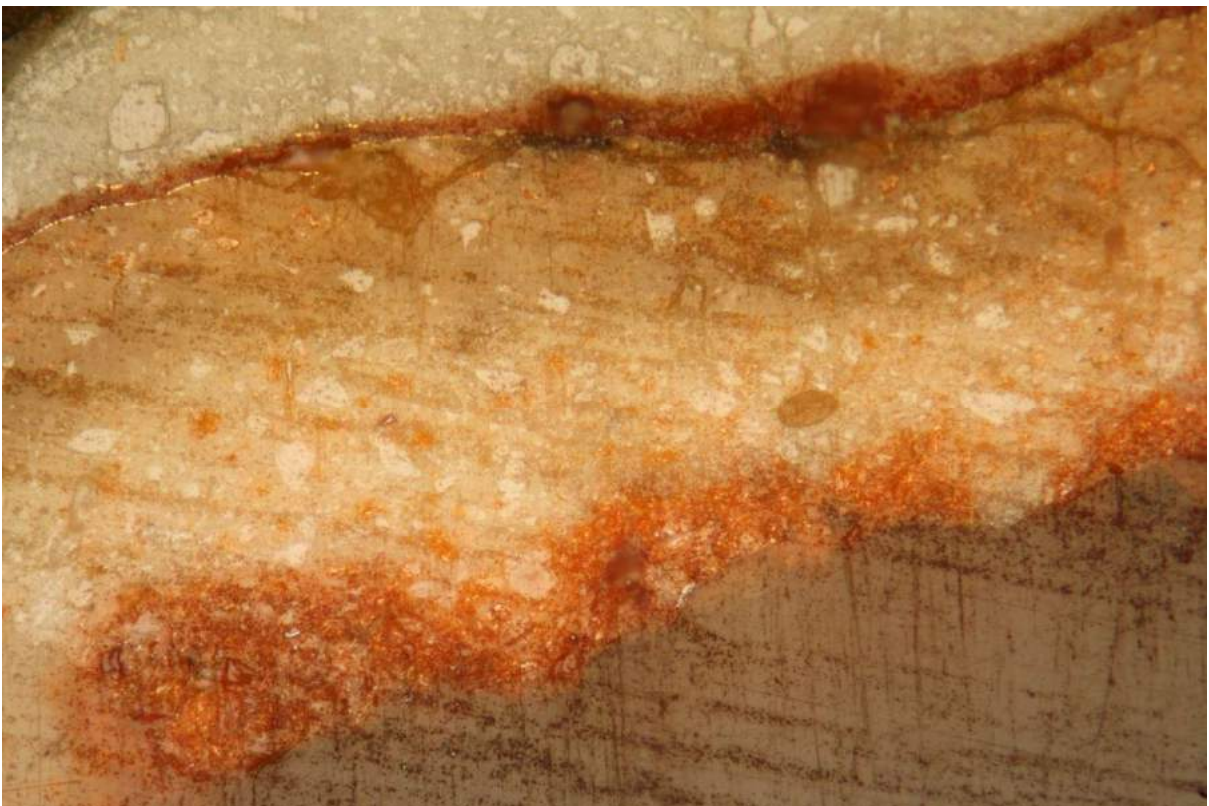
Sample 5

Also notable in the analysis was the double layer of gold leaf visible in sample 5 both above the mordant as expected and again on top of the red lake glaze. This was either accidental placement of leaf on a sticky glaze surface or a deliberate highlight/gilding of this element.

1. Thin red ground, mainly red earth, some impurities and chalk
2. Yellow ochre layer with some red lead and chalk
3. A second layer of yellow ochre which is more translucent and slightly darker but essentially has the same constituents as the layer below. This is the mordant for the gilding
4. Gold leaf layer-I think this is gold, but it could be silver leaf
5. Red lake glaze. Interestingly, there are areas where there is a layer of leaf applied over the red lake glaze as well as under it
6. Gold leaf again (only in places, this could be highlights or just stray bits of leaf?)
7. Lead white
8. Copper green glaze, some char black
9. Waxy coating

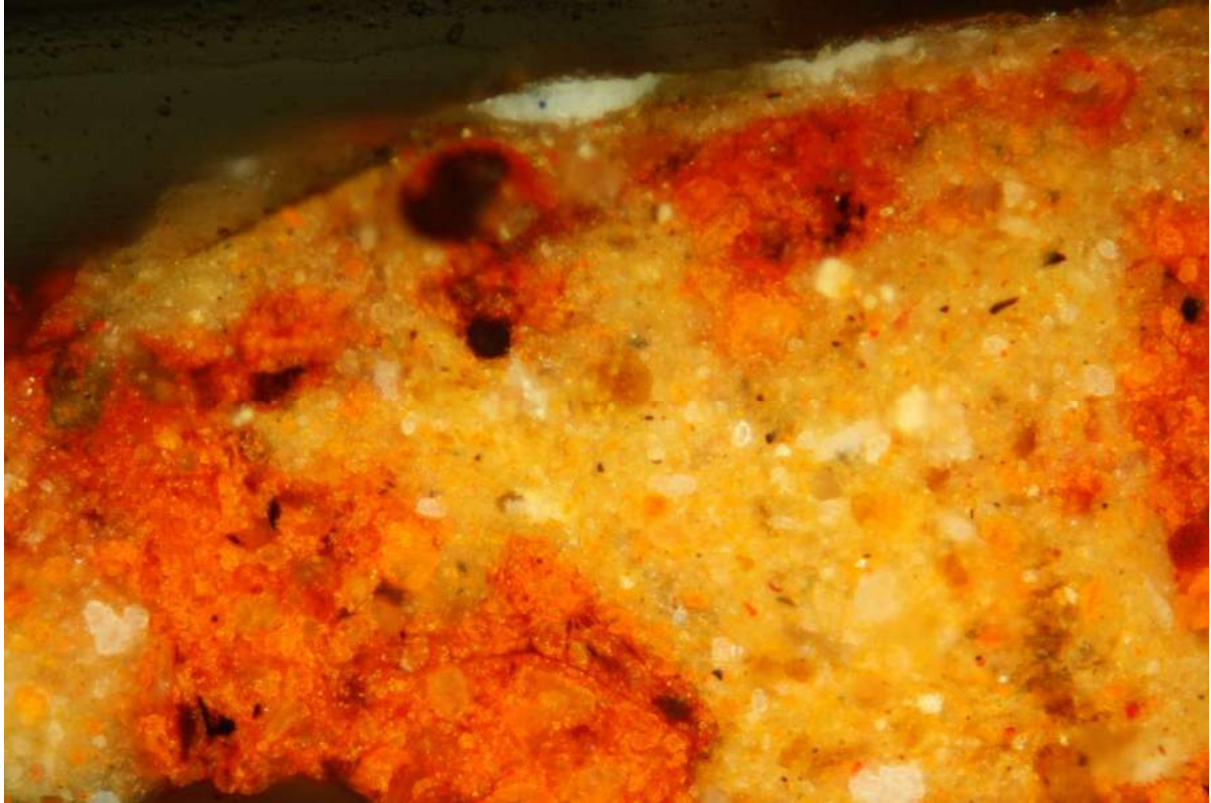
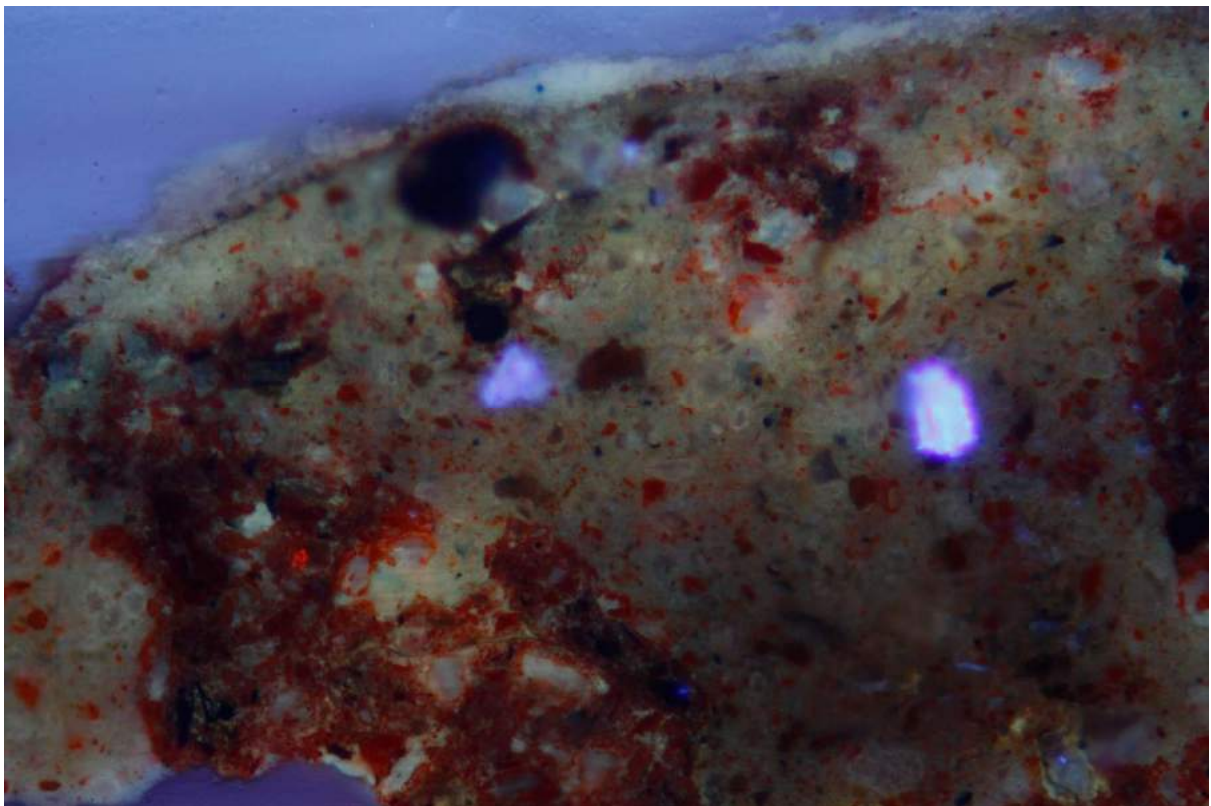
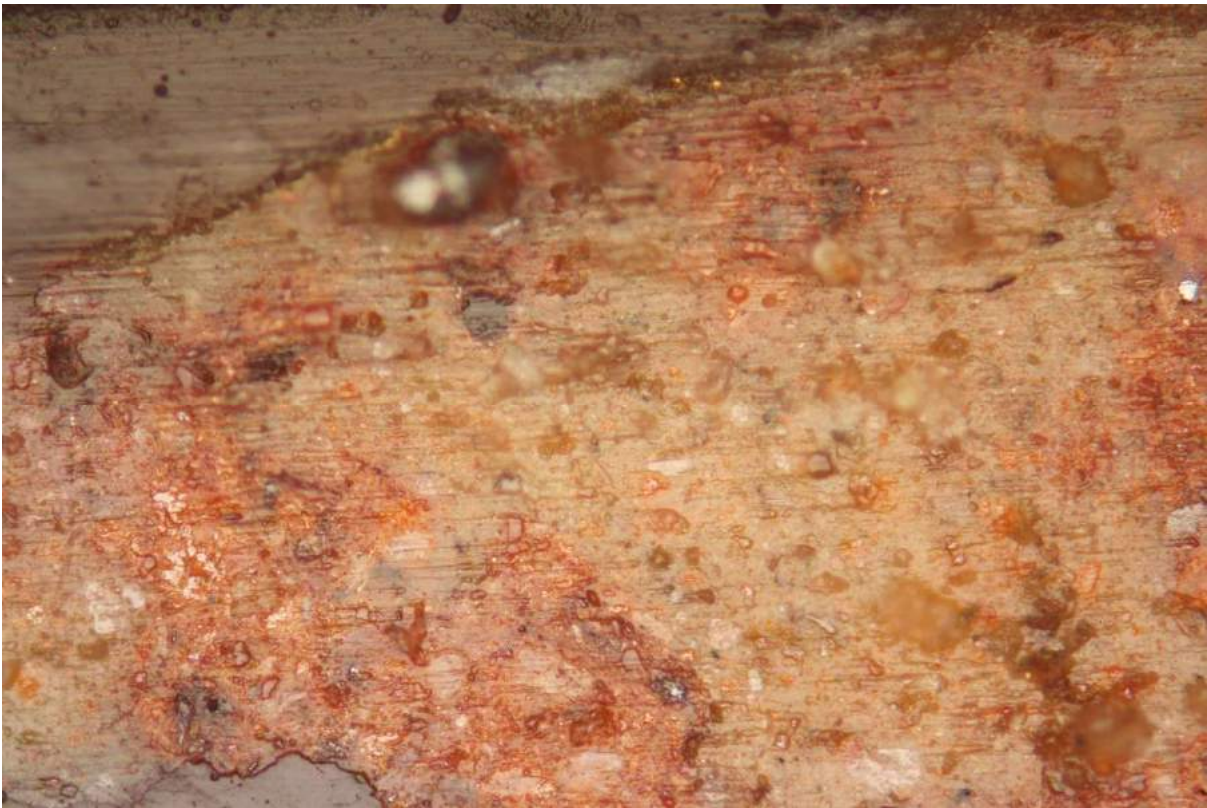
Sample 6

1. Thick mixed earth layer with some chalk, lead white, red lead and char black. Very roughly and unevenly mixed. This is the mordant layer for the gilding
2. Gold leaf
3. White and Prussian blue layer of the type seen elsewhere such as in samples 1, 4 and 12

This sample is unusual compared with the others in having a rather imperfectly mixed red and yellow ochre underlayer with no separate red earth layer at the bottom of the sample. It may be that the lower ground layers were not captured in this sample and that the mordant is not well-mixed.

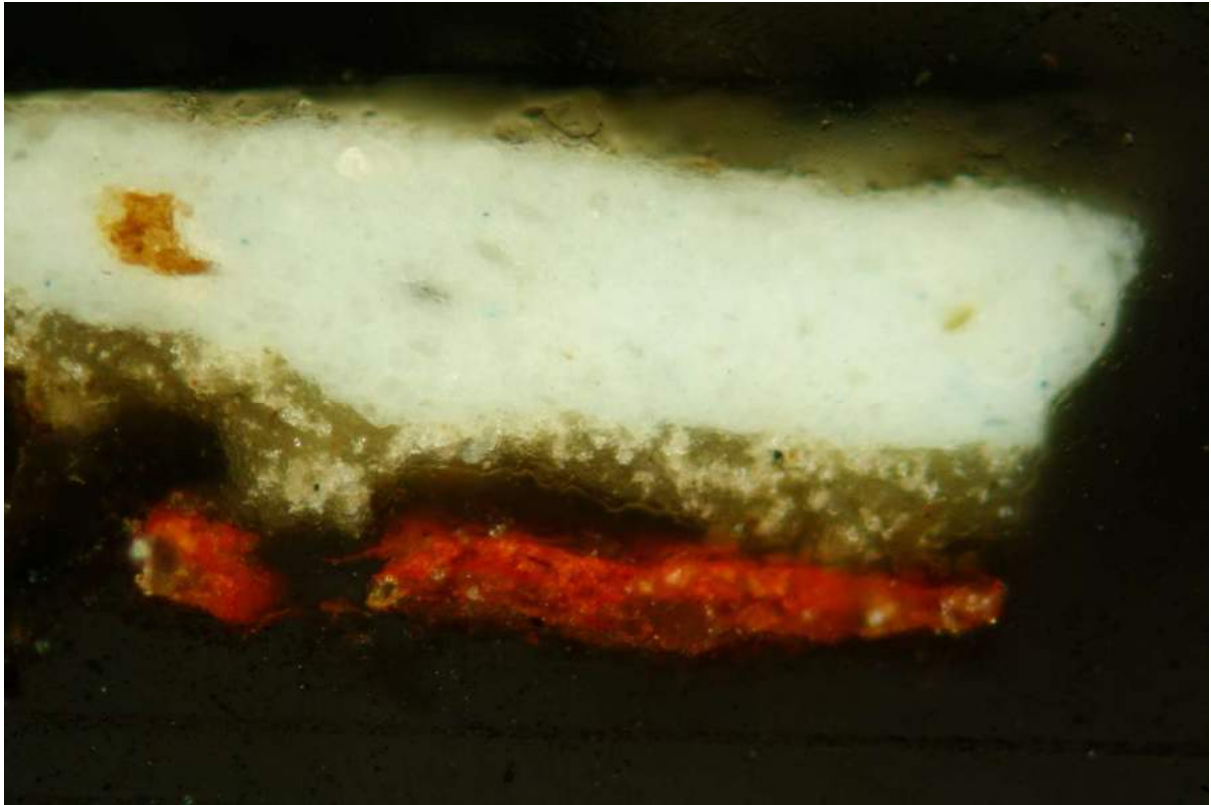
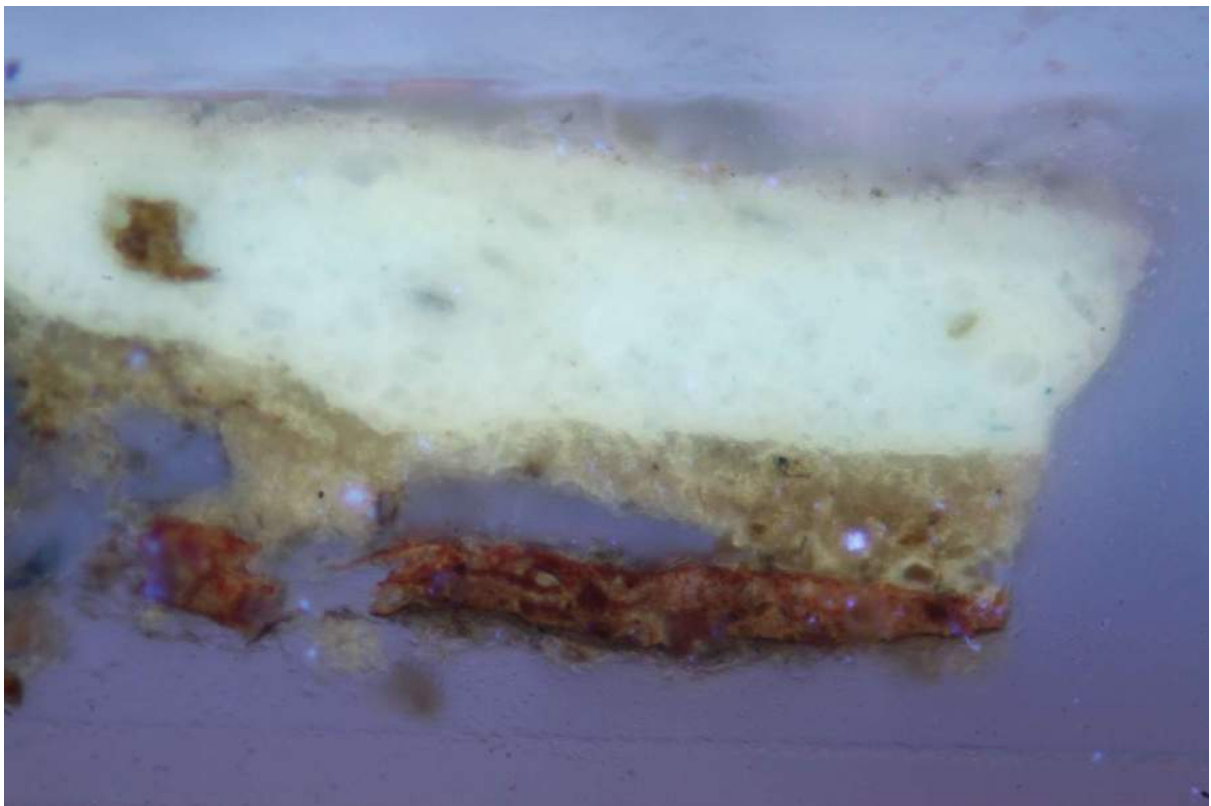
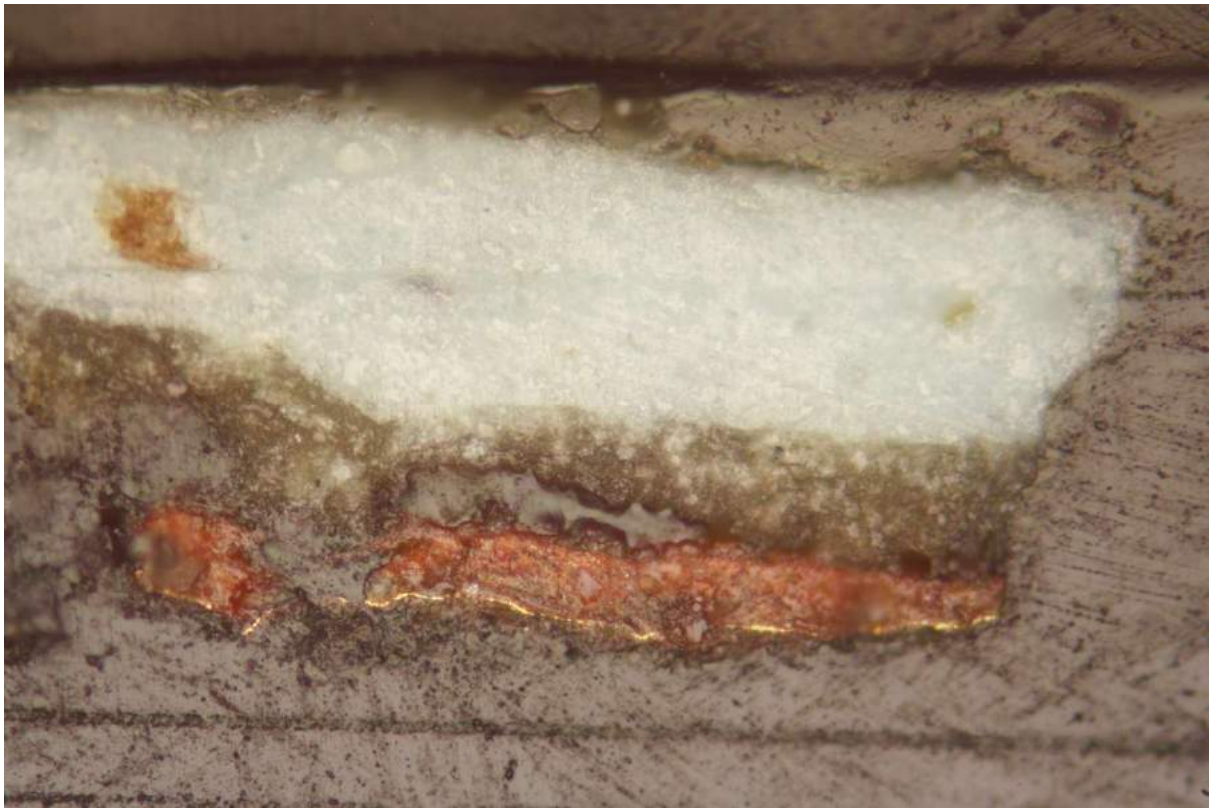
Sample 9

The lowest layers are not present in this sample, which begins at the gilding.

The overpaint in this sample compares closely to that found in sample 1. Prussian blue was seen in the dispersion.

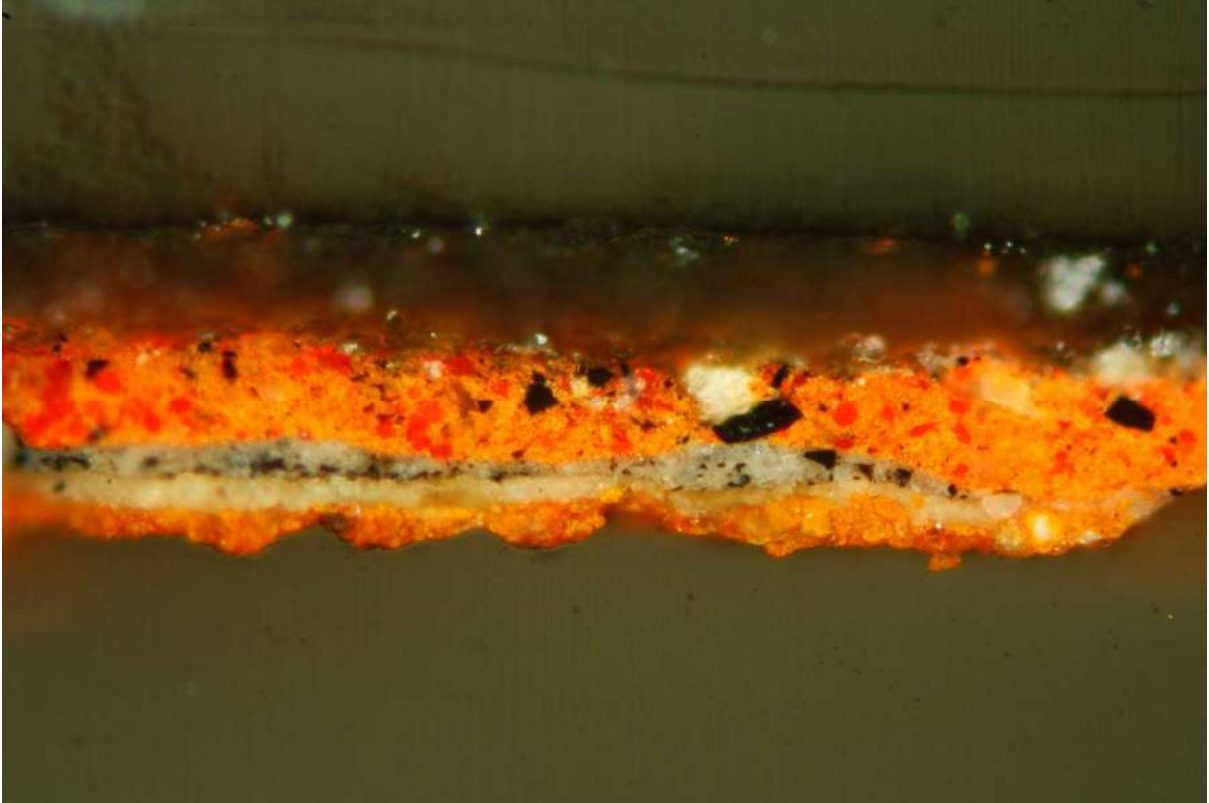
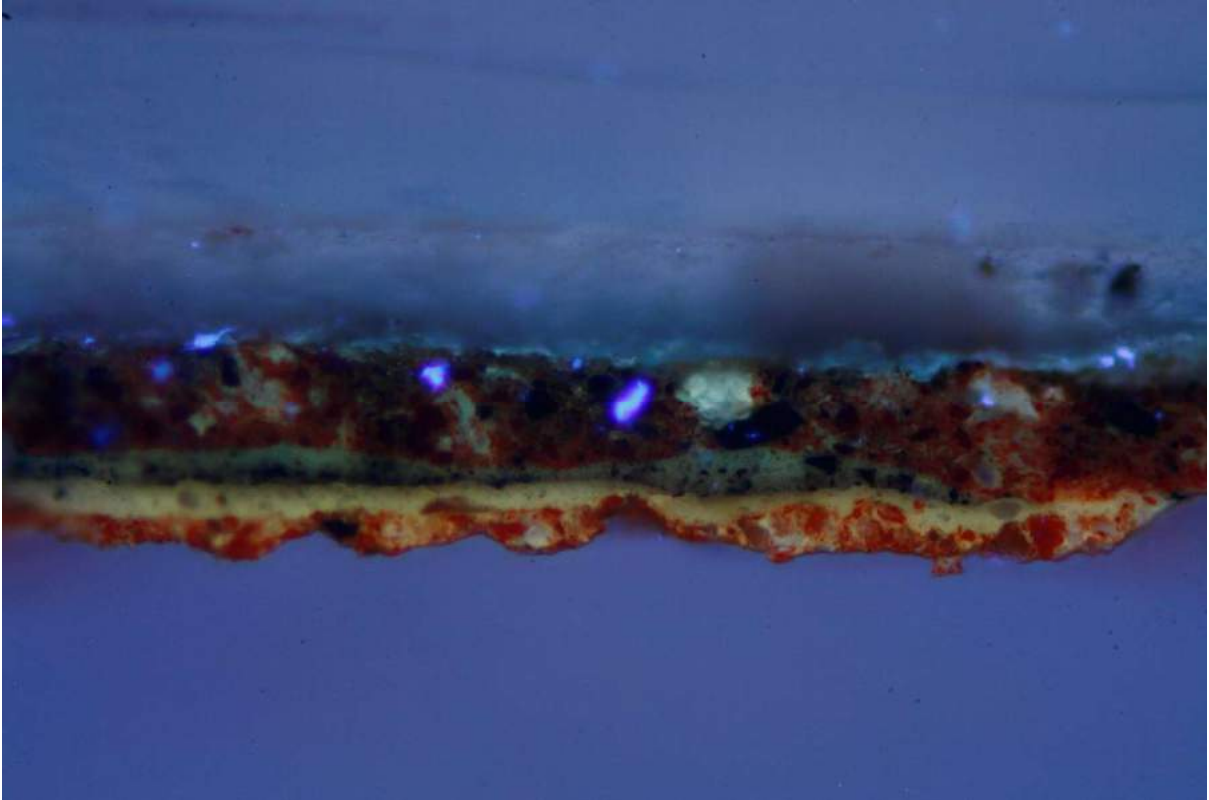
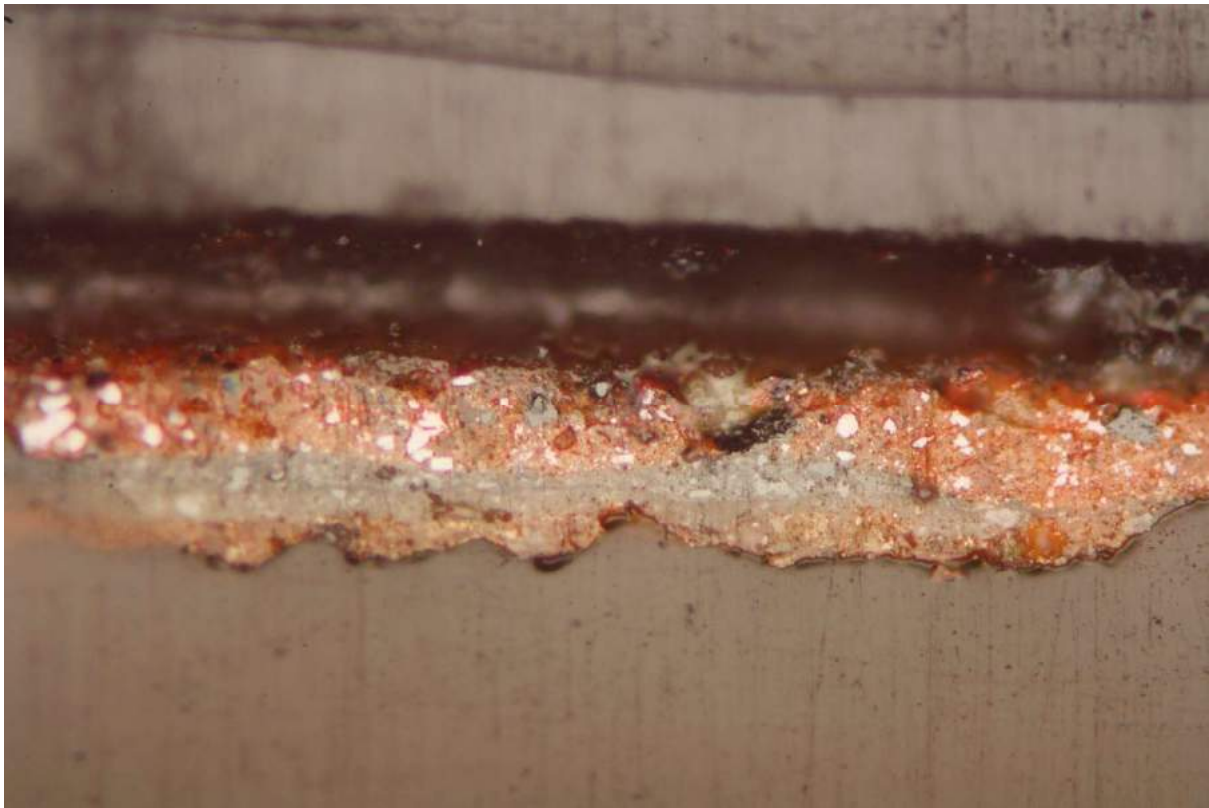
Sample 10

1. Red lead and red earth
2. Yellow ochre
3. Chalk and char black, some lead white (the panel background, I assume)
4. Red lead and vermilion
5. Varnish layer, including some waxy surface material

The preparatory layers here on the figure panel are thinner than those seen elsewhere. In this case, there is only one mixed layer of red lead and red earth rather than the two layers, assuming all layers have been captured in the sample.

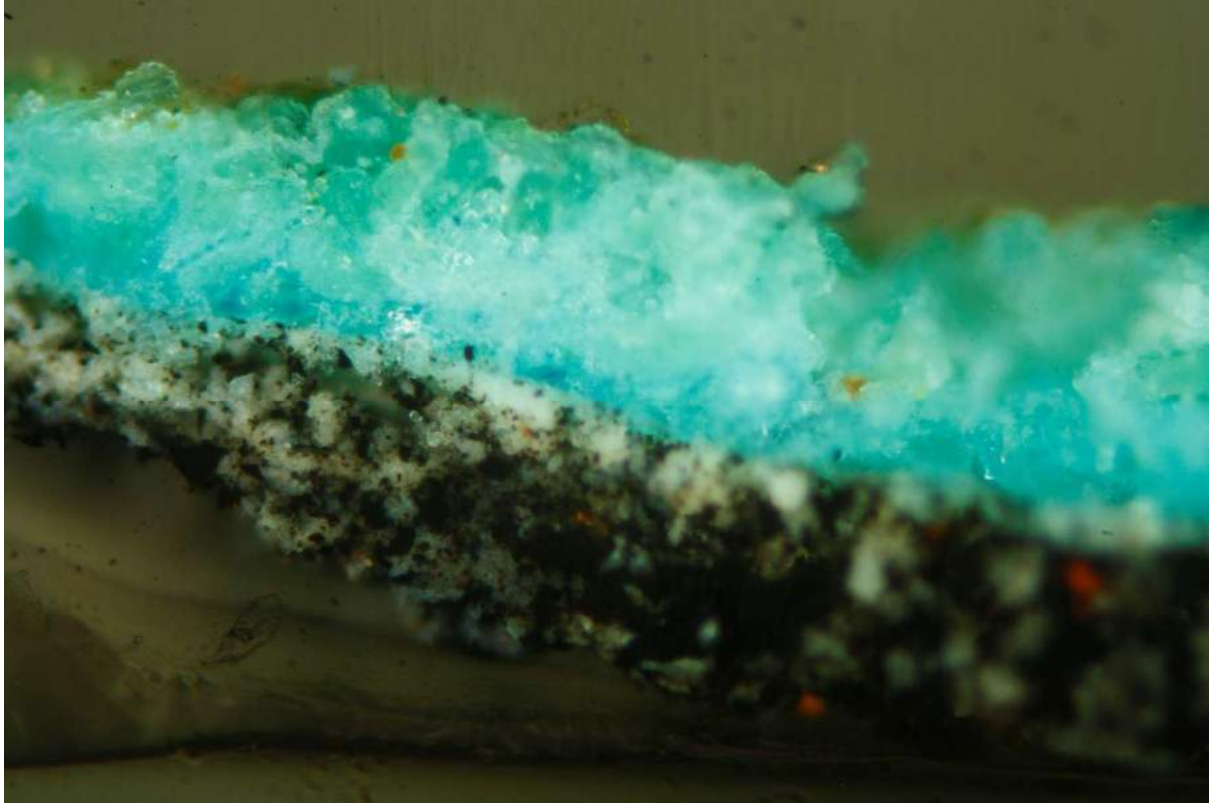
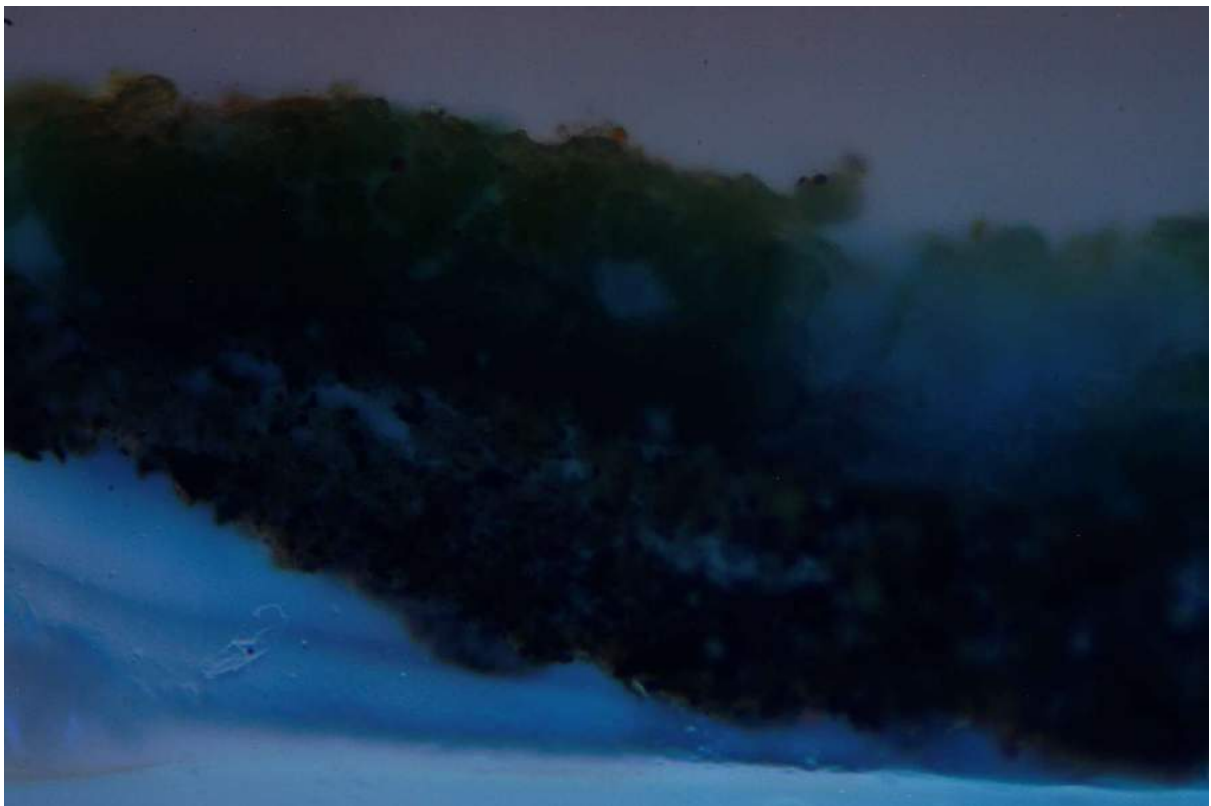
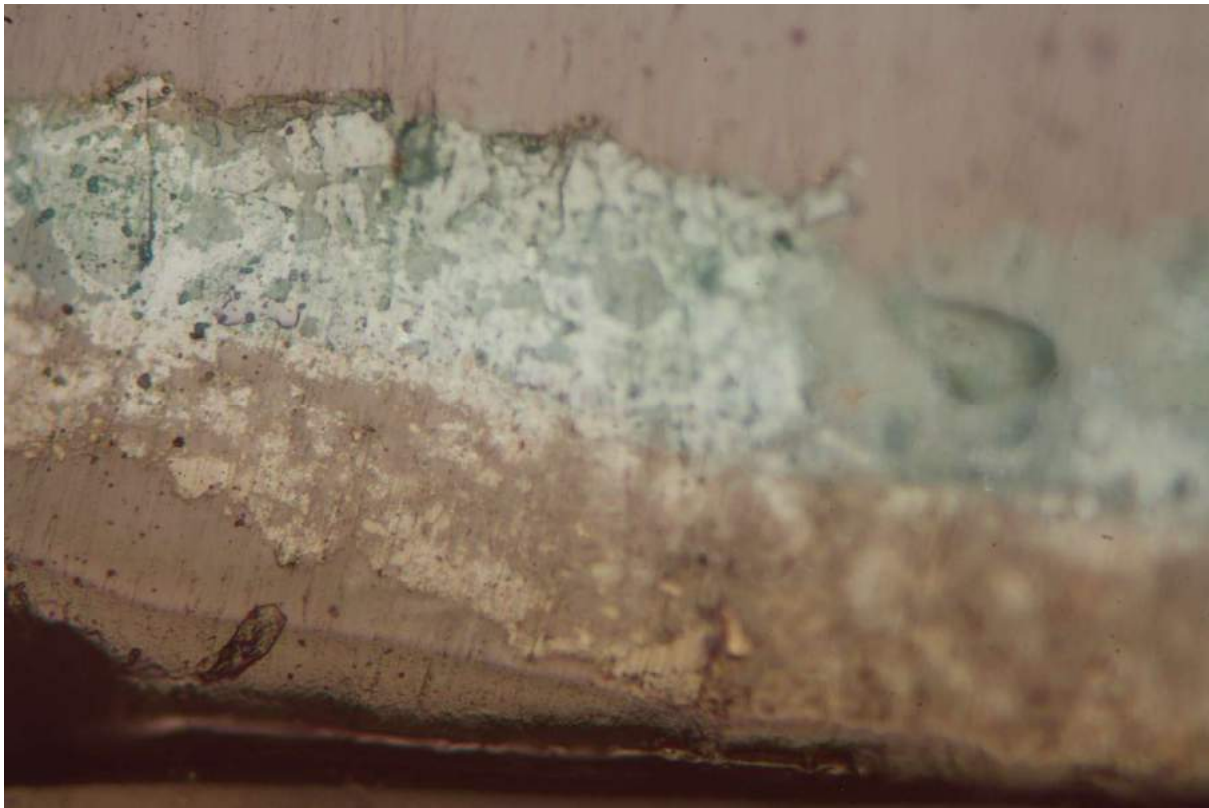
**Sample 11**

The lowest layers are not present in this sample.

It is notable that the grey underlayer has been used to try and make the azurite more impactful as a colour, as it is not a strongly blue example. It is unlike most of the azurite I have seen on East Anglian screens and I wonder if it had a local origin, or whether it has undergone a degradation to paratacamite? In dispersion, there are blue particles of azurite and also green malachite particles. It may be a deliberate blend.

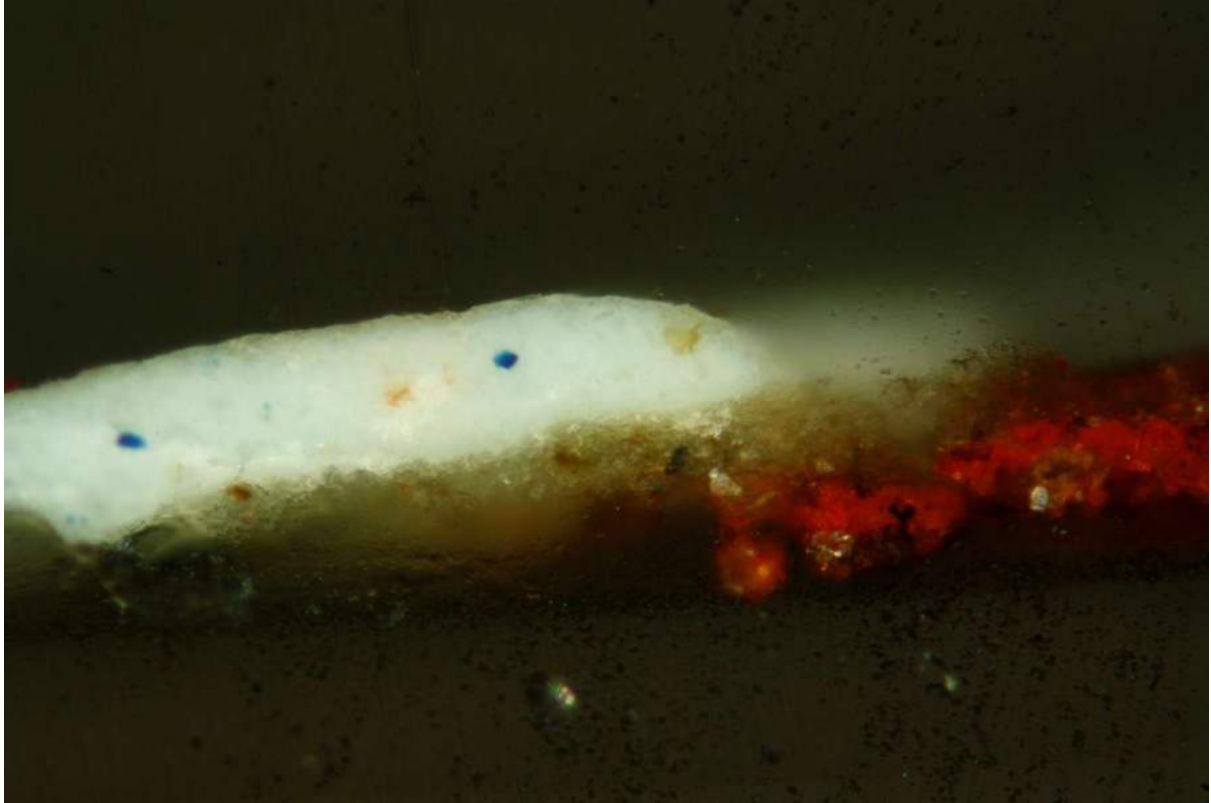
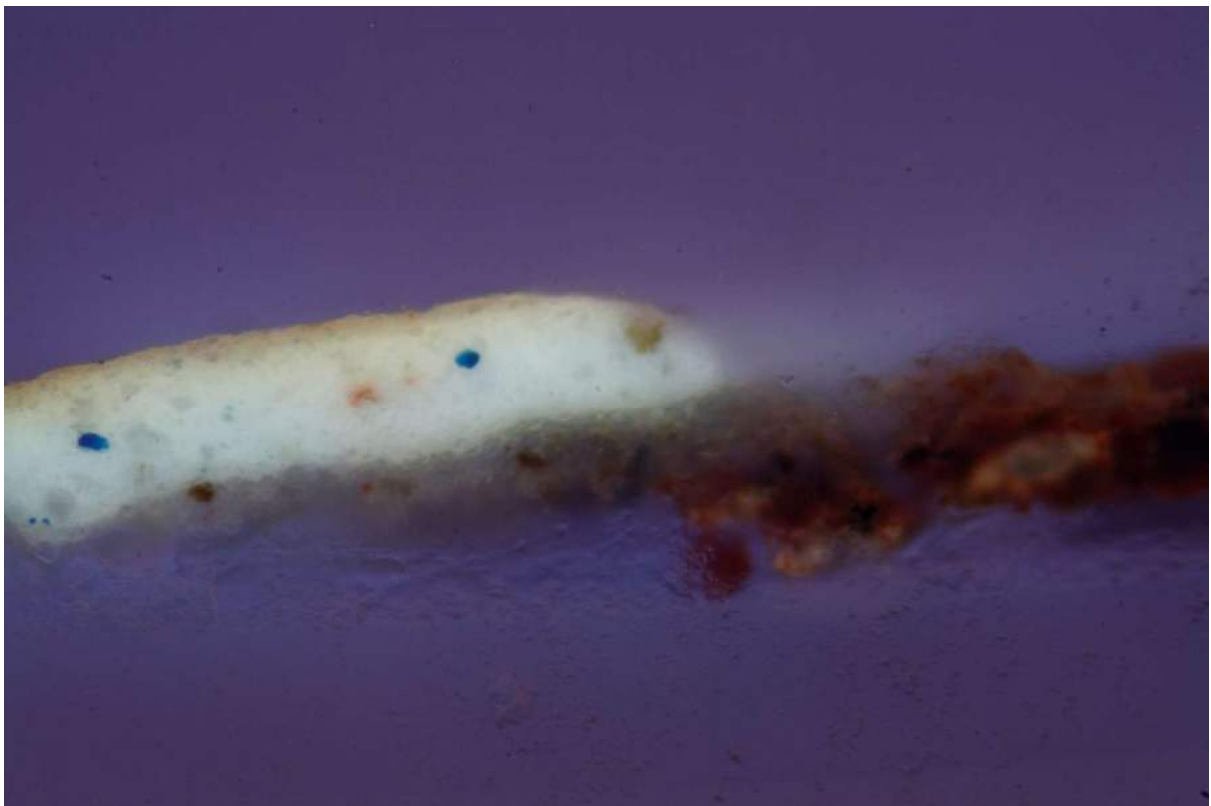
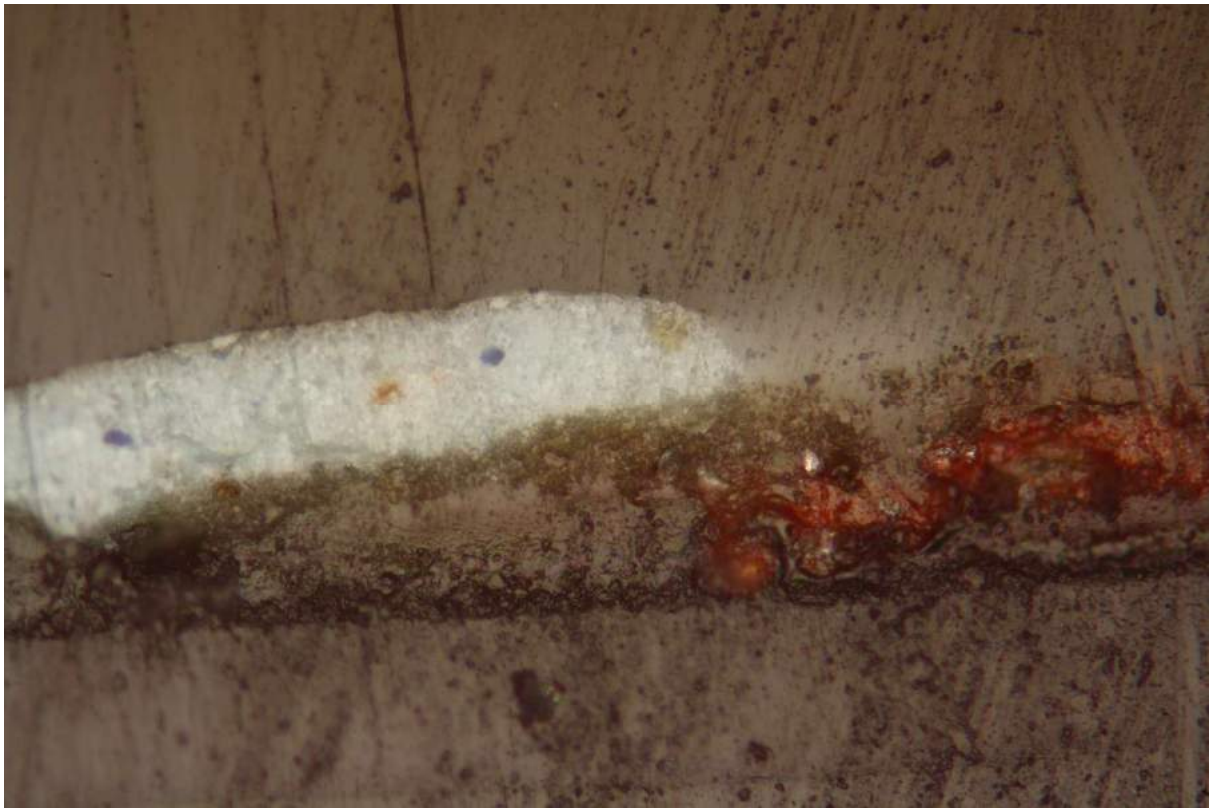
Sample 12

The gilding was not visible in this sample.

1. Red earth layer, probably the same as the lowest ground layer seen in other examples
2. Yellow ochre medium-rich layer comparable to where this overpaint has been seen elsewhere.
3. Upper overpaint layer of lead white, some yellow ochre and some Prussian blue
