St Winwaloe's  
East Portlemouth  
Rood Screen: Polychromy Report

©Eddie Sinclair ACR

October 2016

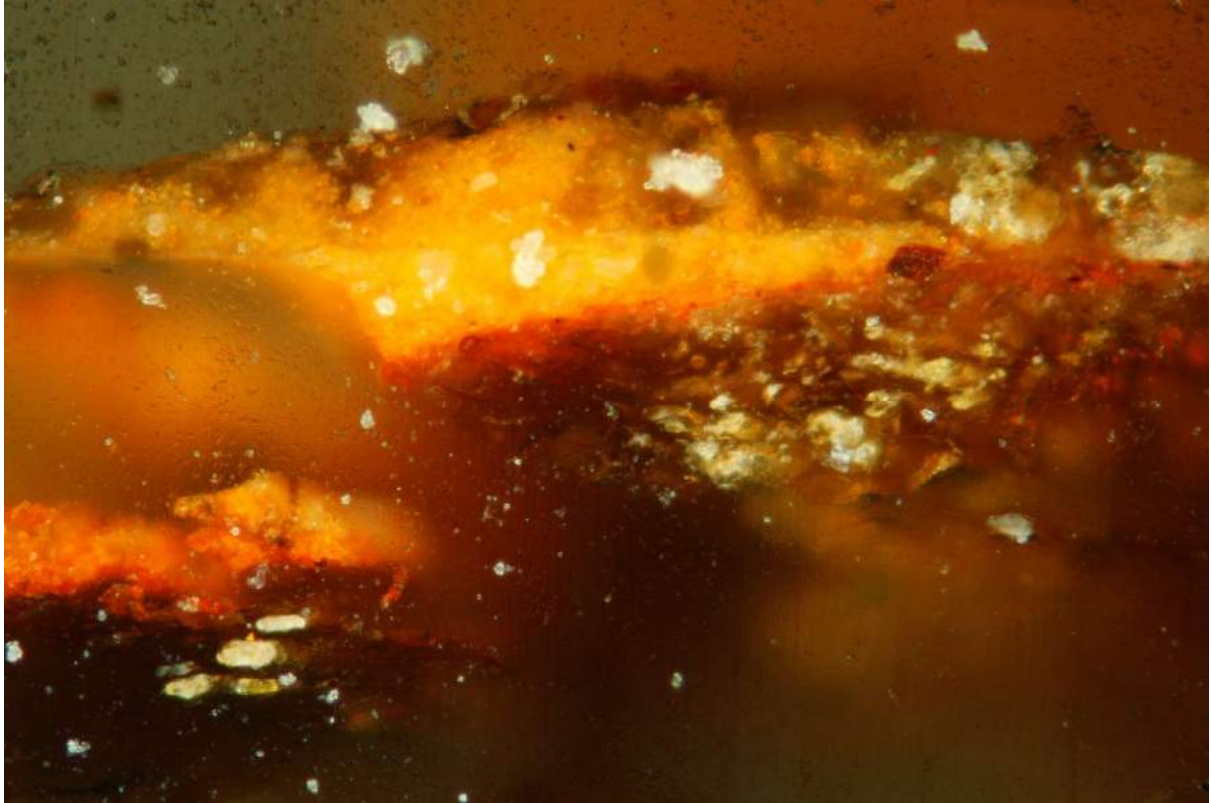
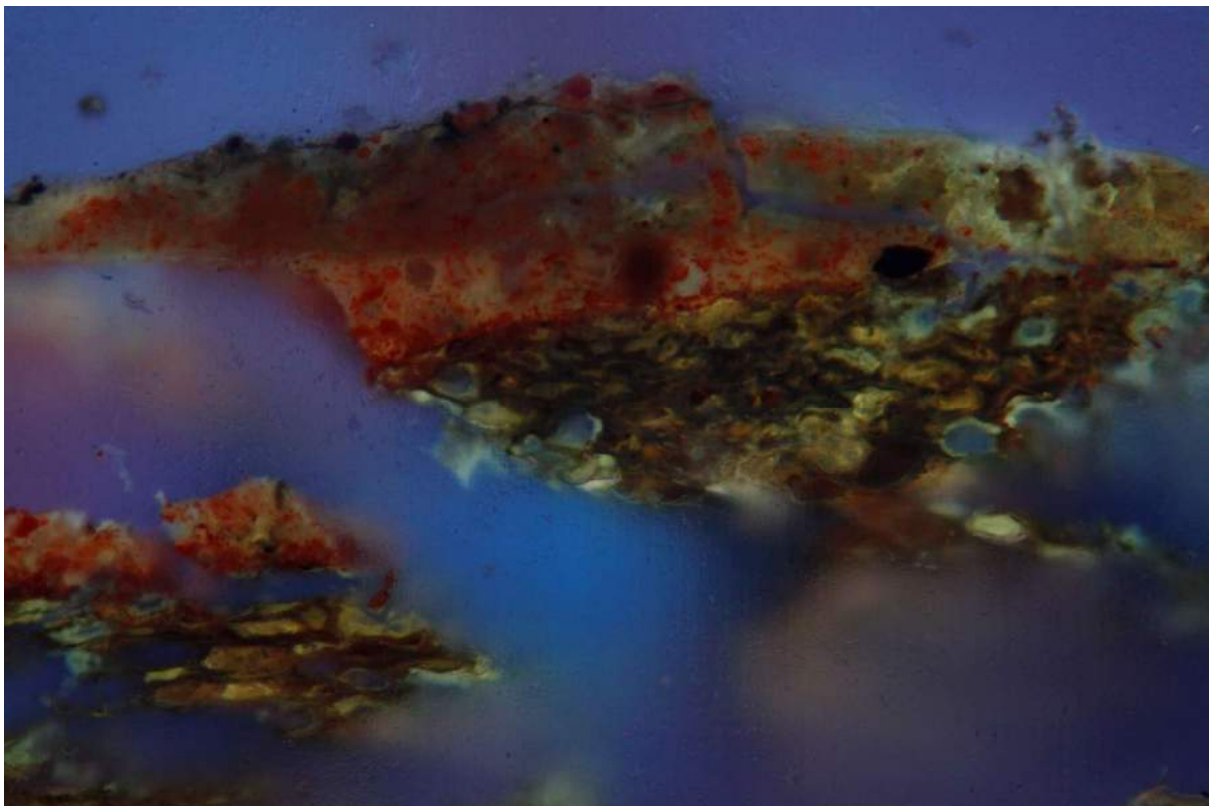
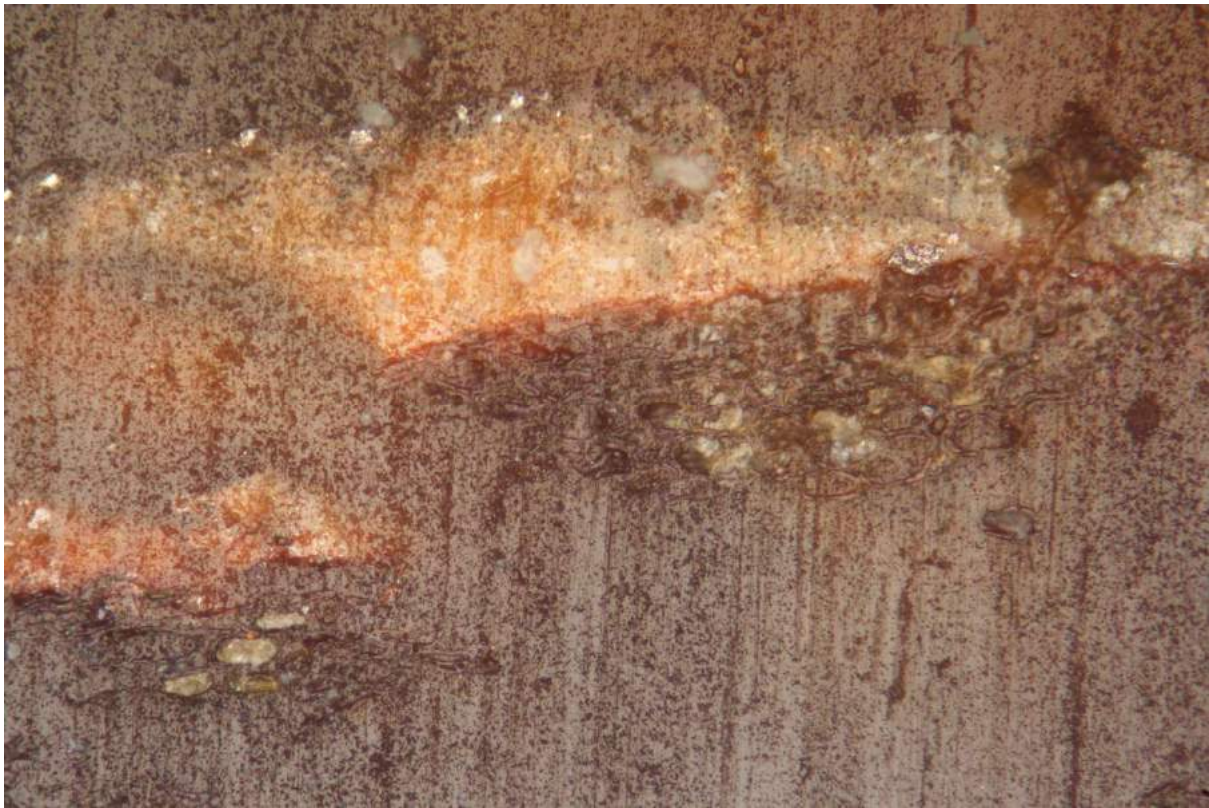
**Sample 13**

1. Wood
2. Thin red earth layer
3. Red lead and red earth layer
4. Secondary reddish layer, this time containing more yellow ochre, more chalk and perhaps more medium. This is the mordant layer. To the right there is an are containing more chalk and lead white.
5. Silver leaf
6. Red lake

Red lakes were seen in the dispersion sample and can be seen at the top of the sample here, although they are not very visible.

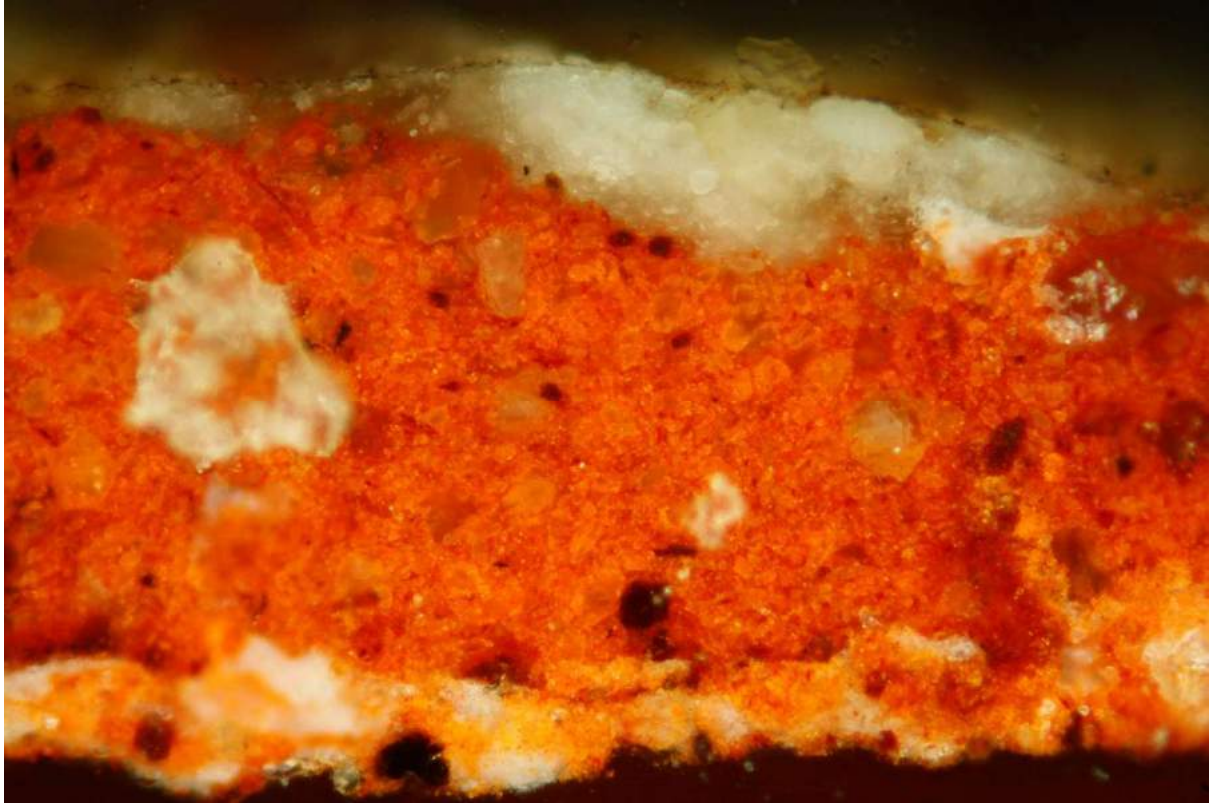
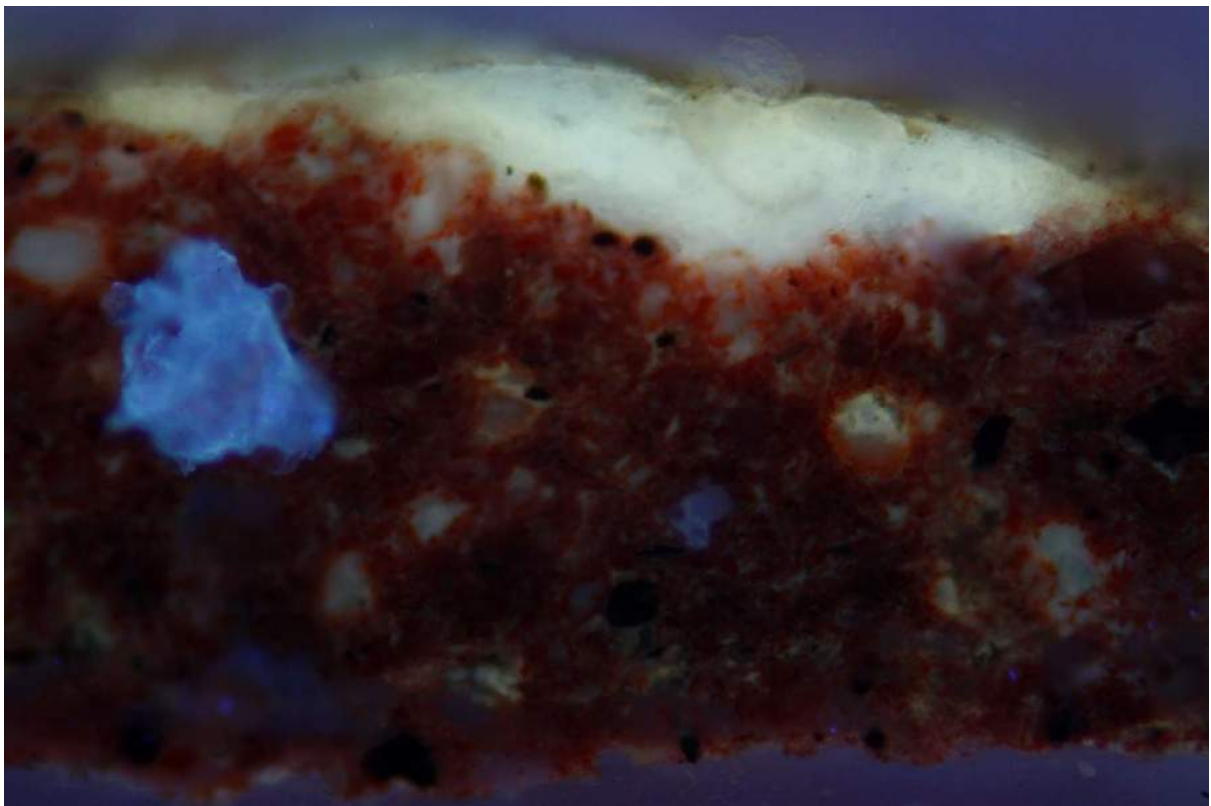
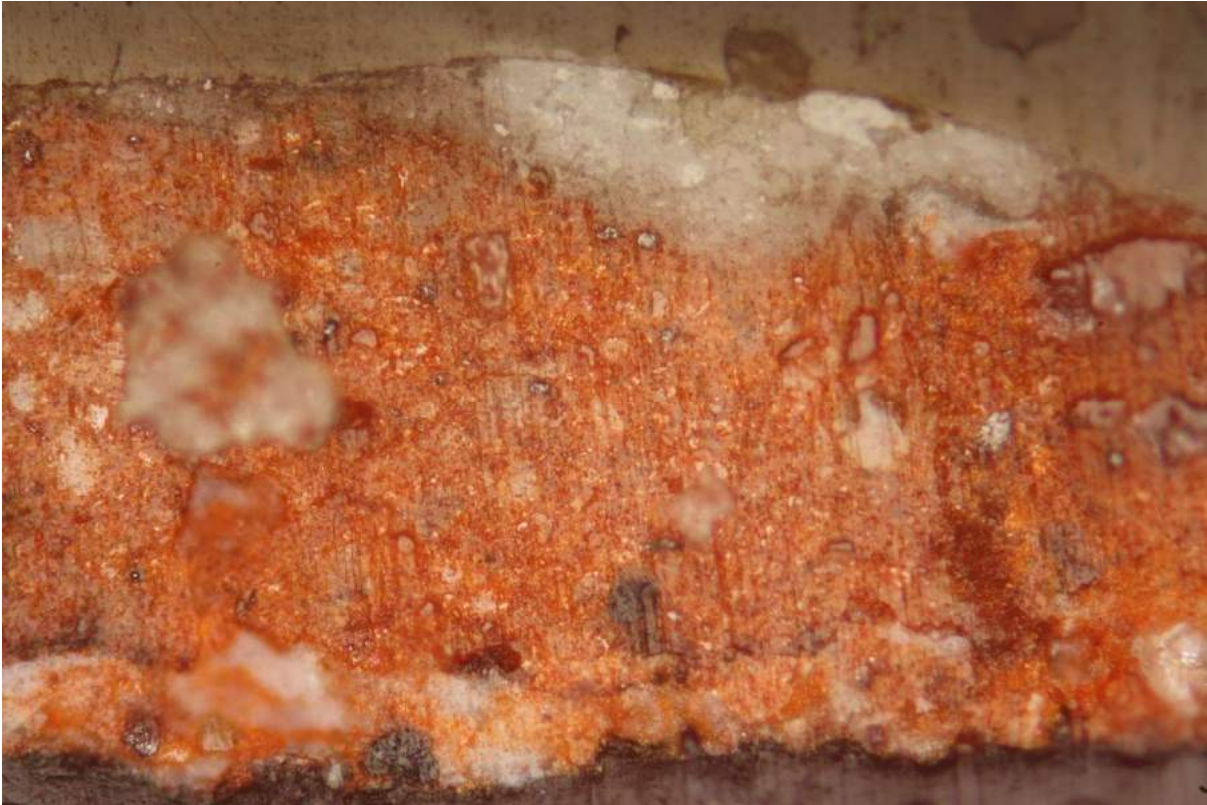
Sample 14

1. Ground layer consisting of lead white, red lead and some red earth
2. Thick red earth layer wuth some red lead
3. Lead white and lead tin yellow layer
4. Surface dirt layer including red earth and soot

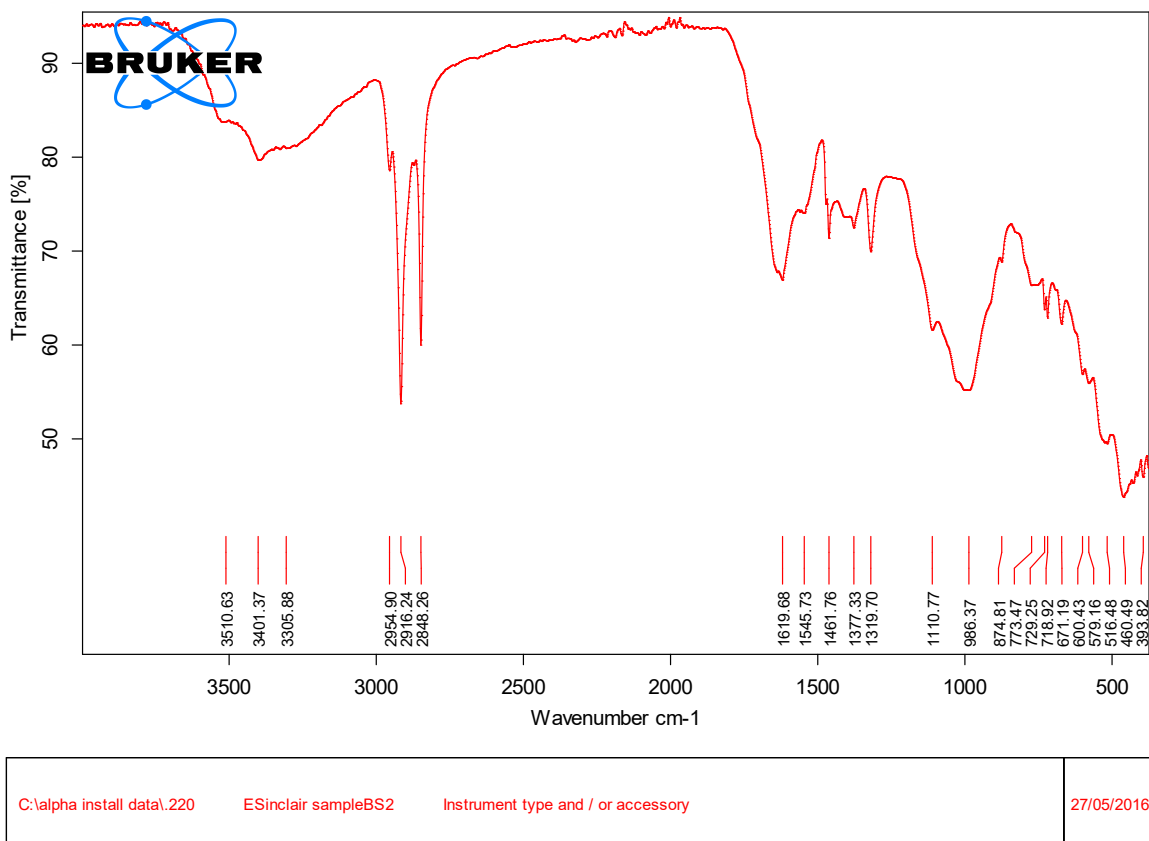
The FTIR (figure 1 ) showed peaks at 2954, 2916, 2848, 1462, 1377, 729 and 719  $\text{cm}^{-1}$  typical of wax, such as paraffin wax (cf Figure 2). But also there are peaks at 1725  $\text{cm}^{-1}$  aprox. and 1700  $\text{cm}^{-1}$  aprox. as shoulders on the peak at 1620  $\text{cm}^{-1}$  and 1320  $\text{cm}^{-1}$  which may be due to the oil in the paint, or previous consolidant, or may be due to an ester wax such as beeswax (cf. Figure 3). The spectrum also contains peaks due to pigments, the peak at 996  $\text{cm}^{-1}$  indicating silicates and the peak at 516 and 460  $\text{cm}^{-1}$  indicating iron oxide.

Figure 1 FTIR Spectrum of sample BS2 white bloom side of paint chip

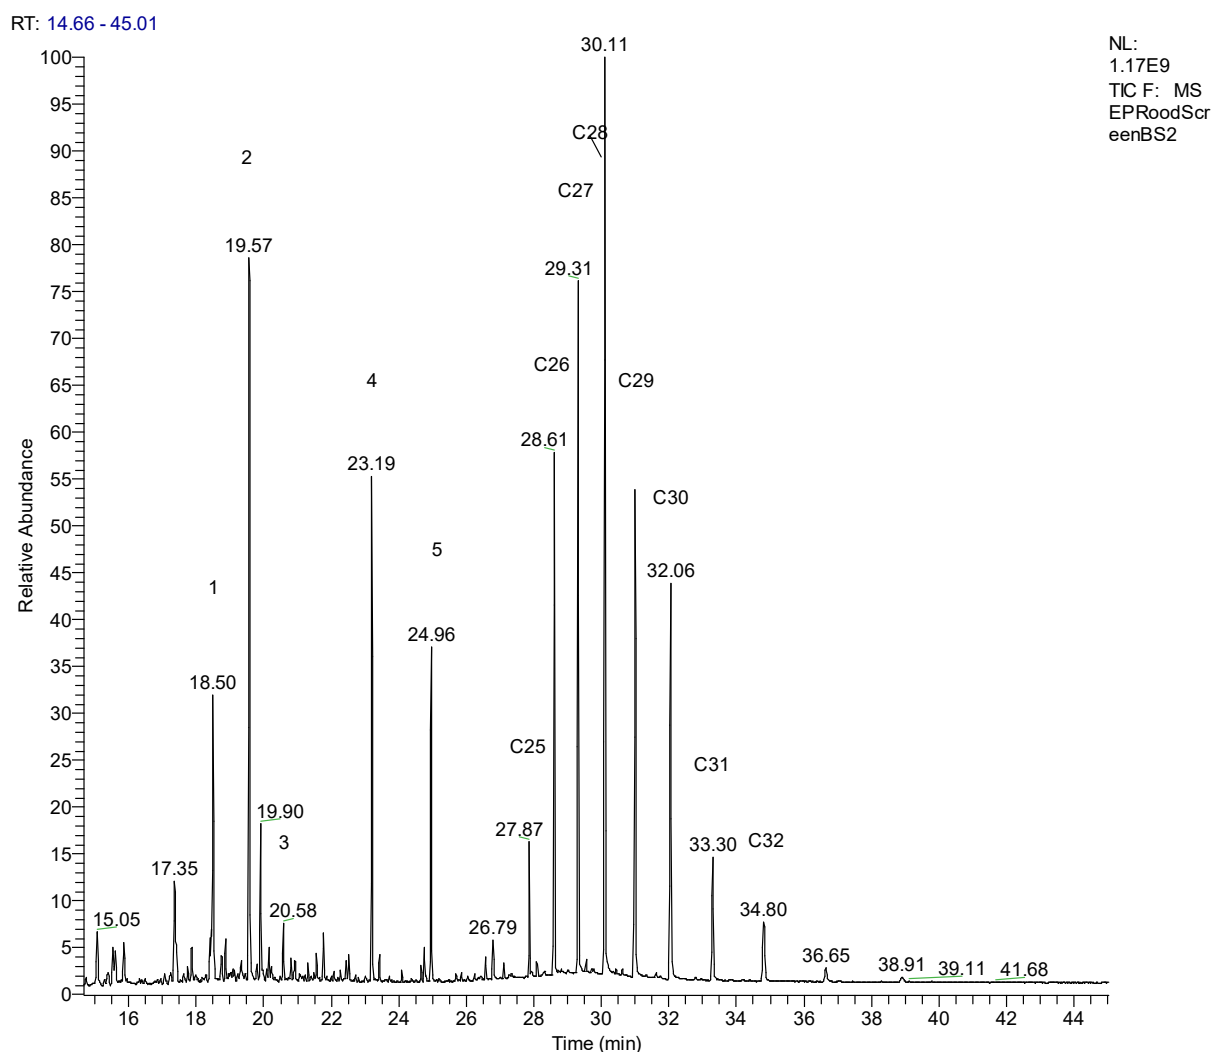
Some of the white material was scraped from one of the fragments with a scalpel and analysed. Thermally assisted methylation and pyrolysis followed by GC-MS analysis revealed (figure 4) fatty acids probably either the medium or consolidant from some of the paint scraped up with the white substance, with a high azelate to palmitate ratio indicating a drying oil and with a P/S ratio of 1.5 indicating linseed oil. But also present, probably from the white substance scraped from the surface, is a series of hydrocarbons peaking at the C28 hydrocarbon (Octacosane) characteristic of paraffin wax. Perhaps this wax has been applied as a polish, or further protection against moisture, or perhaps it has come from the fumes of burning candles in the church.

**Figure 4** Thermally assisted methylation-Pyrogram of sample BS2; (1=suberic acid, dimethyl ester; 2=azelic acid, dimethyl ester; 3=sebacic acid, dimethyl ester; 4= palmitic acid, methyl ester; 5= stearic acid, methyl ester; C25= pentacosane; C26=hexacosane; C27= heptacosane; C28= octacosane; C29= nonacosane; C30= triacontane, C31= untriacontane; C32= dotriacontane.)

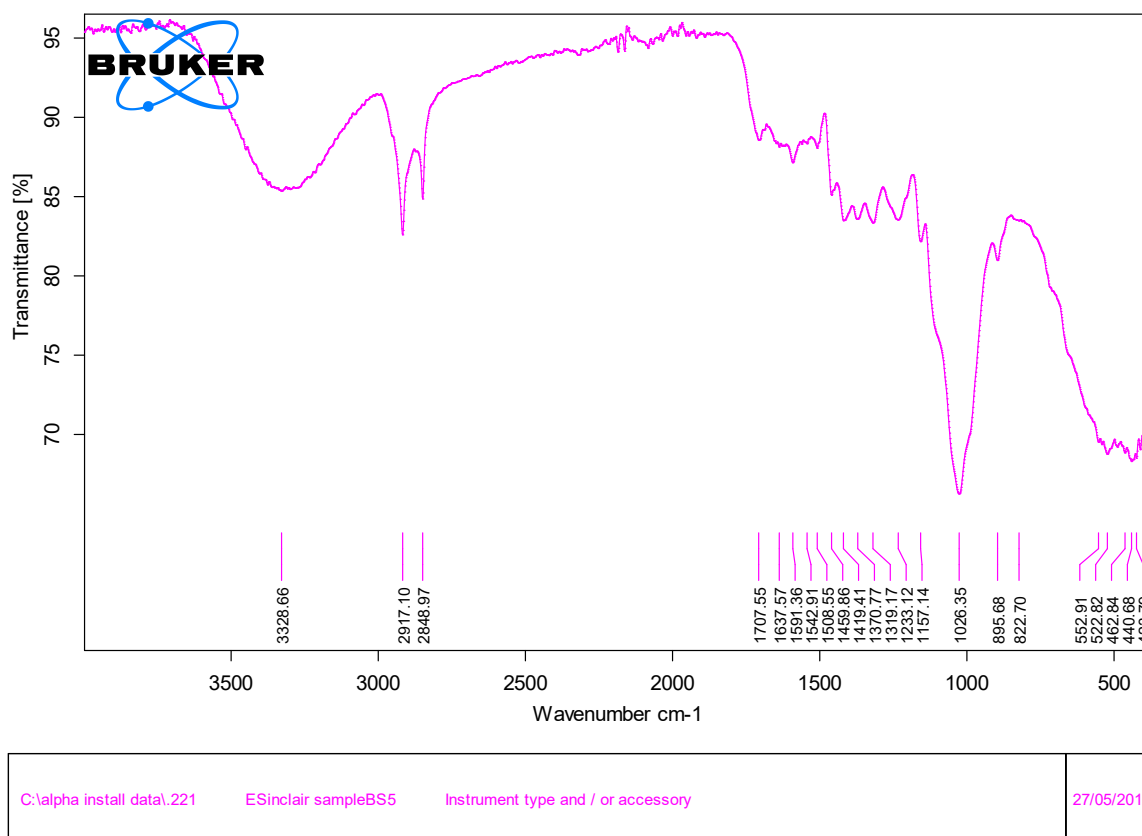
The FTIR of a paint chip from sample BS5 (figure 5) showed peaks at 2917, 2849, 1708, 1233, 1157 and 1080 (shoulder on 1026) typical of a drying oil, perhaps the medium or a previous linseed oil consolidant coating. The spectrum also contains peaks possibly due to the wood, the peak at 1026  $\text{cm}^{-1}$ , indicating cellulose perhaps. However an infrared spectrum of some of the white waxy substance from the same sample (Figure 6) showed peaks at 2955, 2916, 2848, 1461, 1378, 730 and 719  $\text{cm}^{-1}$  typical of wax, such as paraffin wax (cf Figure 2). But also there are peaks at 1724  $\text{cm}^{-1}$  and 1708  $\text{cm}^{-1}$  which may be due to the oil in the paint or may be due to an ester wax such as beeswax (cf. Figure 3). The peaks at 1378 and 677 are due to lead white in the sample.

Figure 5 FTIR spectrum of paint chip from sample BS5

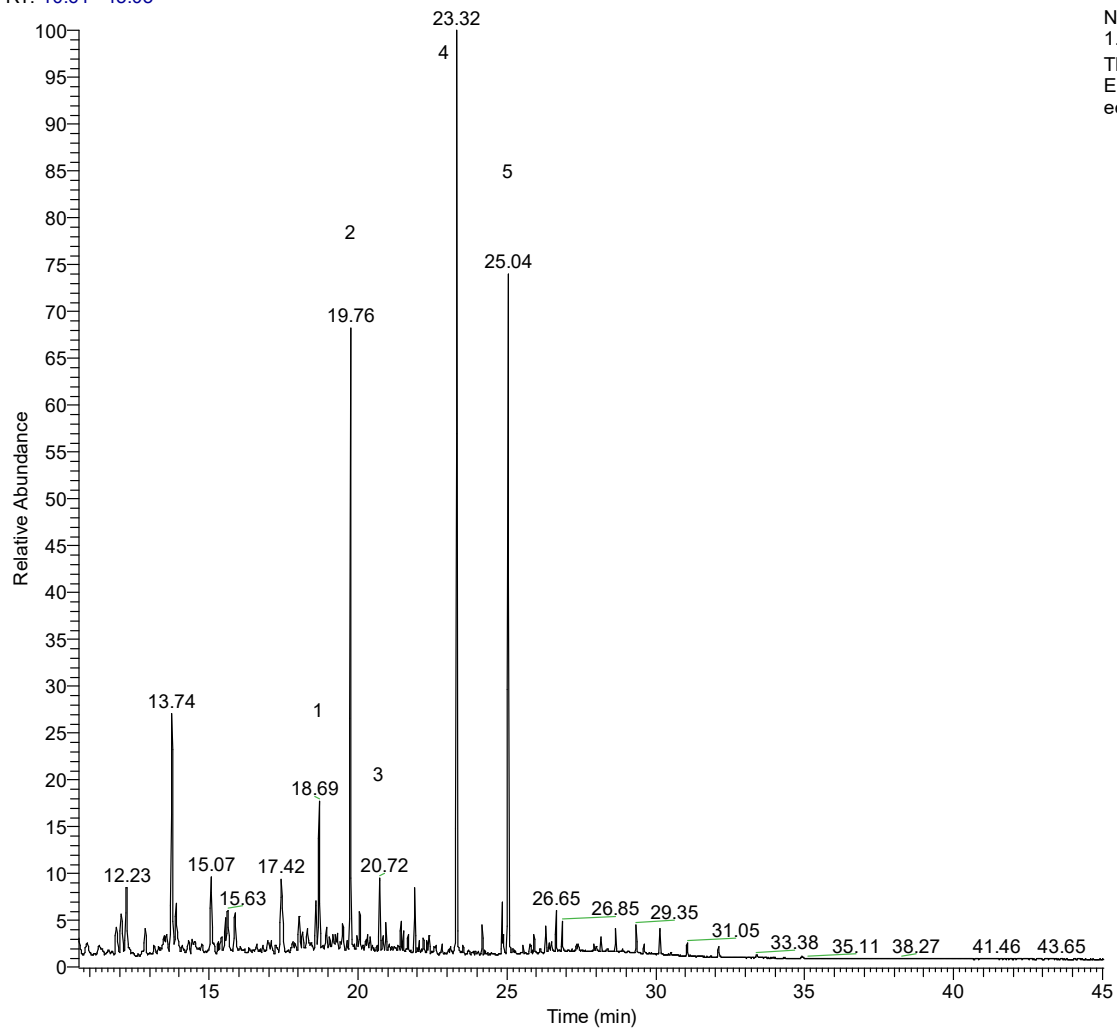
One of the fragments containing some white material on one surface was selected and analysed. Thermally assisted methylation and pyrolysis followed by GC-MS analysis revealed (figure 7) fatty acids probably from the medium or consolidant from some of the paint attached to the white substance, with a high azelate to palmitate ratio indicating a drying oil and with a P/S ratio of 1.4 indicating linseed oil. But also present, probably from the white substance on the surface, is a series of hydrocarbons peaking at the C27 hydrocarbon (heptacosane) (Figure 8) characteristic of parafin wax. There is also some tetracosanoic acid, present as its methyl ester and this may indicate some beeswax mixed with the parafin wax. Beeswax also contains hydrocarbons, mainly with odd numbered carbon atoms and peaking at heptacosane. Perhaps because some beeswax is present here along with the parafin wax the peak is at heptacosane rather than octacosane as in the other sample which seemed to contain only parafin wax. This mixture of waxes may have been applied as a polish or perhaps it has come from the fumes of burning candles in the church.

**Figure 7 Thermally assisted methylation-Pyrogram of sample BS5; (1=suberic acid, dimethyl ester; 2= azelic acid , dimethyl ester;3 = sebacic acid, dimethyl ester;4= palmitic acid, methyl ester; 5 = stearic acid, methyl ester).**
