## ANGLO-SAXON PREACHING CROSS FRAGMENT : CONDITION REPORT

For the PCC of the Church of Saint Mary the Virgin, Gillingham

August 2021

Job No. 2293

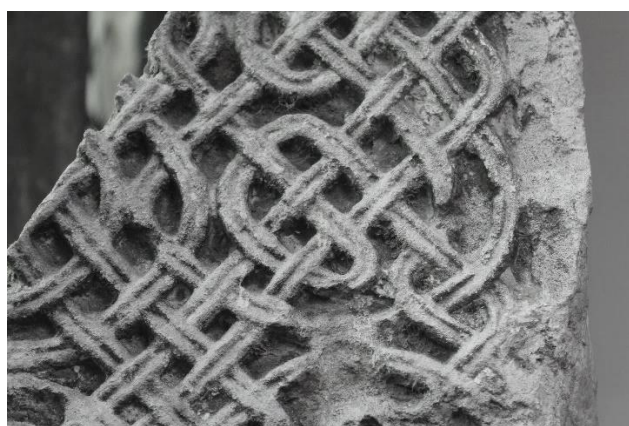
Figure 2 Detail of the west face showing the interlaced double strap work

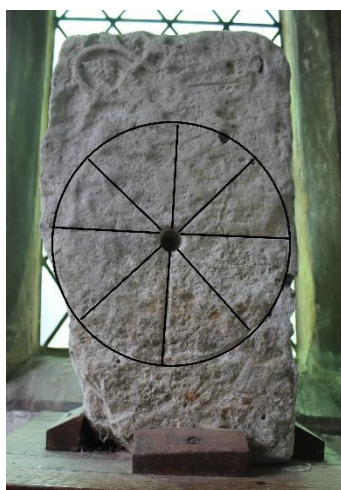
On the south face there is a type of sundial scribed into the stone surface, this was not part of the original design and now the lines are very weathered. The hole which has been drilled in the centre of the dial is for a gnomon. It is believed this sundial to be a mass-dial rather than a sundial by the lack of segments, only eight segments existing. These segments marked times of the day when prayers were said.

Figure 7 Markings of the mass dial

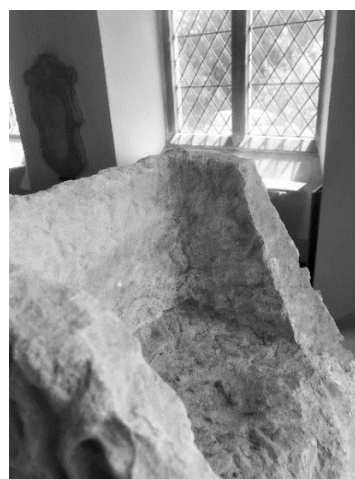
The top of the fragment has a square socket for the cross shaft. Within the base of the socket is a small circular depression, location aid for the shaft.

Figure 8 Top side of the fragment showing the socket and depression

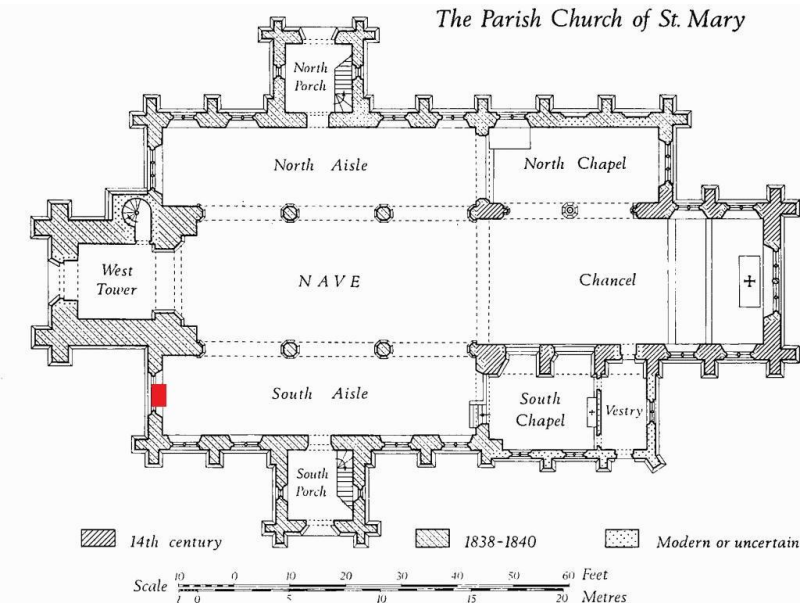
<b>11. Inscription</b>	<p>None</p>
<b>12. Current Location Within the Church</b>	<p>Sitting on a wooden box, sat on the windowsill of the west window in the south aisle of the church.</p> <div data-bbox="204 1160 443 1552">

<p>The Parish Church of St. Mary</p> <p>Figure 10 The red box indicates the current location of the fragment within the church.</p> </div>
<b>12.1 Church Address</b>	<p>Church of Saint Mary the Virgin.  High Street,  Gillingham.  SP8 4AW</p>

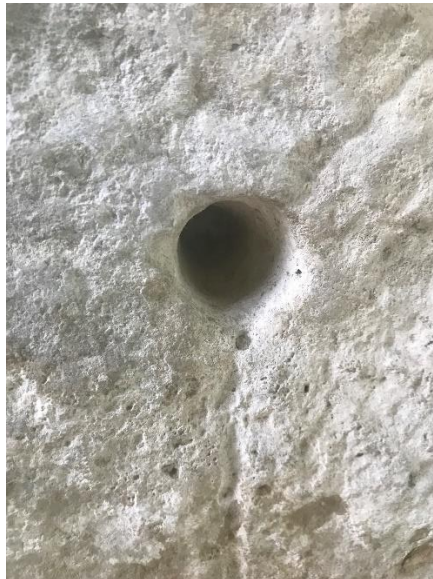
Figure 27 The gnomon hole on the southside

Evidence of small drill holes exist on the south and east sides (see figures 28 and 29). The reason for these little holes is unclear. The set of two holes on the east side are the only holes that seem to have a common link with each other and are more likely to be made when the fragment was used as a building block. They do seem very small for standard building wooden plugs for use with screws; as do the four holes on the front face (south) unless they were for pins to secure light cables such as telephone wire? All the holes have a diameter of 5mm, all the holes but the lower sinister one on the south face are at a ninety-degree angle to the surface. The lower sinister drill hole is set at a forty-five-degree angle down into the block.

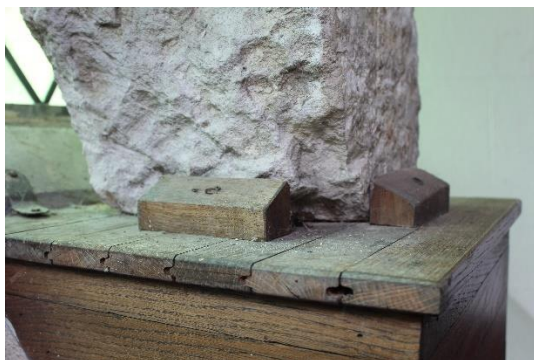
The fragment is presented on the top of a constructed oak wooden box; held in place by three close fitting wooden blocks on the three front faces.

Figure 34 The wooden holding blocks around the base of the cross

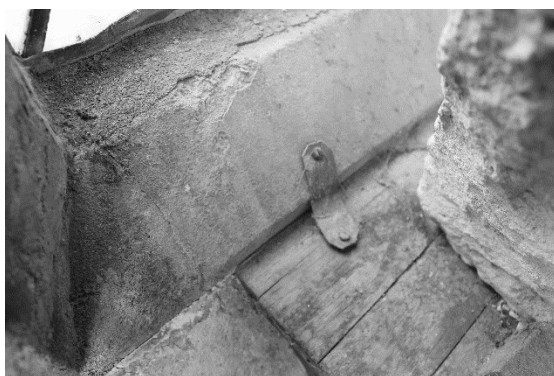
The blocks which hold the fragments are fixed to the box below with screws. The box fits the profile of the sloping sill and has three sides and is central to the inside moulding of the window opening. The box has two visible points of attachment; two brass plates span between the stone of the window and box (see figure 35, below) Both fixed with screws. Hidden fixings within the box may exist as well.

Figure 35 One of the visible attachment points from the oak box to the stone window

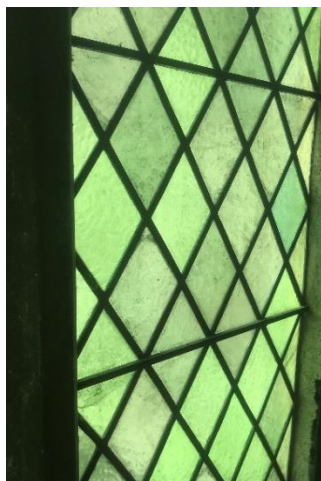
The glass within the window have differing shades of the colour green; set as diamonds in lead cames. This coloured glass does cast a displeasing hue onto the stone (see figures 37 and 38 for comparison).

Figure 36 Detail of the leaded light and the green hues of the glass

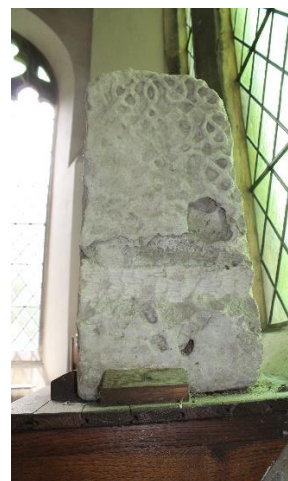
Figure 38 East side, photograph taken with flash
